PROPERTY CHECK EXPRESS REPORT

| Property Inspected | 24B Larch Place, Casebrook, Christchurch |
| Inspection Date | 25 July 2025 |
| Scope of Report | Visual inspection of the buildings that are listed in this report for the purpose of a residential inspection in accordance with NZS4306: Residential Property Inspections. |

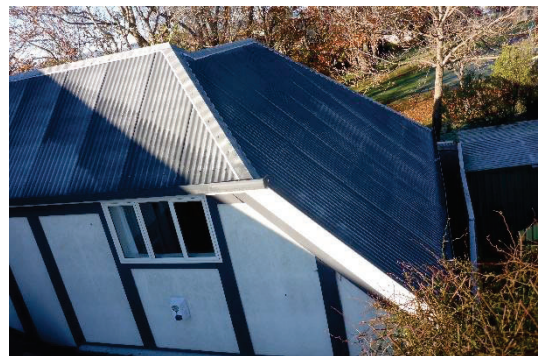
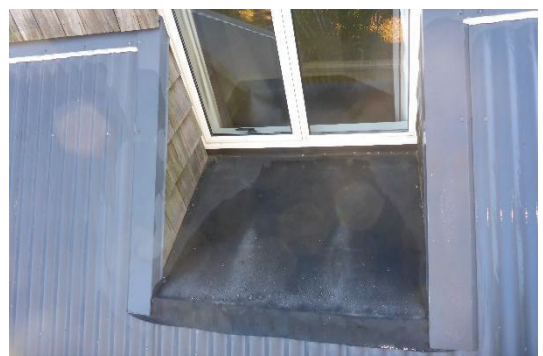
The butyl rubber membrane over the dormers is in good condition.

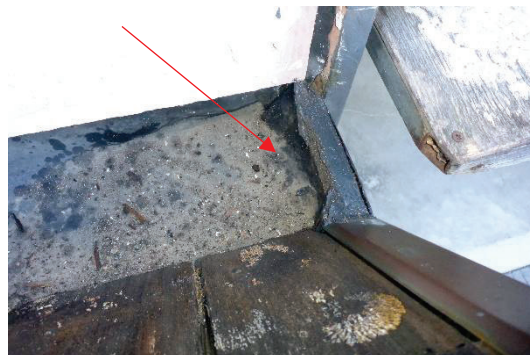
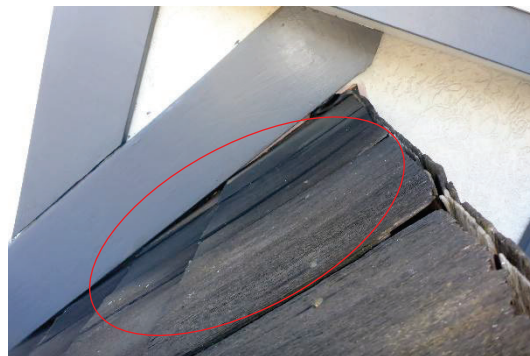
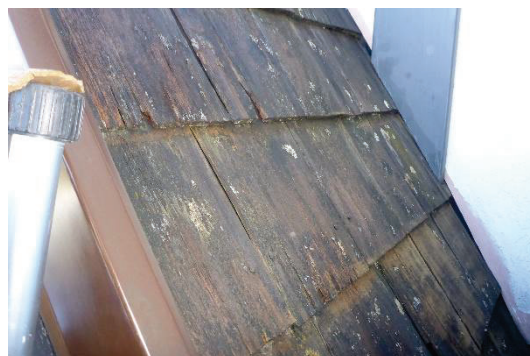
Some timber shingles over the main entrance are deteriorating and may need replacing in the near future.

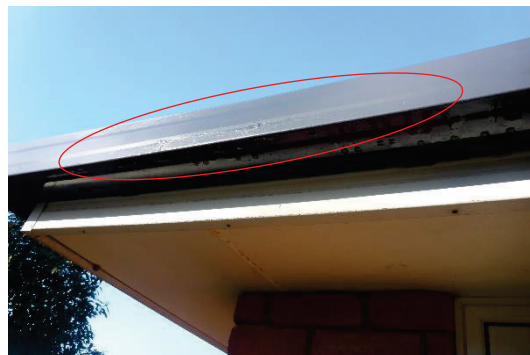
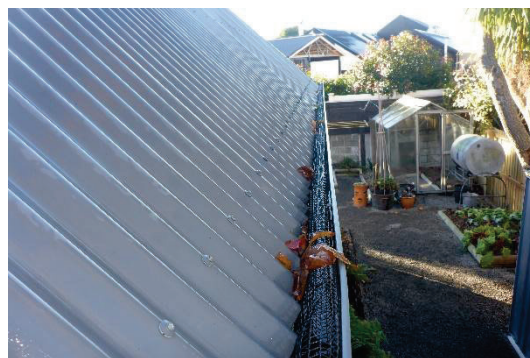
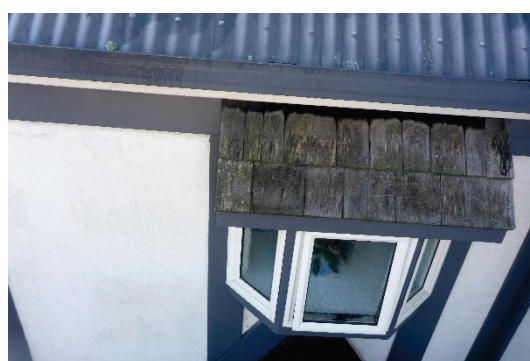
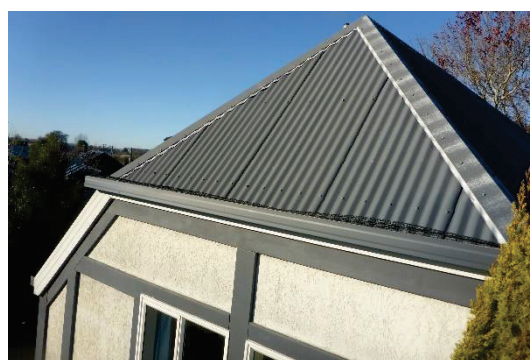
Spoutings to the upper level above the garage and the lower level north elevation near the dining room are corroding and may require replacement.

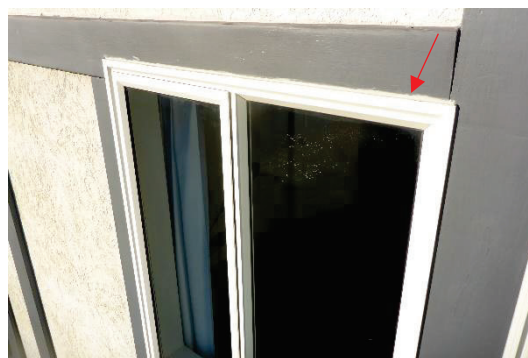
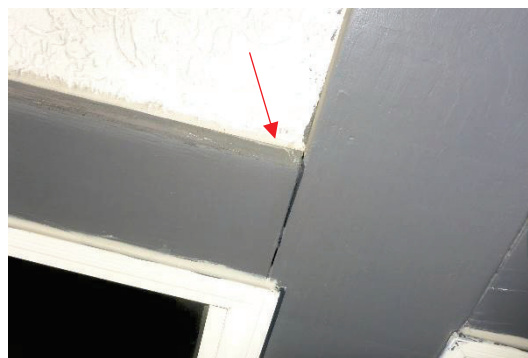
Upper level windows on the north gable end lack head flashings. It is important that the top edge sealant joints and back facings remain well sealed.

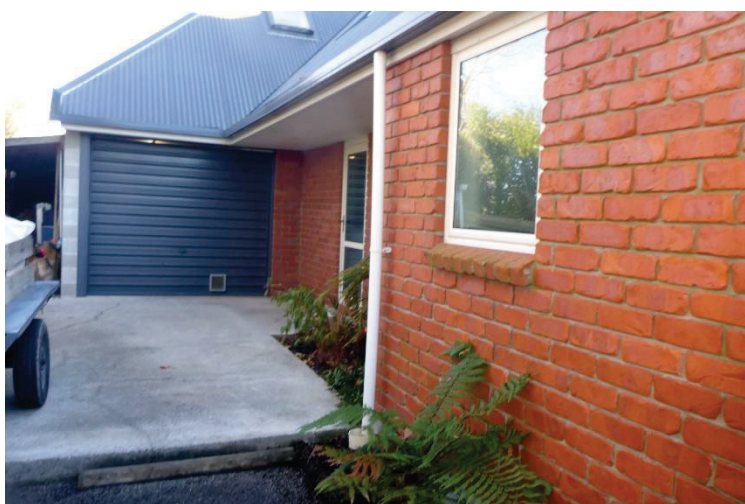
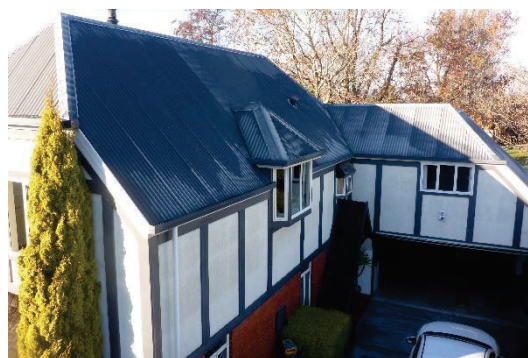
The brick veneer is in good condition and should require only low-level maintenance.

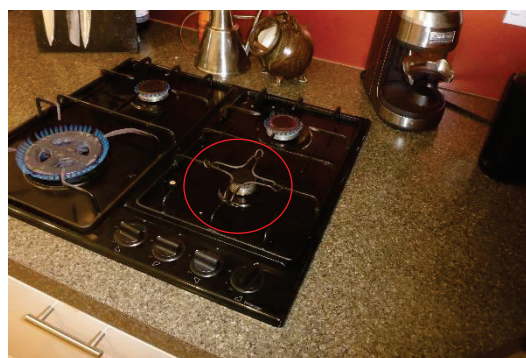
No significant defects identified. However, the igniter to the front right gas cooktop element does not work and may require repair.

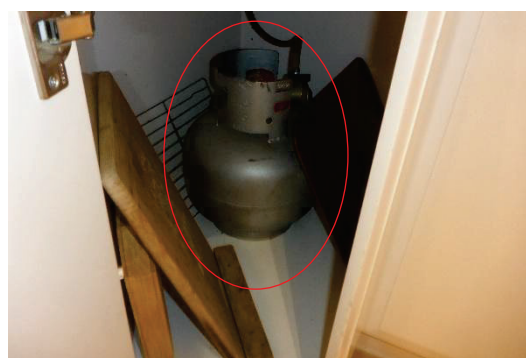
The gas bottle is stored in a cupboard beside the kitchen sink, which is non-compliant. It should be relocated to a properly ventilated external area.

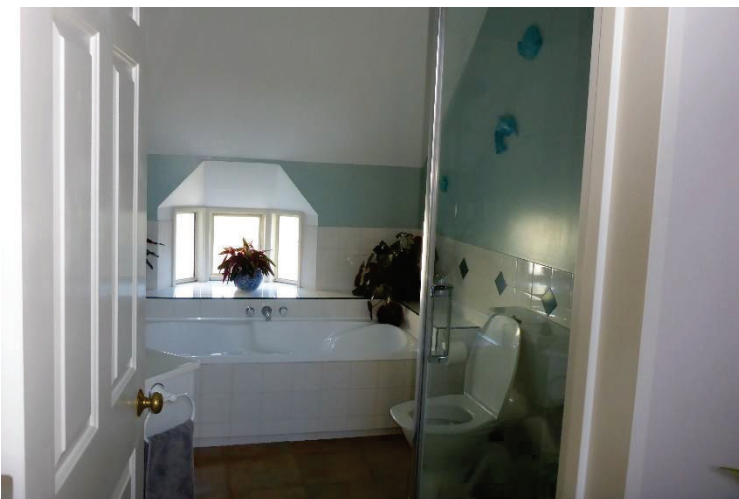
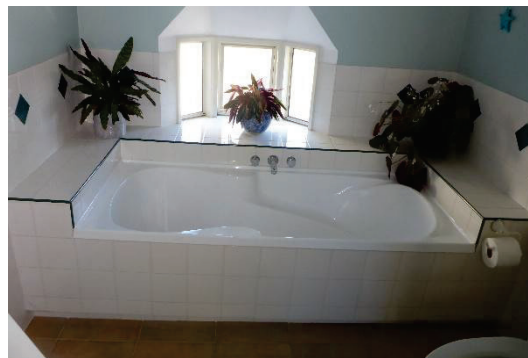
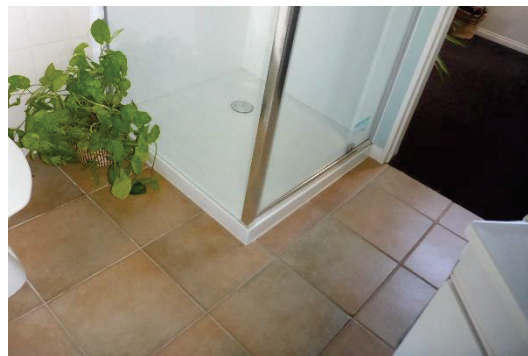
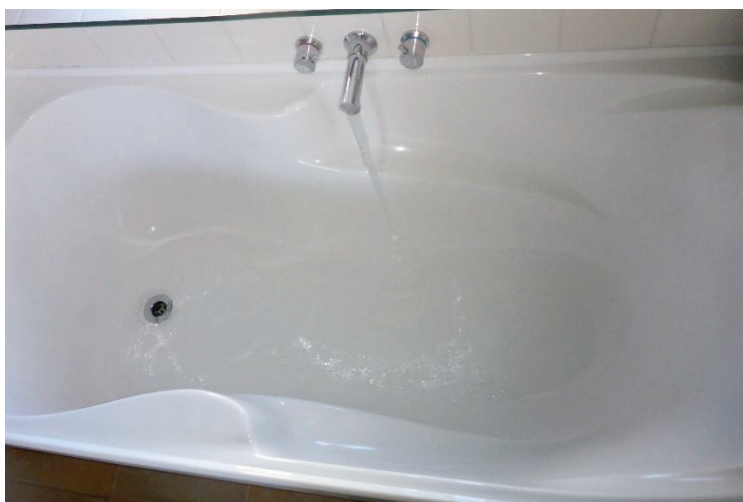
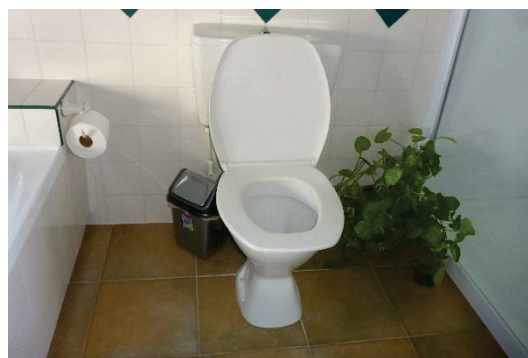
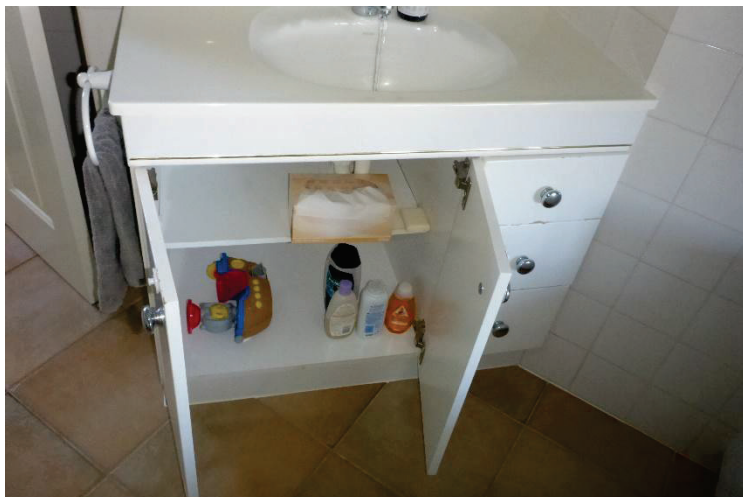
BATHROOM

No significant defects identified.

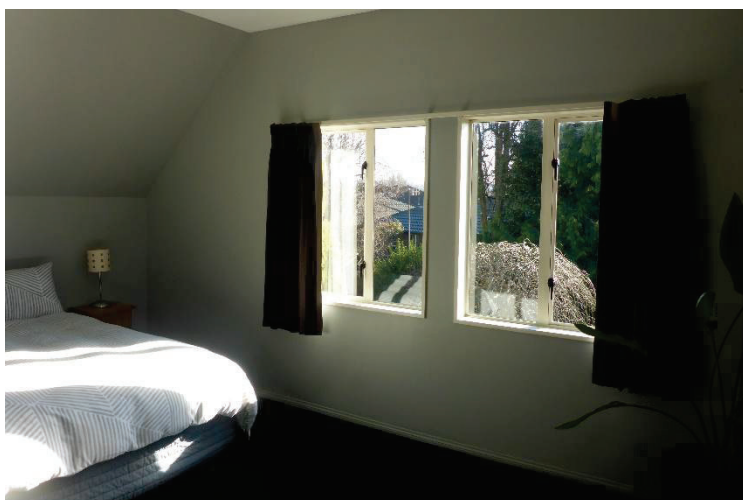
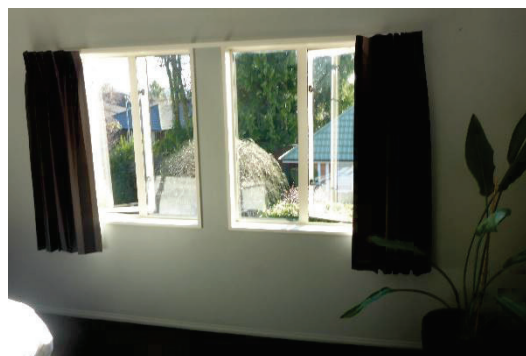
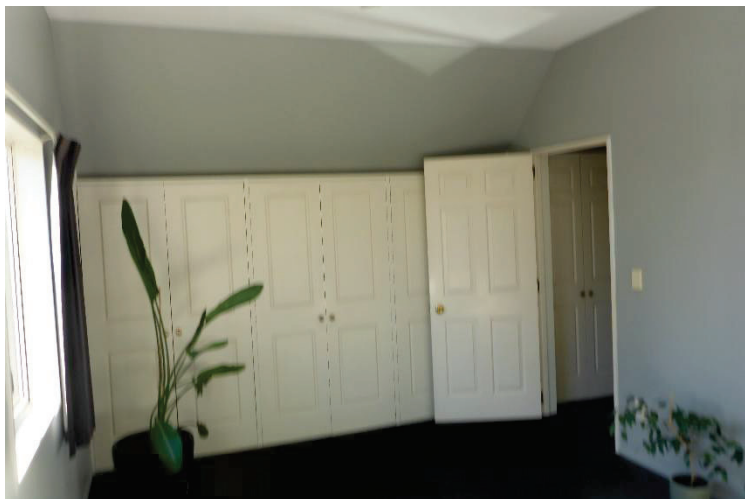
BEDROOM 2

No significant defects identified.

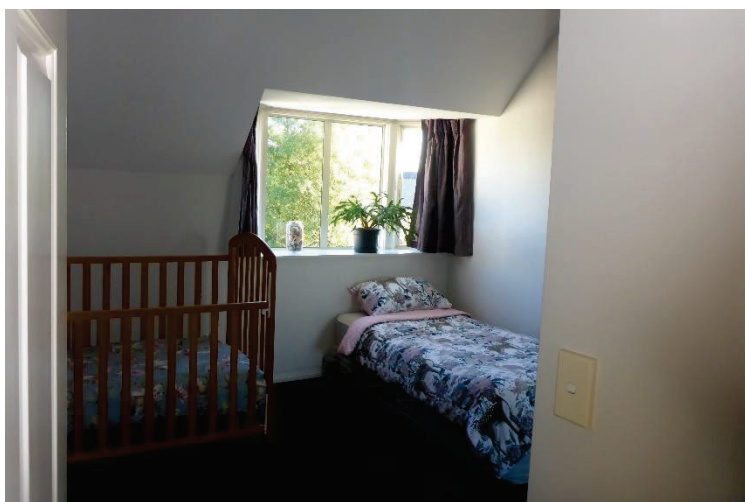
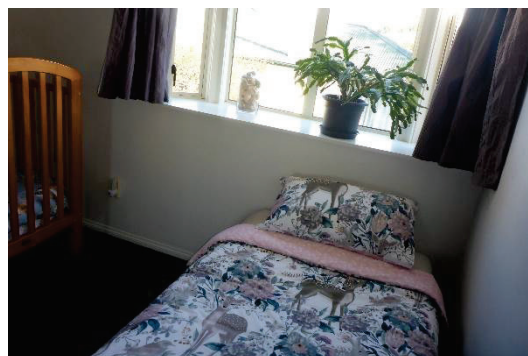
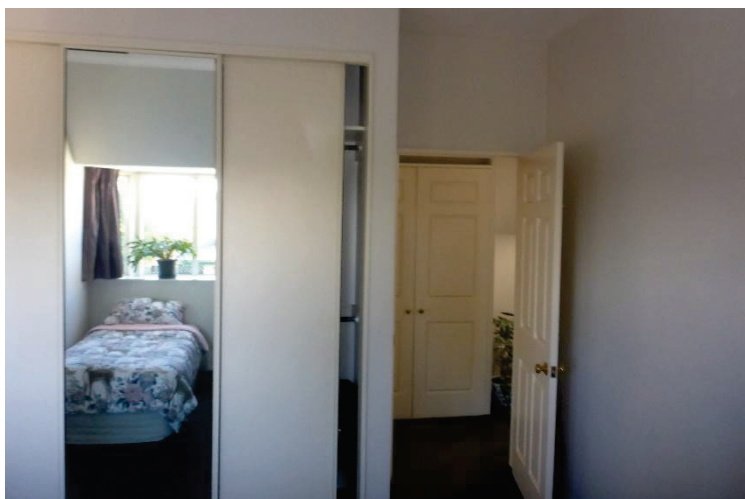
BEDROOM 3
Next to the bathroom

No significant defects identified.

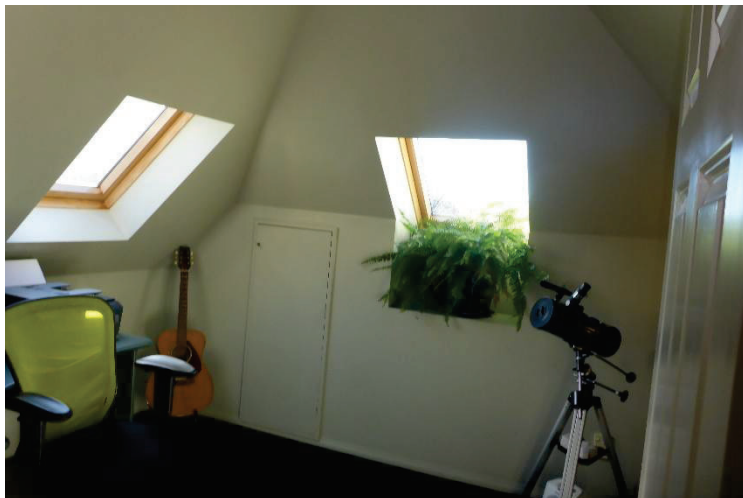
BEDROOM 4
Southeast corner

No significant defects identified.

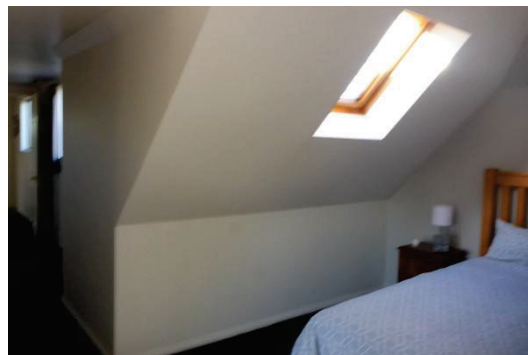
BEDROOM 5

No significant defects identified.

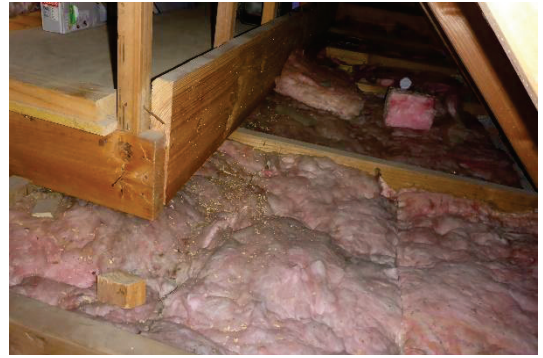
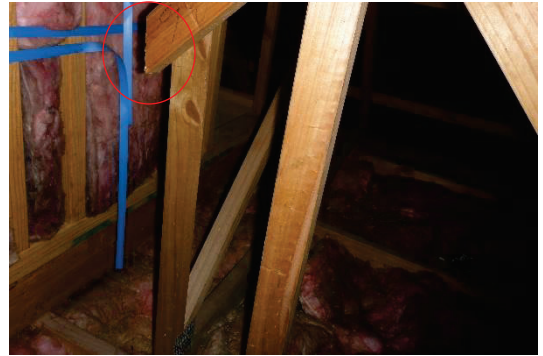
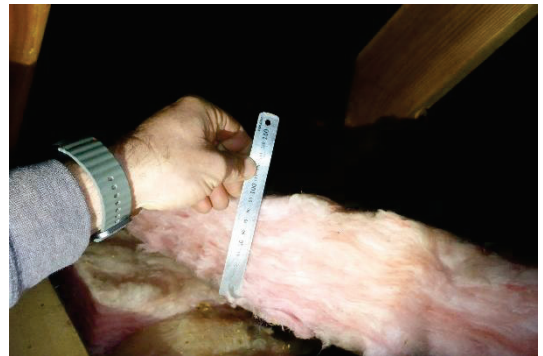
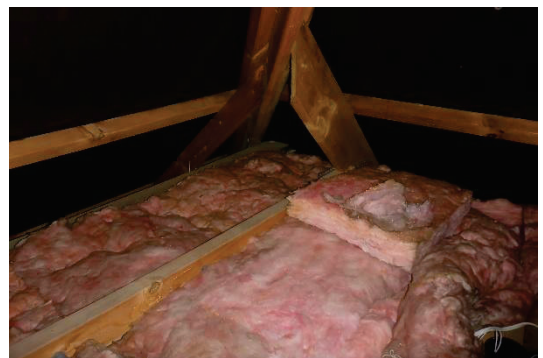
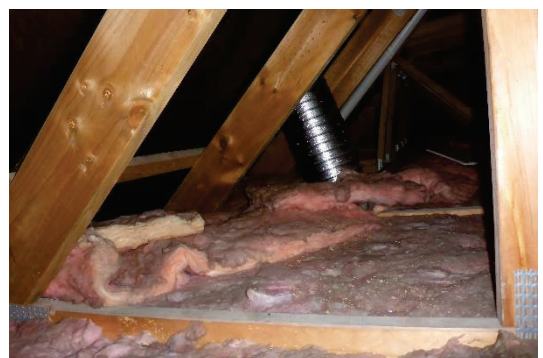
ROOF SPACE

No significant defects identified.

There is evidence of structural changes to roof framing in the southeast upper-level corner. This work is covered by a building consent and Code Compliance Certificate. All areas inspected appear in sound condition.

Ceilings are insulated with fibreglass batts, though thickness does not meet Healthy Homes standards. Upgrades may be considered.

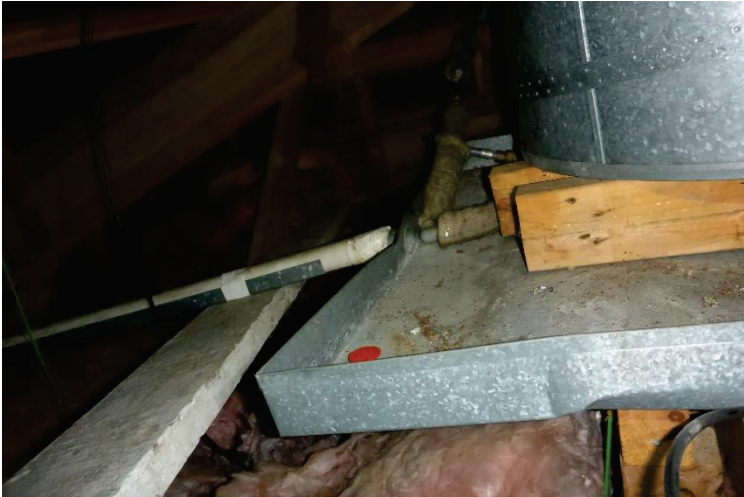
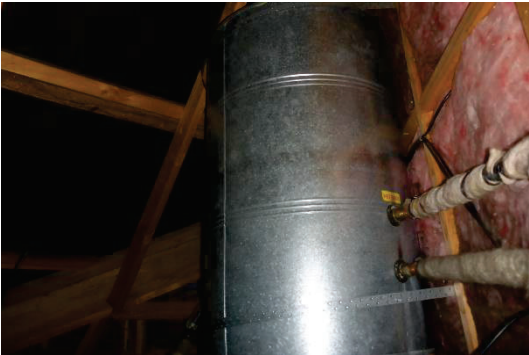
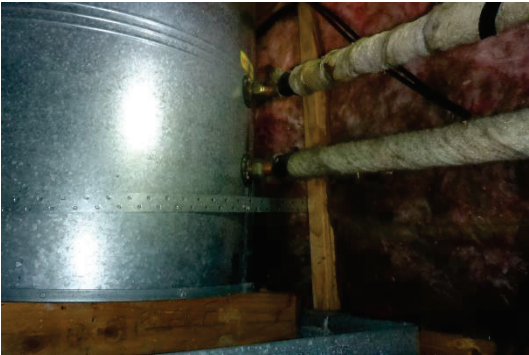
| <div data-bbox="145 118 497 152" data-label="Section-Header"><p>HOT WATER CYLINDER</p></div> <div data-bbox="145 185 866 224" data-label="Text"><p><i>Location – Roof space accessed via upper hallway cupboard</i></p></div> <div data-bbox="145 253 285 286" data-label="Section-Header"><p><u>Comments:</u></p></div> <div data-bbox="145 286 901 389" data-label="Text"><p>The power to the cylinder was switched on at the time of the inspection and appeared to be operating correctly. No significant faults were identified to the cylinder or pipework.</p></div> <div data-bbox="145 421 892 916" data-label="Image"></div> | <div data-bbox="924 116 1455 470" data-label="Image"></div> <div data-bbox="924 501 1455 855" data-label="Image"></div> |

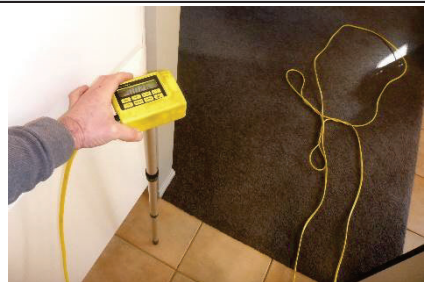
| Description | Locations | Photographs |
|--|---|---|
| Overall Variation Across Floor (note: some displayed readings may not match the readings provided due to the adjustments made for differing floor covering thicknesses and steps in floor levels) | Lowest reading: Kitchen (-26mm) | |

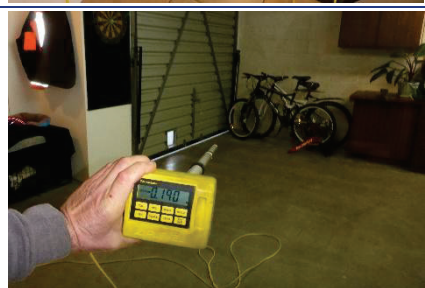
| Description | Locations | Photographs |
|--|---|---|
| | Highest reading: Northwest corner of the garage (+36mm) | |

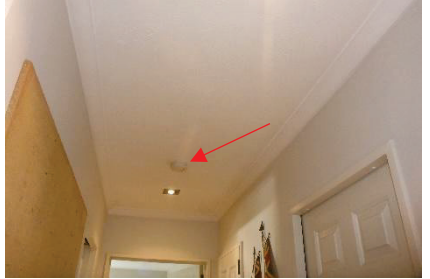
| | Comments | Photographs |
|---|--|---|
| Smoke Detectors | Smoke detectors were found to be located in the compliant locations. | |
