RED LBP PRE-PURCHASE REPORT

PRE-PURCHASE BUILDING REPORT

Property Address	16 Kitchener Place, Opawa, Christchurch 8023
Client	White Sparrow Homes Ltd.
Date of Inspection	21st April 2026
Time	9:30 am
Inspector	Andy Vann National Certificate in Carpentry, Licensed Building Practitioner.
LBP Number	BP135432
People Present	Inspector
House Occupied	Staged

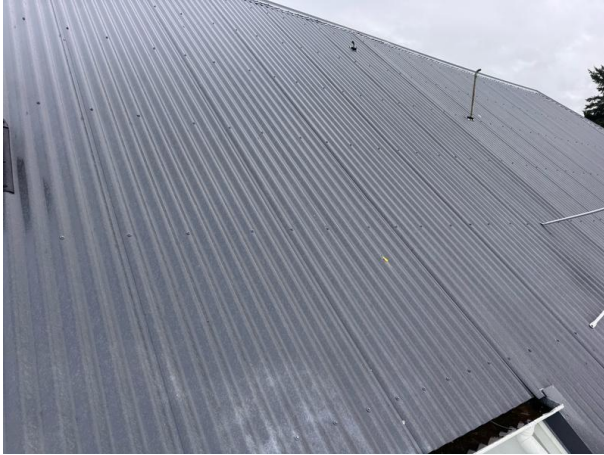
Photo 4
Profiled metal corrugated hip roof east elevation.

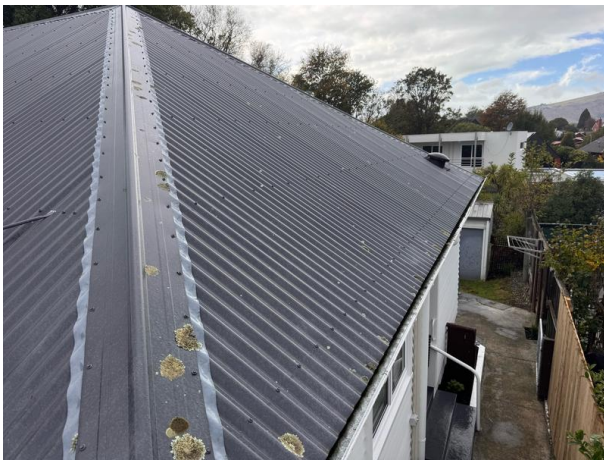
Photo 5
Profiled metal corrugated hip roof south elevation.

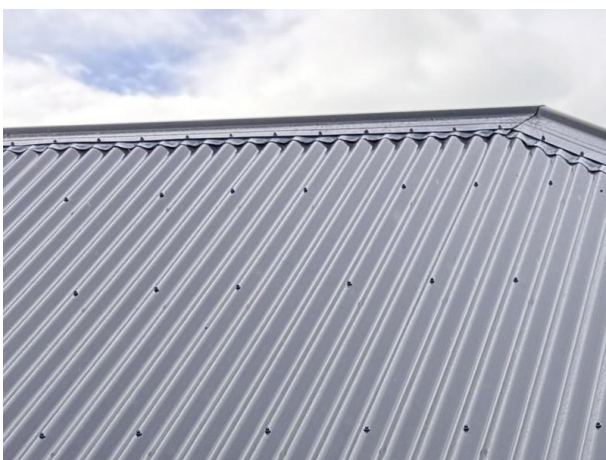
Photo 8
Profiled metal ridge roof top flashings.

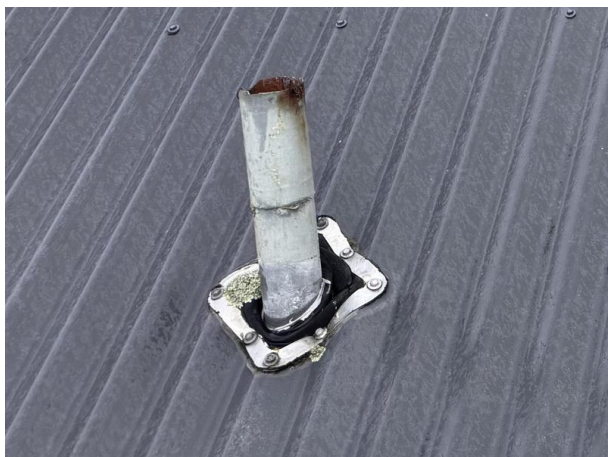
Photo 10

Terminal vent pipe, no vermin cap, with EPDM boot flashing, no water-shed back-flashing installed.

It is recommended the installation of a water-shed back flashing beneath any EPDM boot flashing where the pipe diameter exceeds 85 mm or covers one or more troughs. In accordance with E2/AS1.

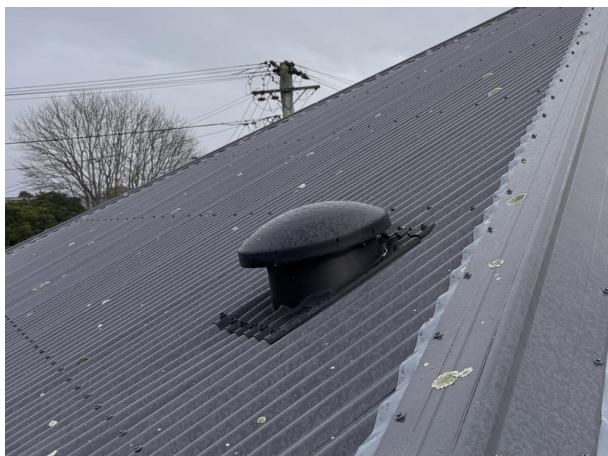
Photo 12

Extraction vent roof penetration on the south elevation, with a rubber boot base flashing.

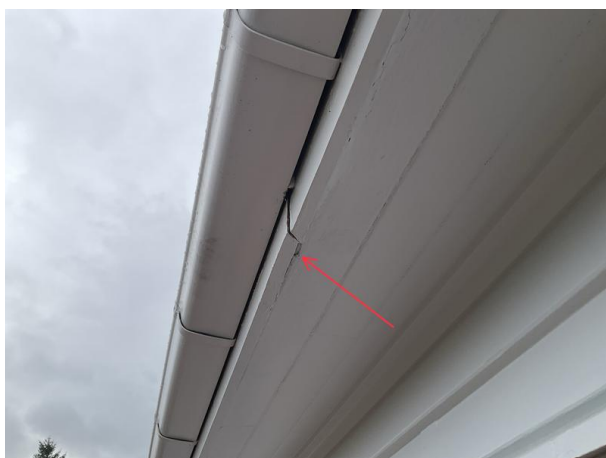
Photo 17
Profiled metal roof edge gutter attached to timber fascia boards and timber soffit linings. Some separation of the timber fascia boards visible on the west elevation.

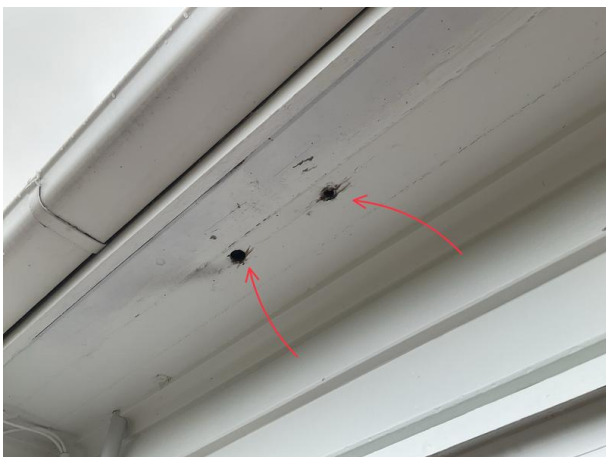
Photo 18
Holes visible in the timber soffit on the west elevation.

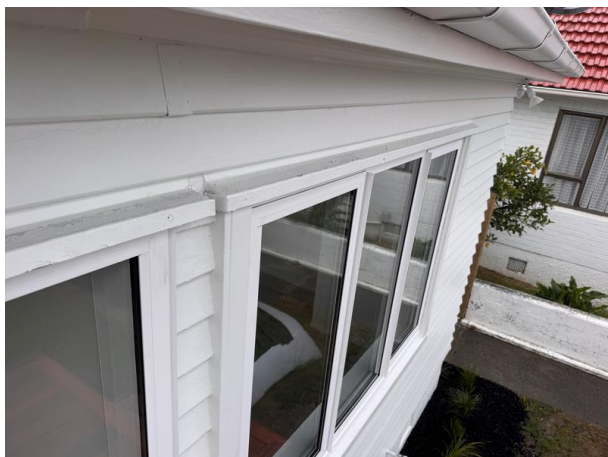
Photo 31
Original profiled metal head flashings remain providing good protection.

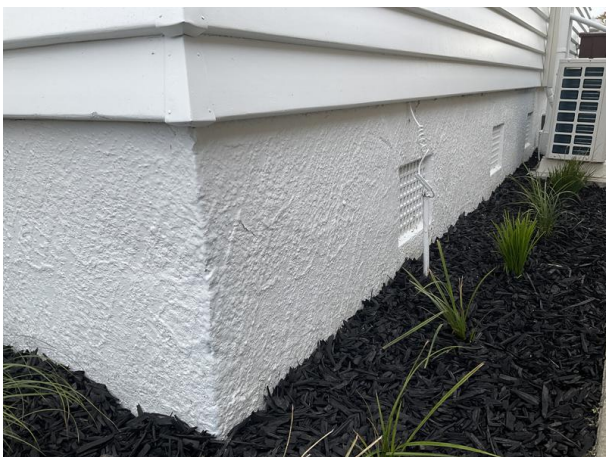
Photo 37
Concrete perimeter ring foundation.

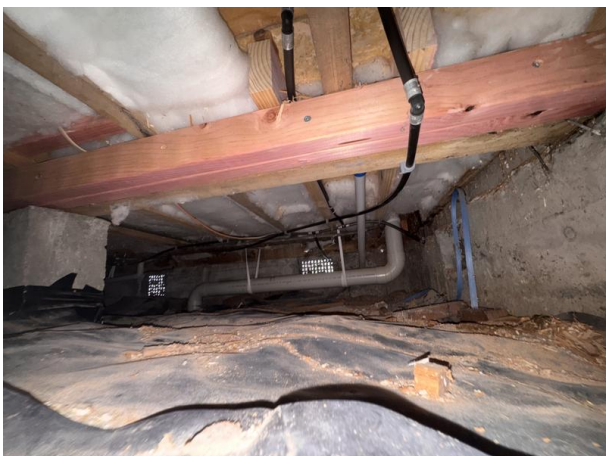
Photo 39
Modern black plumbing and Bathroom uPVC waste pipes visible. Additional framing visible under the bathroom.

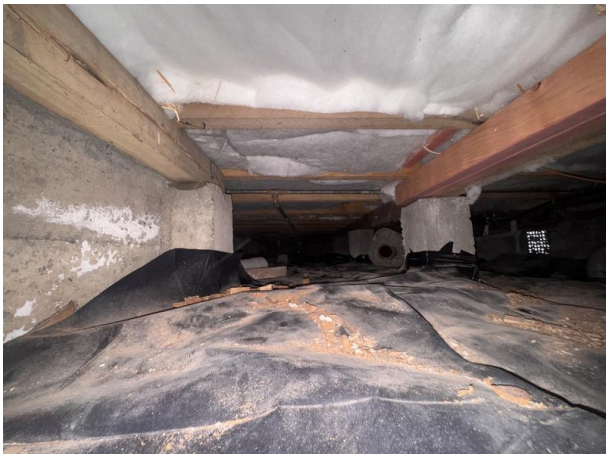
Photo 40

Polyester insulation installed with full coverage where visible. Polythene ground moisture barrier installed.

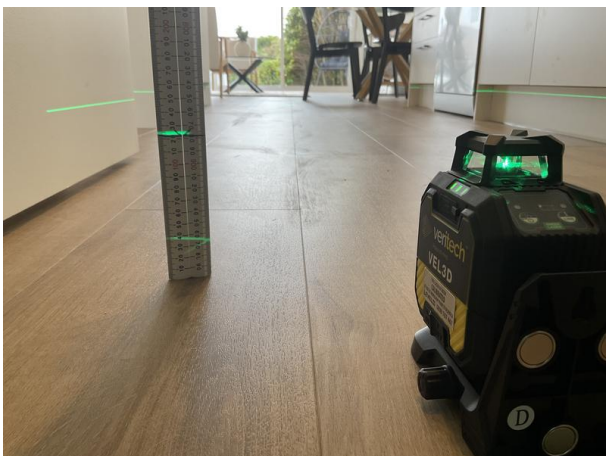
Photo 42

The overall level difference measured in the sampled areas was approximately 3mm. This assessment is limited to a visual, non-invasive spot-check and is not a full floor-level survey or certification of compliance.

Floor levels checked using a self levelling laser.

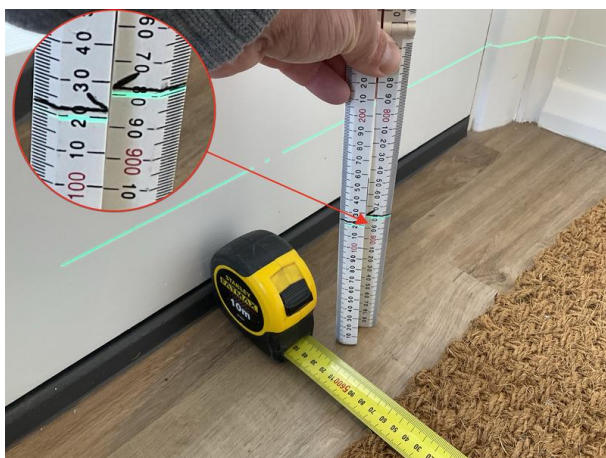
Photo 45
2mm deviation over 5.6m from the living
to the front entrance.

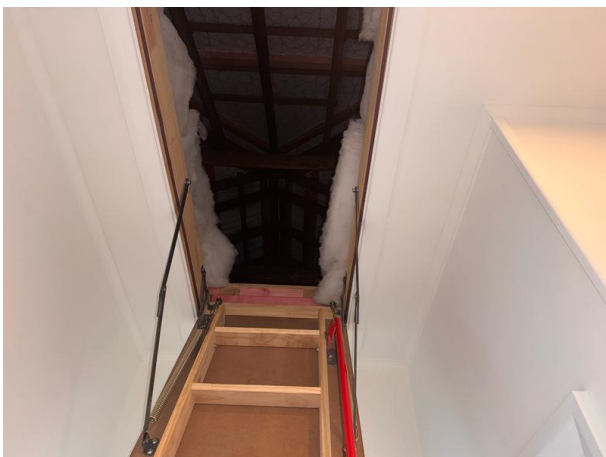
Photo 46

Roof space access located in the hallway near the front entrance.

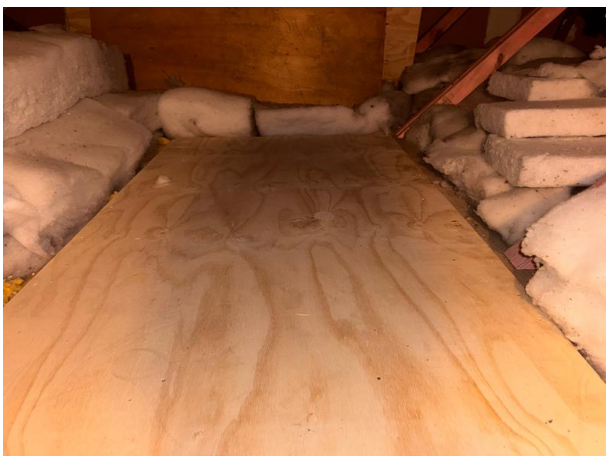
Photo 48

Plywood storage platform.

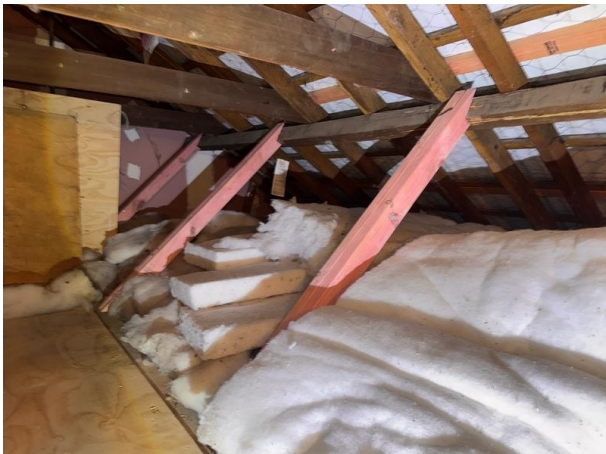
Structural alterations were observed within the roof space, including the installation of additional underpurlin supports, new purlins, and an LVL structural beam over the open-plan living area. These works are indicative of modifications to the original roof framing structure.

Photo 49
New timber under purlin support props.
Polyester insulation installed over
Glasswool.

It is recommended that documentation be obtained to verify that the works were completed in accordance with regulatory requirements.

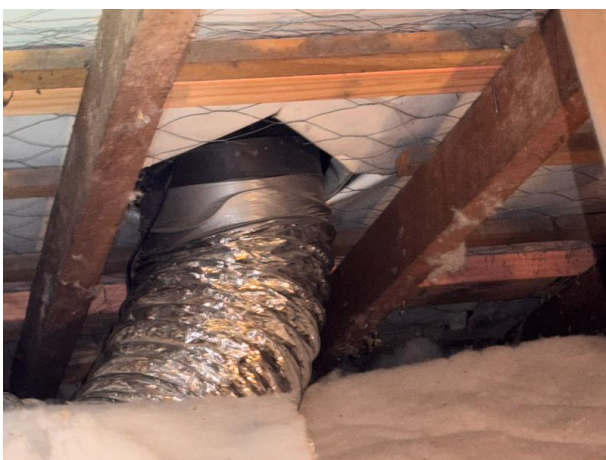
Photo 50
Extraction vent roof penetration.

Penetrations through the roofing underlay were observed to be unsealed. In accordance with manufacturer installation requirements, these penetrations should be sealed to maintain the secondary weather barrier. While no active moisture ingress was observed at the time of inspection, this condition presents a risk of moisture entry and should be addressed.

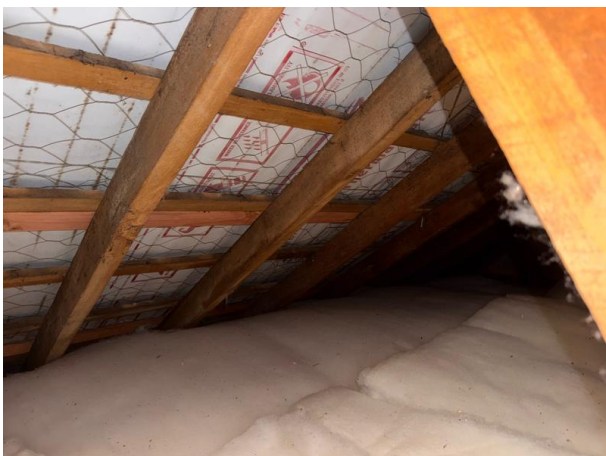
Photo 51
Pitched timber roof frame.

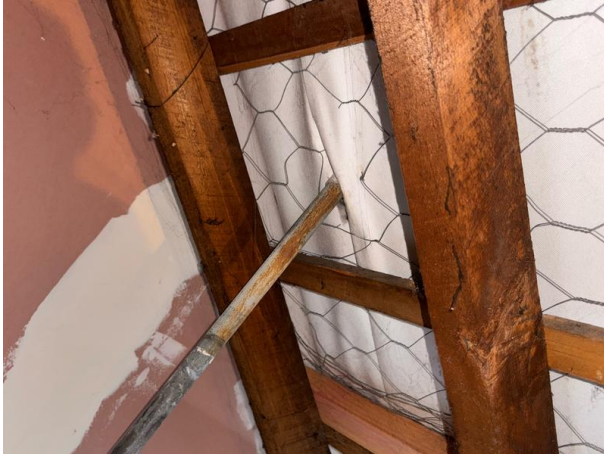
Photo 52
Hot water cylinder pipe roof penetration.

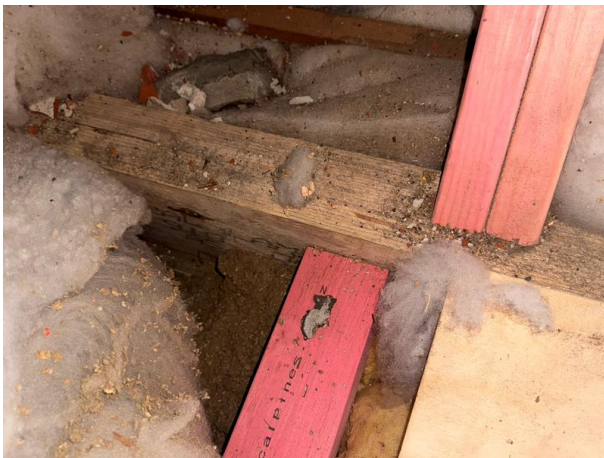
Photo 53
Hyspan LVL structural beam installed.

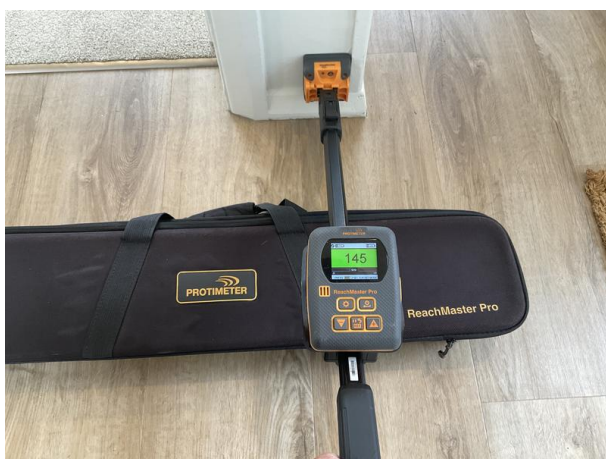
Photo 55

Base moisture reading taken from an internal wall.

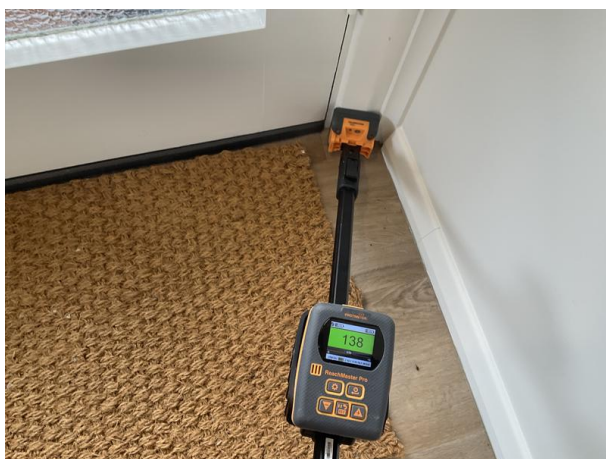
Photo 56

Moisture reading taken from the front entrance door frame. No indications of elevated moisture found at the time of inspection.

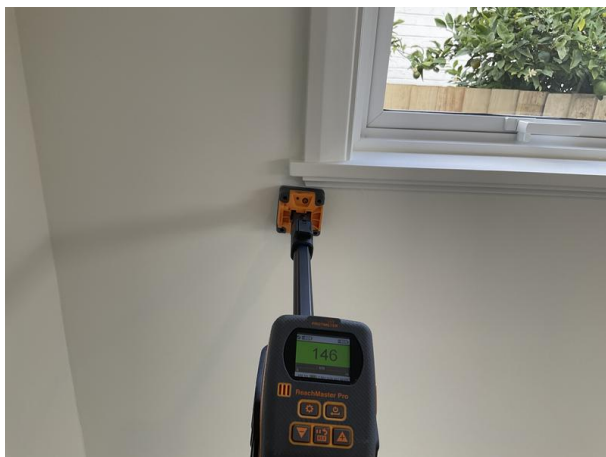
Photo 57
Moisture taken from all access accessible window and door openings. No indications of elevated moisture found at the time of inspection.

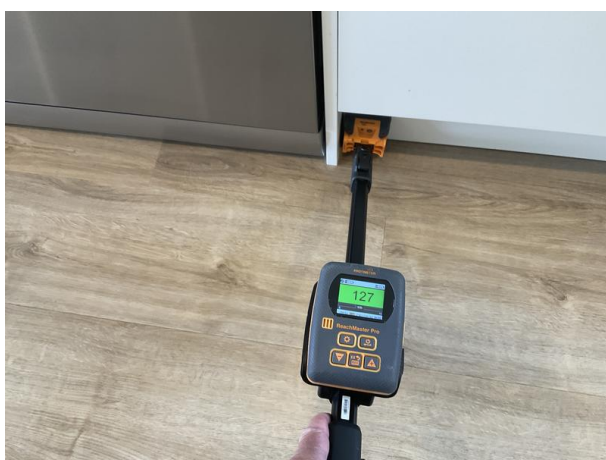
Photo 58
Moisture taken from the kitchen base cabinet near the dishwasher. No indications of elevated moisture found at the time of inspection.

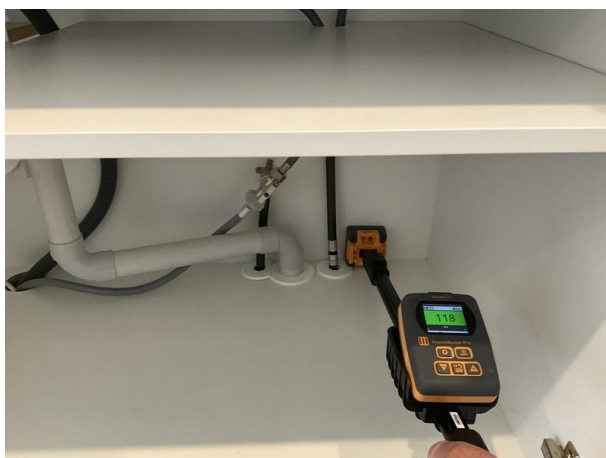
Photo 59
Moisture reading taken from under the kitchen sink. No indications of elevated moisture found at the time of inspection.

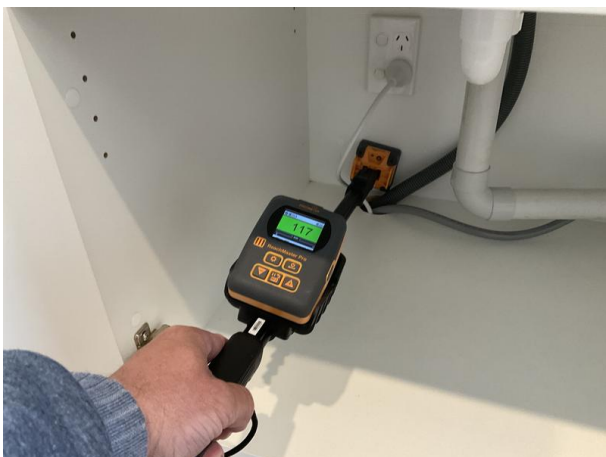
Photo 60
Moisture reading taken from under the kitchen sink. No indications of elevated moisture found at the time of inspection.

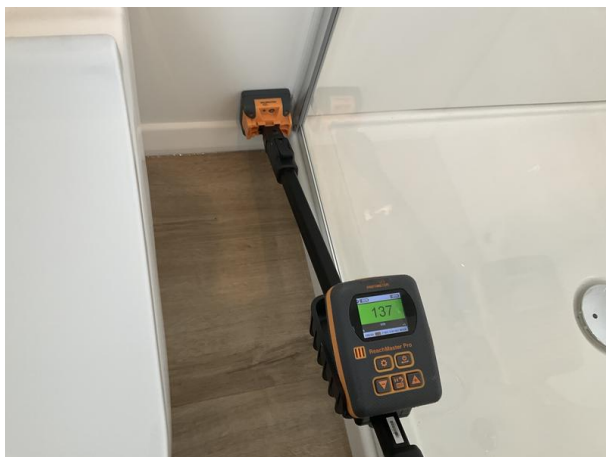
Photo 63

Moisture reading taken from the shower corner. No indications of elevated moisture found at the time of inspection.

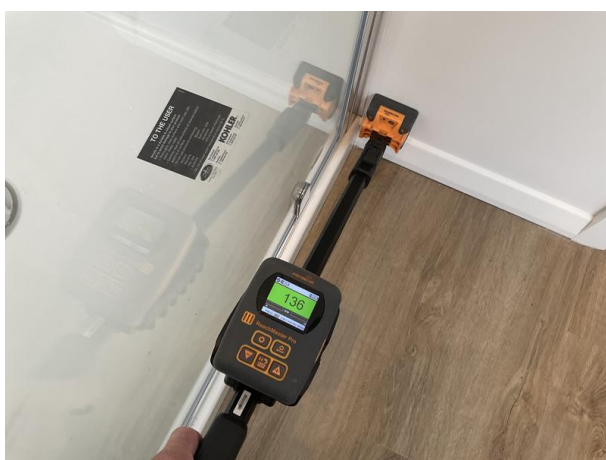
Photo 64

Moisture taken from the shower corner. No indications of elevated moisture found at the time of inspection.

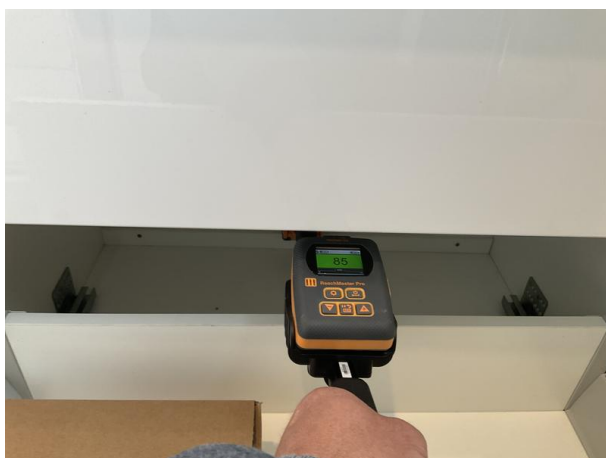
Photo 65

Moisture taken from under the bathroom vanity. No indications of elevated moisture found at the time of inspection.

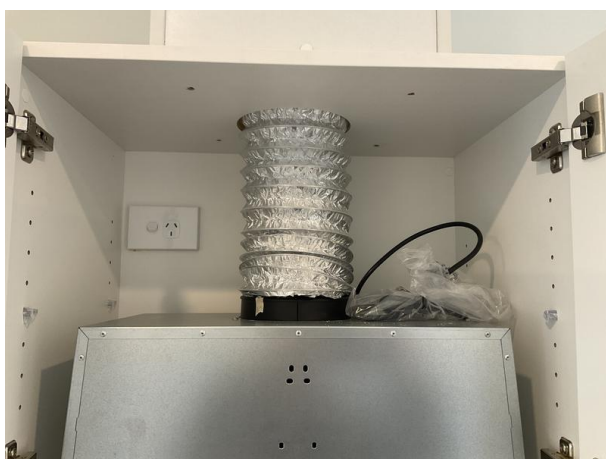
Photo 70
Kitchen extraction ducting not fixed in place. Power not connected at the time of inspection.

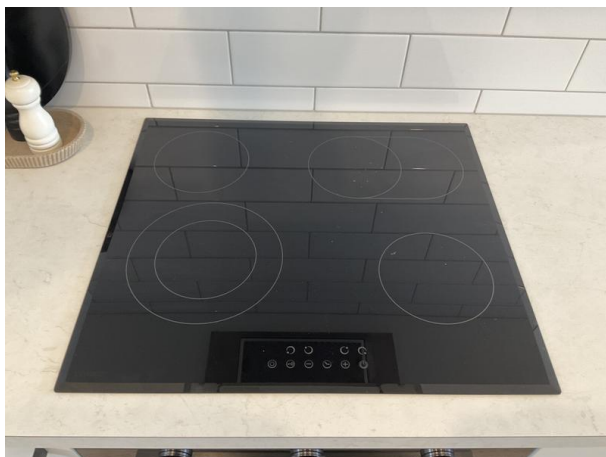
Photo 71
Cook top not powering on at the time of inspection.

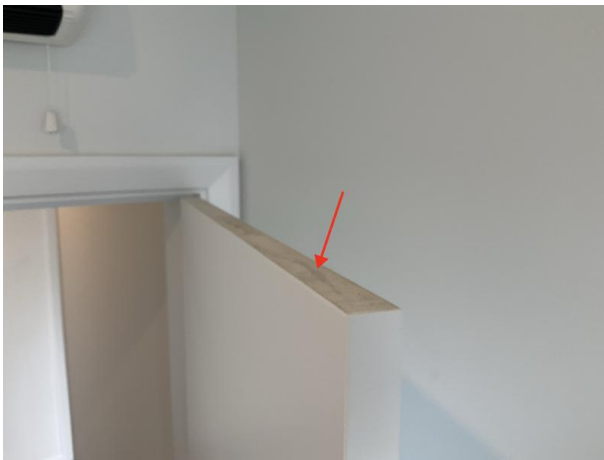
Photo 78
Unsealed bathroom door.

It's advisable to seal all six sides of every interior door. Neglecting to seal the tops and bottoms may result in moisture ingress, leading to surface damage on the door.

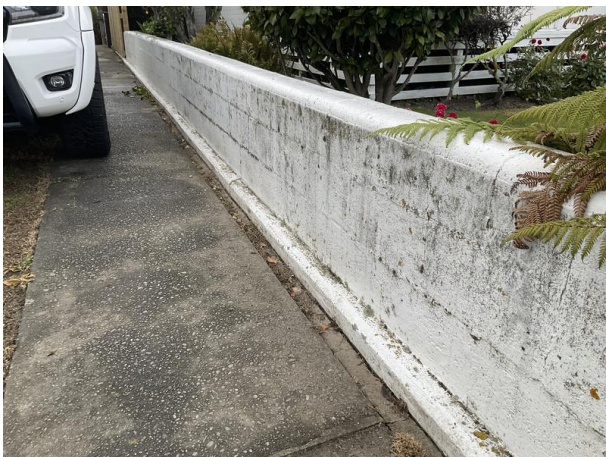
Photo 82
Concrete block south boundary fence.

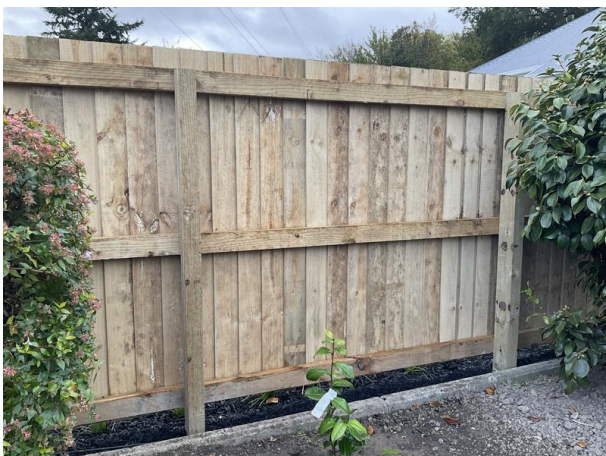
Photo 83
New timber paling north boundary fence.

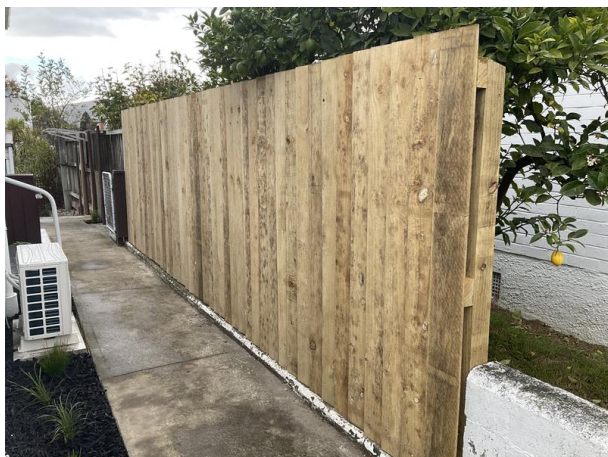
Photo 84
New section of the timber paling south boundary fence.

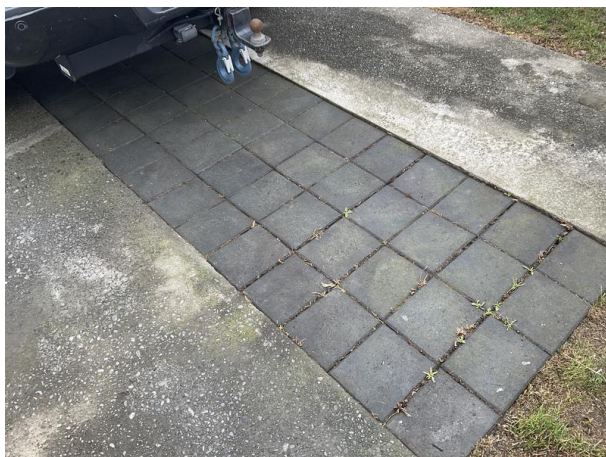
Photo 89
Concrete pavers installed between the concrete driveway strips.

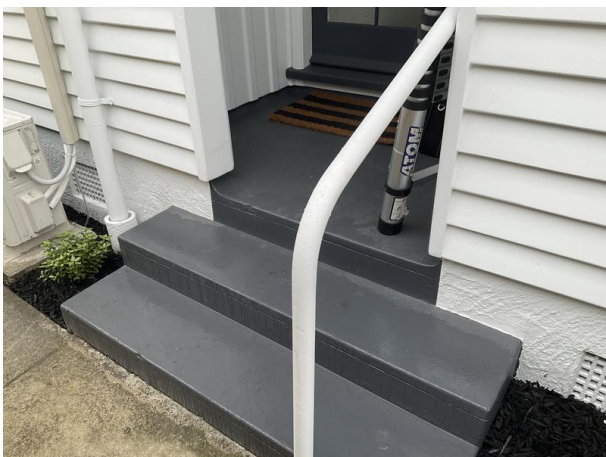
Photo 90
Painted concrete front entrance.

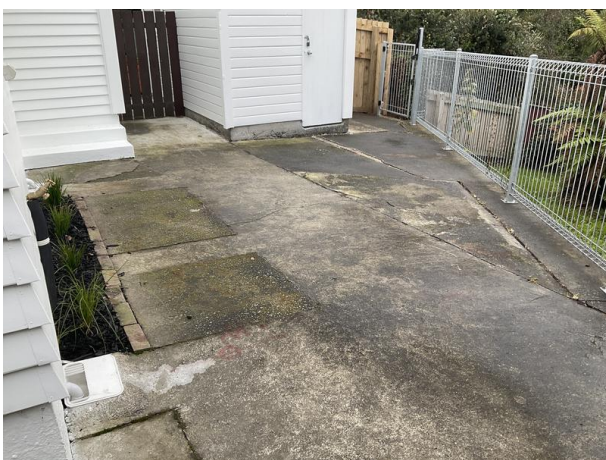
Photo 91
Plain concrete patio area month east side of the dwelling.

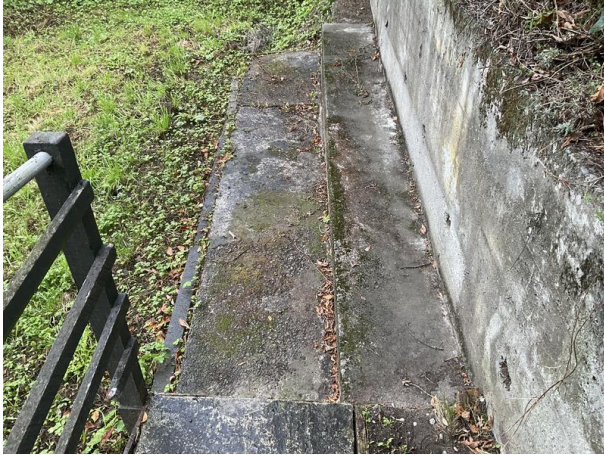
Photo 93
Concrete path under the concrete retaining wall on the east elevation.

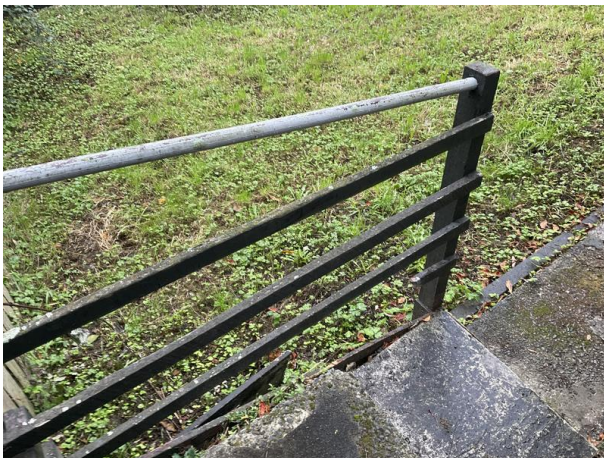
Photo 94
Flimsy timber barrier at the bottom for the concrete stairs.

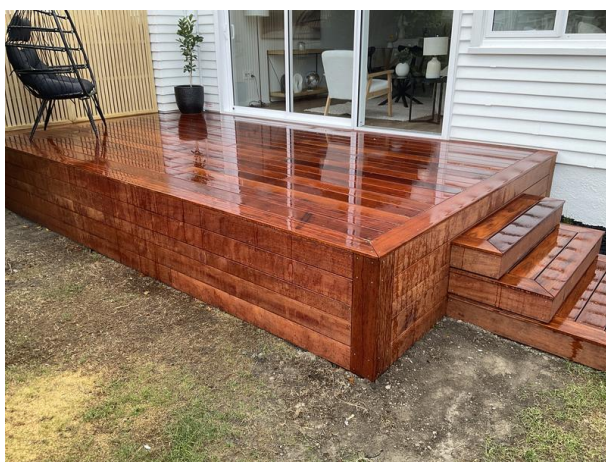
Photo 95
Hardwood timber deck on the west elevation with access to the living room.

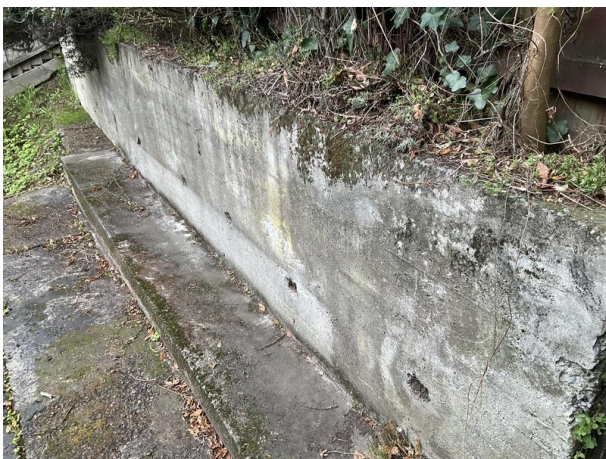
Photo 99

Poured concrete retaining wall on the east elevation. Drain holes visible near the bottom.

It is recommended to clear vegetation from the retaining wall to prevent damage and to inspect for any signs of deterioration.

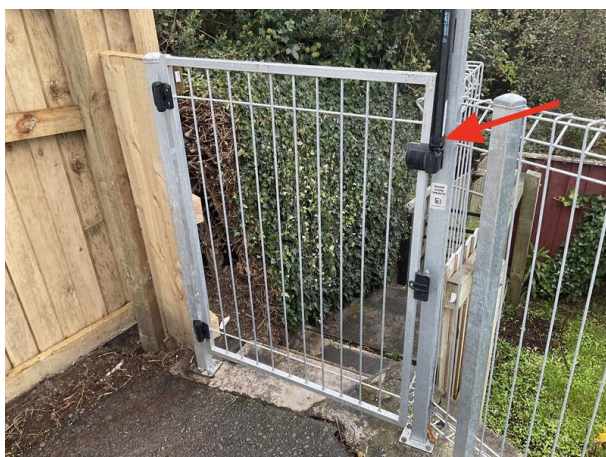
Photo 101
Side pedestrian gate on the east elevation access to the lower lawn area. Latch has moved out of alignment.

It is recommended to apply regular maintenance to hinges and latches to maintain smooth operation.

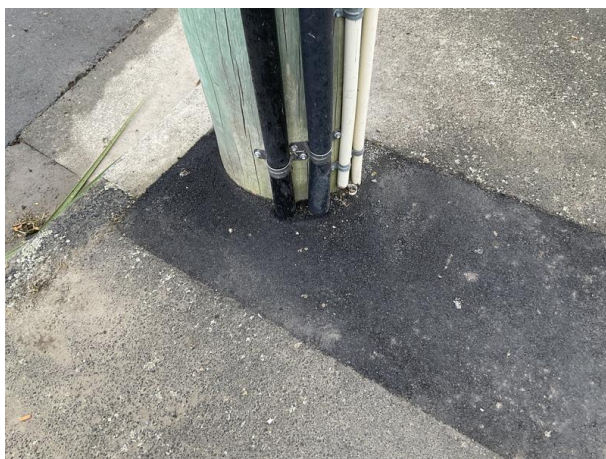
Photo 102
Under ground power supply.

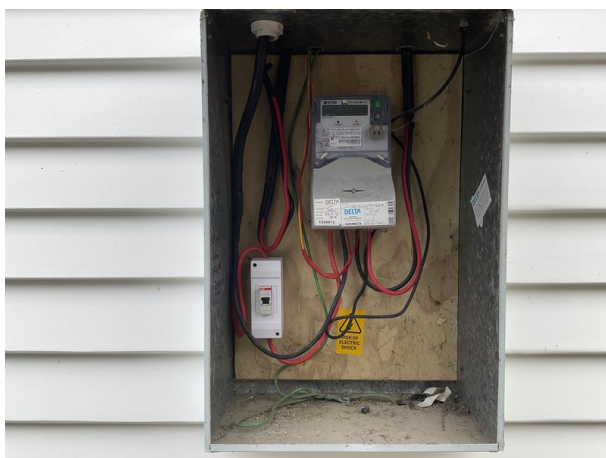
Photo 103
Power meter located on the south elevation.

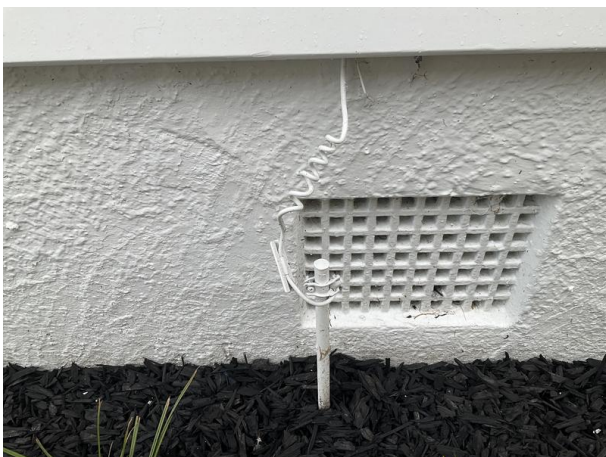
Photo 104
Earth stake located on the south elevation.

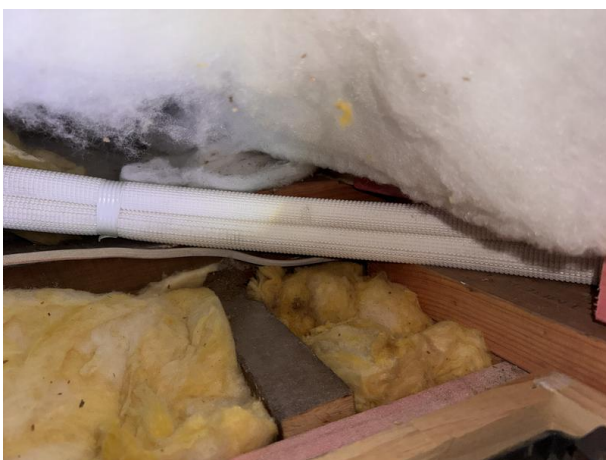
Photo 105
Modern TPS wiring visible in the roof space.

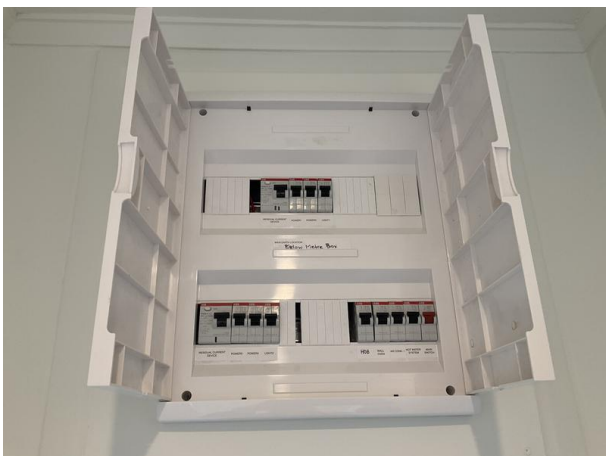
Photo 106
Power distribution board located in the hallway.

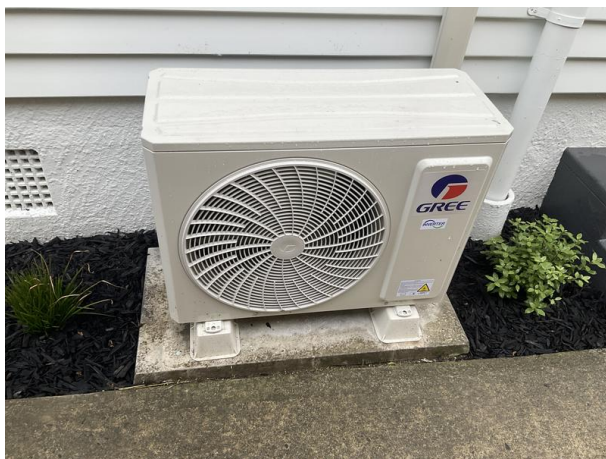
Photo 107

Gree heat pump inverter located on the south elevation.

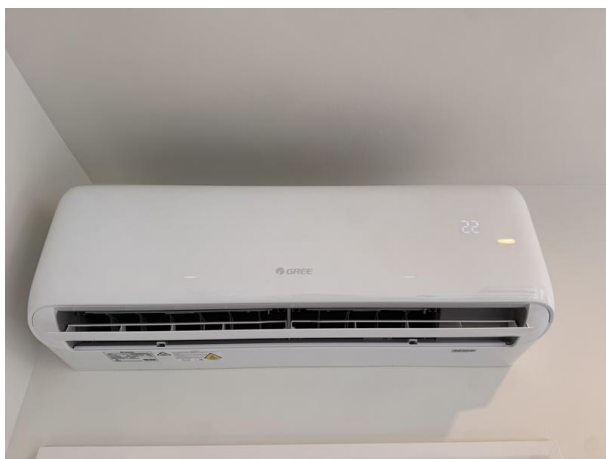
Photo 108

Gree high wall heat pump installed in the living room.

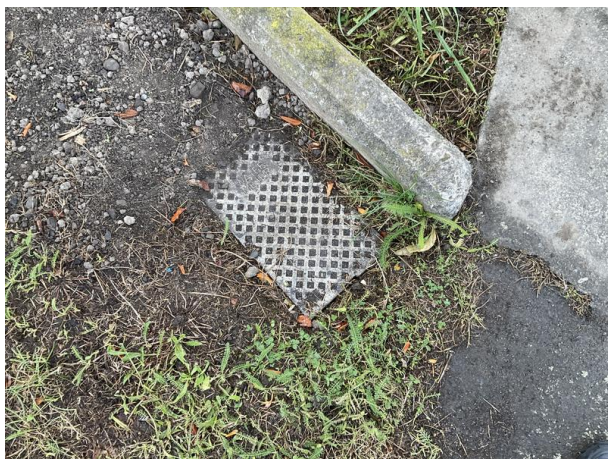
Photo 109
Water meter located in the front grass verge.

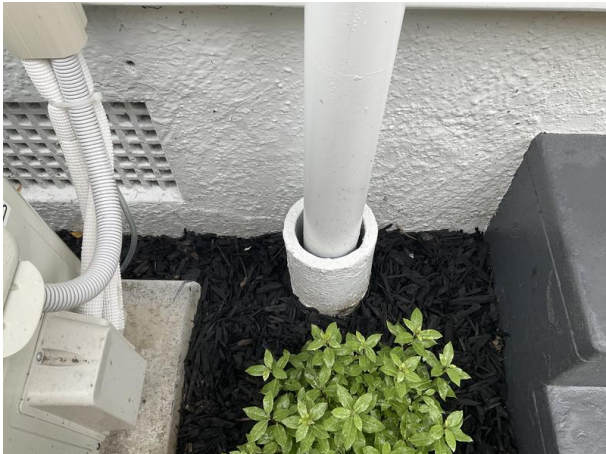
Earthenware drains were noted at the property. These are prone to tree root blockage. It is recommend that these drains be CCTV inspected and cleared if required.

Photo 110
Earthenware stormwater risers.

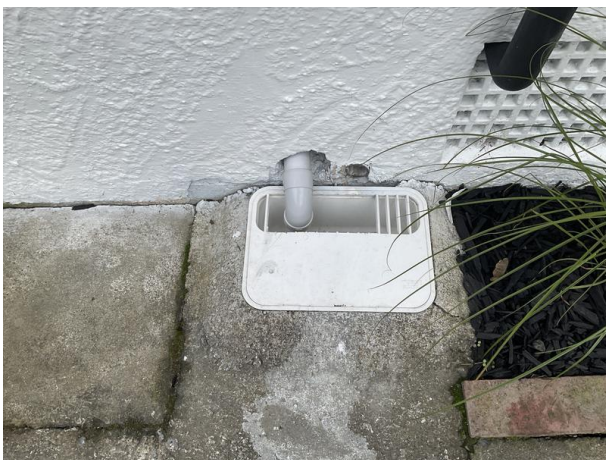
Photo 111
PVC gully traps.

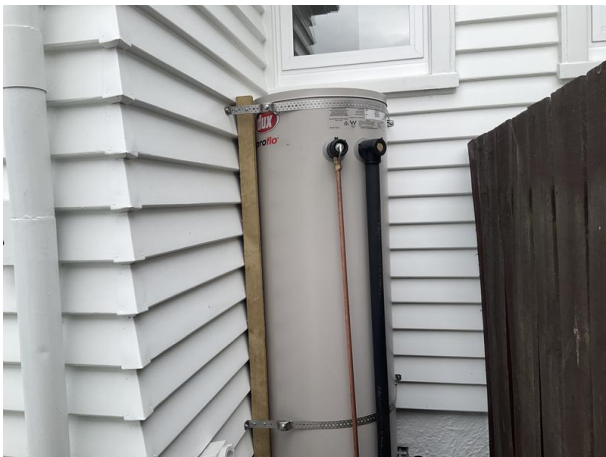
Photo 112
External mains pressure hot water cylinder located on the east elevation.

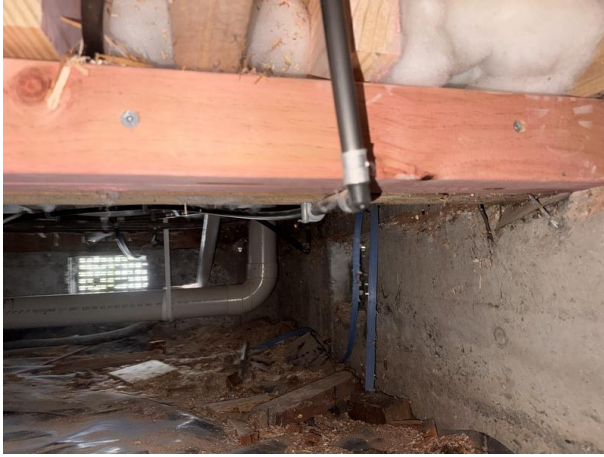
Photo 113
Modern black plumbing and PVC waste pipes visible in the subfloor.

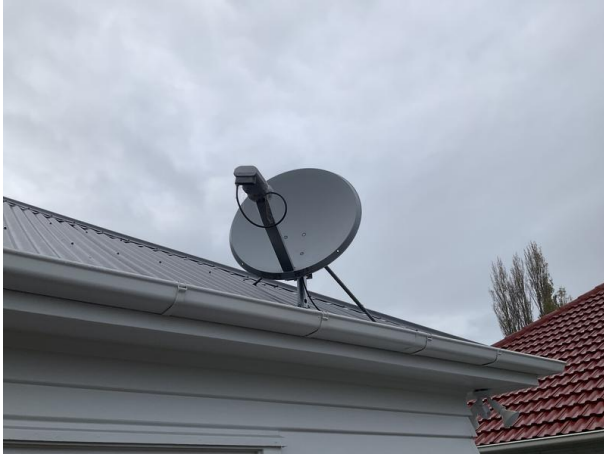
Photo 114
Satellite dish installed.

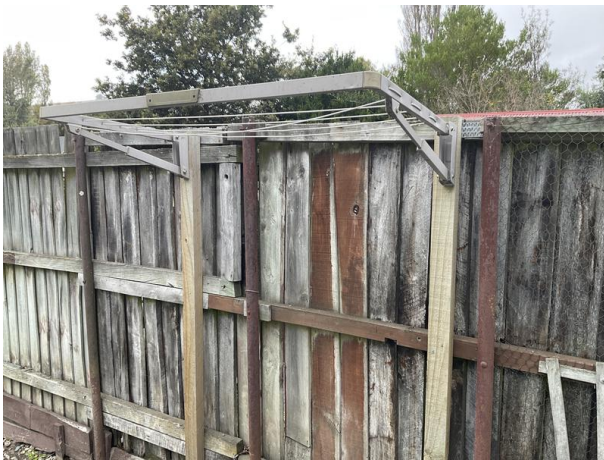
Photo 115
Clothesline installed on the south boundary fence.

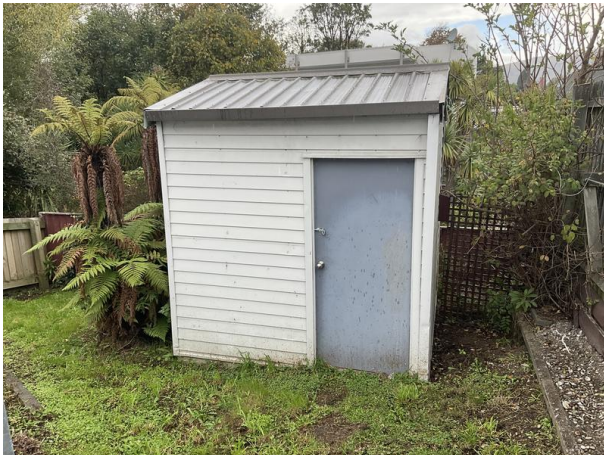
Photo 116
Garden shed.

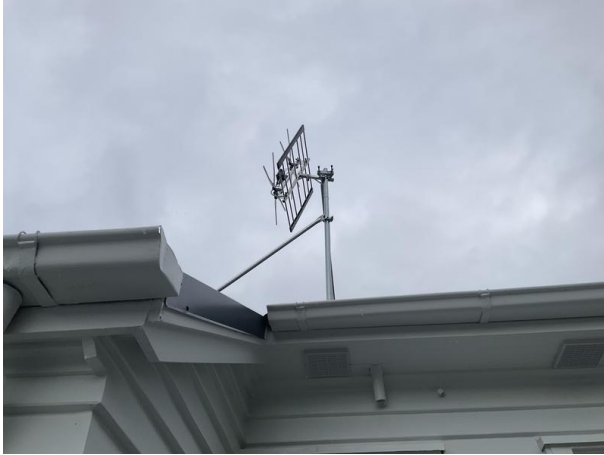
Photo 117
Aerial installed.

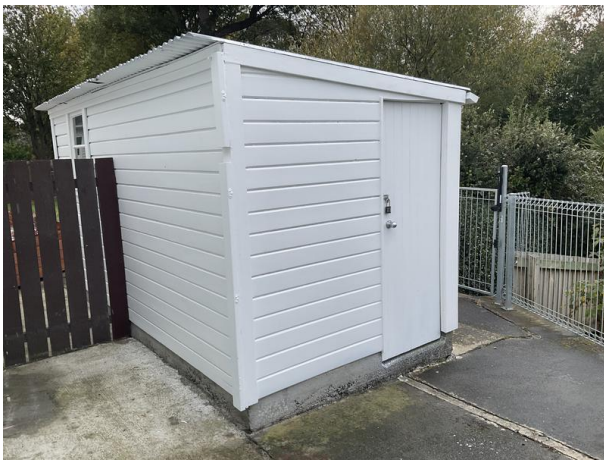
Photo 118
Storage out building not inspected.

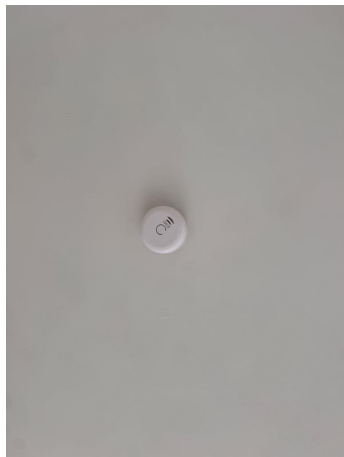
Photo 119
Connected smoke detectors installed.

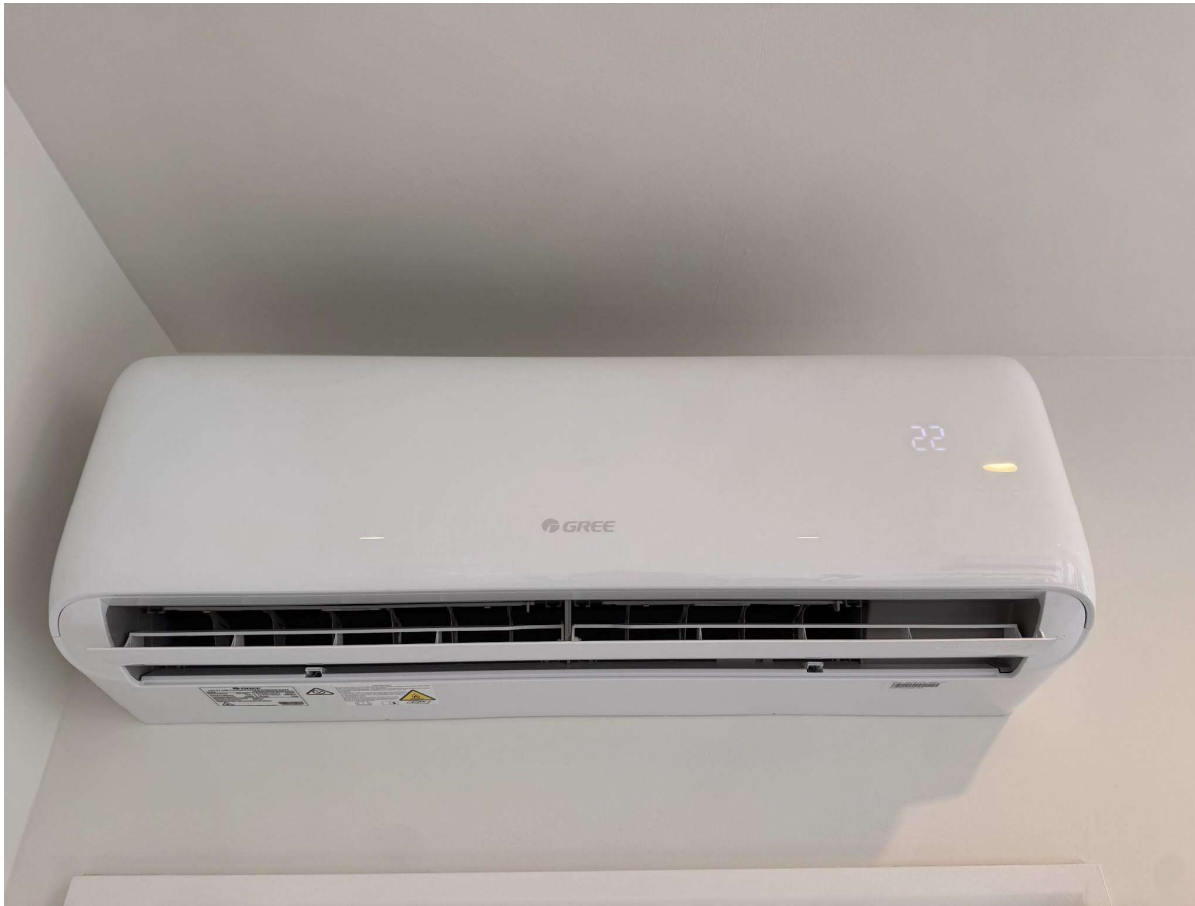
Gree high wall heat pump located in the living room 5.8KW

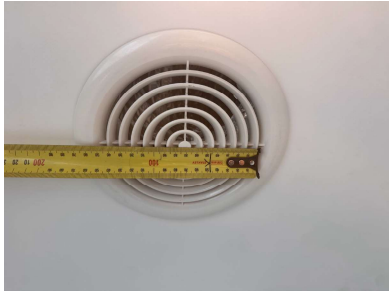
150mm extraction fan.
