RED LBP PRE-PURCHASE REPORT

PRE-PURCHASE BUILDING REPORT

Property Address	18 Kitchener Place, Opawa, Christchurch 8023
Client	White Sparrow Homes Ltd.
Date of Inspection	21st April 2026
Time	12:00 pm
Inspector	Andy Vann National Certificate in Carpentry, Licensed Building Practitioner.
LBP Number	BP135432
People Present	Inspector
House Occupied	Staged

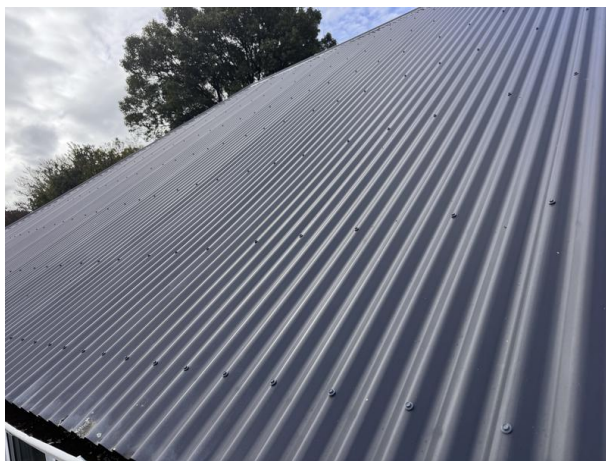
Photo 3

Profiled metal corrugated roof north elevation with screw fixings used.

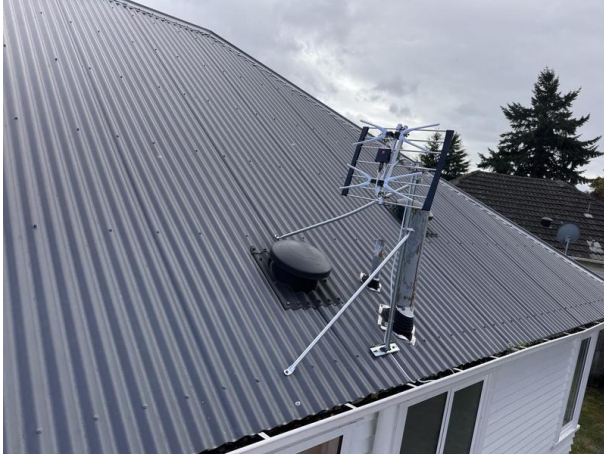
Photo 4
Profiled metal corrugated roofing east elevation.

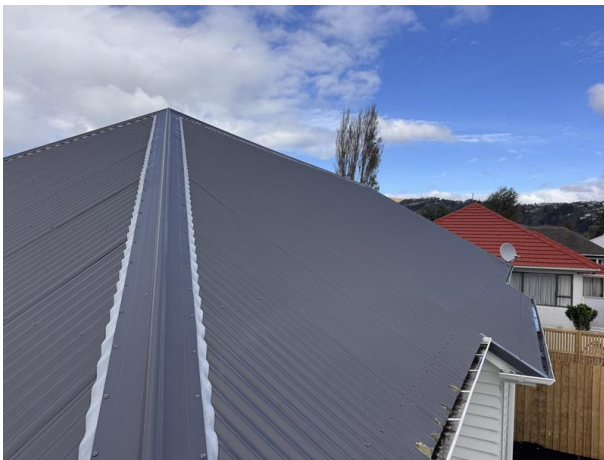
Photo 5
Profiled metal corrugated metal roof west elevation, some lichen growth visible on the bottom edges.

The roof displayed visible signs of lichen growth in certain areas, and it is advised to address this issue as part of regular maintenance. Failure to do so could cause deterioration of the coating system.

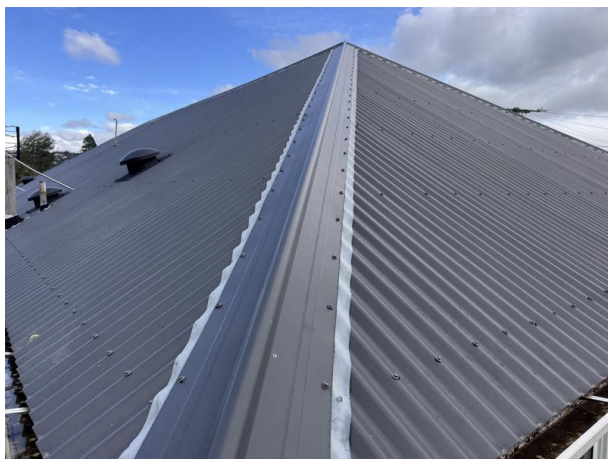
Photo 6
Profiled metal hip flashings.

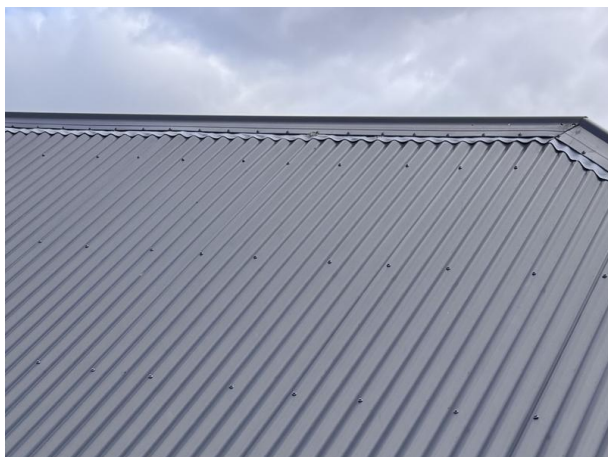
Photo 7
Profiled metal ridge roof top flashing,

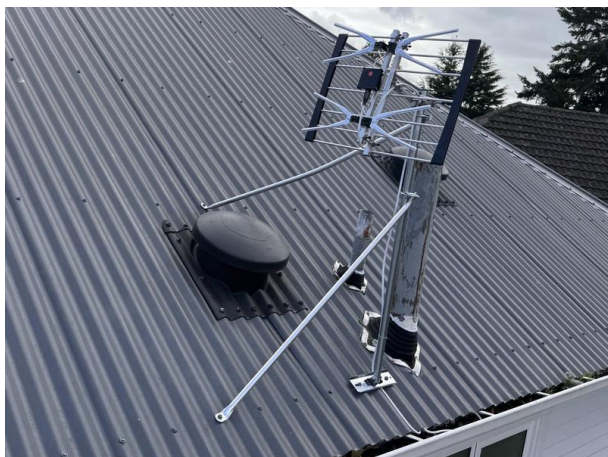
Photo 10
Extraction vent roof penetration on the east elevation with a manufactured base flashing installed. Also aerial installed on the roof.

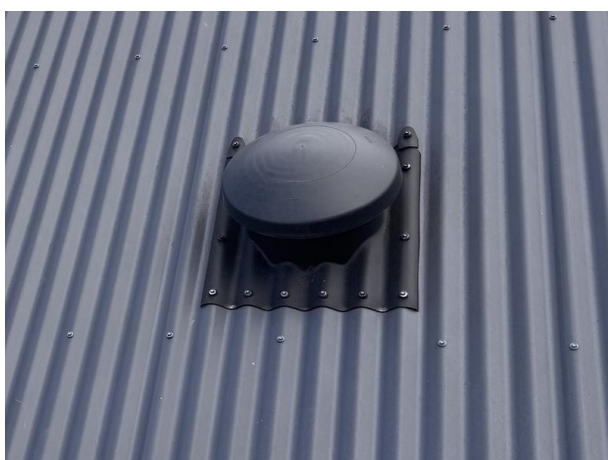
Photo 11
Extraction vent roof penetration on the east elevation with a manufactured base flashing installed.

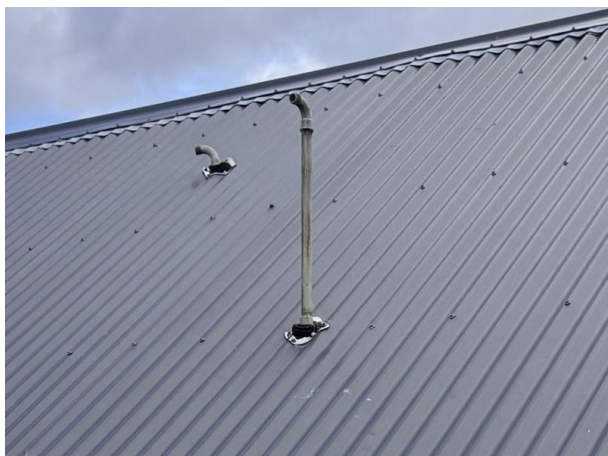
Photo 12
Hot water cylinder pressure pipe roof penetration on the east elevation with a EPDM boot base flashing.

It is recommended the installation of a water-shed back flashing beneath any EPDM boot flashing where the pipe diameter exceeds 85 mm or covers one or more troughs. In accordance with E2/AS1.

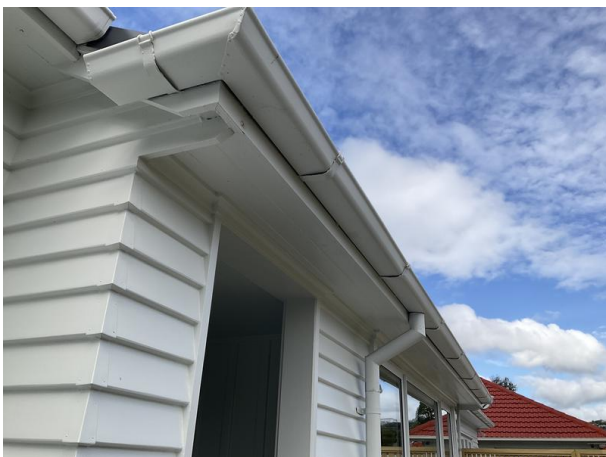
Photo 13
Profiled metal roof edge gutter on the west elevation attached to the timber fascia with profiled metal down pipe.

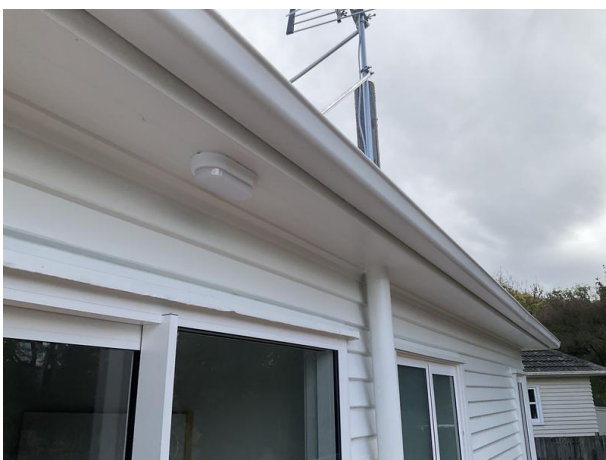
Photo 14
PVC roof edge gutter on the east elevation, timber soffit linings.

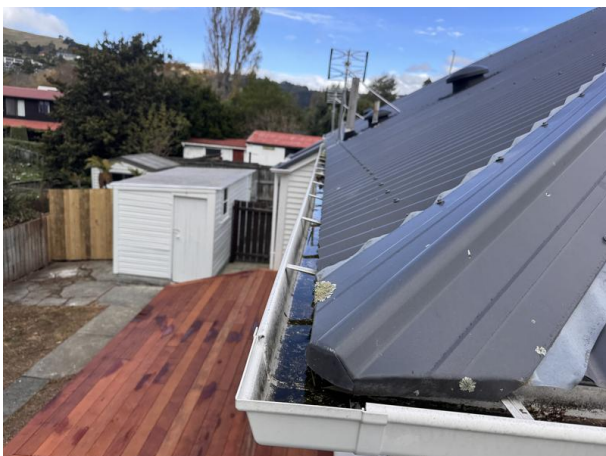
Photo 15
PVC roof edge gutter on the east elevation clear at the time of inspection.

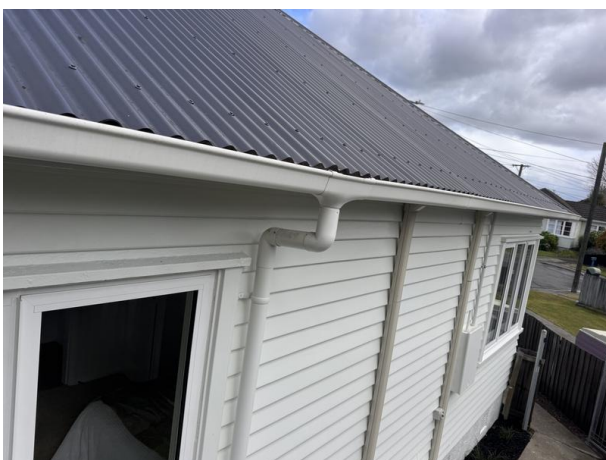
Photo 17
PVC roof edge gutter and down pipe on the north elevation.

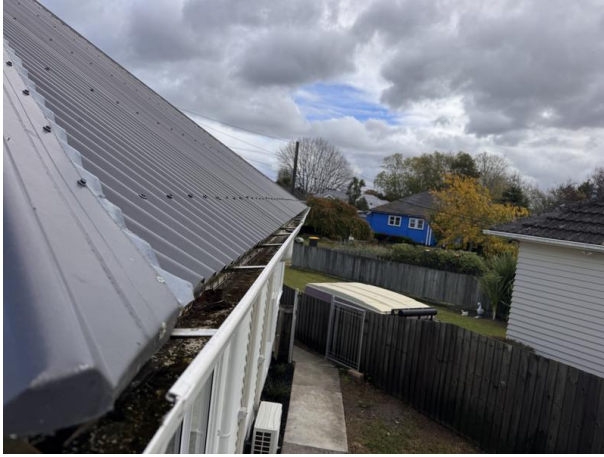
Photo 19
PVC gutter on the north elevation, clear at the time of inspection.

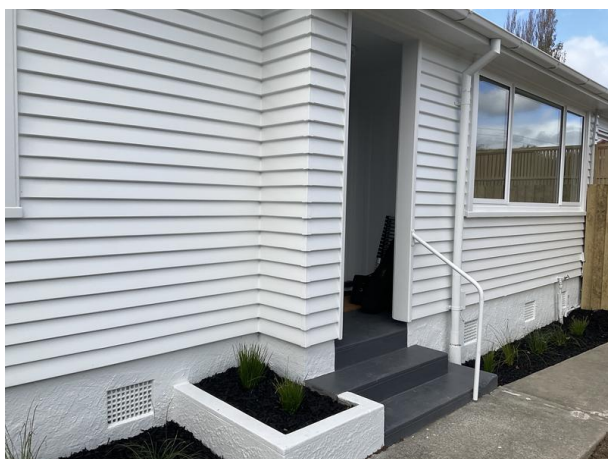
Photo 20
Timber beveled back weatherboard
cladding west elevation.

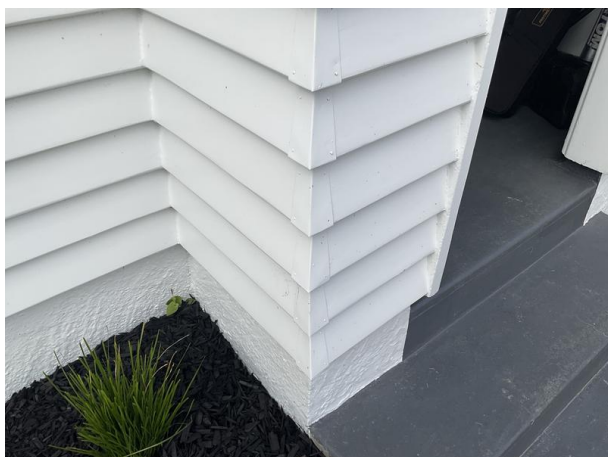
Photo 21
Metal corner soakers installed.

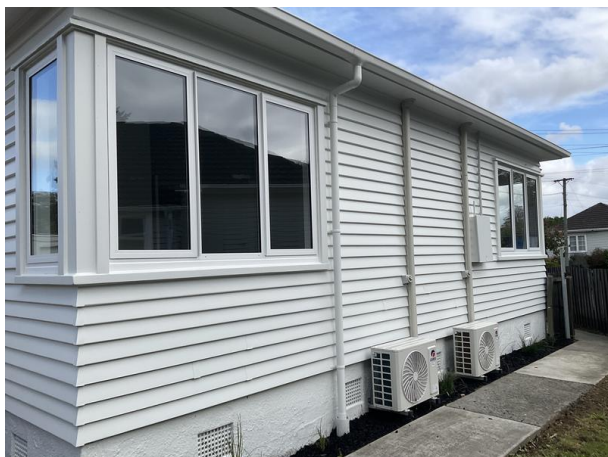
Photo 22
Timber weatherboard cladding, north elevation.

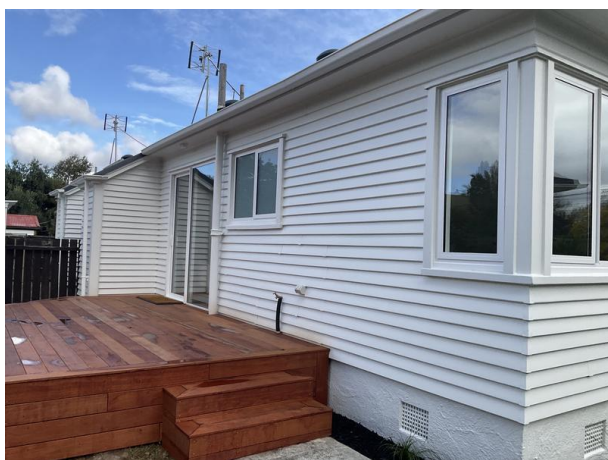
Photo 23
Timber beveled back weatherboard cladding east elevation.

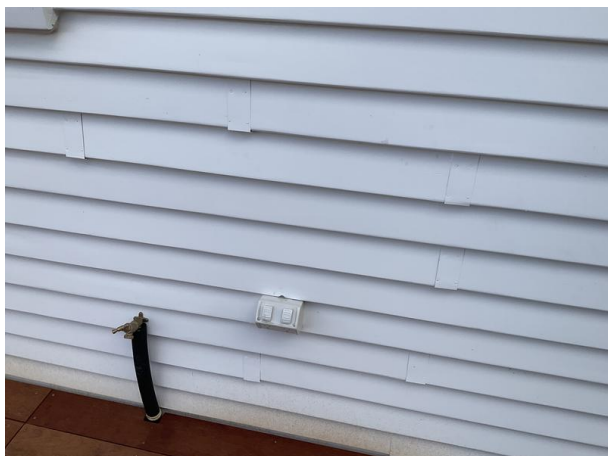
Photo 24
Weatherboard join metal soakers installed.

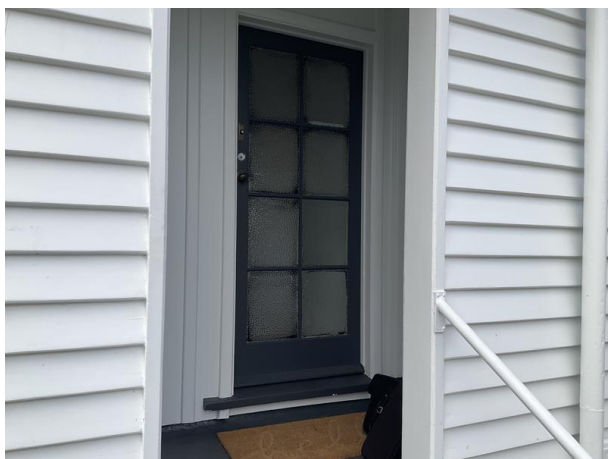
Photo 25
Single glazed timber front entrance door.

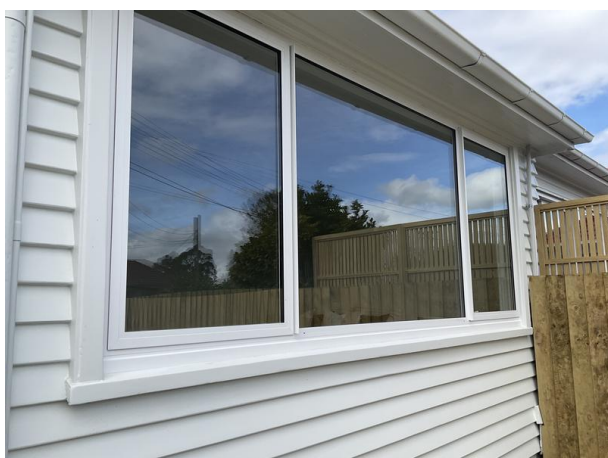
Photo 26
Double glazed aluminium joinery installed with timber facing and sills installed with suitable run off angle.

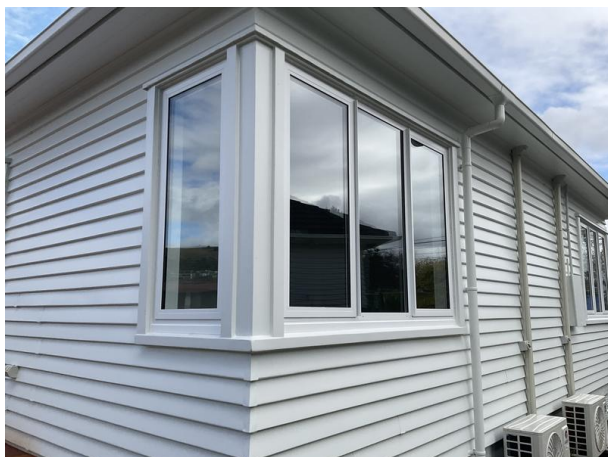
Photo 27
Double glazed aluminium corner window on the north east corner.

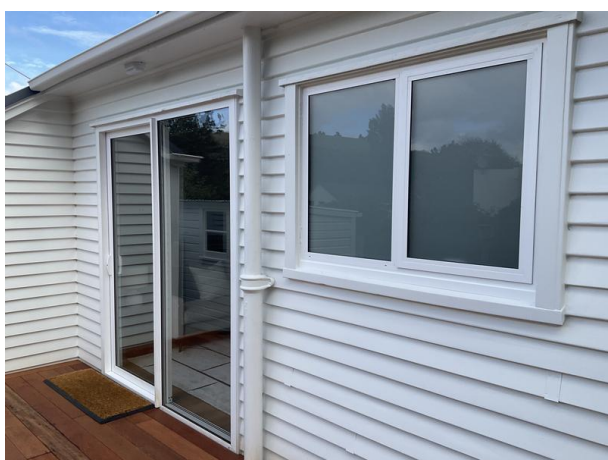
Photo 28
Double glazed aluminium joinery with profiled metal head flashings installed.

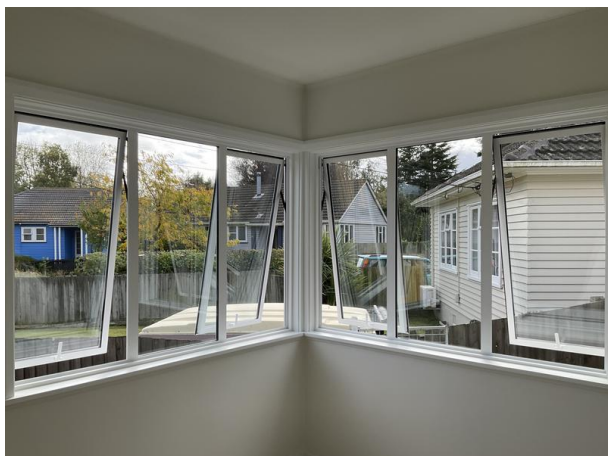
Photo 29
All accessible window and doors tested for function.

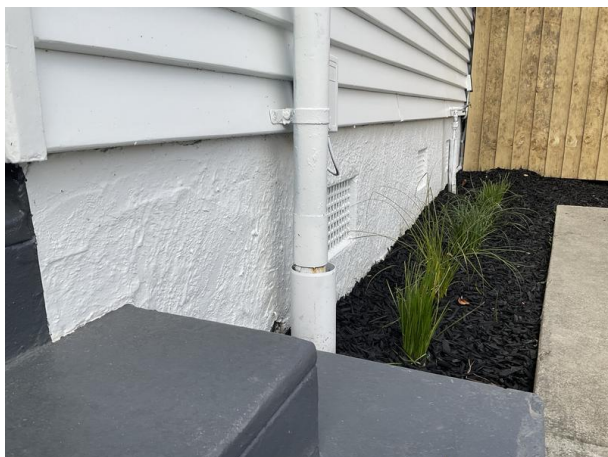
Photo 30
Concrete perimeter ring foundation.

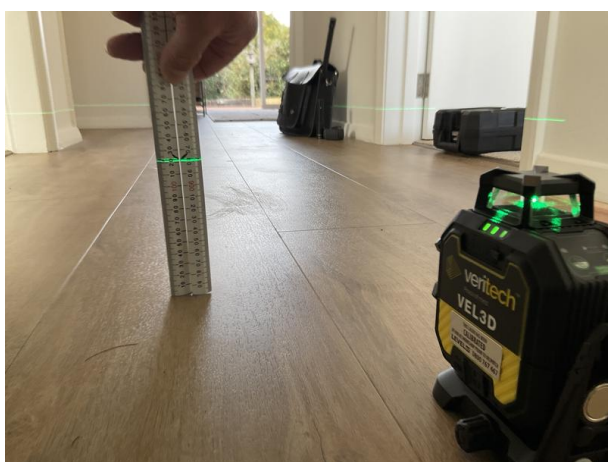
Photo 31
Floor levels checked using a self levelling laser.

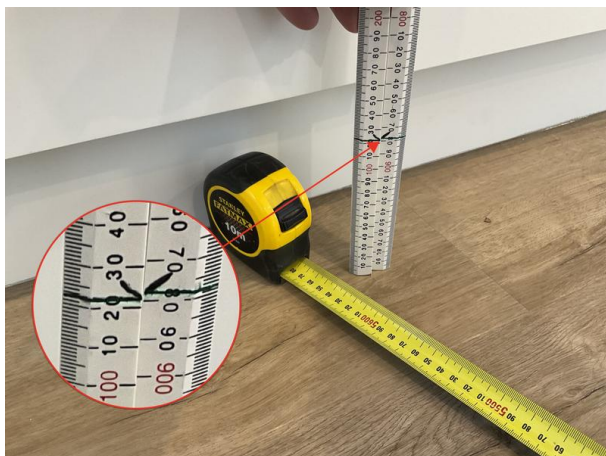
Photo 35

No deviation over 5.6 m from the hallway to the kitchen.

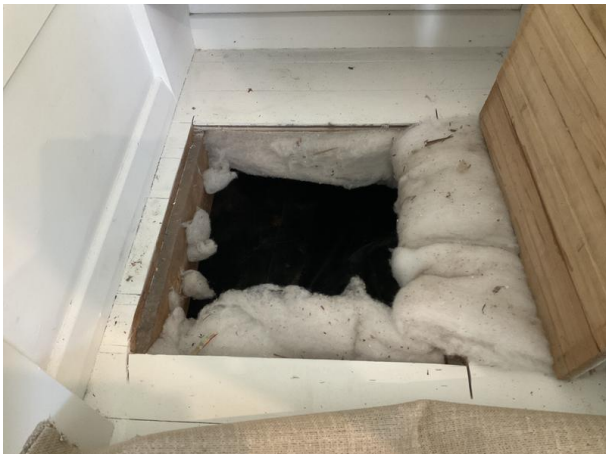
Photo 36
Subfloor access located in bedroom three cupboard.

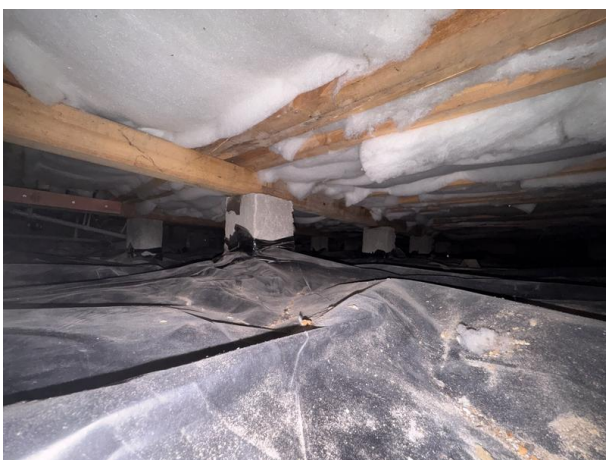
Photo 37
Suspended timber floor supported by precast concrete piles. Polythene ground moisture barrier installed.

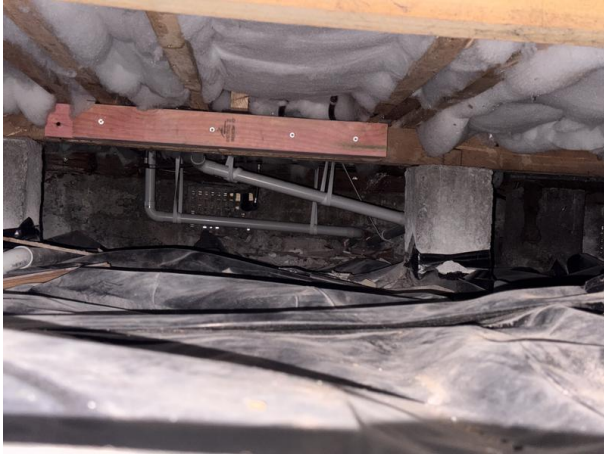
Photo 39

The bearer timbers appear to be inadequately treated for a subfloor environment. NZS 3604:2011 requires a minimum of H3.2 treatment for bearers; however, the timbers present are consistent with a lower treatment level.

PVC waste pipe and modern black plumbing visible. Bearer splicing timber installed near the bathroom.

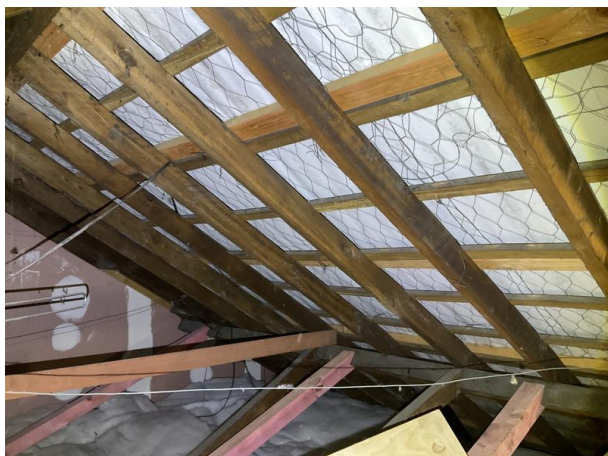
Structural alterations were observed within the roof space, including additional supports and structural members. These works are indicative of modifications to the original roof framing and require verification of compliance. Refer to the Roof Space section for further detail. It is recommended that documentation, including any LBP Record of Work, is obtained to confirm compliance with the Building Code.

Photo 42
Pitched timber framed roof with underlay with wire mesh support. Additional timber purlins installed.

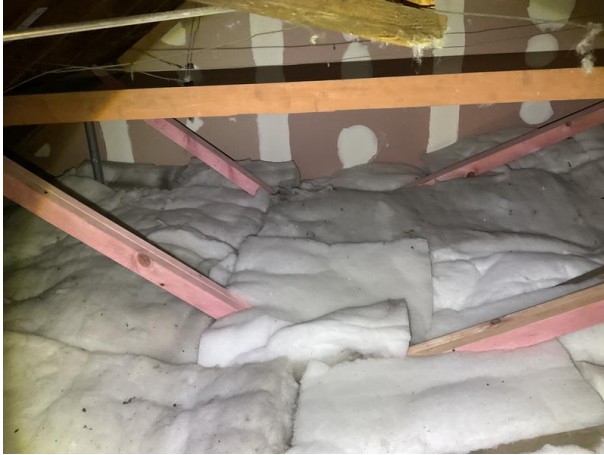
Photo 43
Polyester insulation installed.

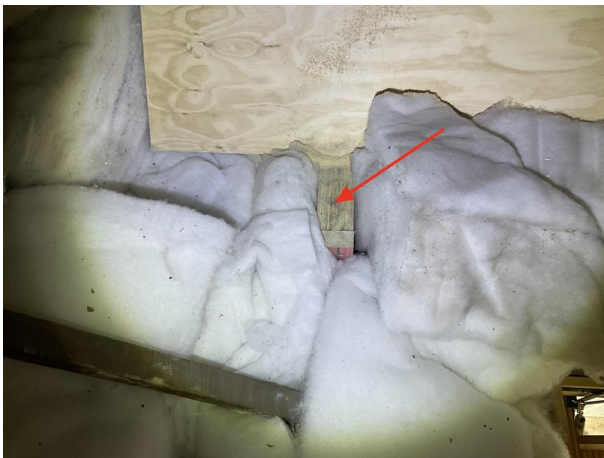
Structural alterations were observed within the roof space, including the installation of additional underpurlin supports, new purlins, and an LVL structural beam over the open-plan living area. These works are indicative of modifications to the original roof framing structure.

Photo 44
LVL hyspan structural beam partial visible.

It is recommended that documentation be obtained to verify that the works were completed in accordance with regulatory requirements.

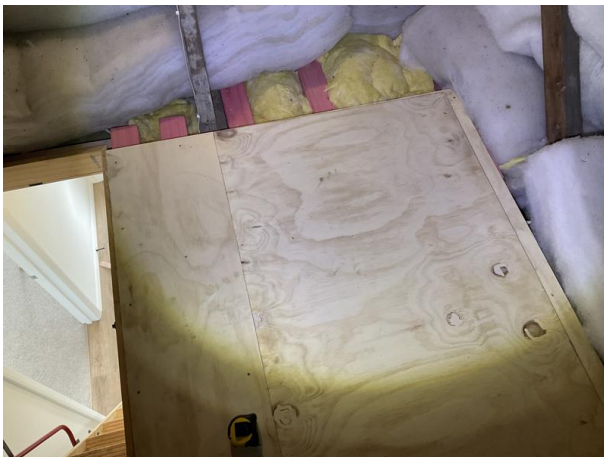
Photo 45
Plywood storage platform.

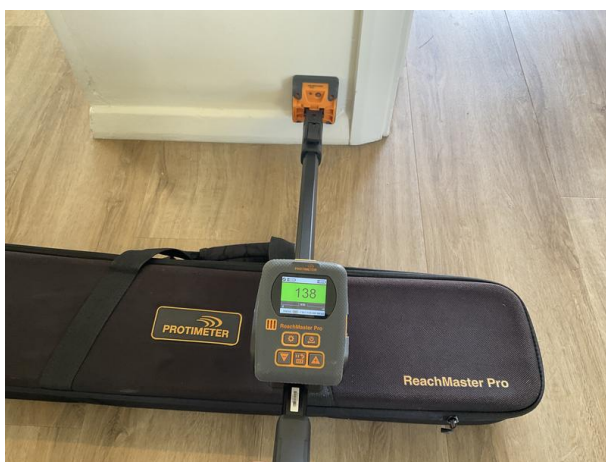
Photo 47

Base moisture reading taken from an internal wall.

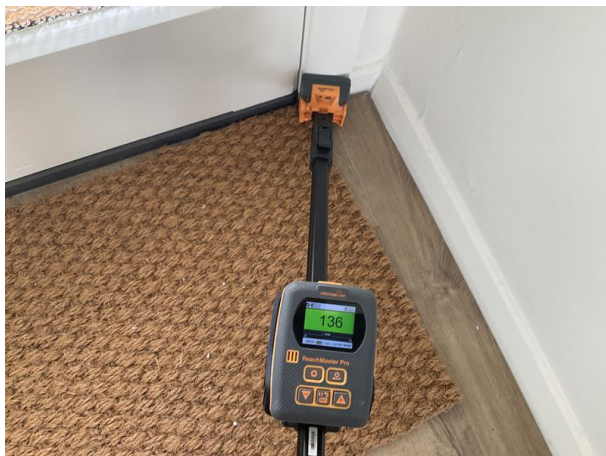
Photo 48

Moisture taken from the front entrance door frame. No indications of elevated moisture found at the time of inspection.

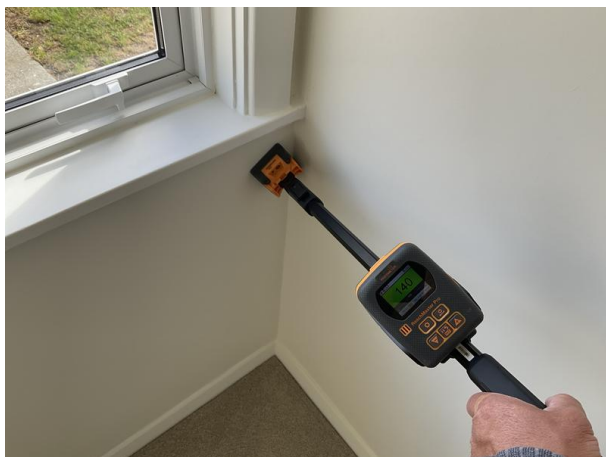
Photo 49

Moisture readings taken from all accessible window and door openings. No indications of elevated moisture found at the time of inspection.

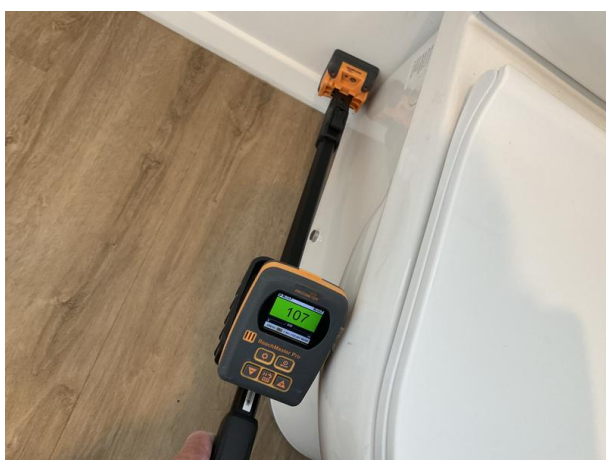
Photo 50

Moisture reading taken from behind the bathroom toilet. No indications of elevated moisture found at the time of inspection.

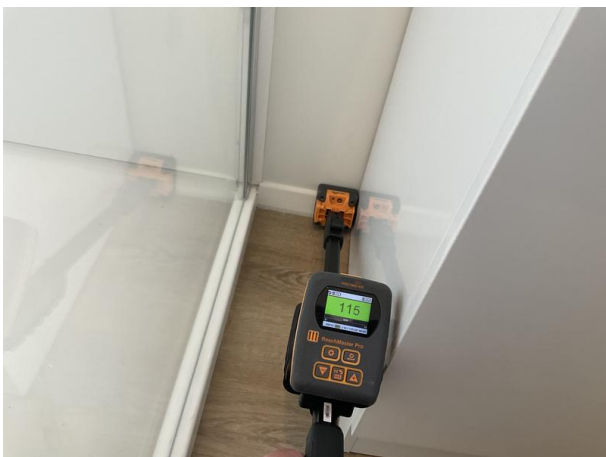
Photo 52
Moisture reading taken from behind the bathroom vanity. No indications of elevated moisture found at the time of inspection.

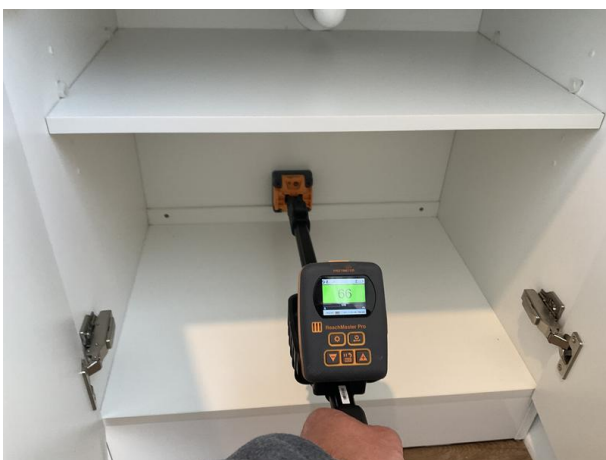
Photo 53
Moisture reading taken from under the bathroom vanity. No indications of elevated moisture found at the time of inspection.

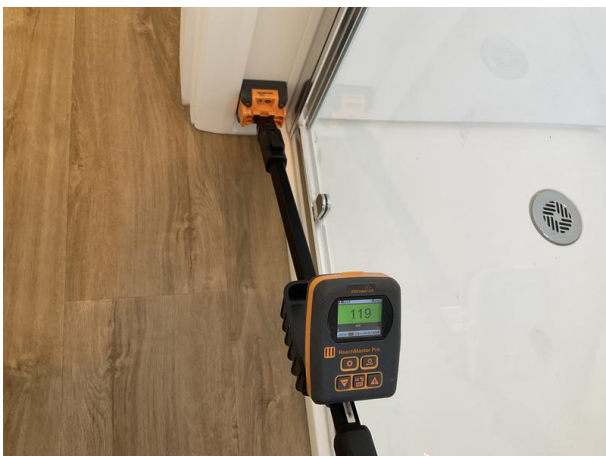
Photo 54
Moisture taken from the shower corner. No indications of elevated moisture found at the time of inspection.

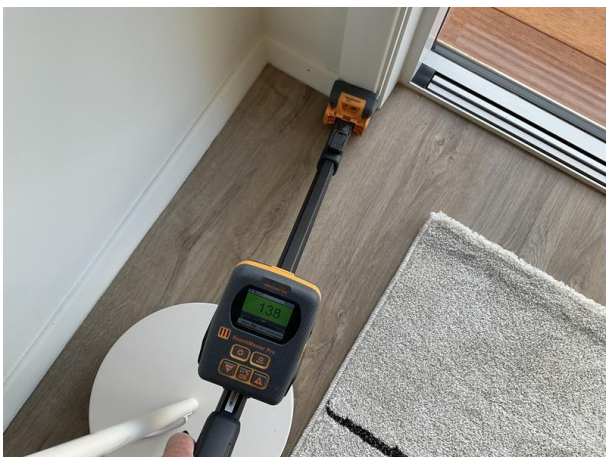
Photo 55
Moisture reading taken from the living room door frame. No indications of elevated moisture found at the time of inspection.

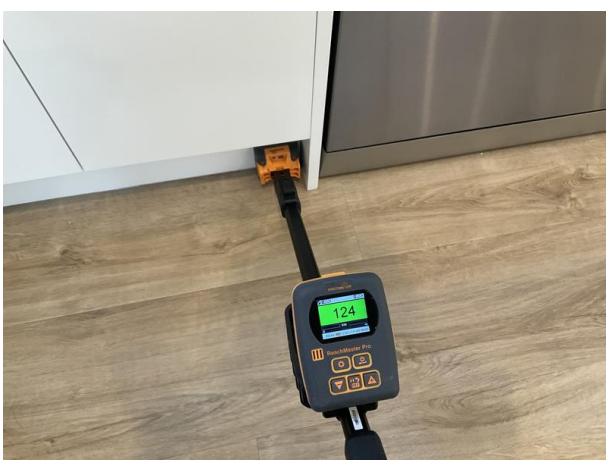
Photo 56
Moisture taken from the kitchen base cabinet near the kitchen sink and dishwasher. No indications of elevated moisture found at the time of inspection.

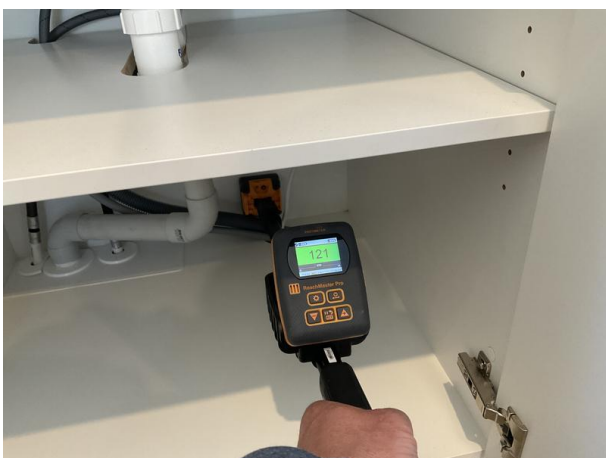
Photo 57
Moisture taken from under the kitchen sink. No indications of elevated moisture found at the time of inspection.

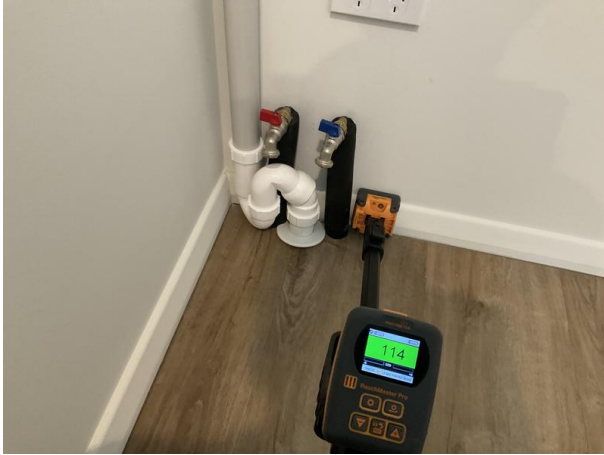
Photo 58

Moisture reading taken from near the laundry plumbing. No indications of elevated moisture found at the time of inspection.

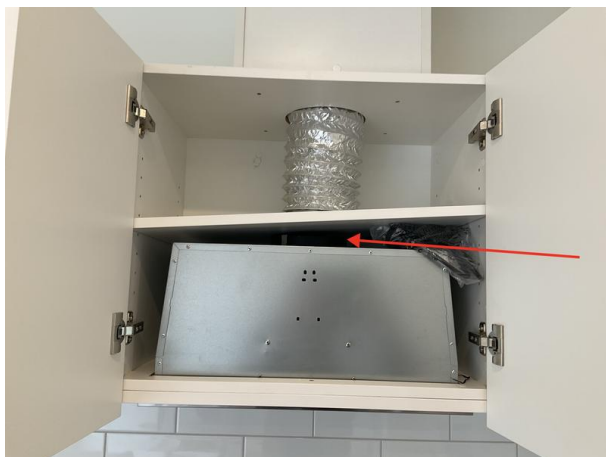
Photo 71
Kitchen extractor ducting hasnt been connected yet.

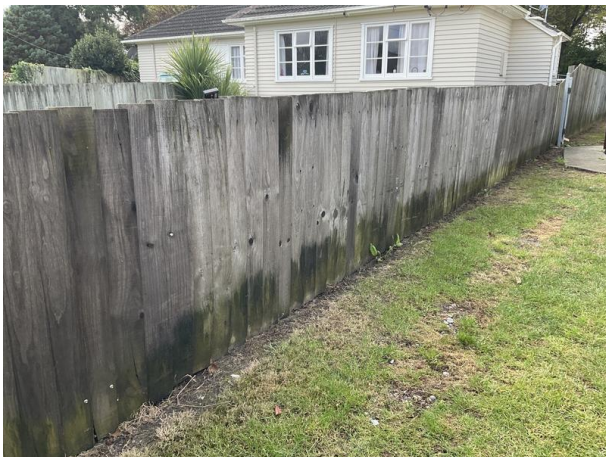
Photo 77

Timber paling north boundary fence, rising damp visible due to contact with the ground.

Ensure regular upkeep and maintenance by keeping vegetation and soil away from exterior timbers. These timbers are treated for external exposure but are not designed for prolonged contact with vegetation or soil, which can trap moisture and accelerate rot. Periodically inspect the area and clear any overgrowth or soil buildup.

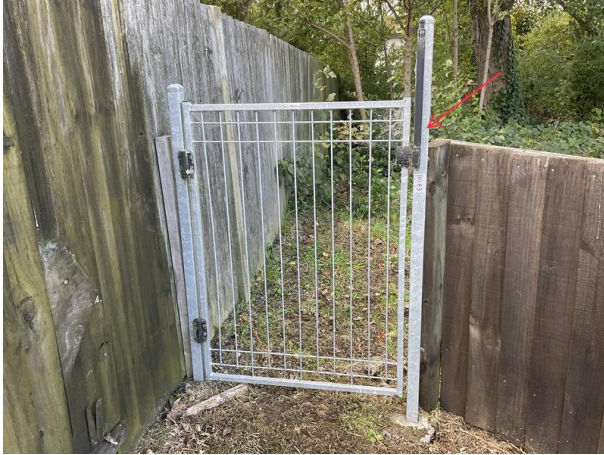
Photo 88

Metal side pedestrian gate access to the east garden creek side lawn. The latch has become misaligned.

It is recommended to apply regular maintenance to hinges and latches to maintain smooth operation.

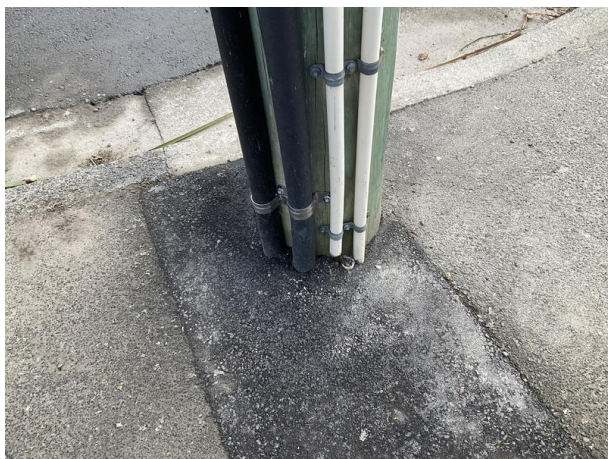
Photo 89
Under ground power supply.

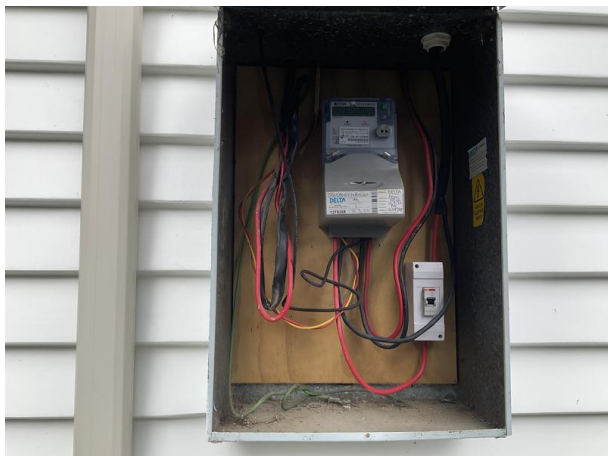
Photo 90
Power meter located on the north elevation.

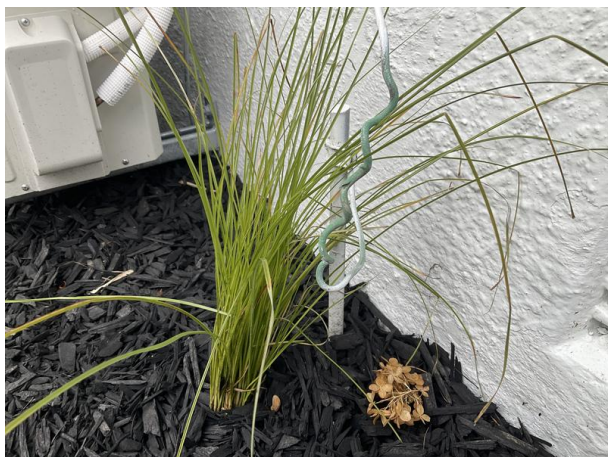
Photo 91
Earth stake located under the power meter on the north elevation.

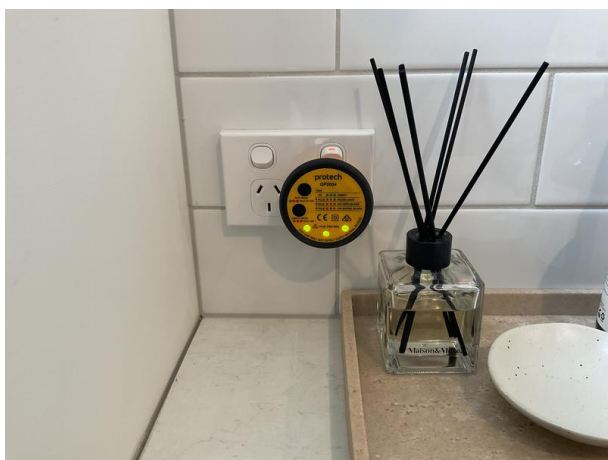
Photo 92
All accessible power sockets tested for faults. No faults detected at time of inspection.

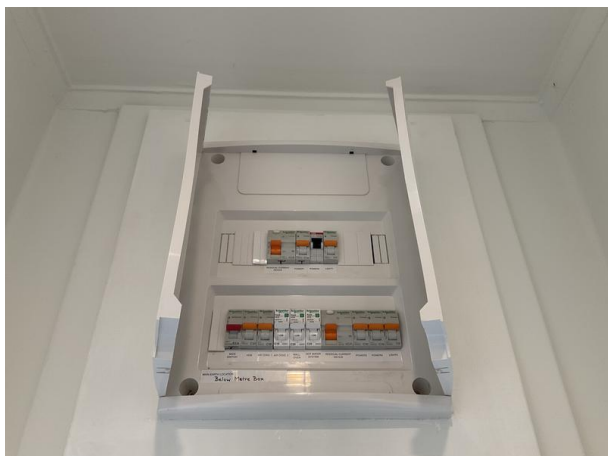
Photo 93
Power distribution board located in the hallway.

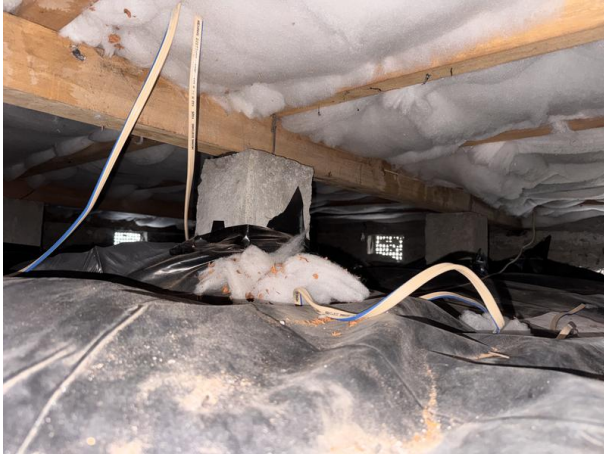
Photo 94
Unsupported TPS wire visible in the subfloor.

Some electrical and communications cabling in the roof space was observed to be unsupported. To reduce the risk of mechanical damage and to align with good practice, it is recommended that a registered electrician review the wiring layout and securely fix cable runs to the framing or battens as appropriate.

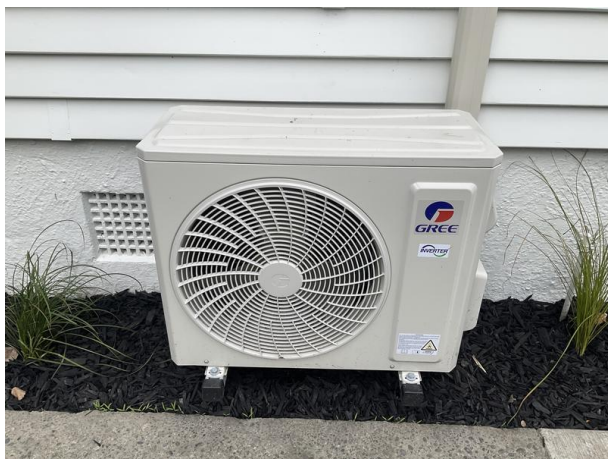
Photo 95

Gree heat pump inverter located on the north elevation.

Follow the manufacturer's recommended servicing schedule to ensure the equipment operates efficiently and maintains optimal performance. Adhering to these guidelines helps identify and address potential issues early, reducing the risk of costly repairs and ensuring compliance with warranty requirements.

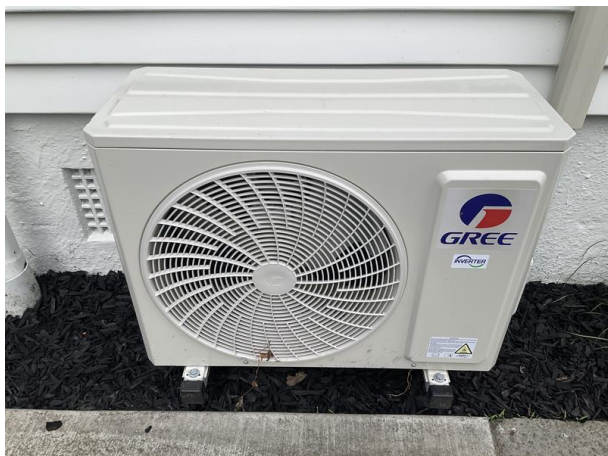
Photo 96

Gree heat pump inverter located on the north elevation.

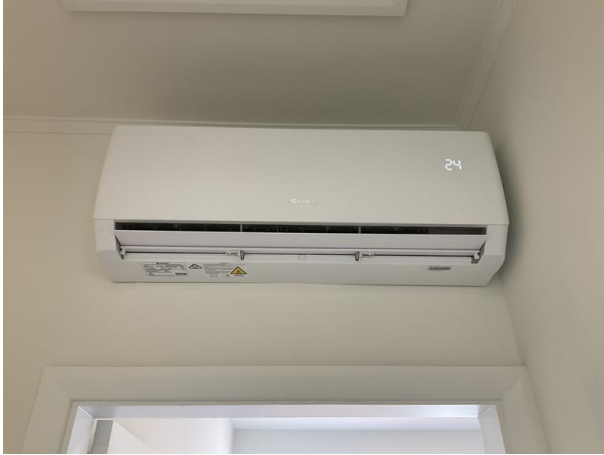
Photo 97
Gree high wall heat pump installed in the hallway.

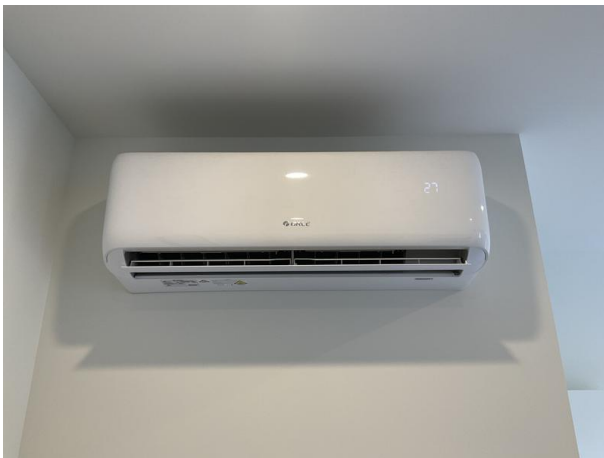
Photo 98
Gree high wall heat pump installed in the living room.

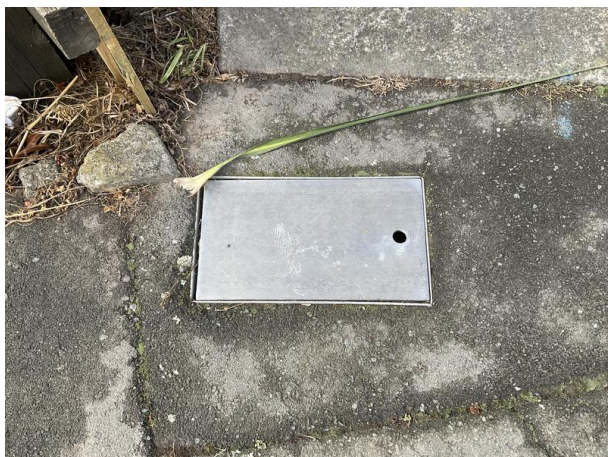
Photo 99

Water meter located in the front council path.

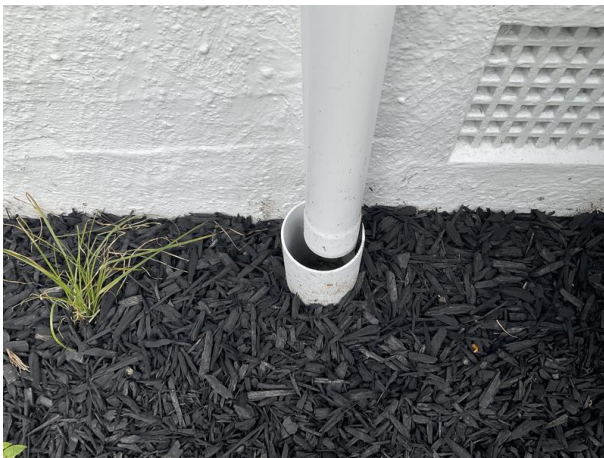
Photo 101
PVC stormwater riser.

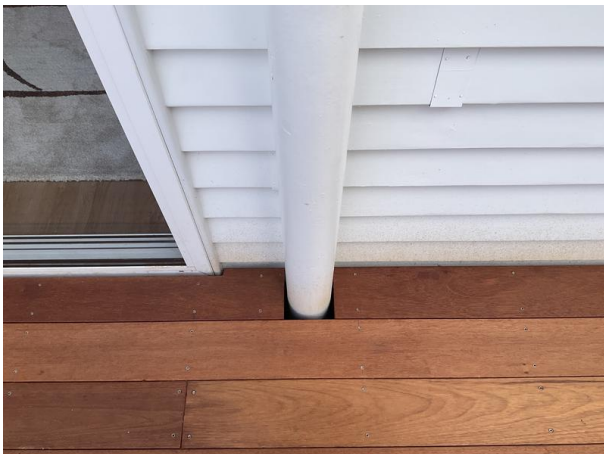
Photo 102
Terminal vent pipe passes through the decking on the east elevation.

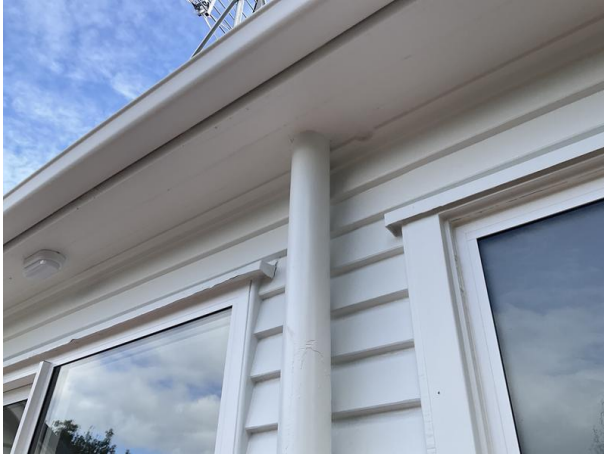
Photo 103
Terminal vent pipe soffit penetration.

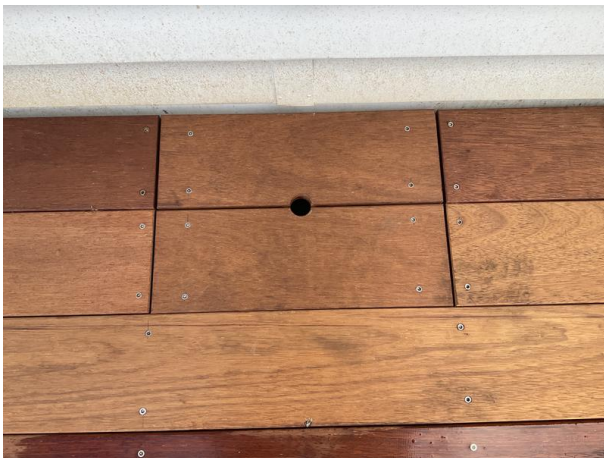
Photo 104
Access to the gully trap on the east elevation under the deck.

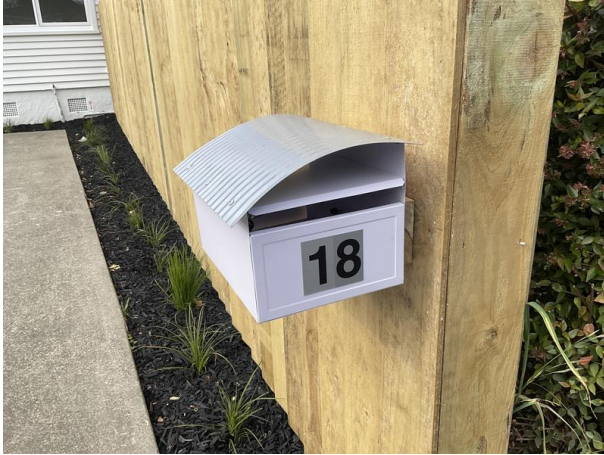
Photo 106
Letter box.

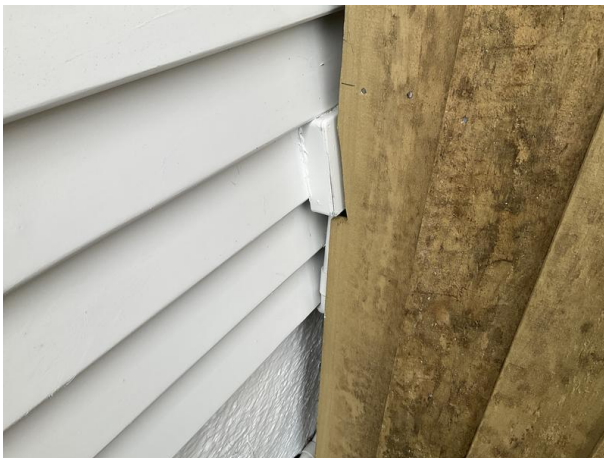
Photo 107
Fibre installed.

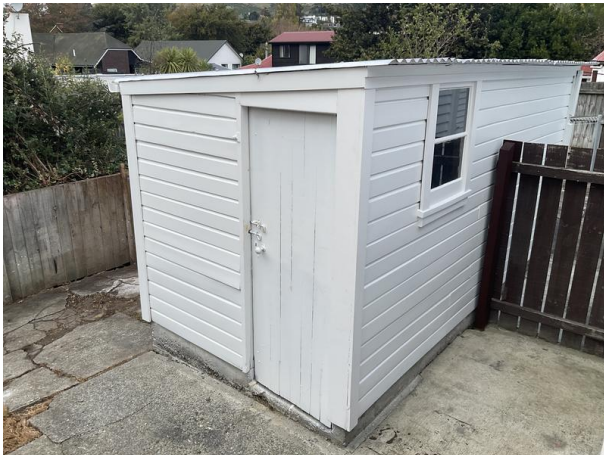
Photo 108
Storage shed.

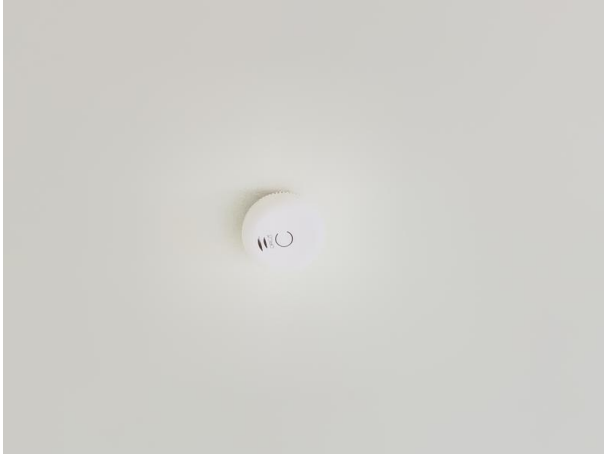
Photo 109

Interconnected smoke detectors installed.

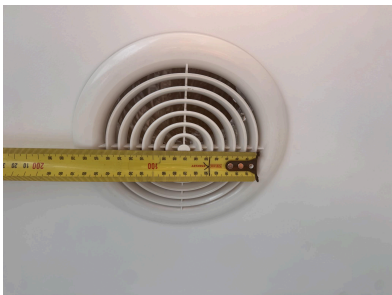
150mm extraction fan
