**Information request – 427 Armagh Street, Linwood, Christchurch 8011**

## TR001: Technical Report – Desktop Technical Review & Structural Inspection

## **Canterbury Claims – Assessment Report**

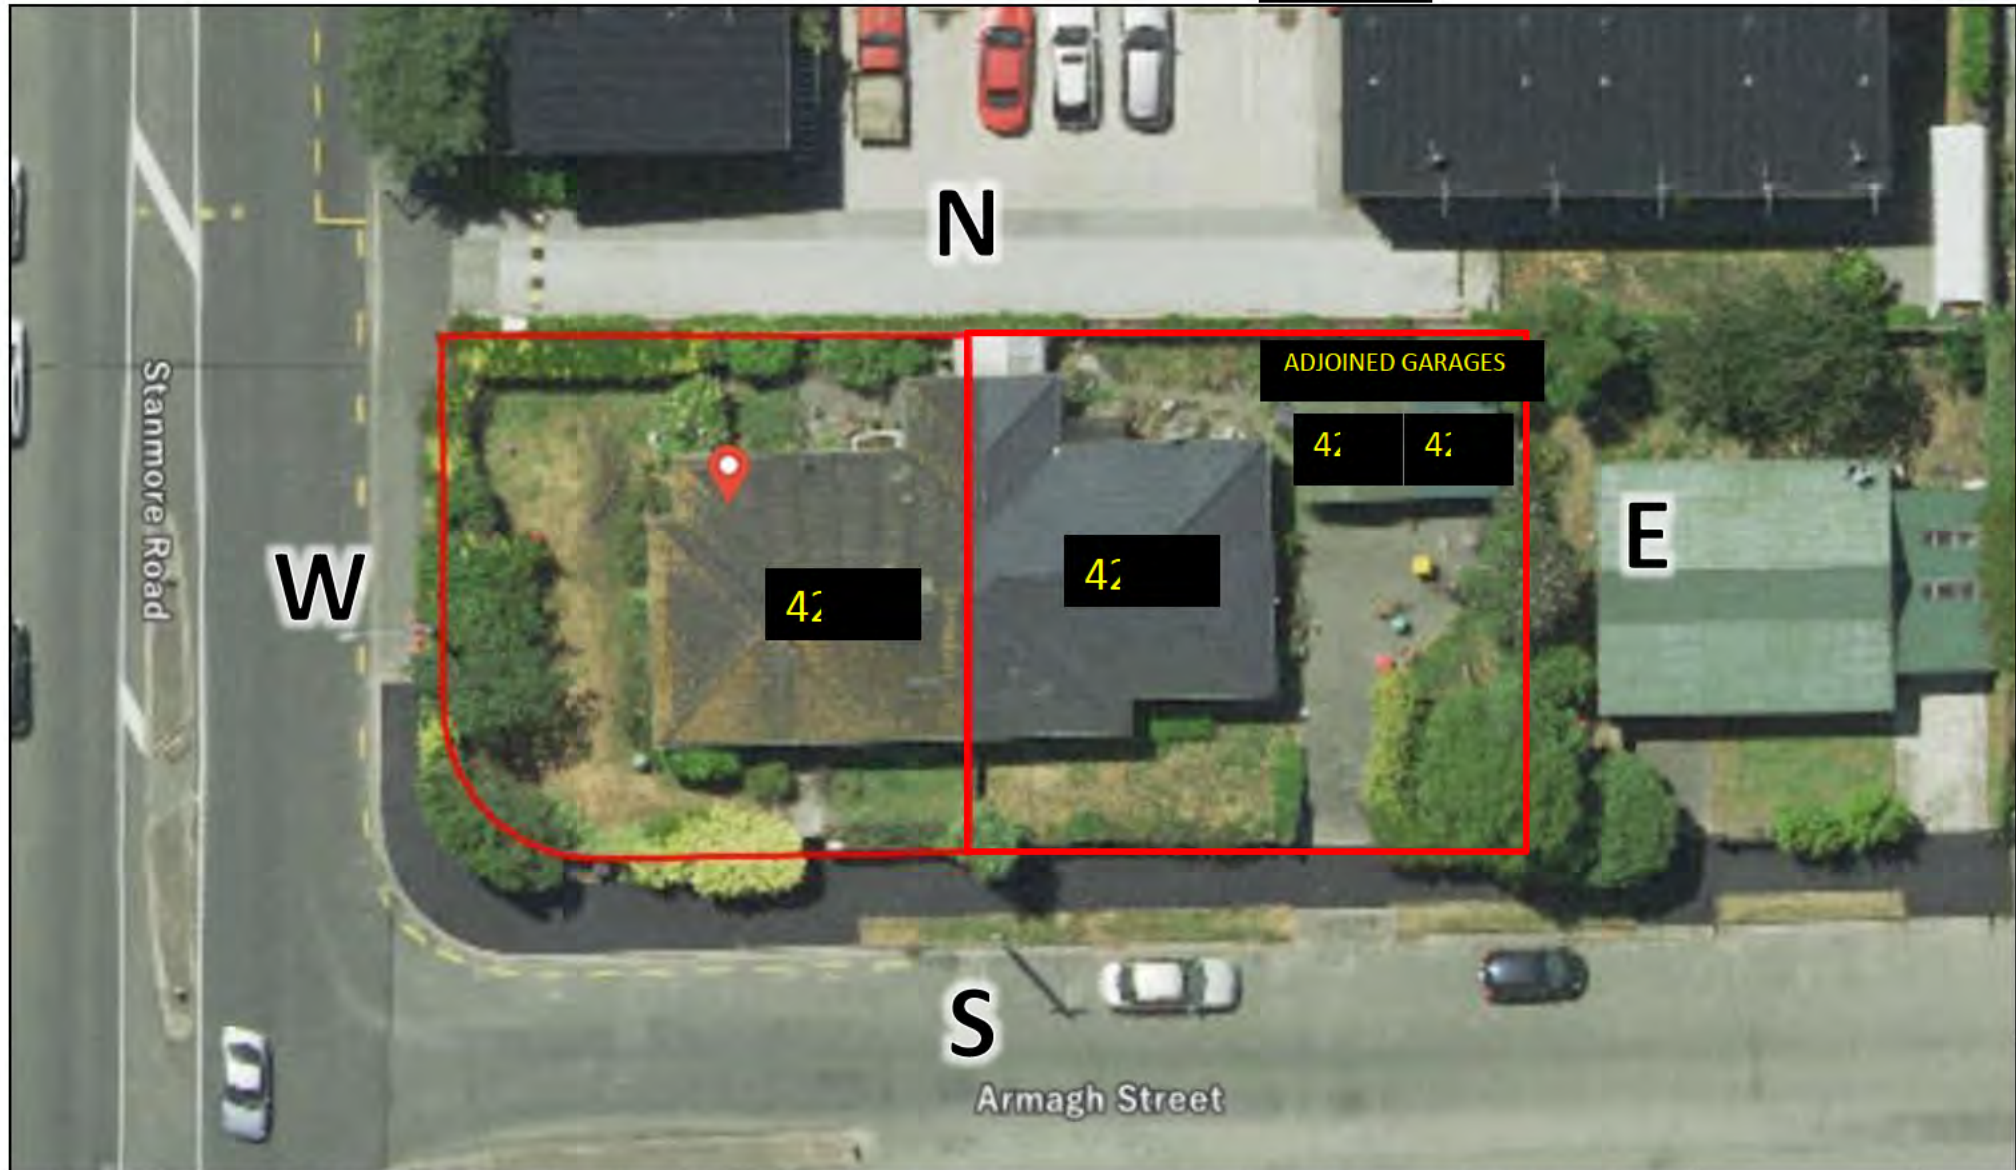
Photo 1A – Screenshot of latest aerial imagery from canterburymaps.govt.nz showing property layout and simplified cardinal directions

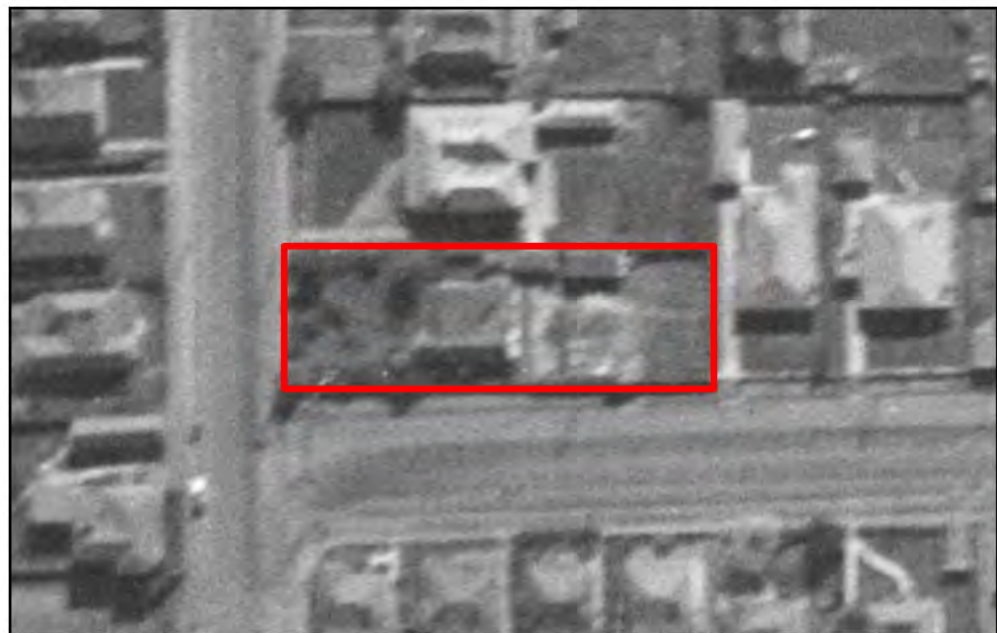
Photo 1B – 1940-1944 earliest available aerial imagery of the property, showing the original property (now 3 titles).

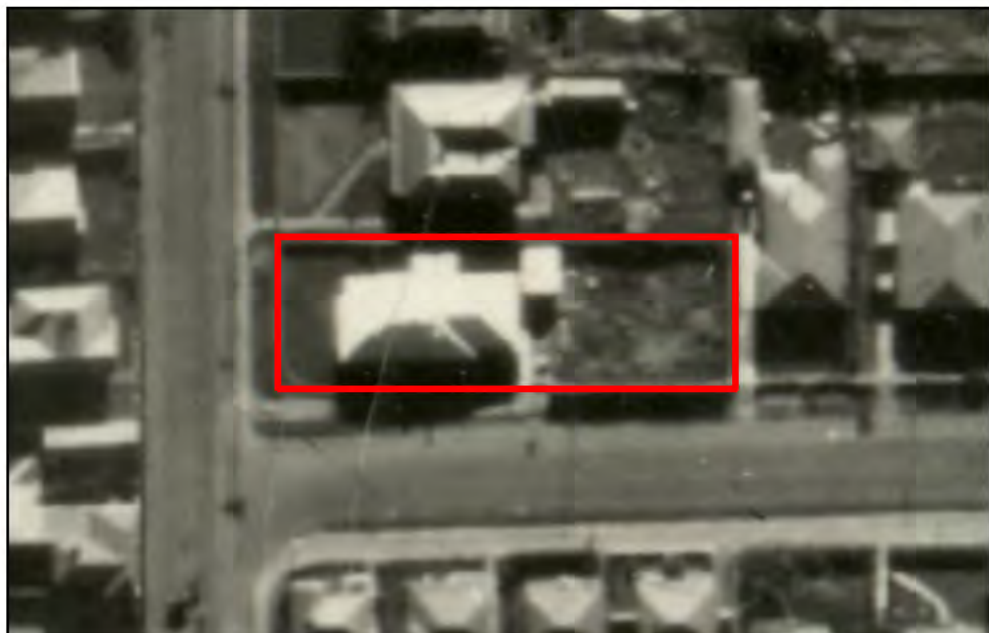
Photo 1C – 1945-1949 aerial imagery shows the new dwelling and original garage.

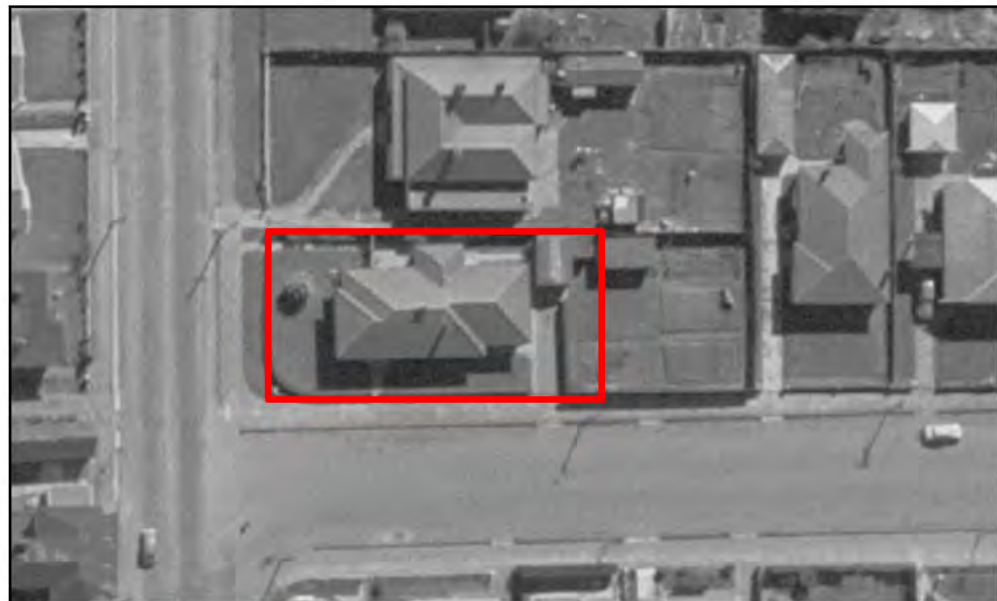
Photo 1D – 1960-1964 aerial imagery shows the carport against the garage.

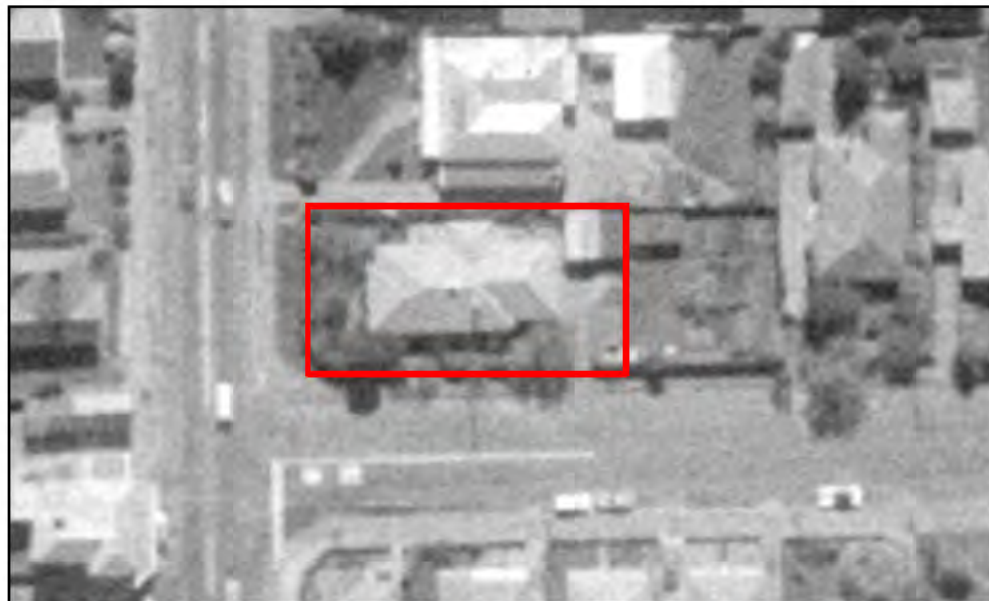
Photo 1E – 1980-1984 aerial imagery shows the second garage (carport permitted to be enclosed in 1978).

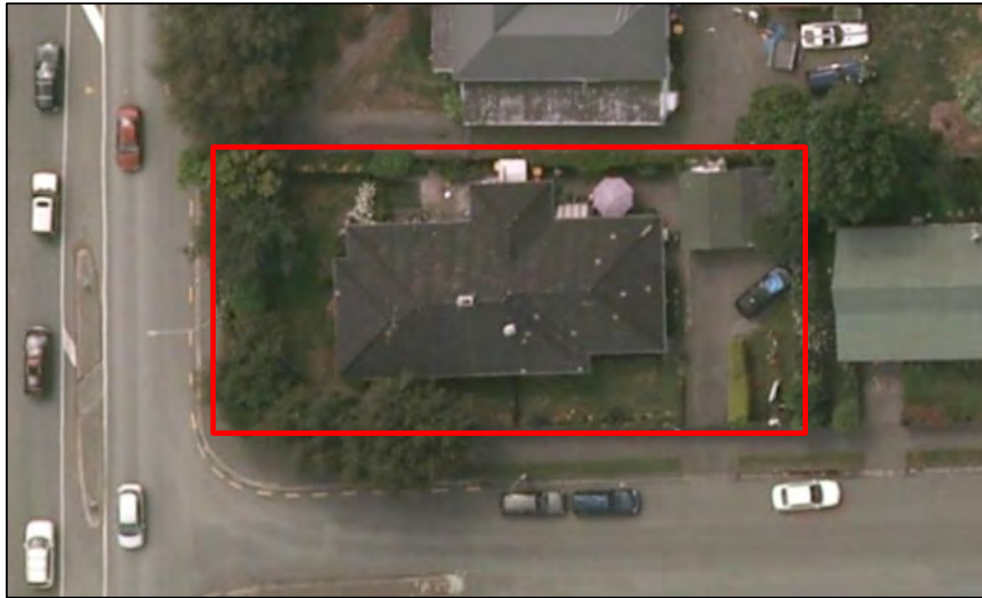
Photo 1F – 2010-2014 first (clear) aerial imagery of the conservatory at 427 Armagh Street.

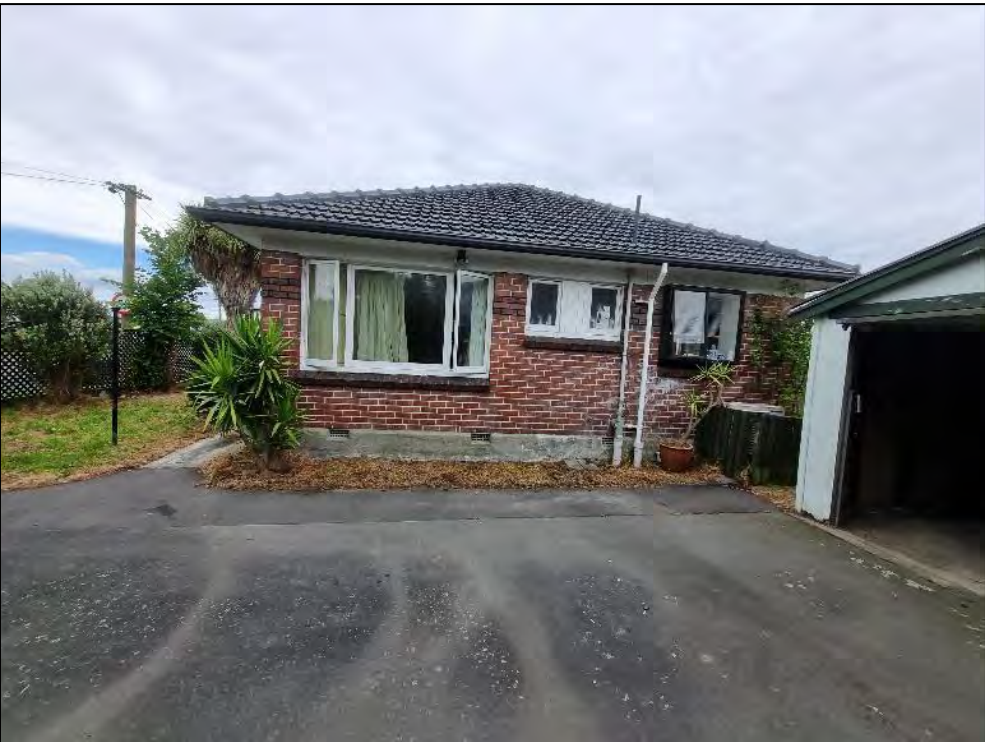
Photo 2B – East elevation.

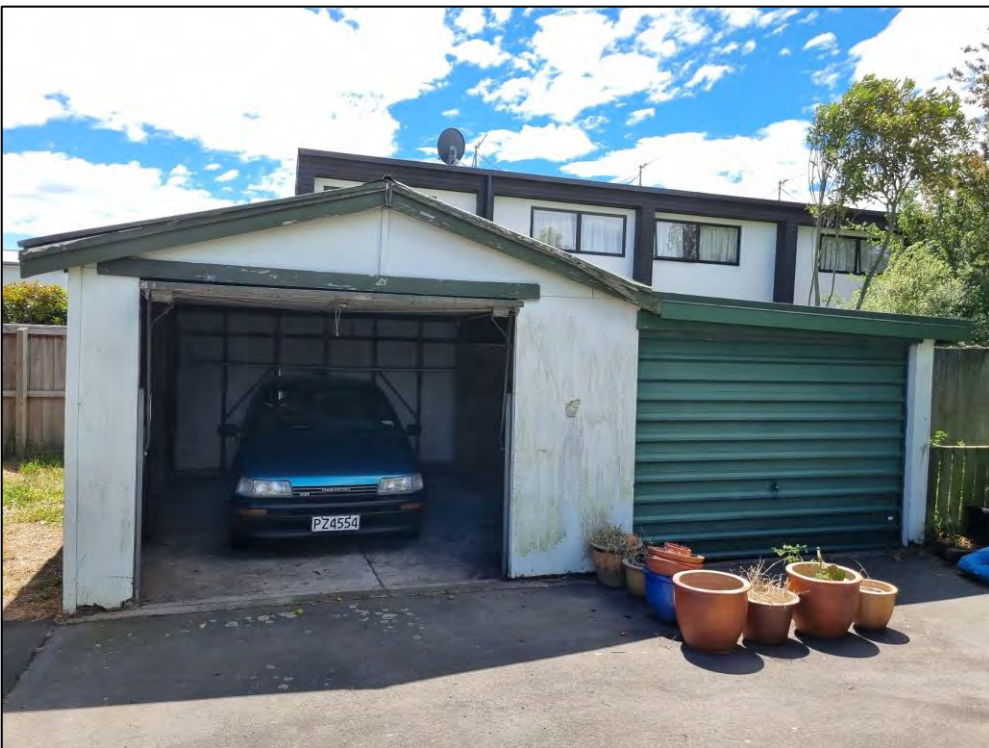
Photo 7A – South elevation of adjoining garages.

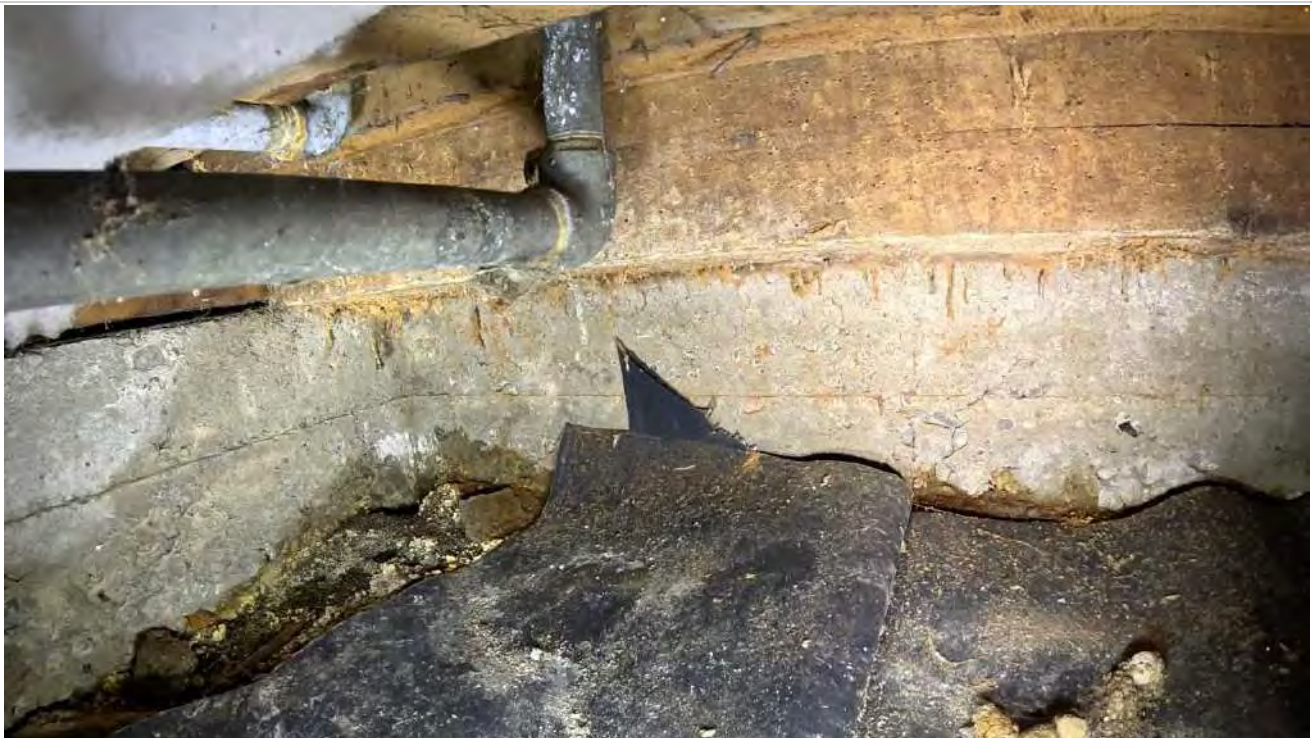
3: View along party wall foundation.

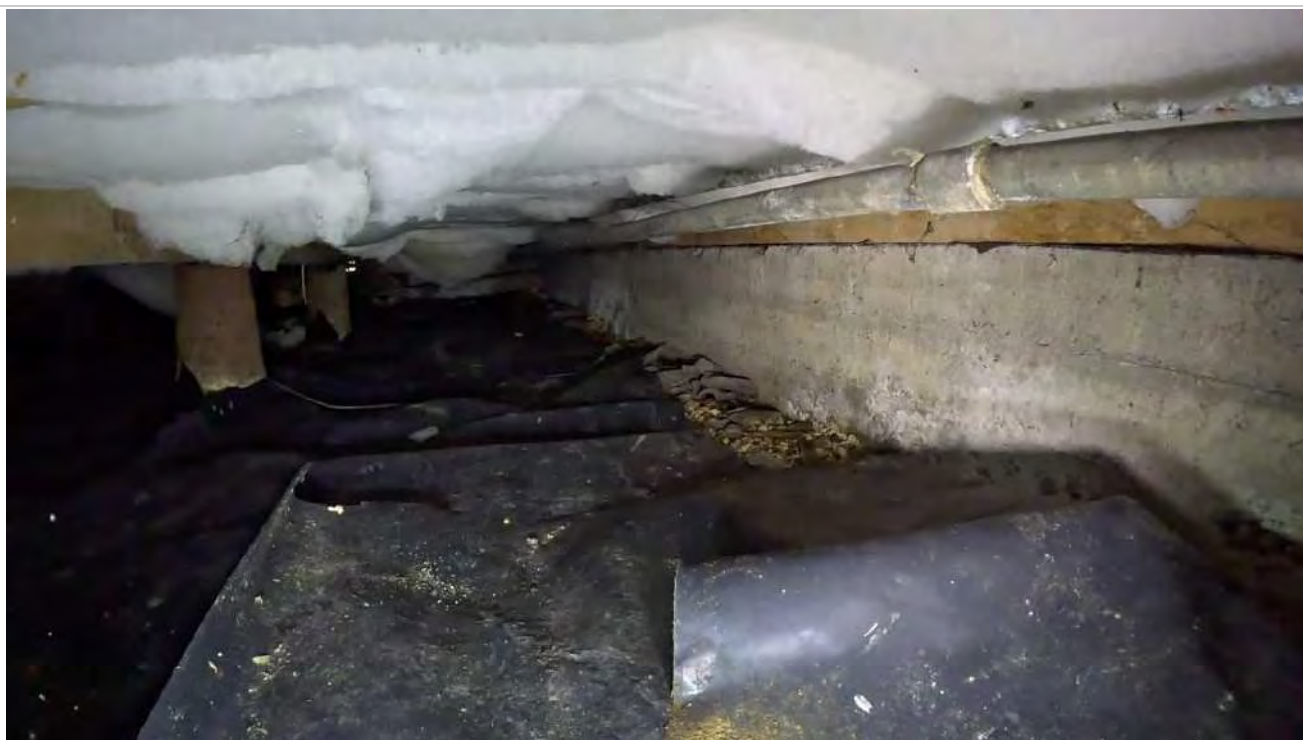
4: View of foundation.

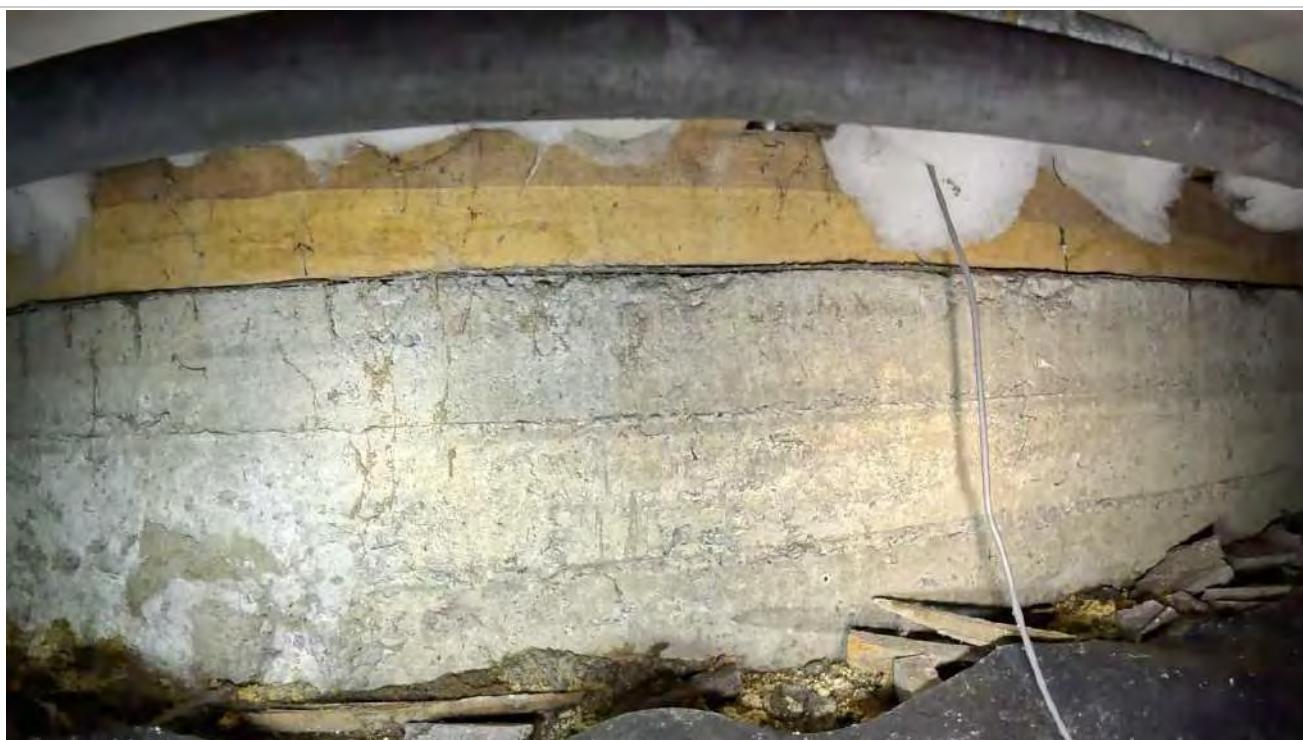
5: There are a lot of services and batts that have been pulled down that obstructed our access.

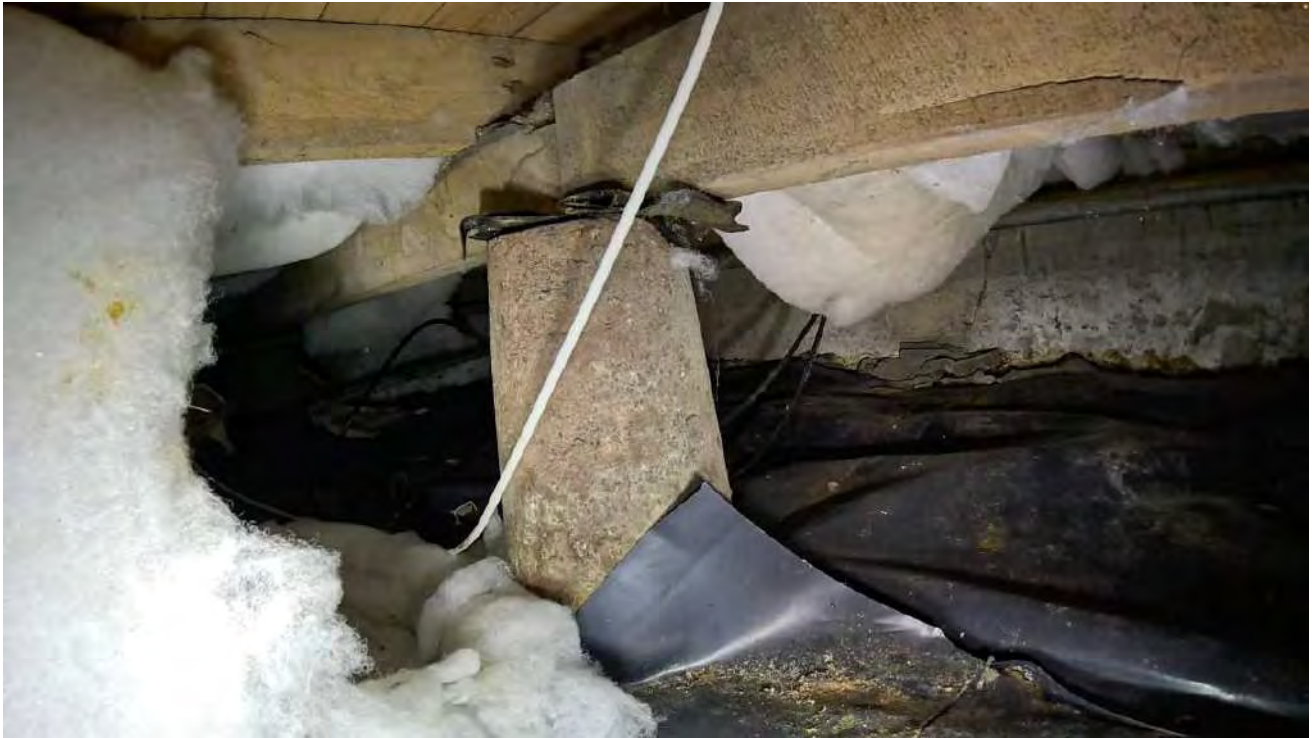
8: Precast concrete pile with no connection.

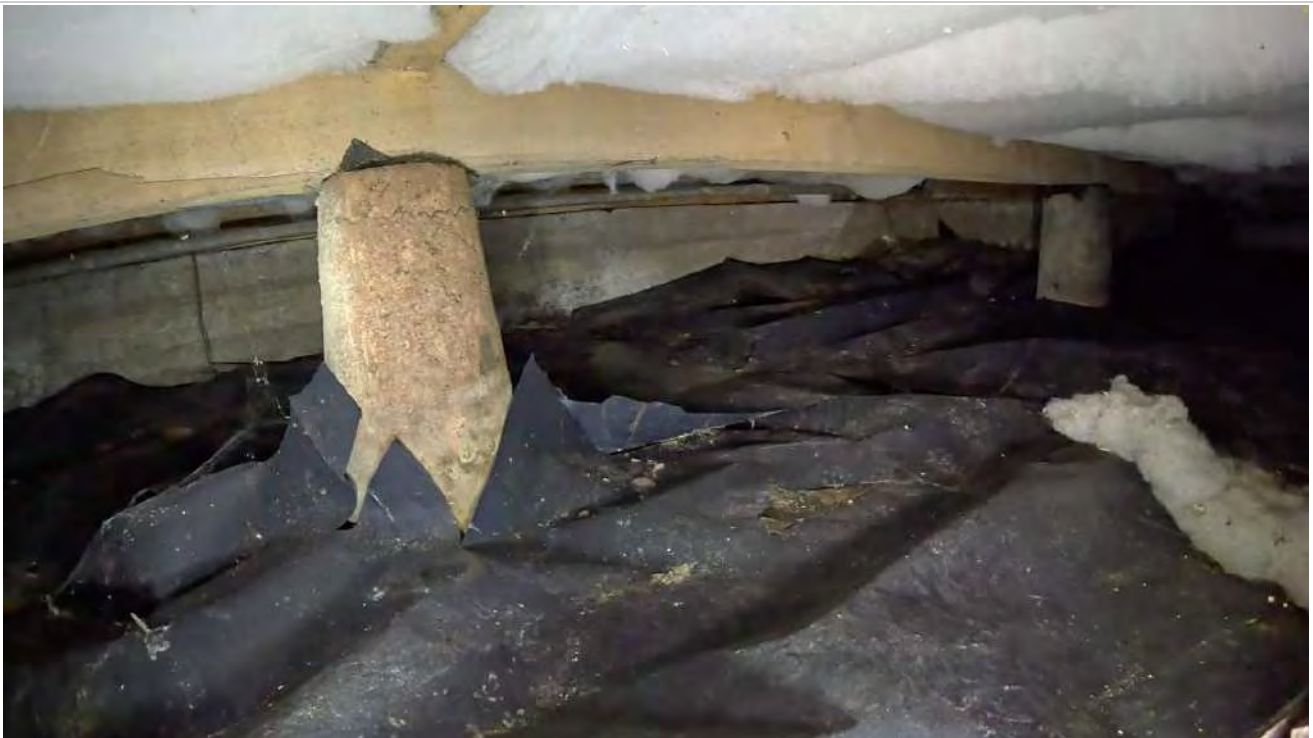
9: Precast concrete pile with no connection.

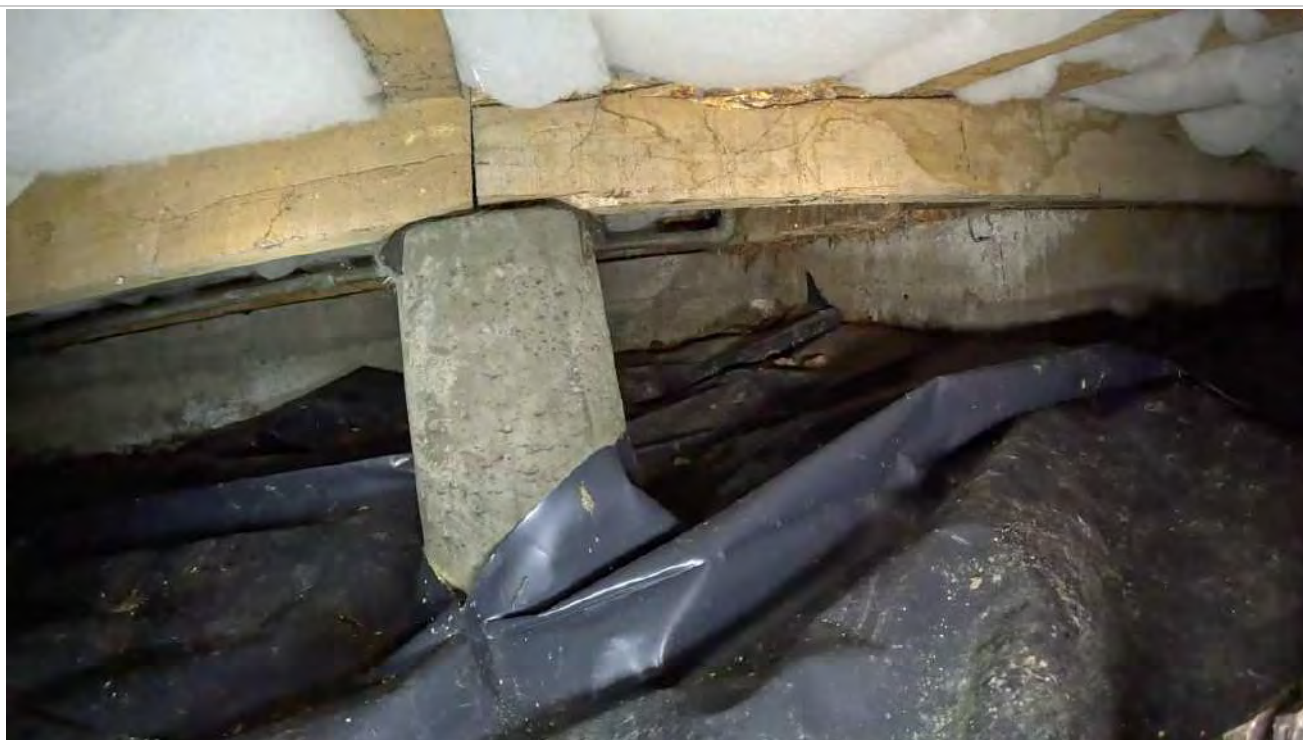
10: Precast concrete pile with no connection.

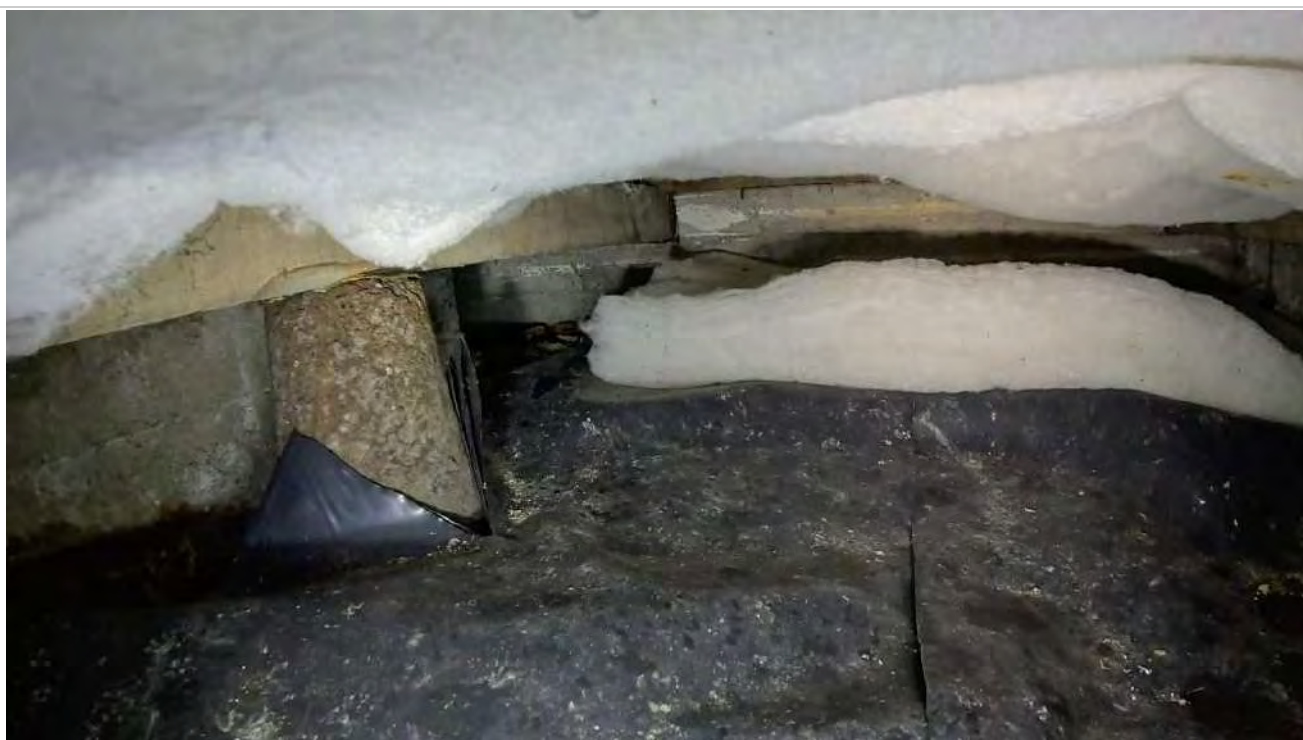
11: I think that there is a concrete base here, but I am not completely sure of the layout.

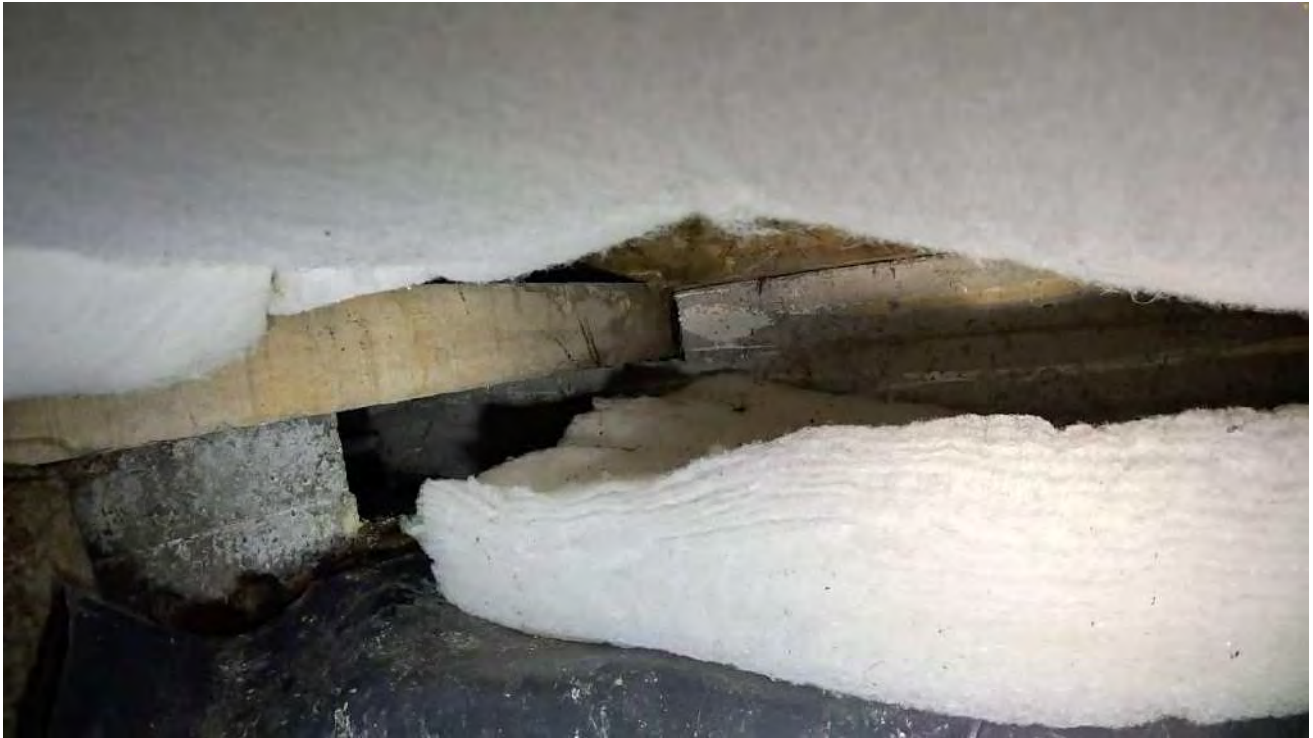
12: View of foundation.

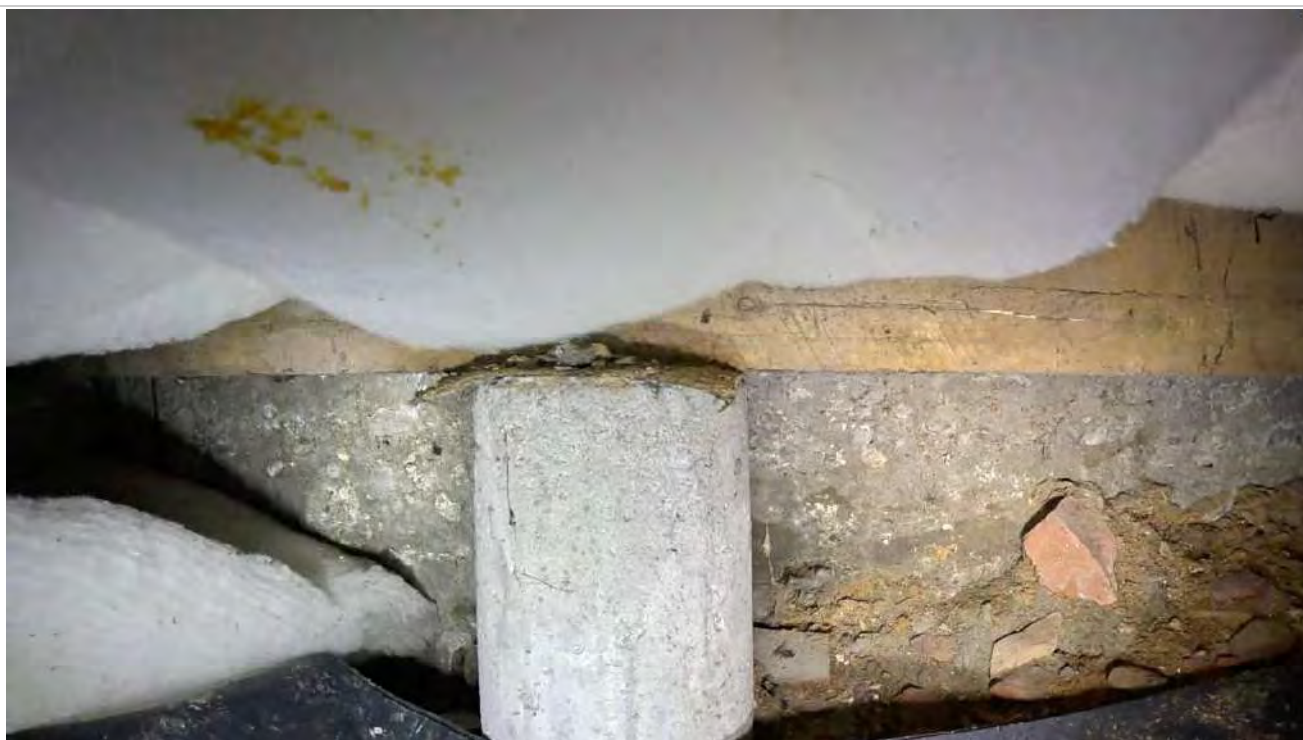
14: View of bearer meeting concrete base.

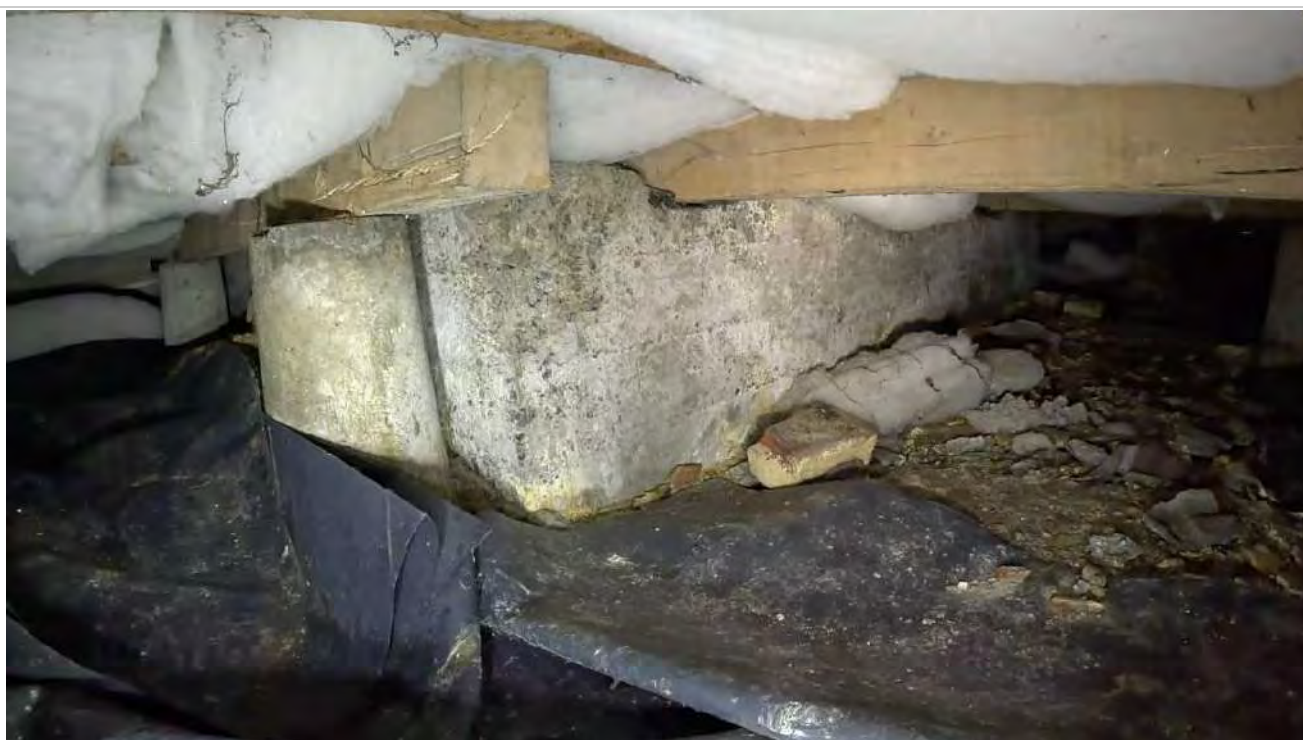
15: Precast concrete pile with no connection.

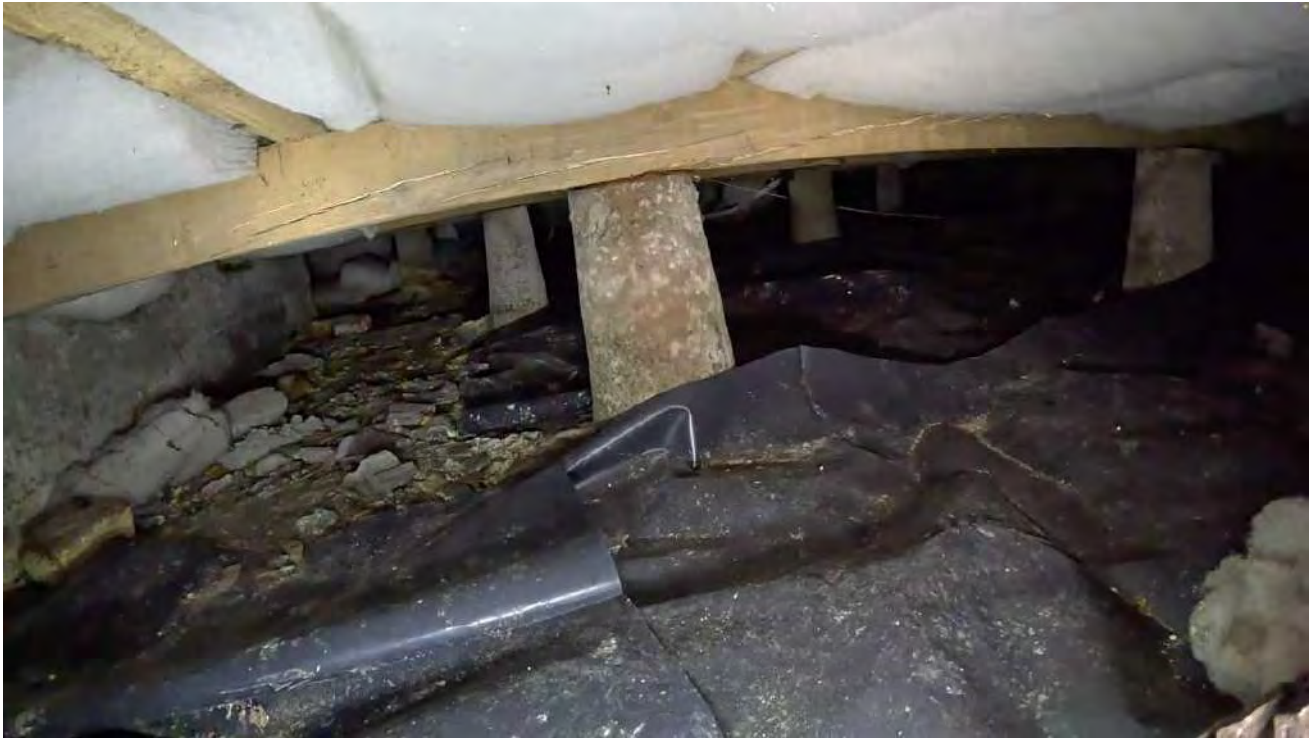
16: Precast concrete pile with no connection.

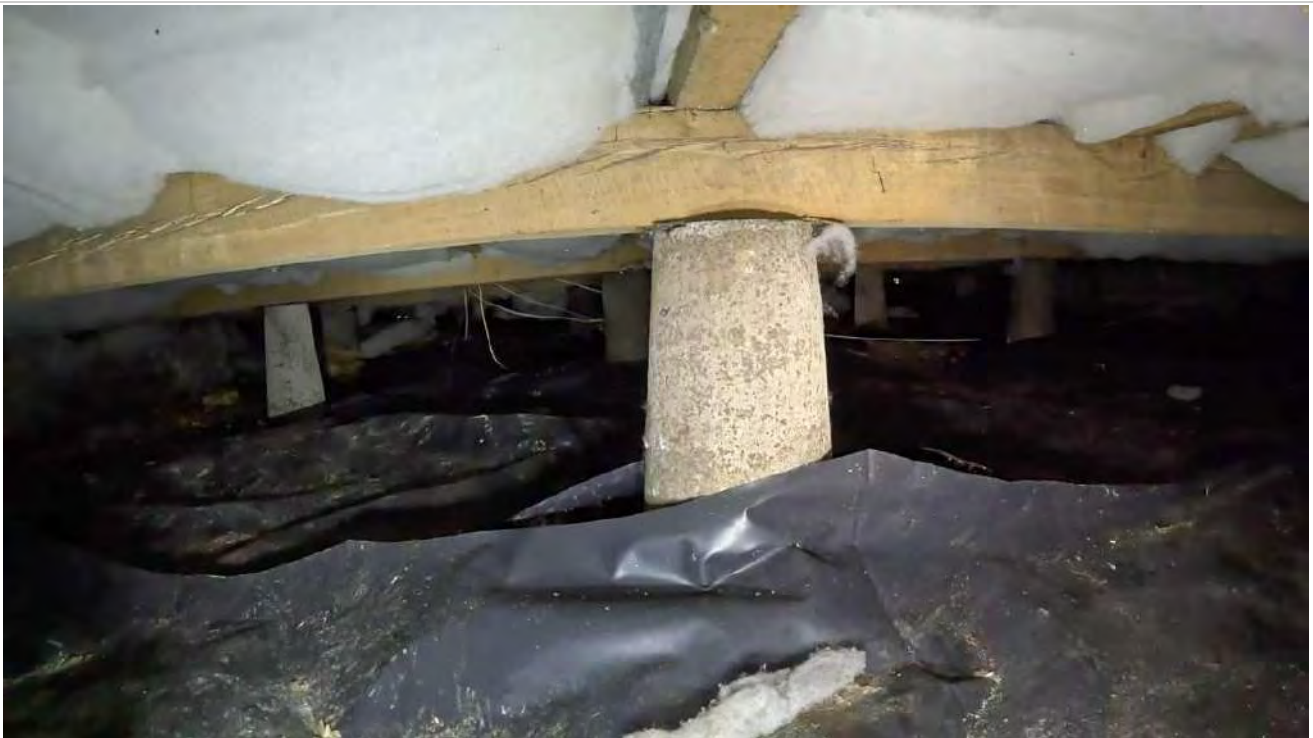
17: Precast concrete pile with no connection.

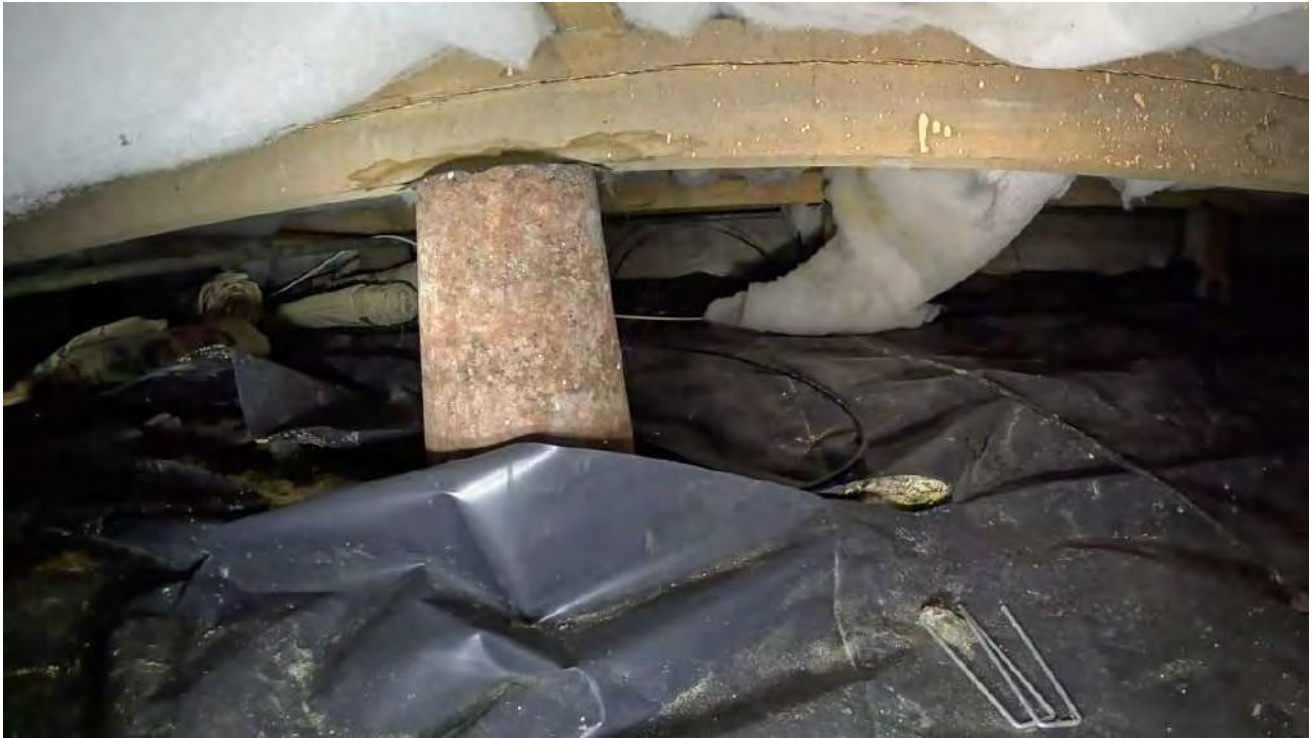
18: Precast concrete pile with no connection.

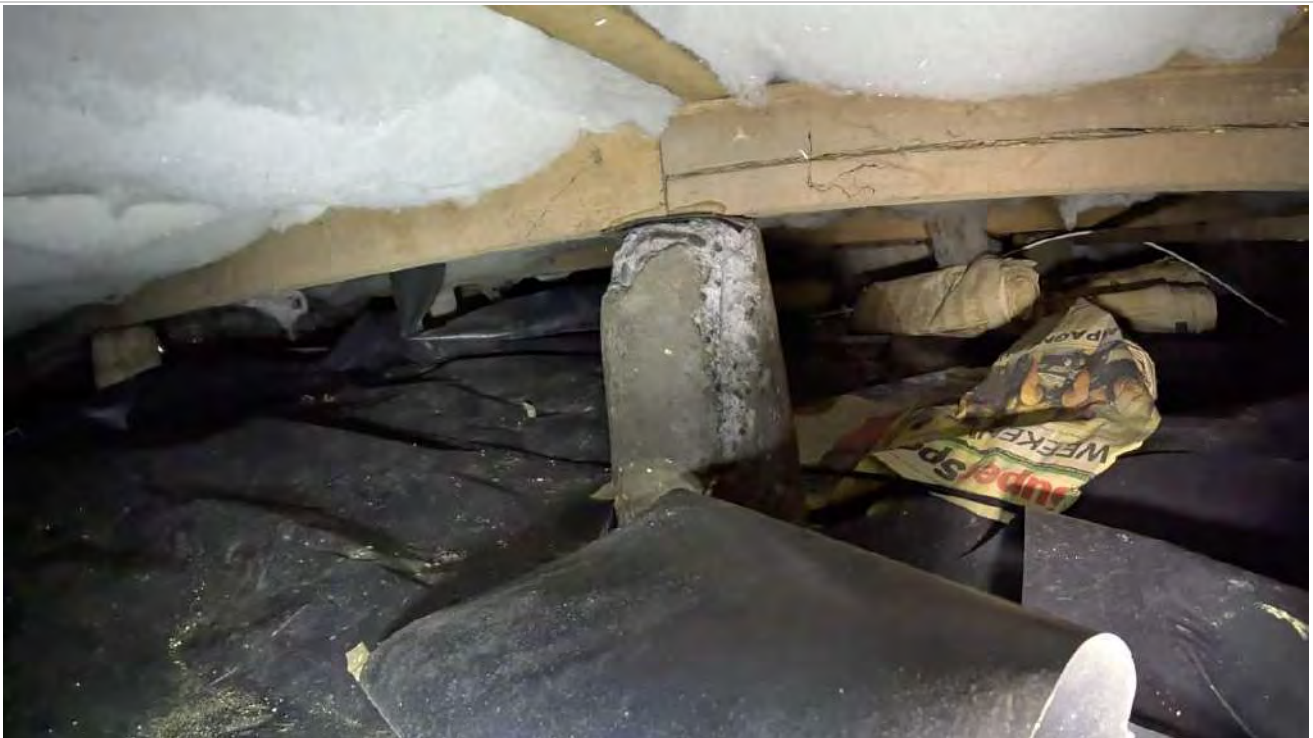
19: Precast concrete pile with no connection.

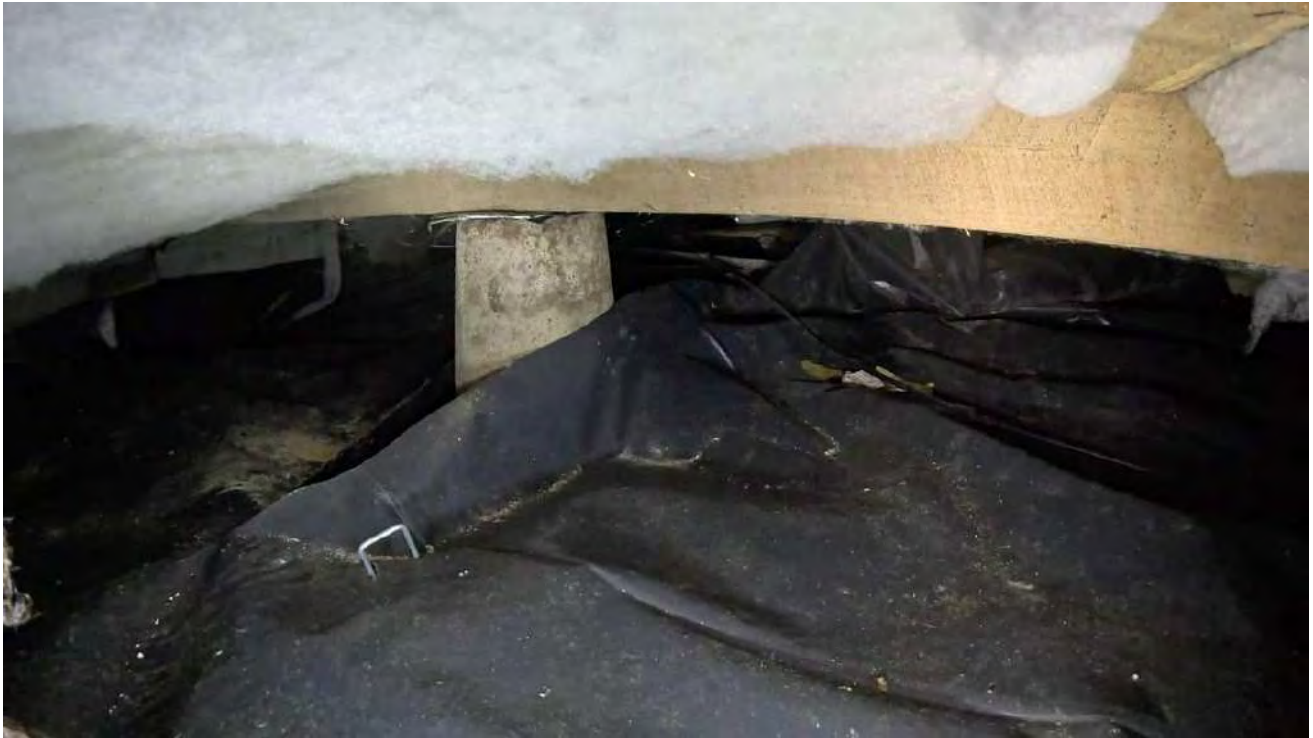
20: View of concrete base with pile to the left.

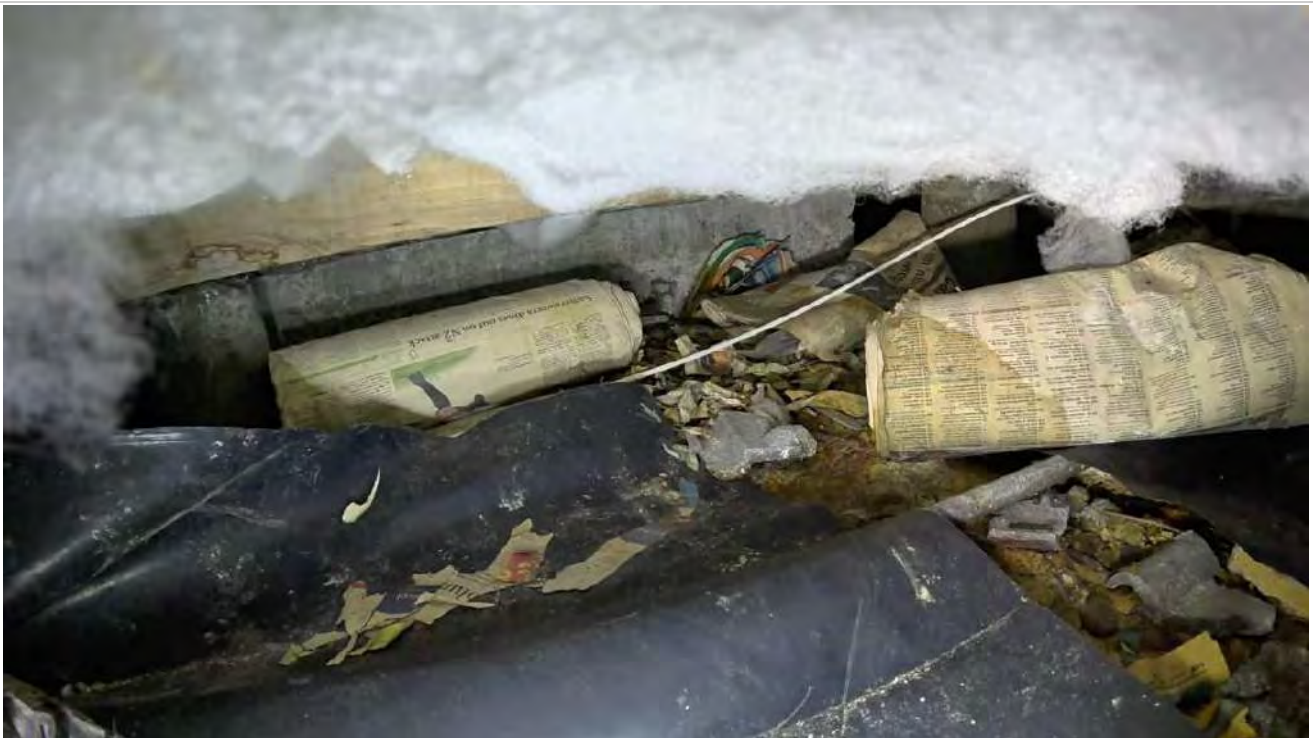
21: Precast concrete pile with no connection.
