**Information request – 427 Armagh Street, Linwood, Christchurch 8011**

## TR001: Technical Report – Desktop Technical Review & Structural Inspection

## **Canterbury Claims – Assessment Report**

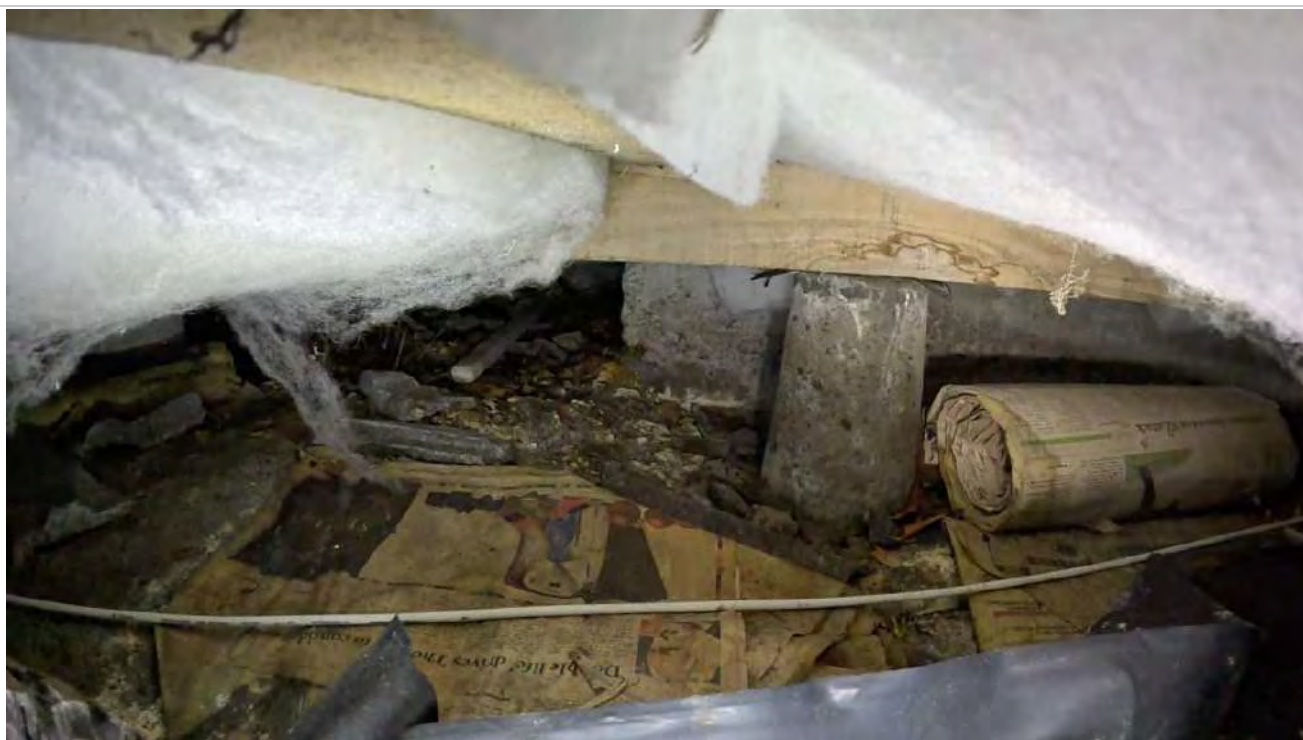
22: We couldn't get into this area.

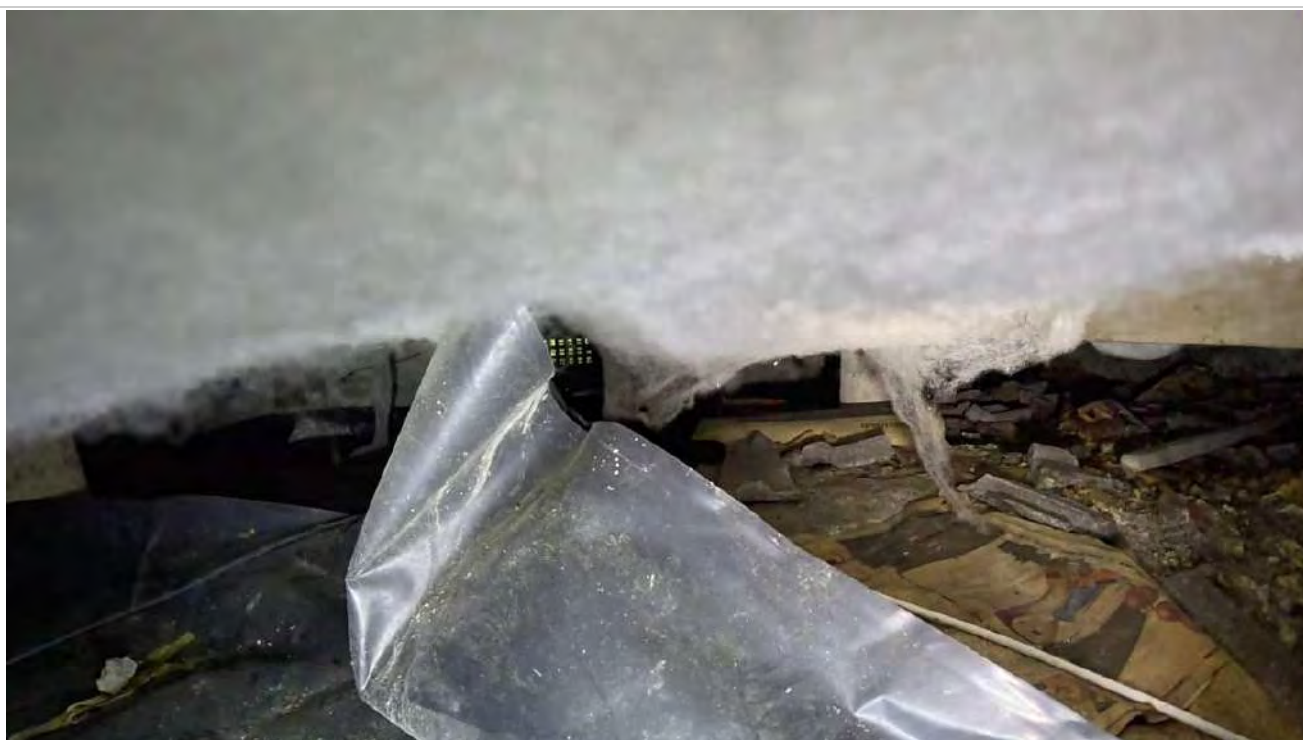
23: View of piles.

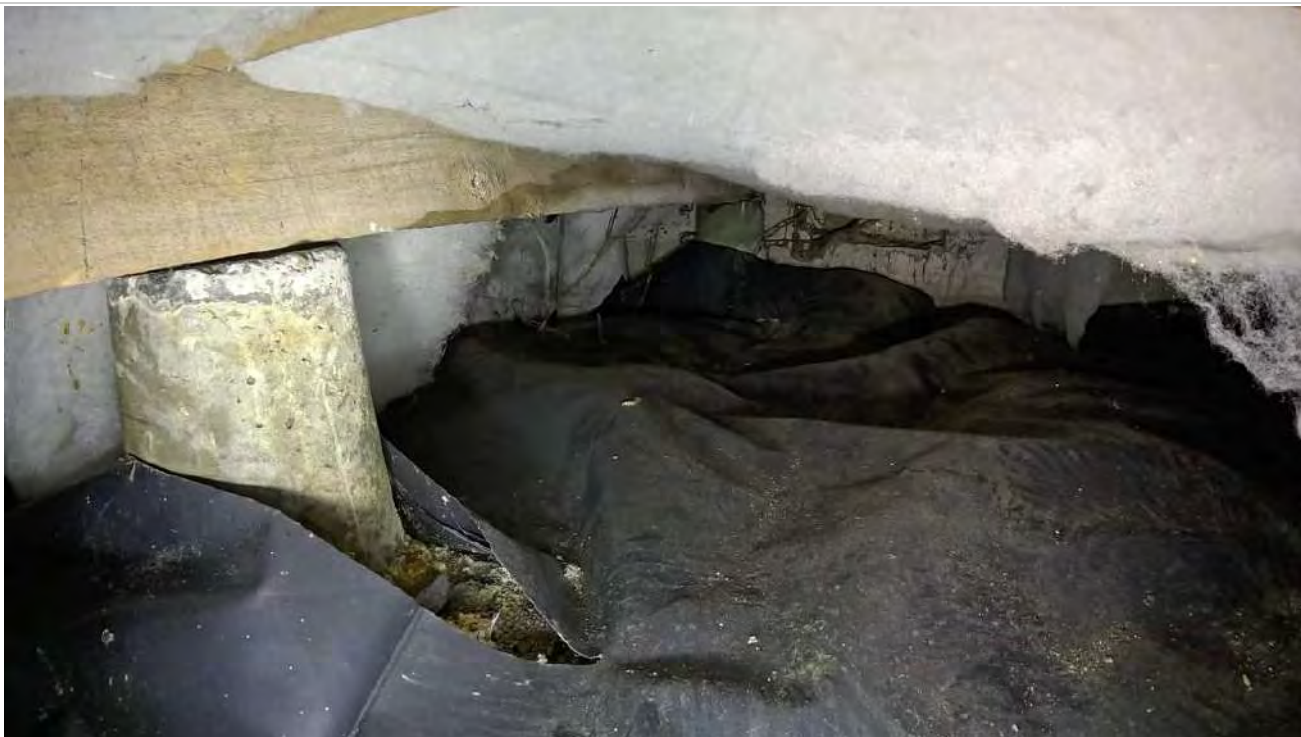
24: View of foundation.

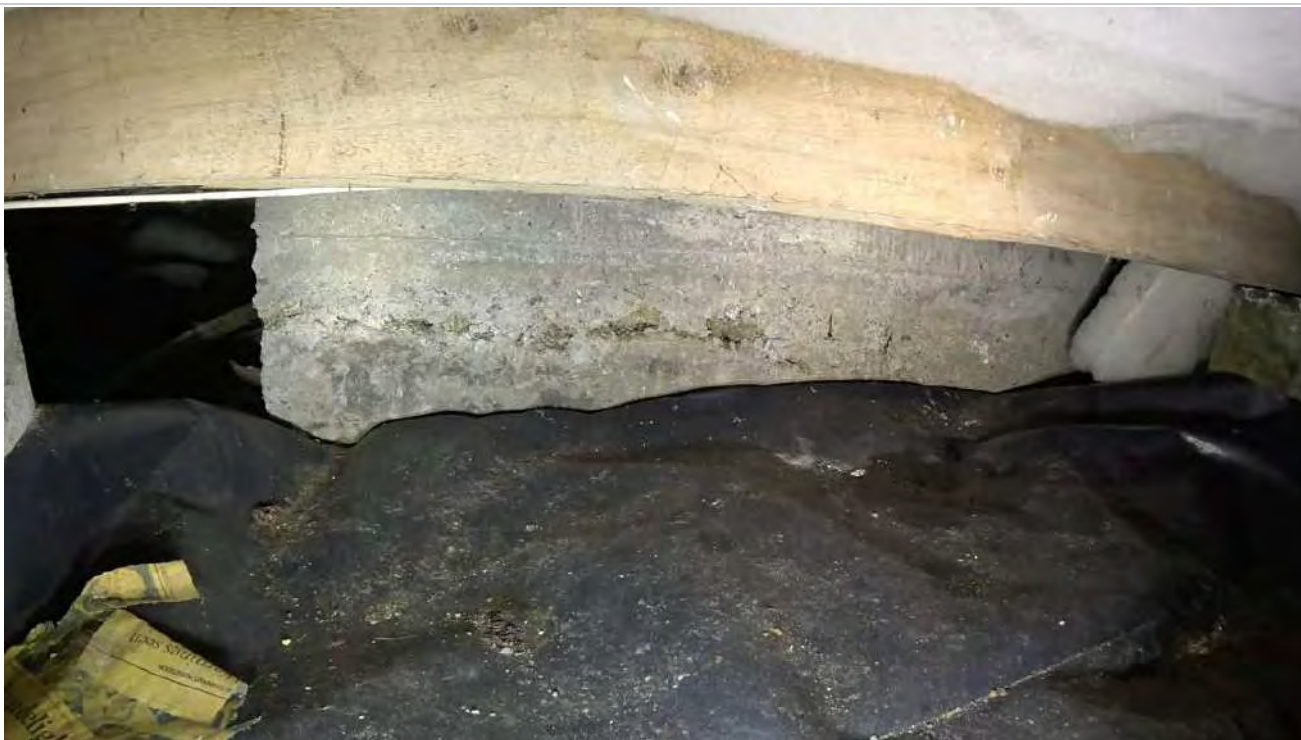
25: Precast concrete pile with no connection.

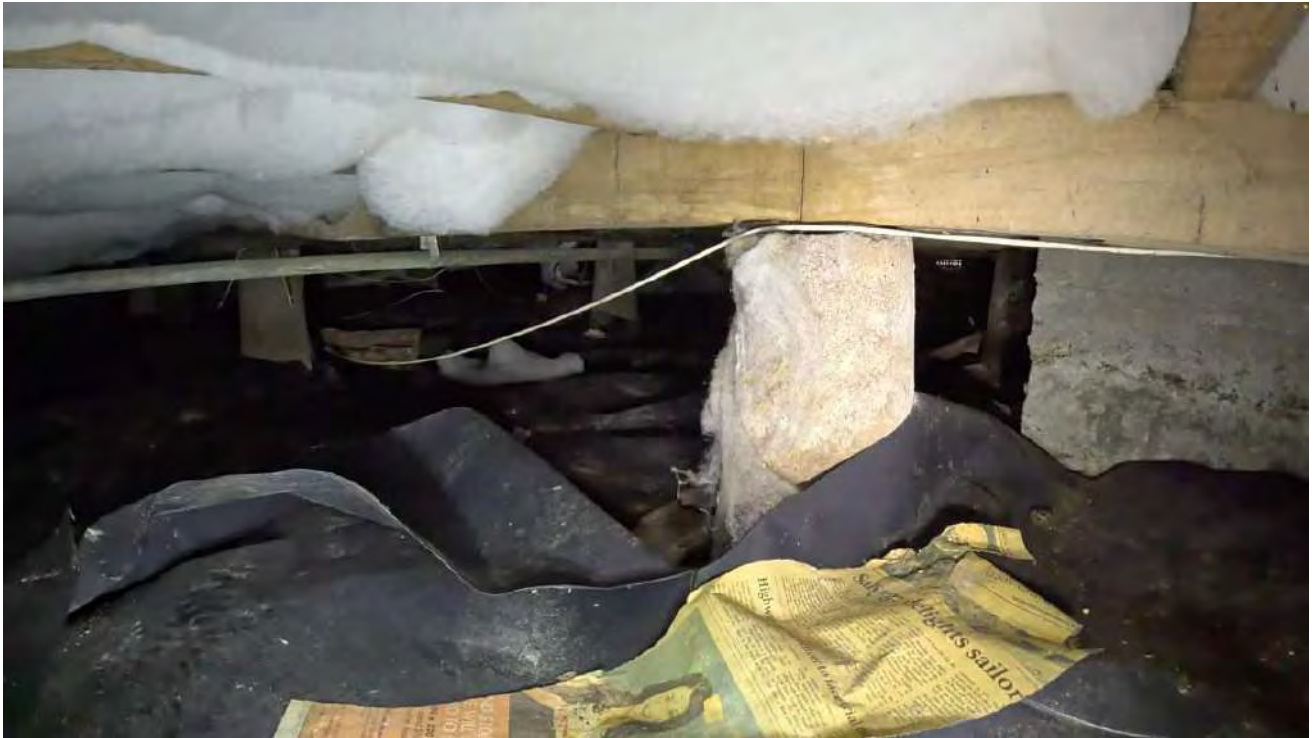
26: Precast concrete pile with no connection.

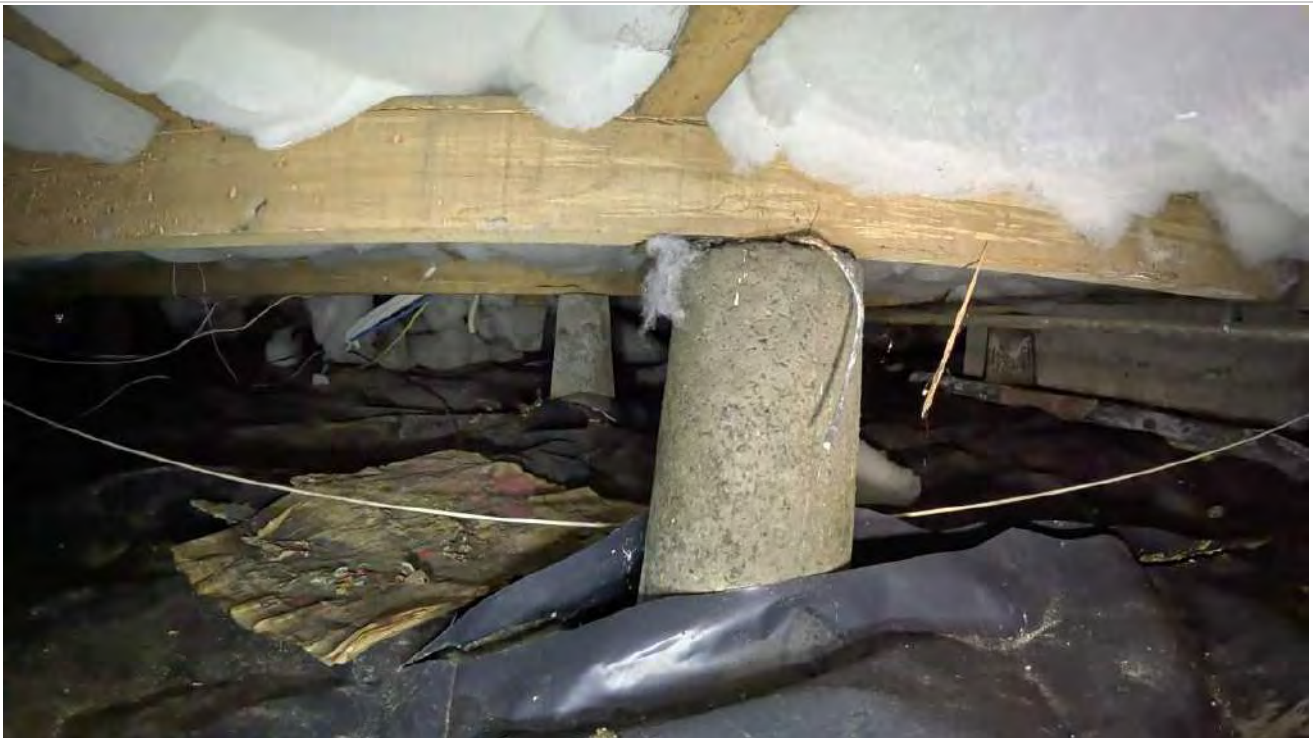
27: Precast concrete pile with no connection.

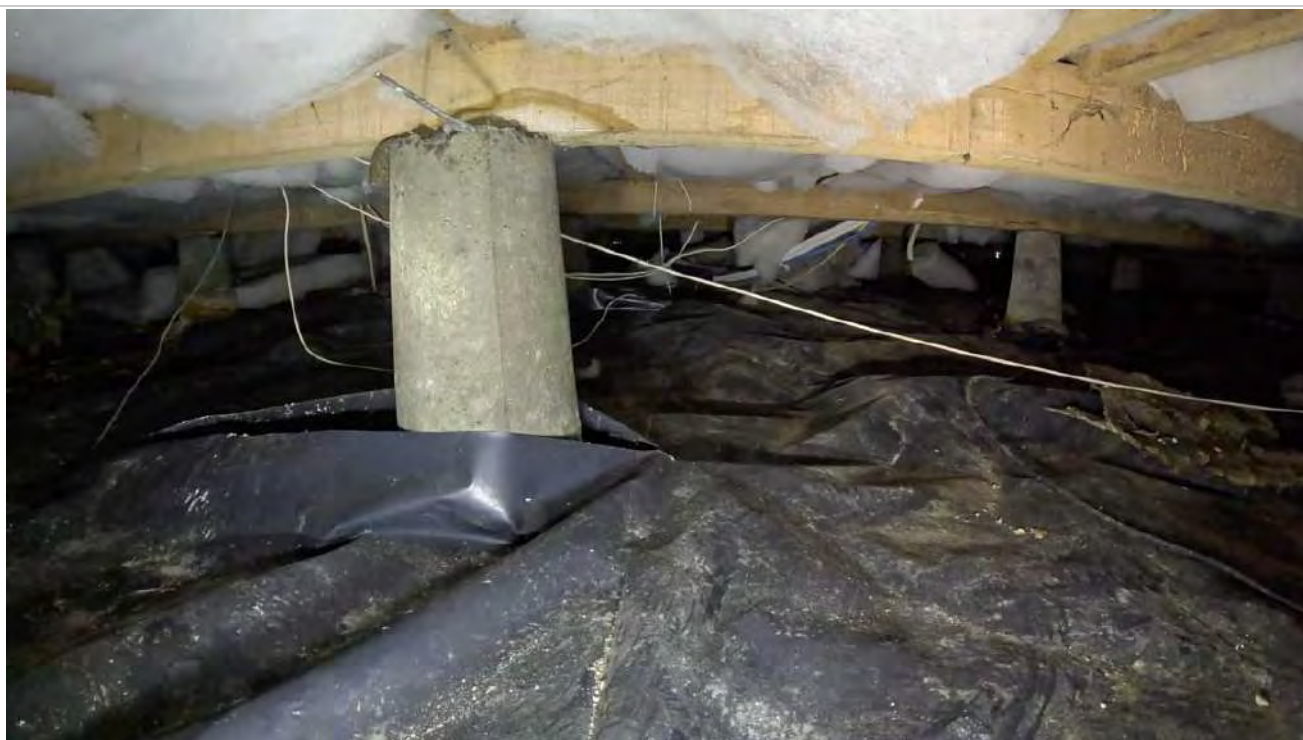
28: Precast concrete pile with no connection.

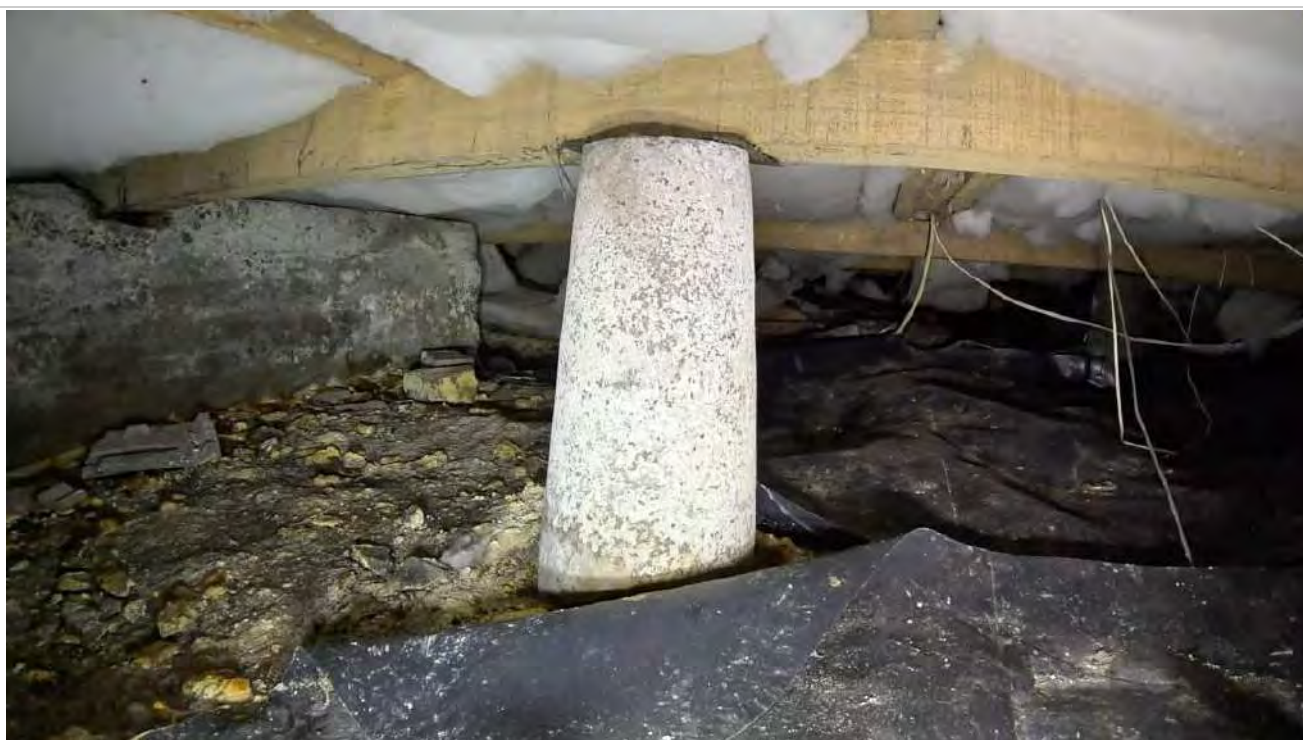
29: View of bearer meeting concrete base.

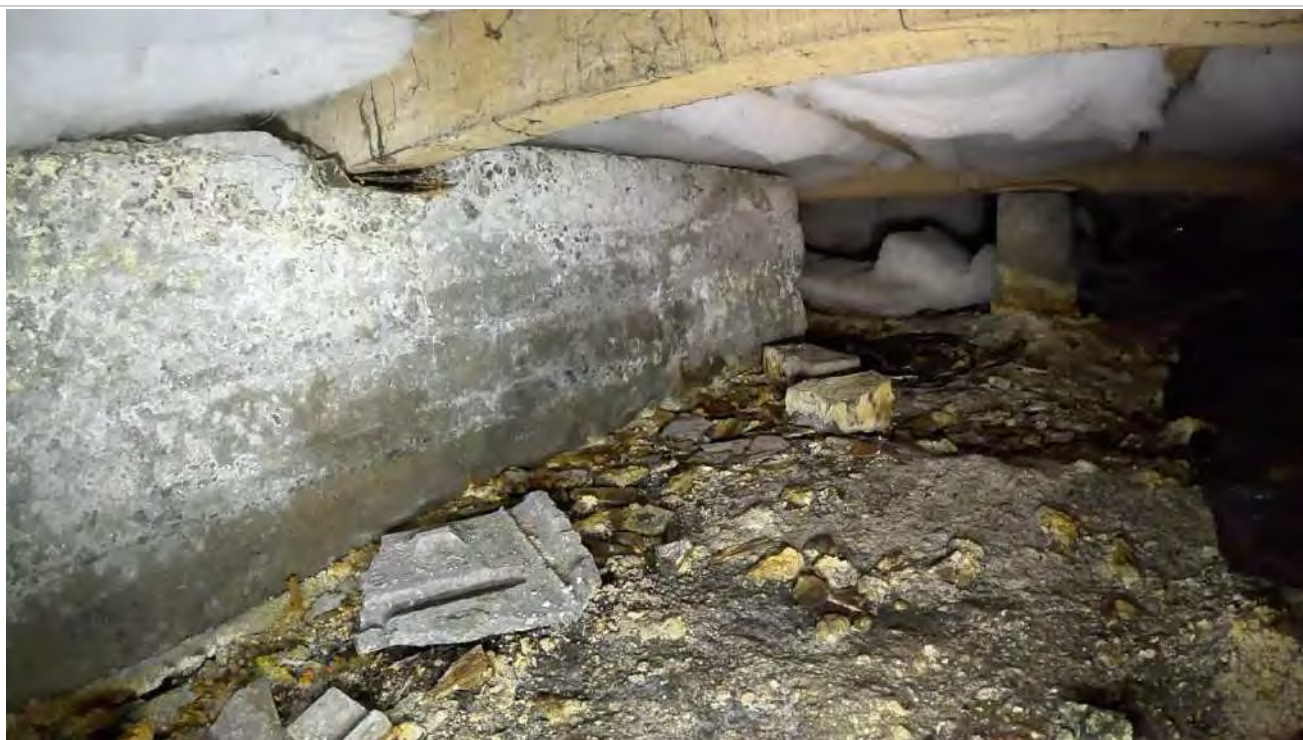
30: View of concrete base.

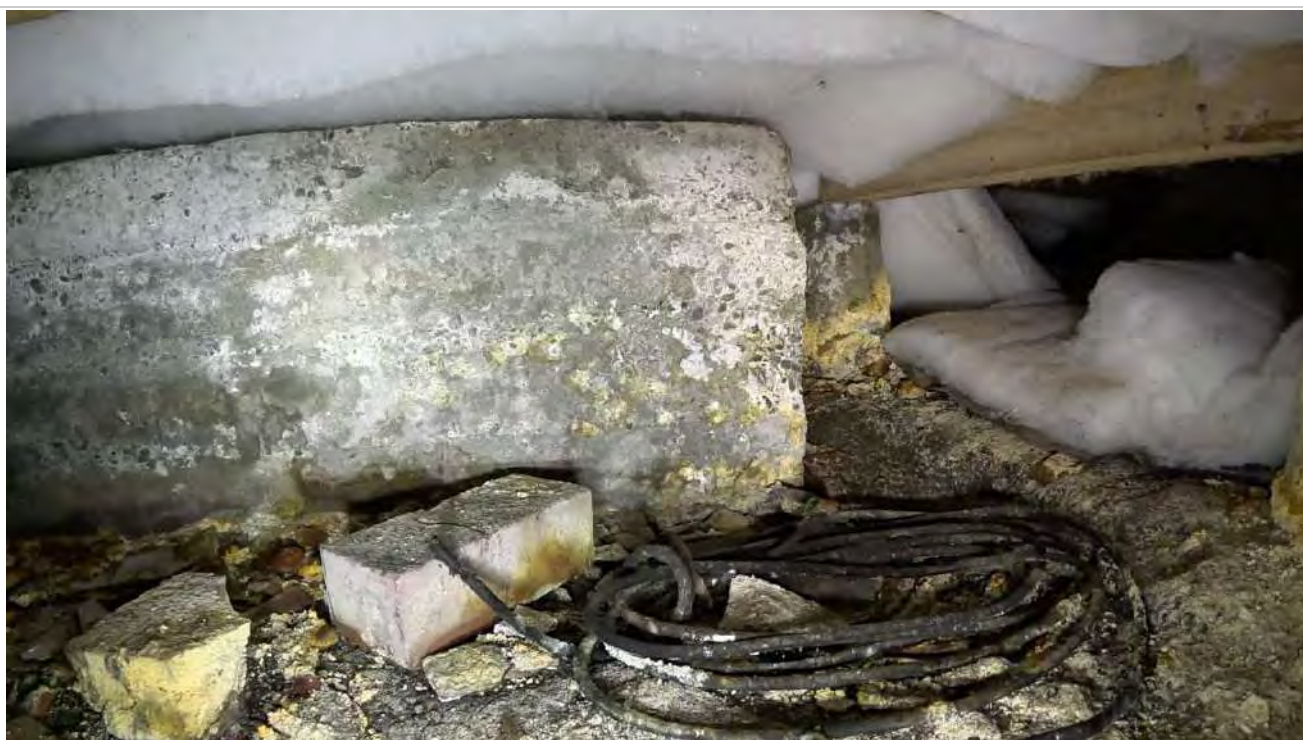
31: Precast concrete pile with no connection.

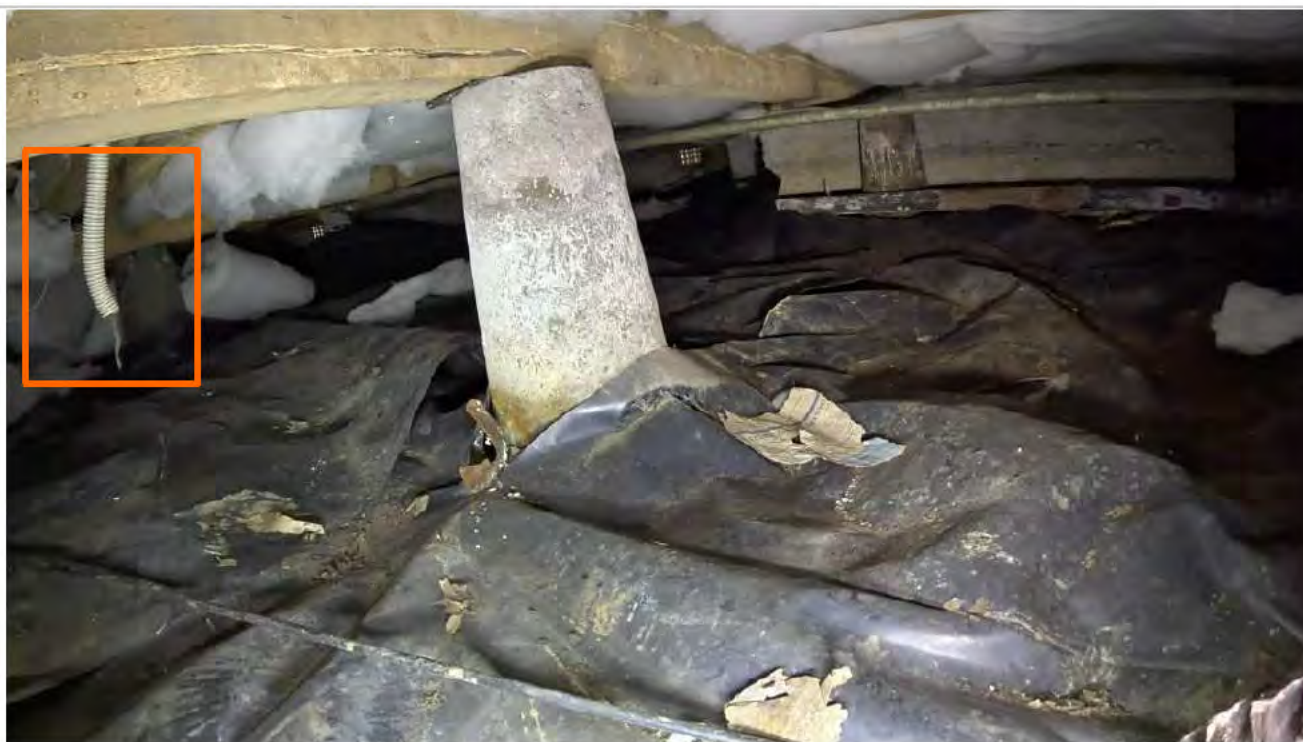
34: View of concrete base.

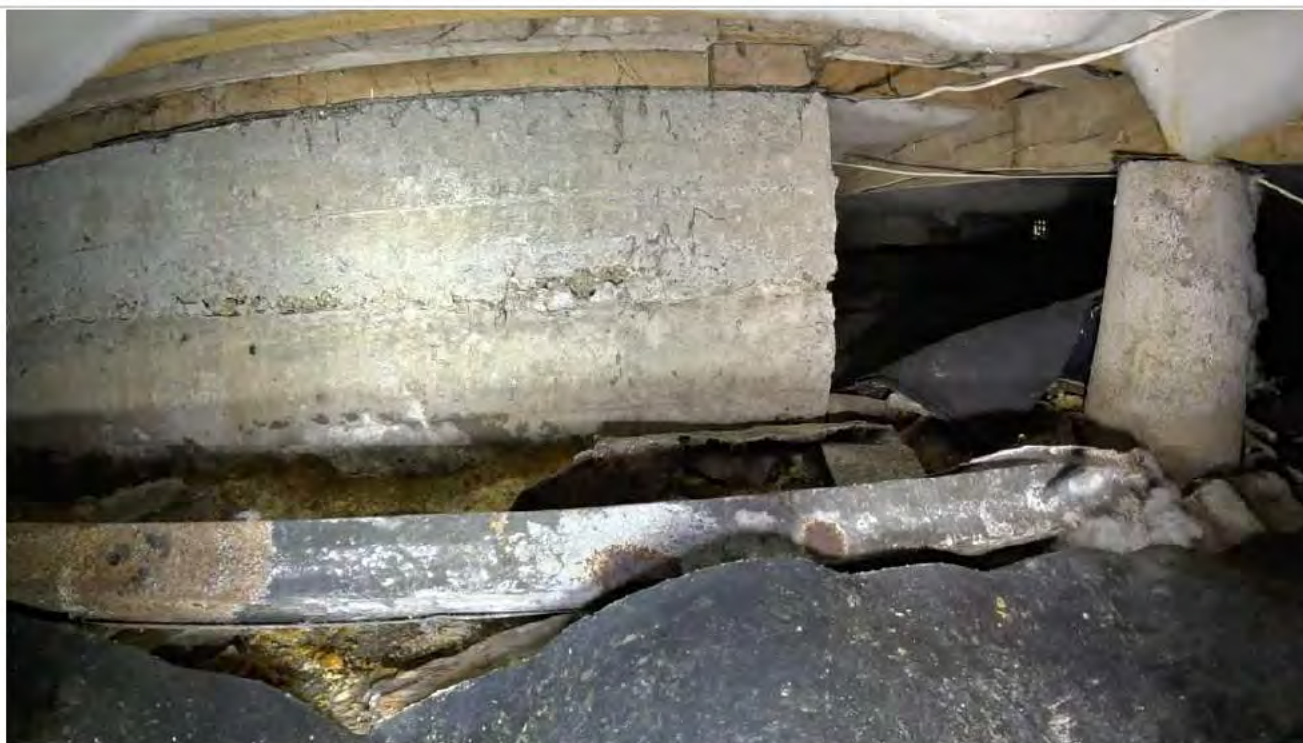
35: Precast concrete pile with no connection.

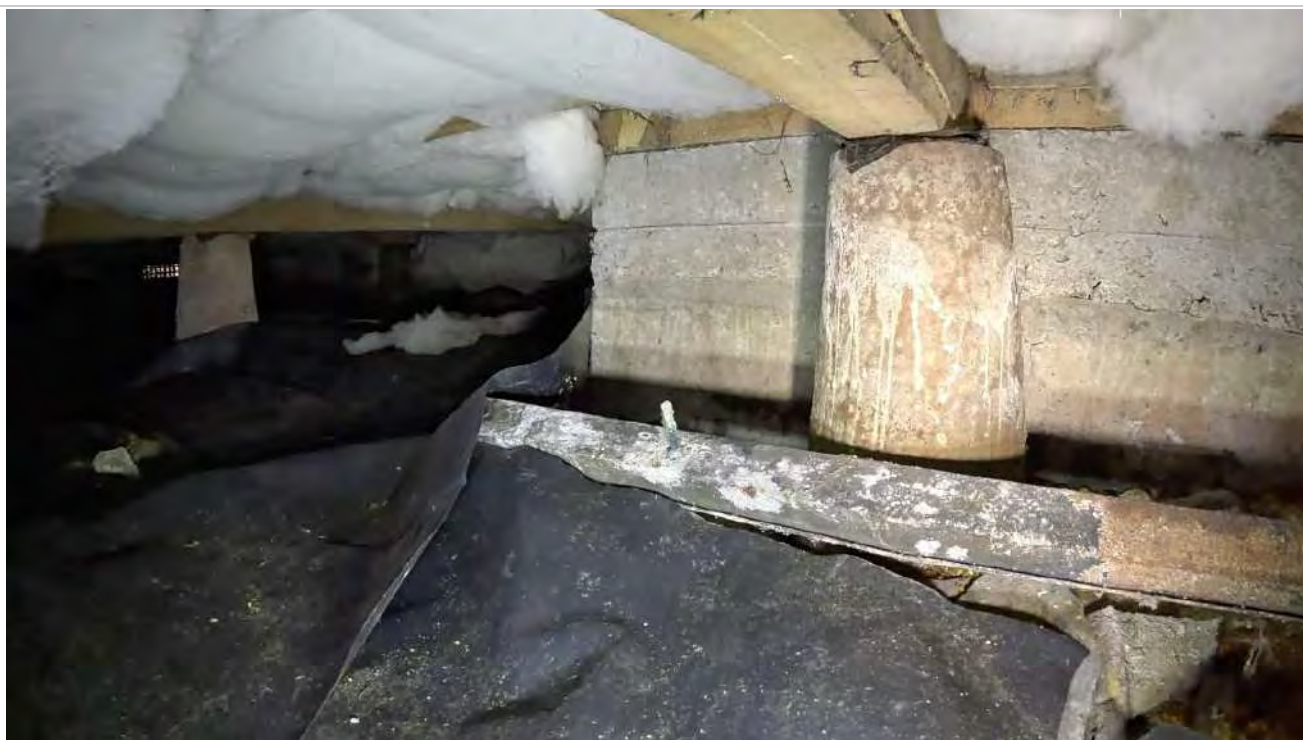
36: View of ring foundation with concrete base to the right.

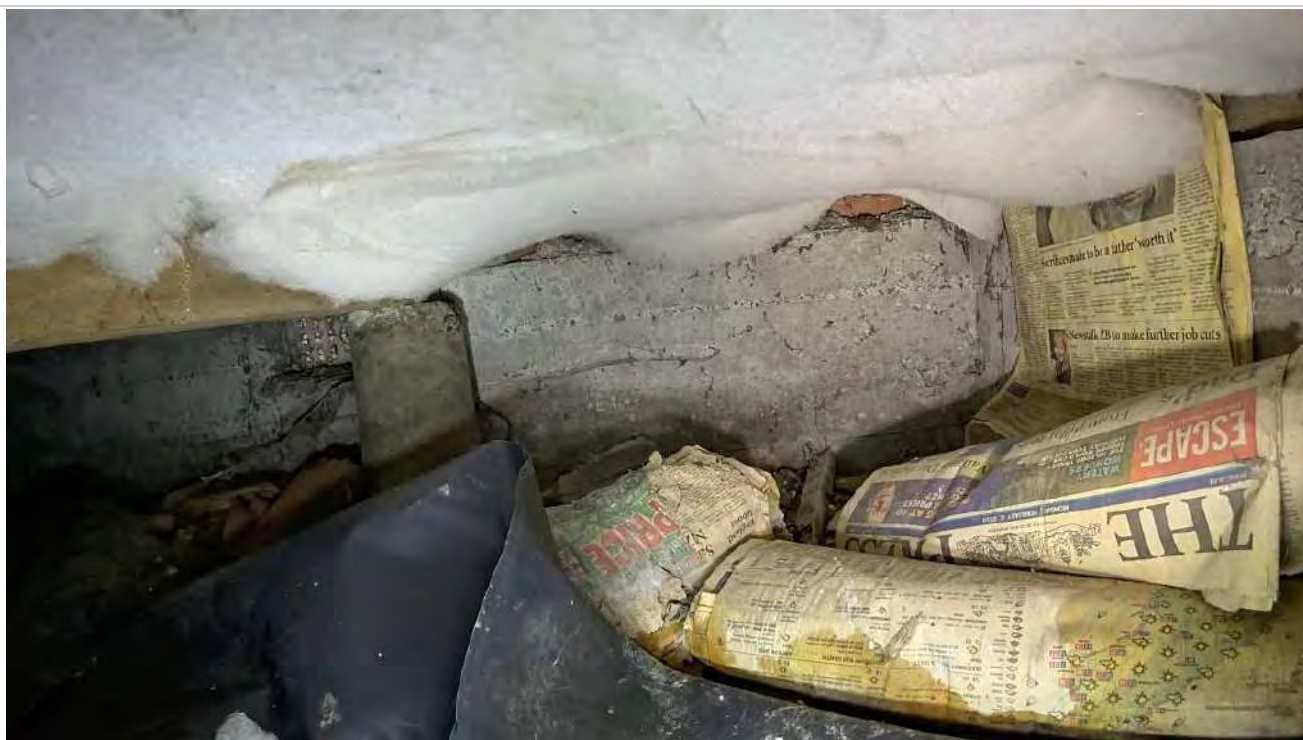
38: Precast concrete pile with no connection.

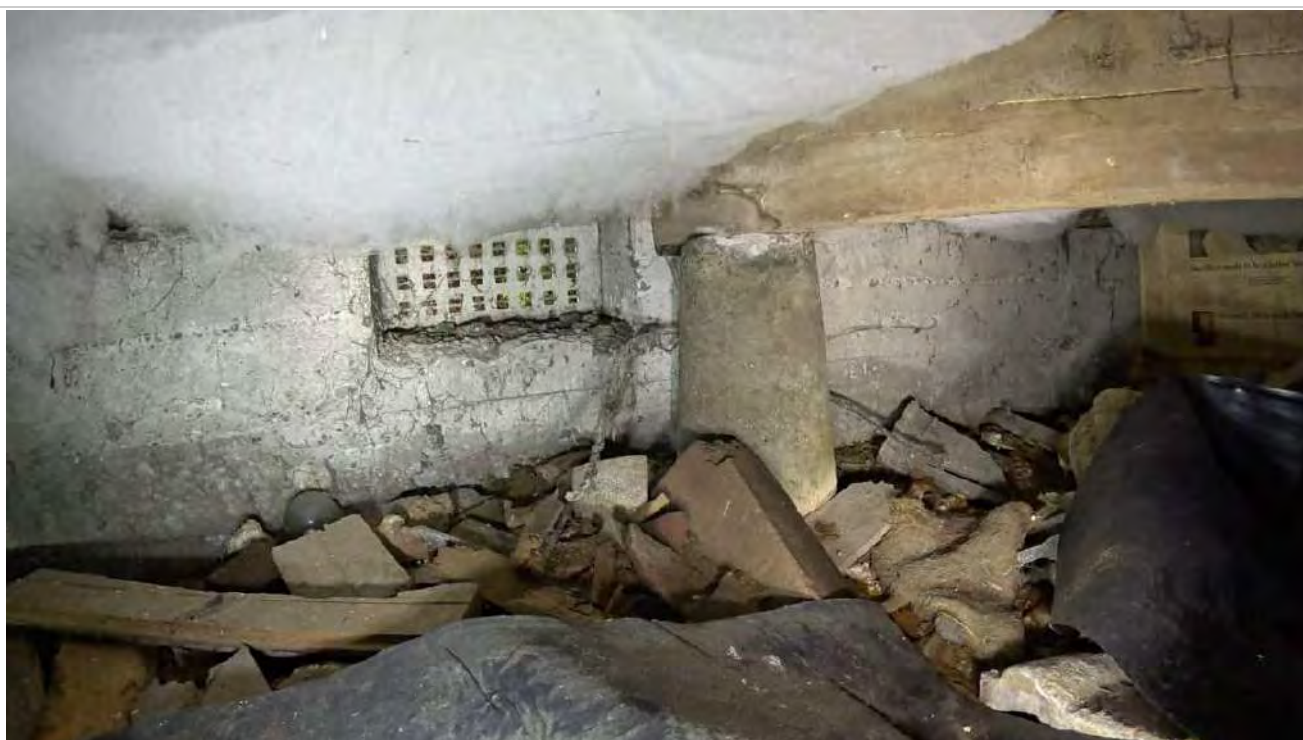
39: Precast concrete pile with no connection.

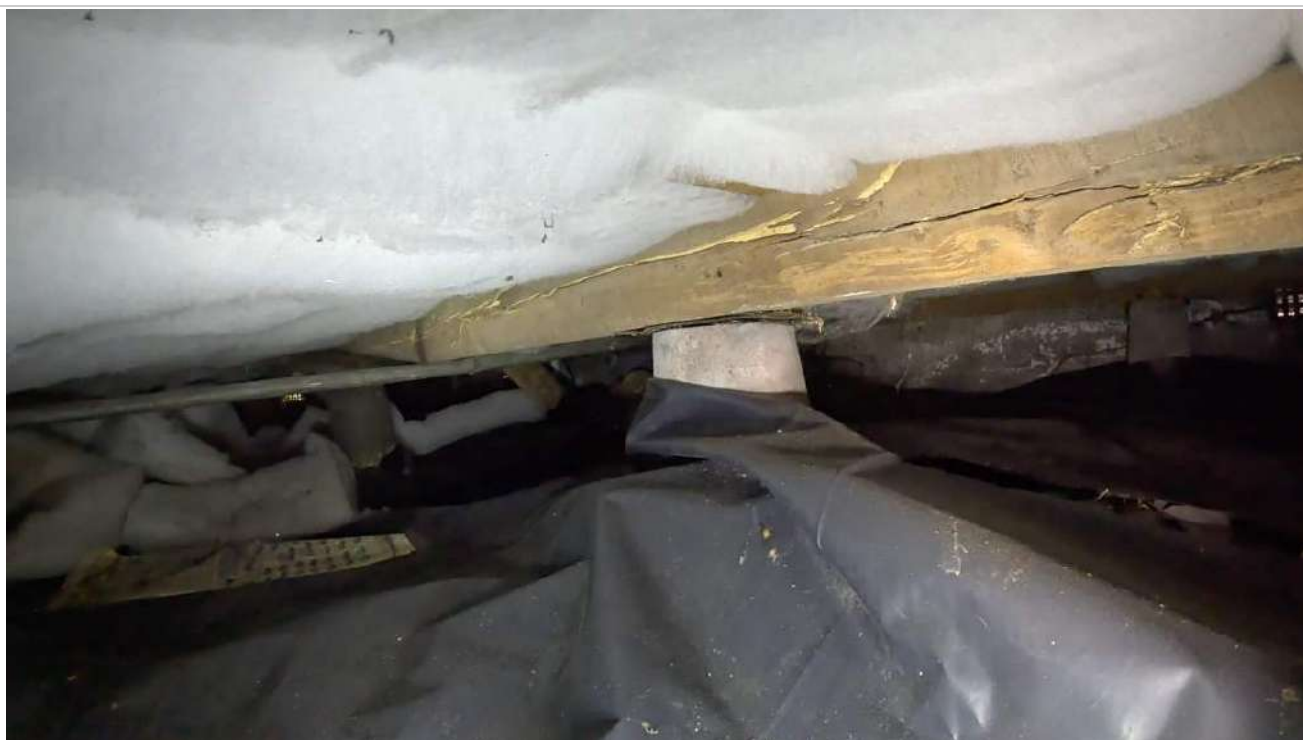
42: Precast concrete pile with no connection.

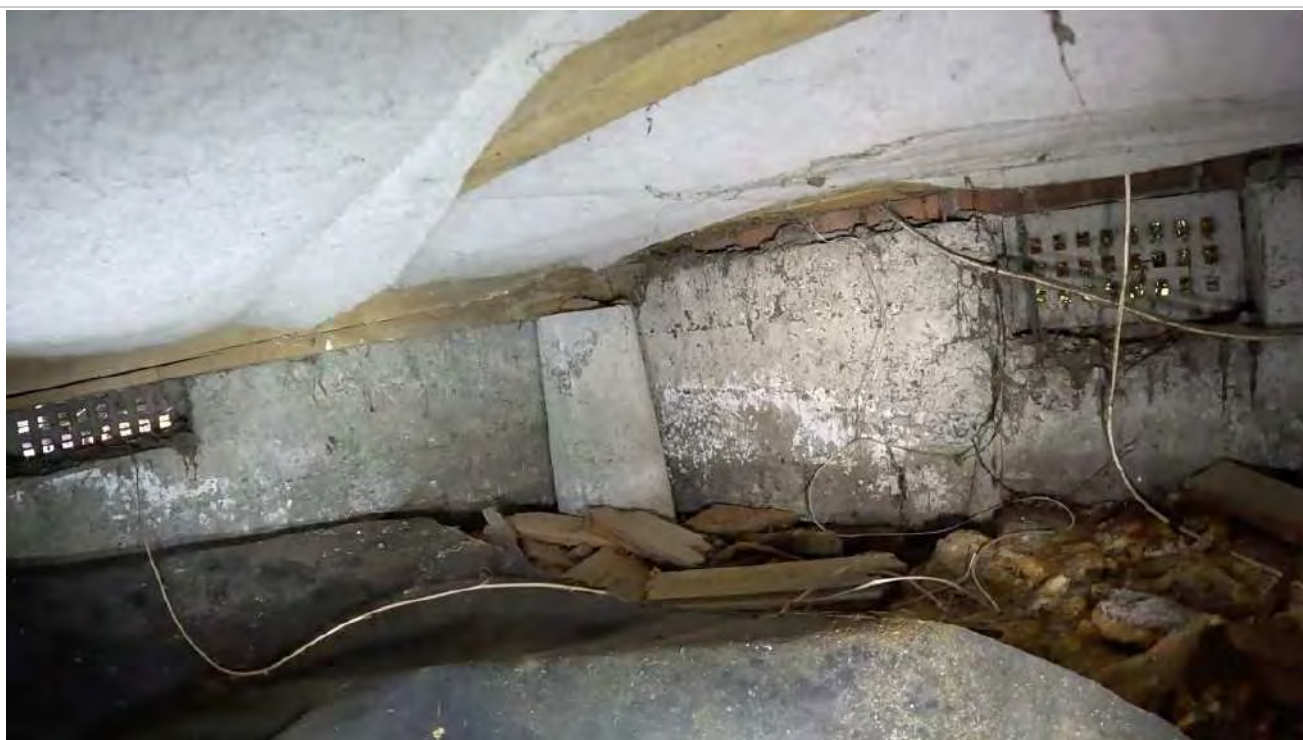
43: Precast concrete pile with no connection and the pile leans to the right.

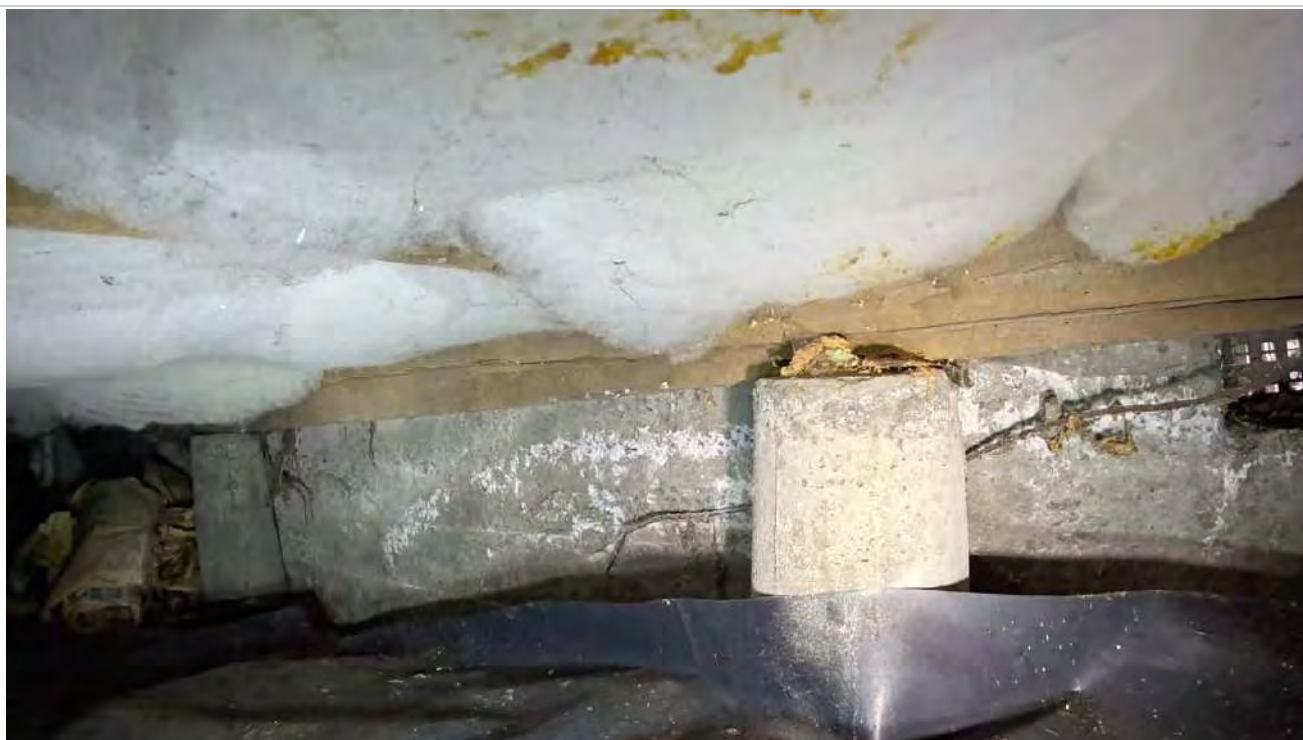
44: The ground level appears to drop in this area.

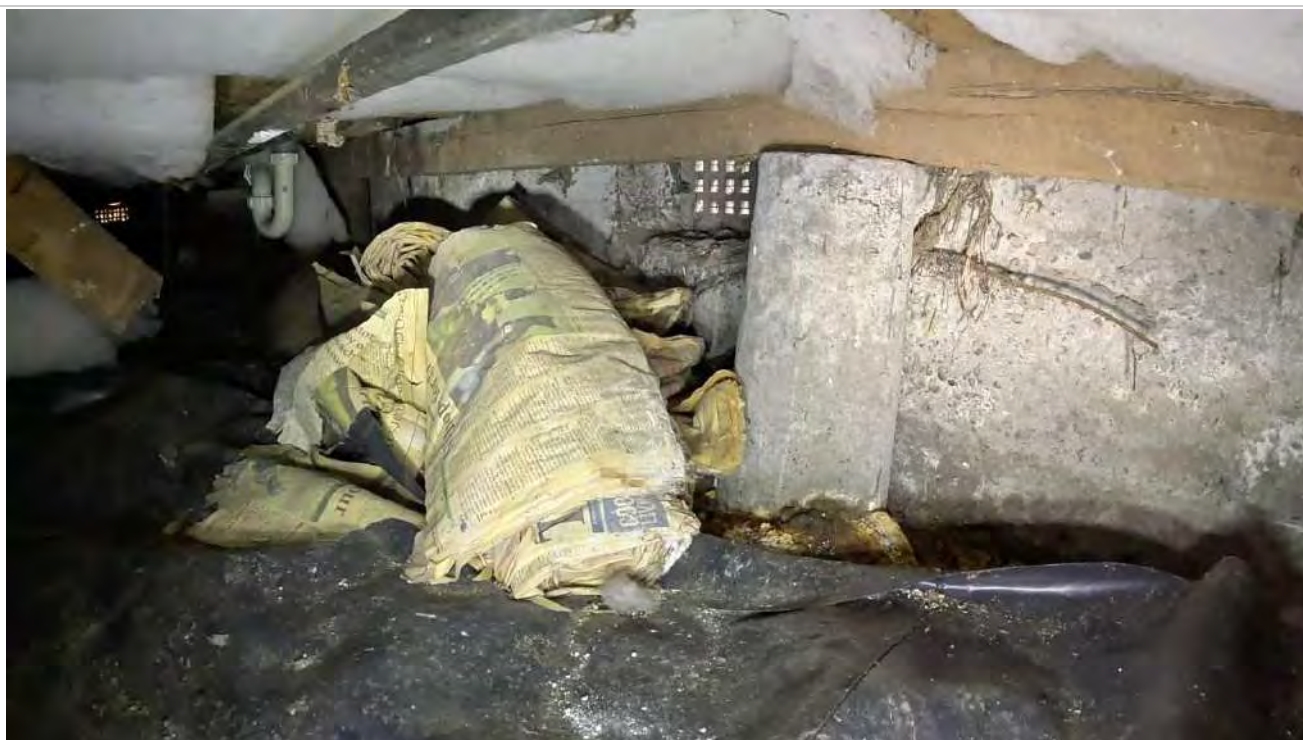
45: Precast concrete pile with no connection and the pile leans to the right.

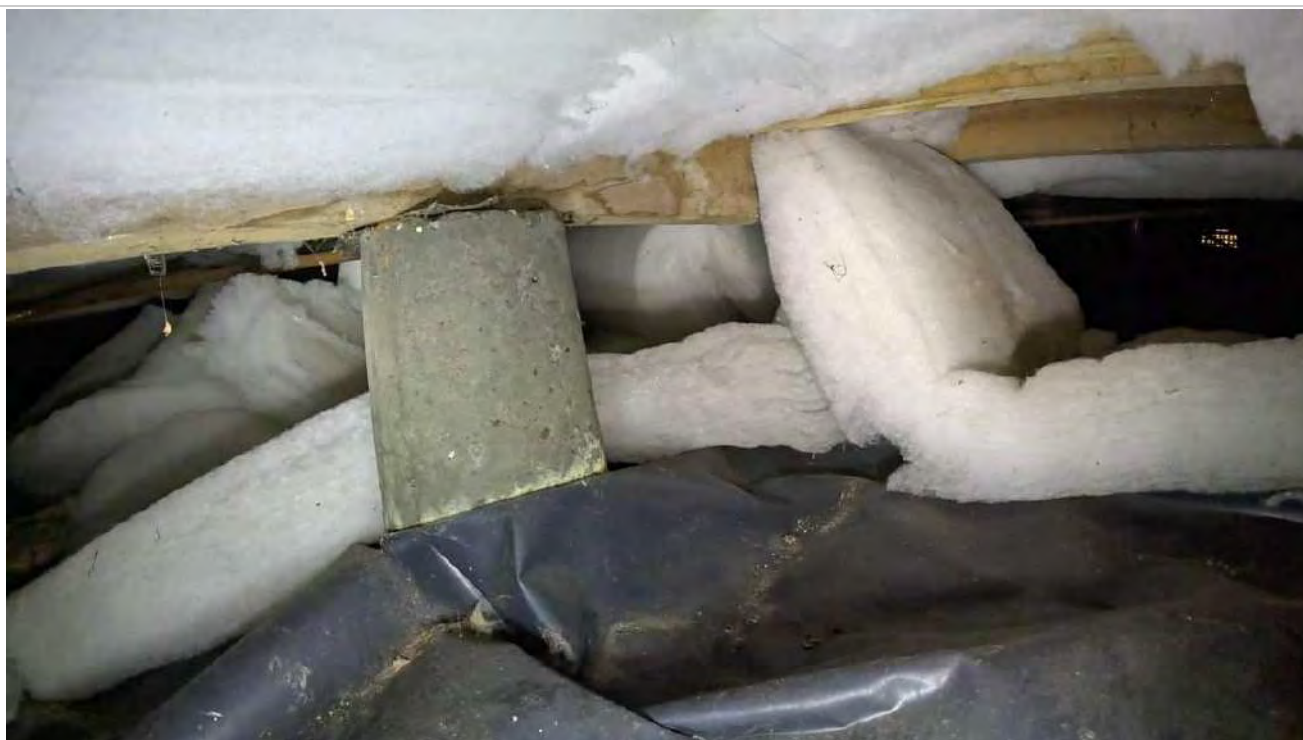
47: Precast concrete pile with no connection.

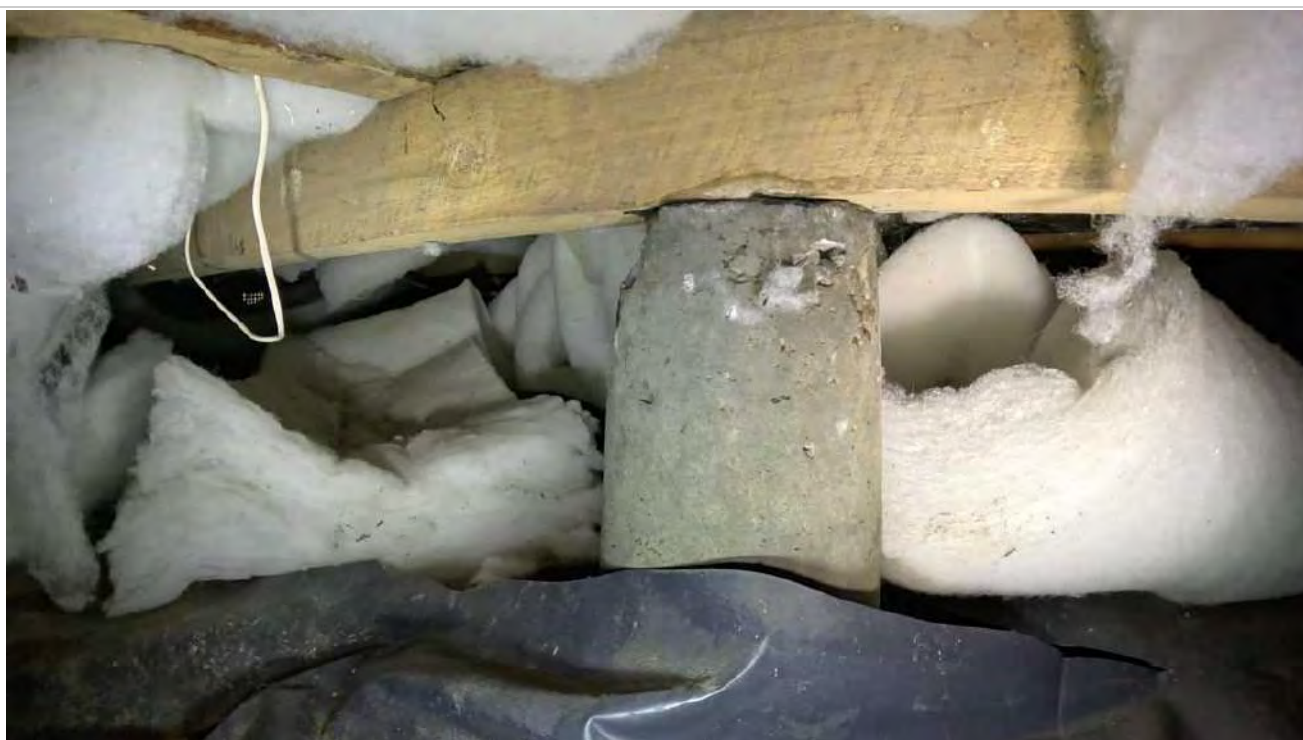
48: Precast concrete pile with no connection.

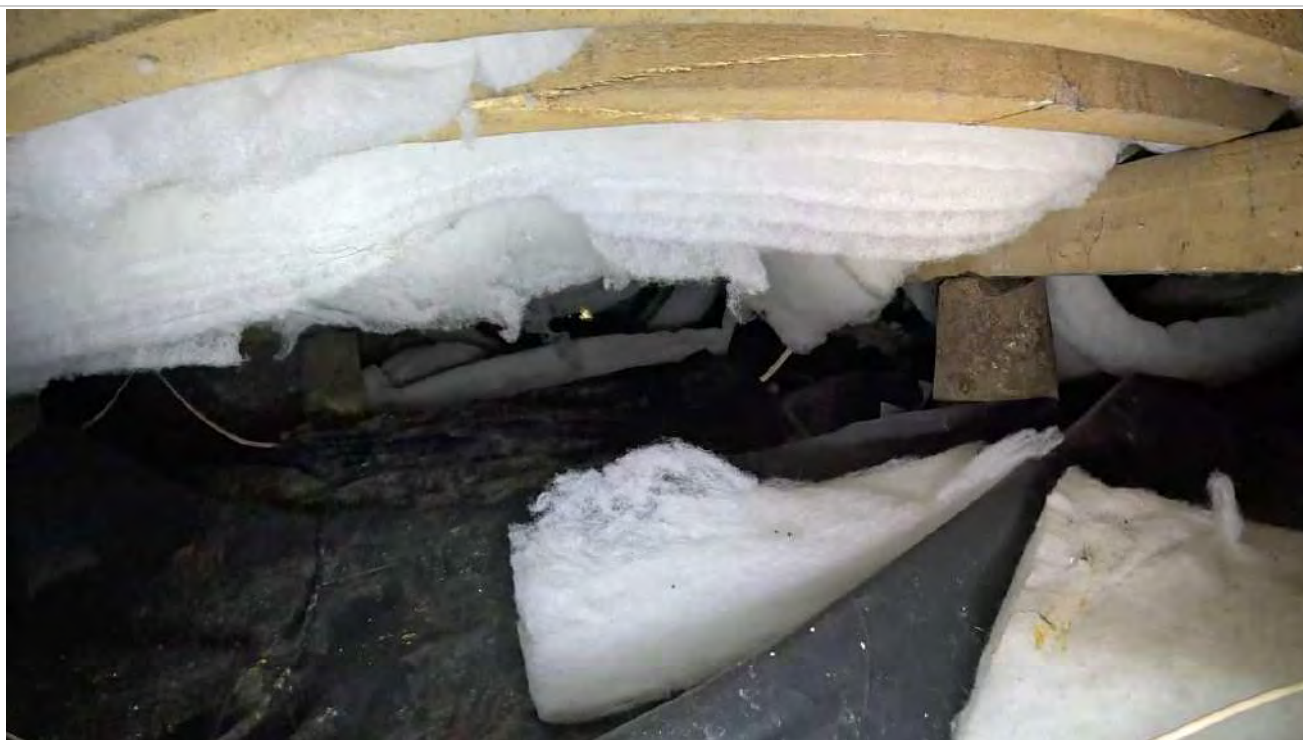
49: Precast concrete pile with no connection.

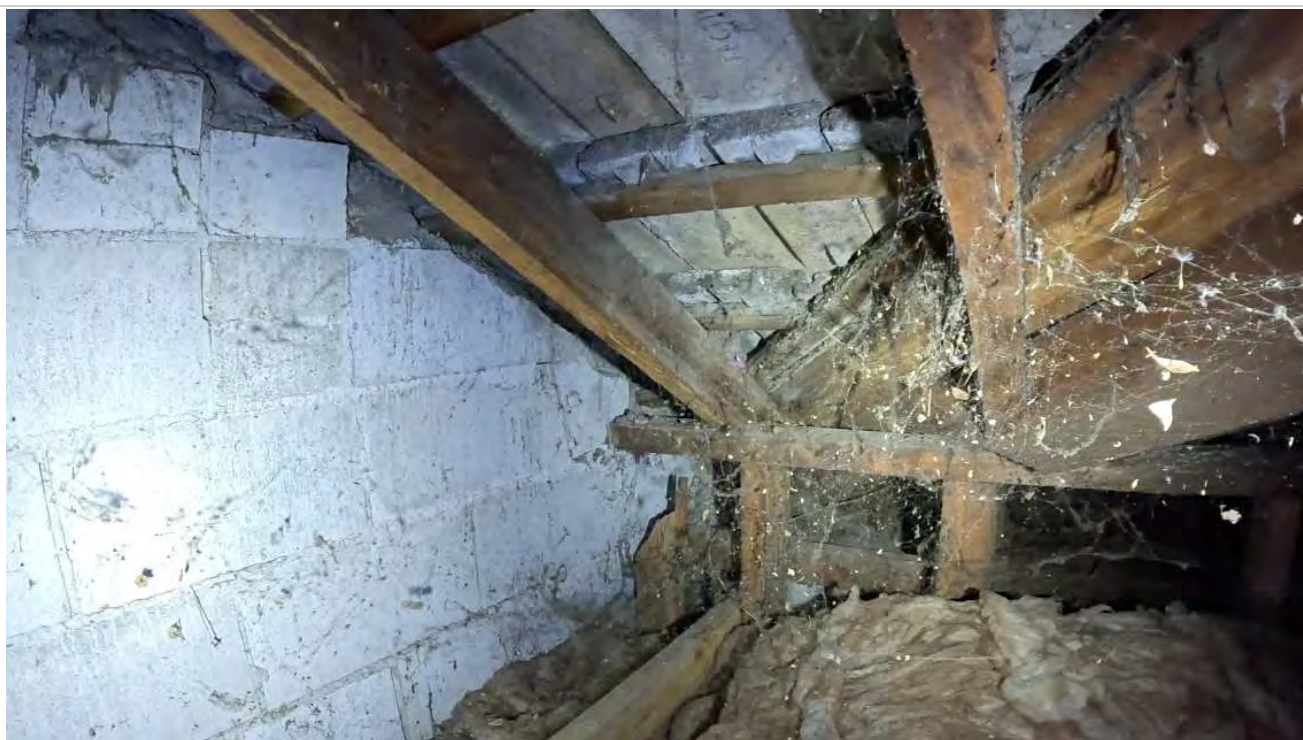
3: This is the fire wall between the units with the other unit's bathroom being on the other side. Although the fire wall is covered with spider webs, it does appear to be okay, and I could find no evident cracks on this side.
