**Information request – 427 Armagh Street, Linwood, Christchurch 8011**

## TR001: Technical Report – Desktop Technical Review & Structural Inspection

## **Canterbury Claims – Assessment Report**

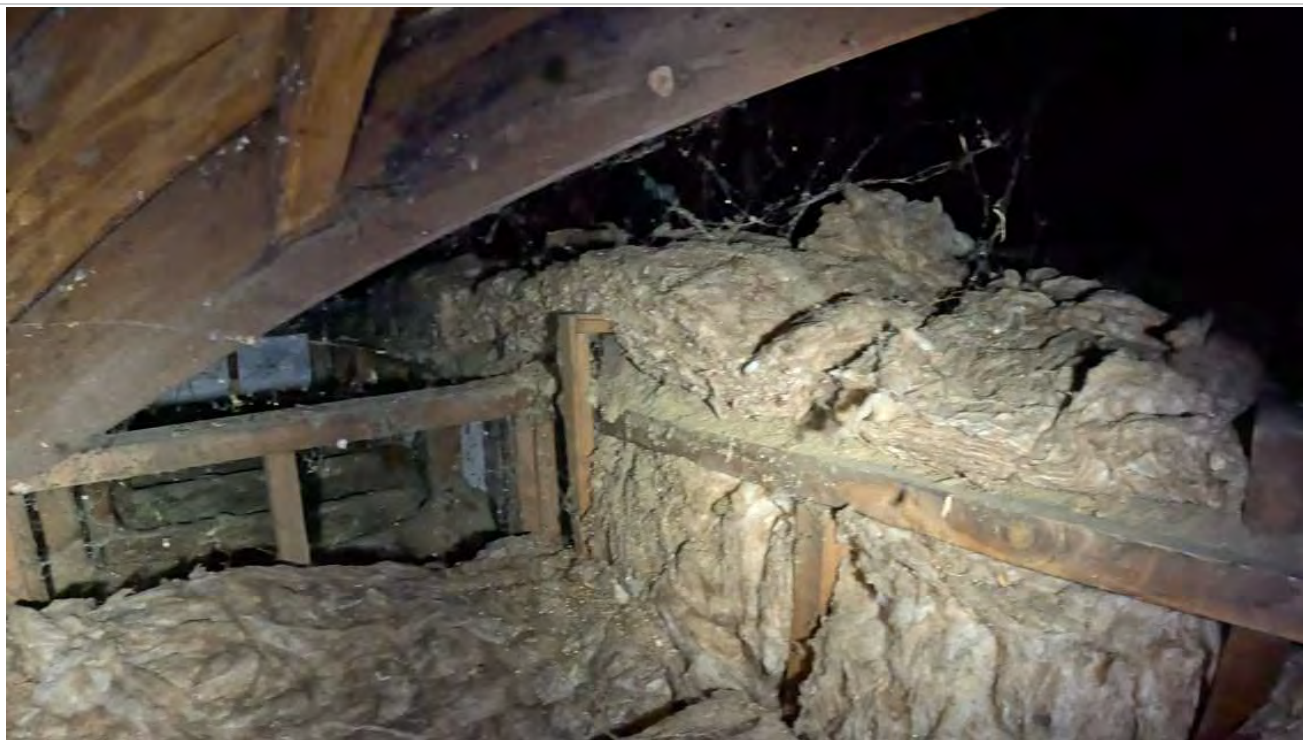
4: The ceiling in lower in this area.

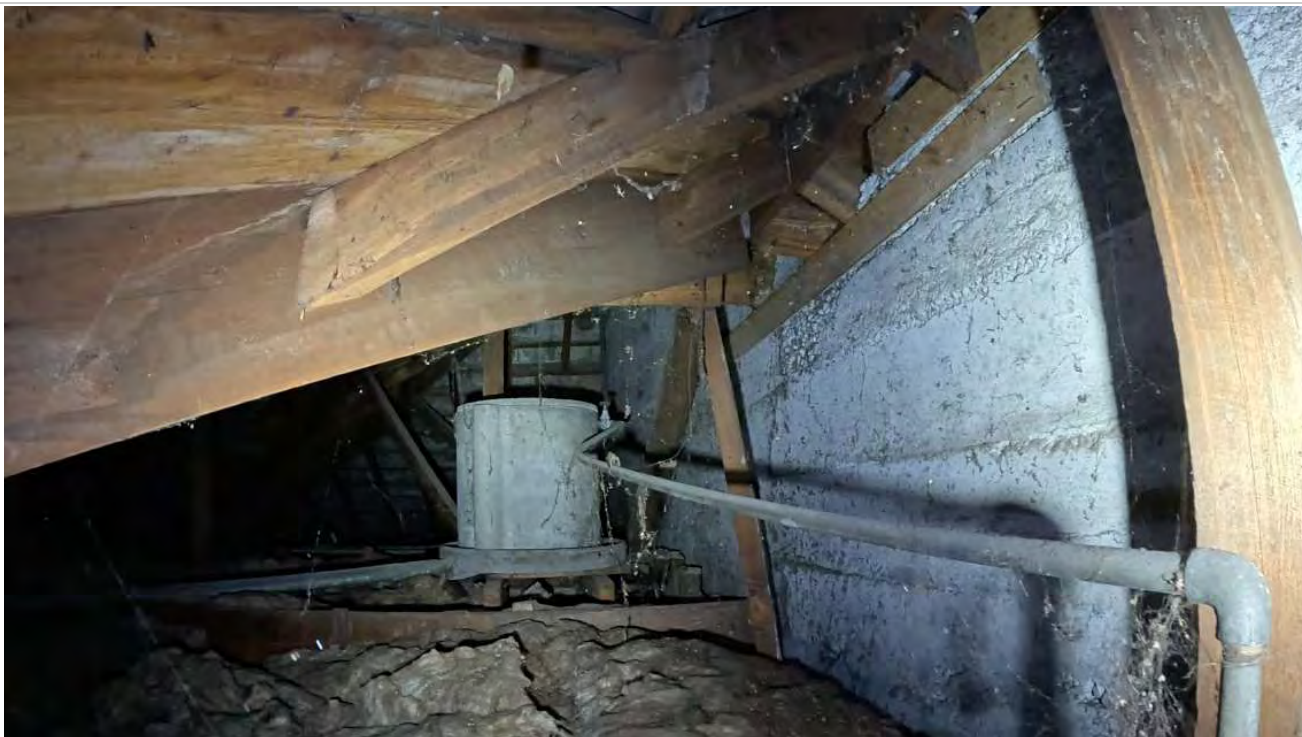
9: View along firewall with the header tank. The header tank is poorly supported and unrestrained.

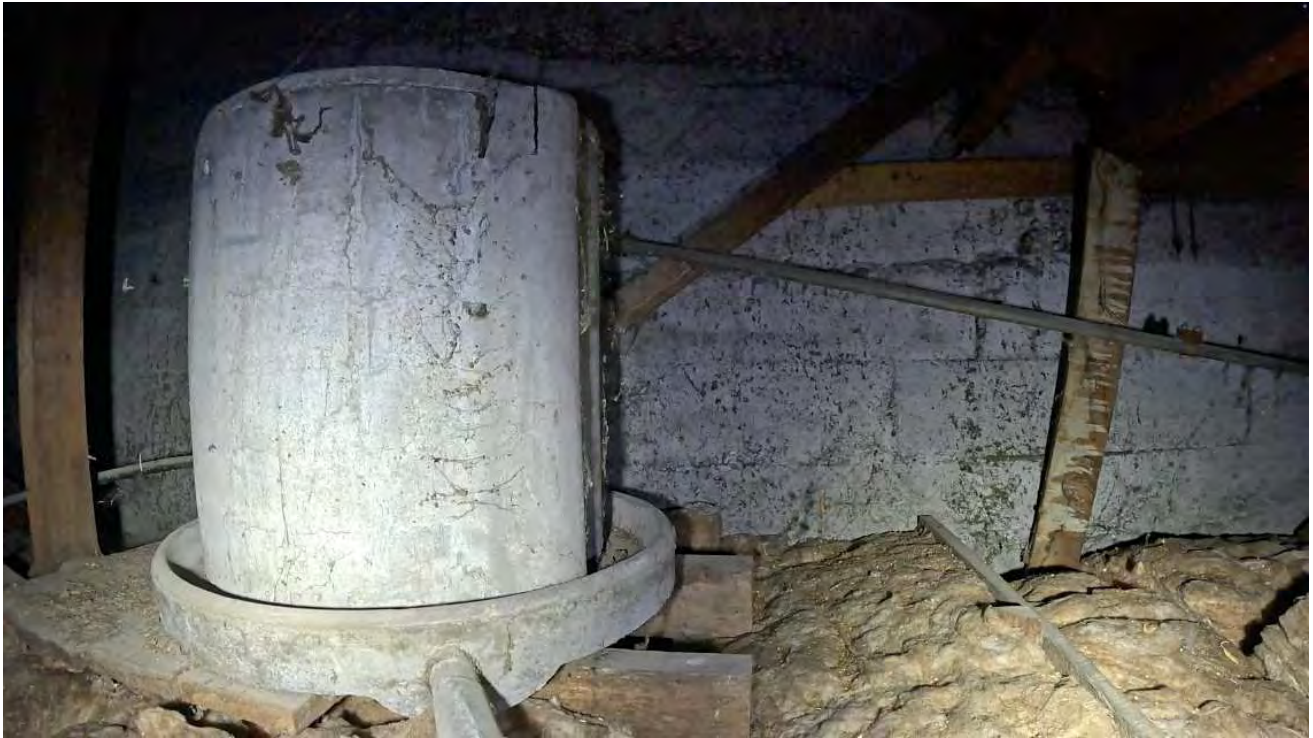
13: This header tank represents a large, poorly supported and unrestrained weight which could easily come through the ceiling.

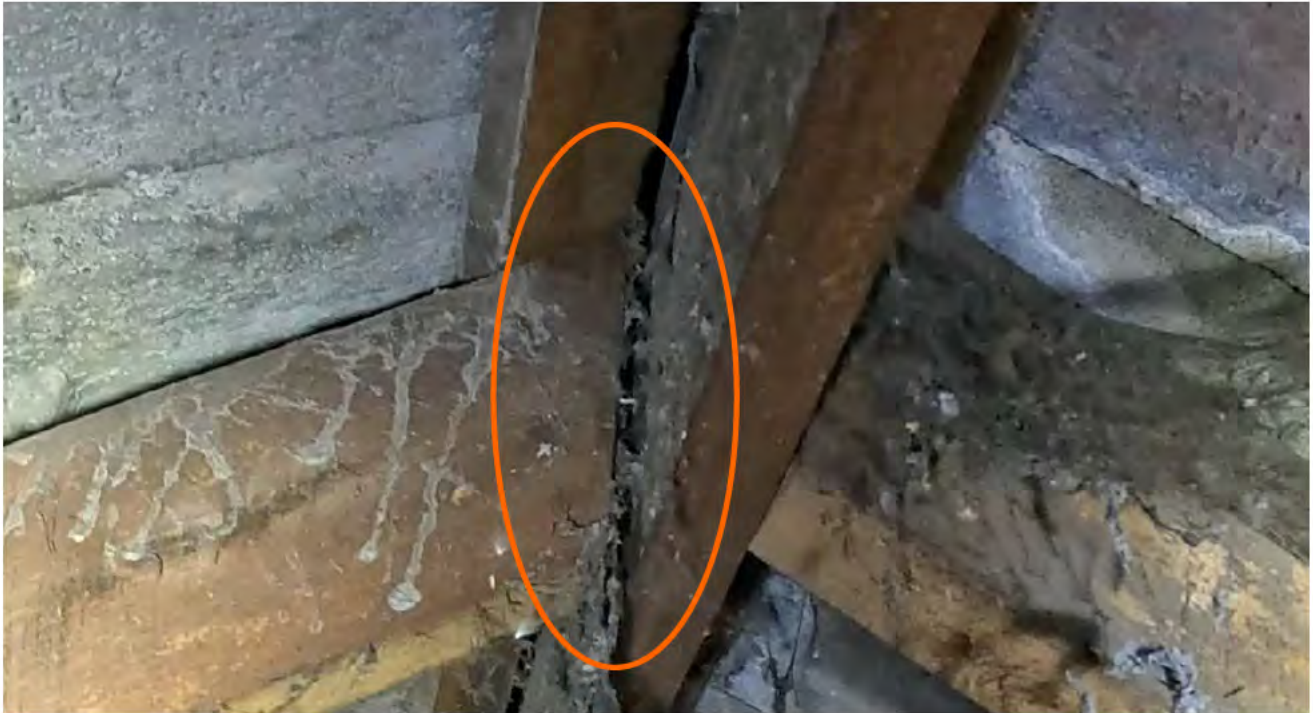
17: There are indications that the left side rafters may have moved around 7mm away from the ridge. Most of them appear to have this gap.

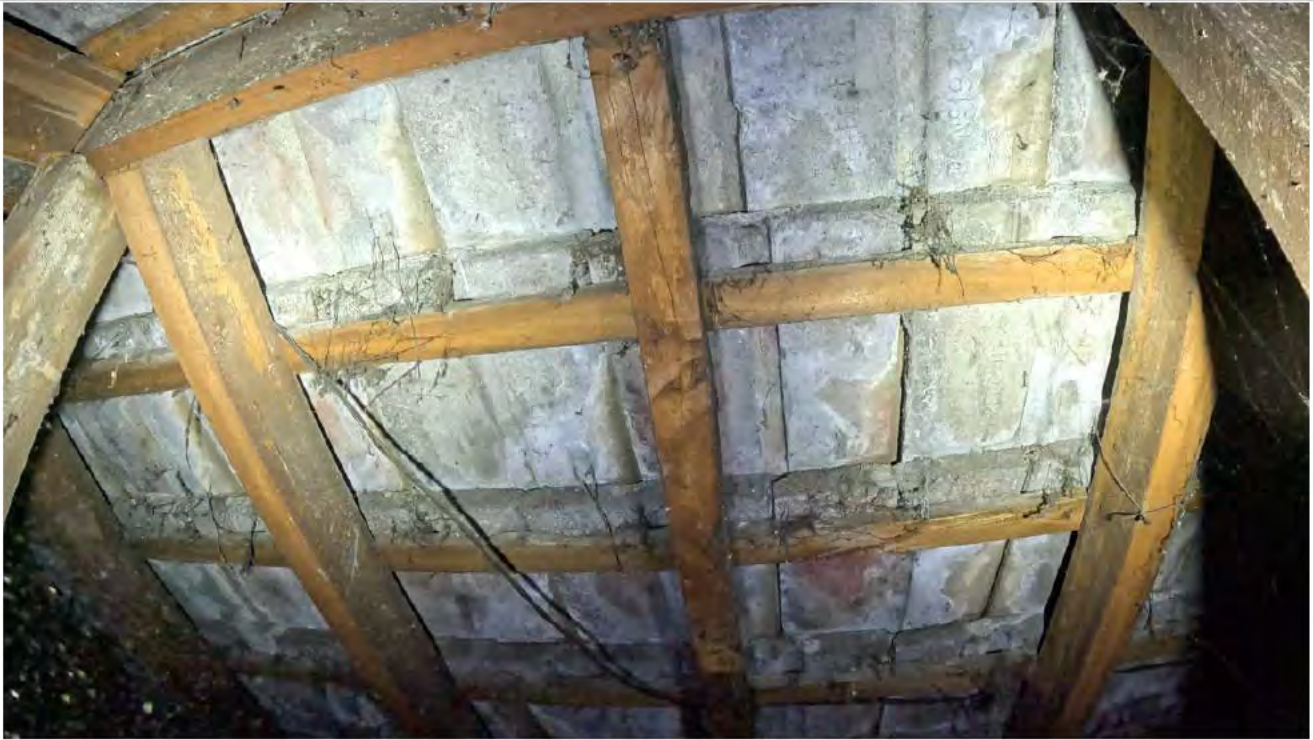
21: Generally, every second or third tile is wired off to a batten or rafter although there appears to be a few missing here.

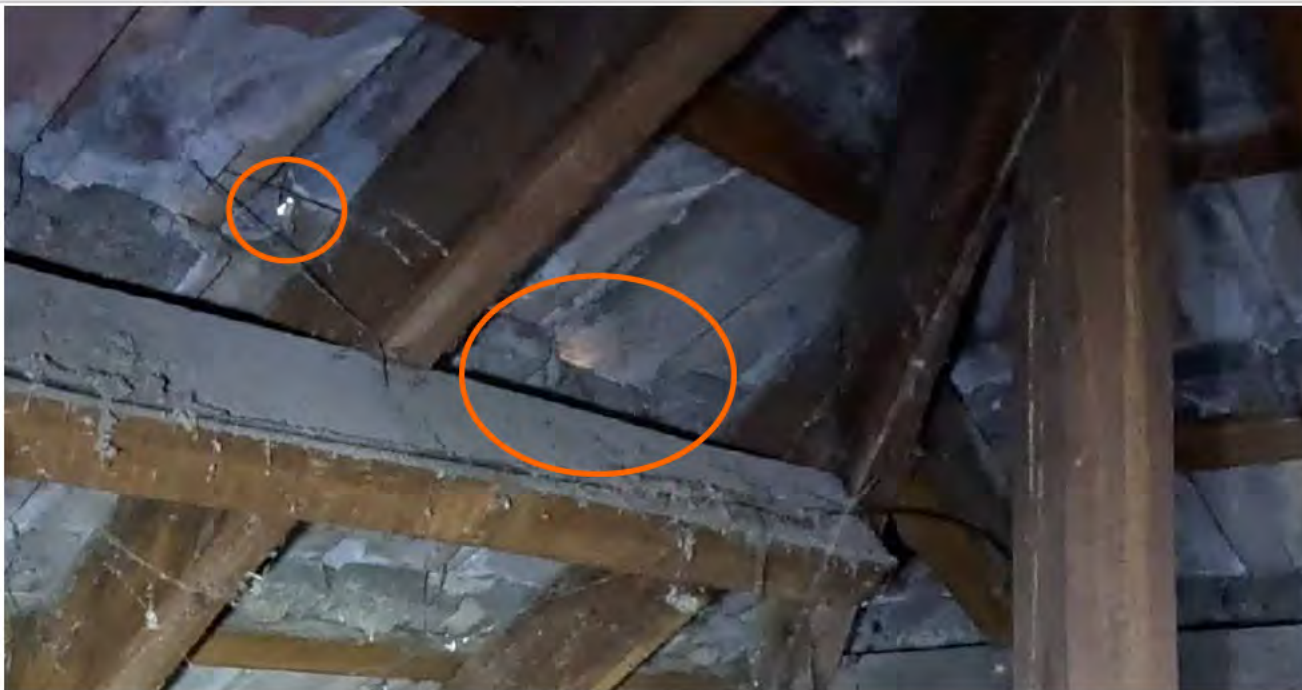
23: Here we see a broken tile and another that has dropped down.

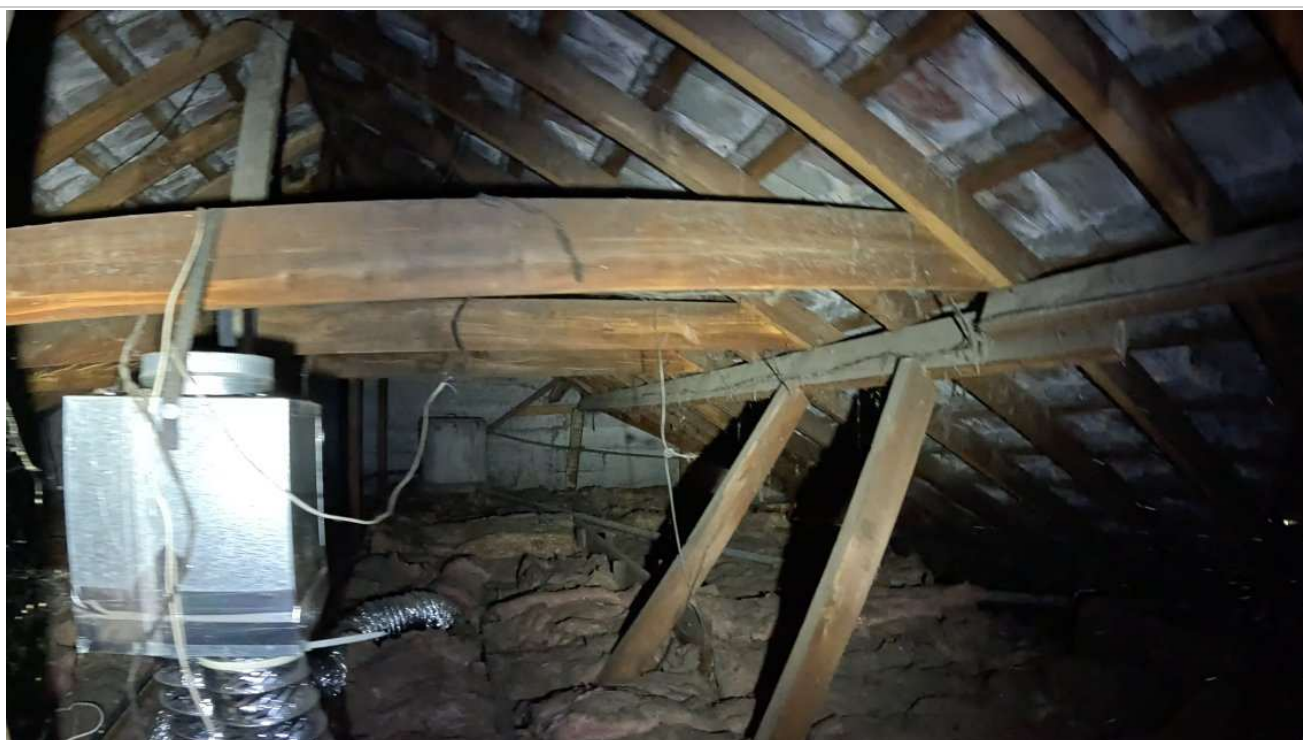
26: View along under purlin and note the lack of support.

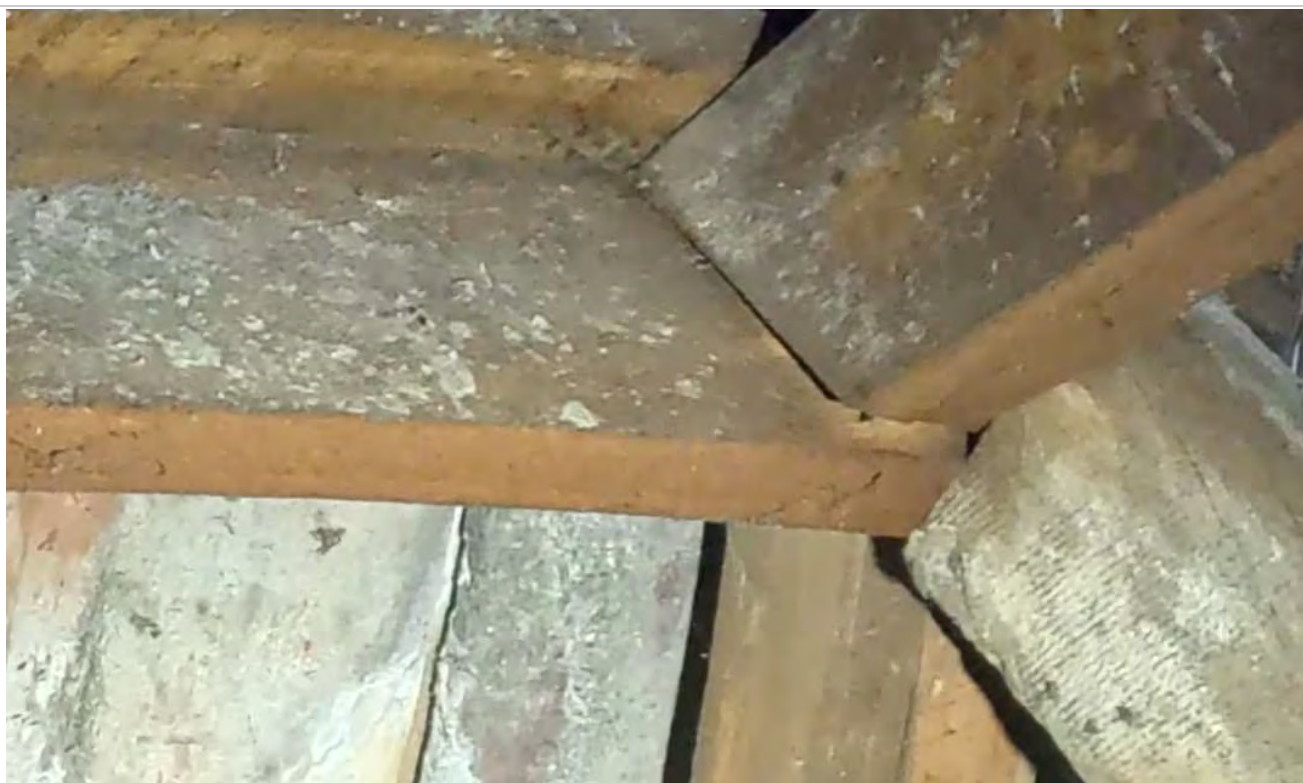
33: The ridge has moved at the bottom here.

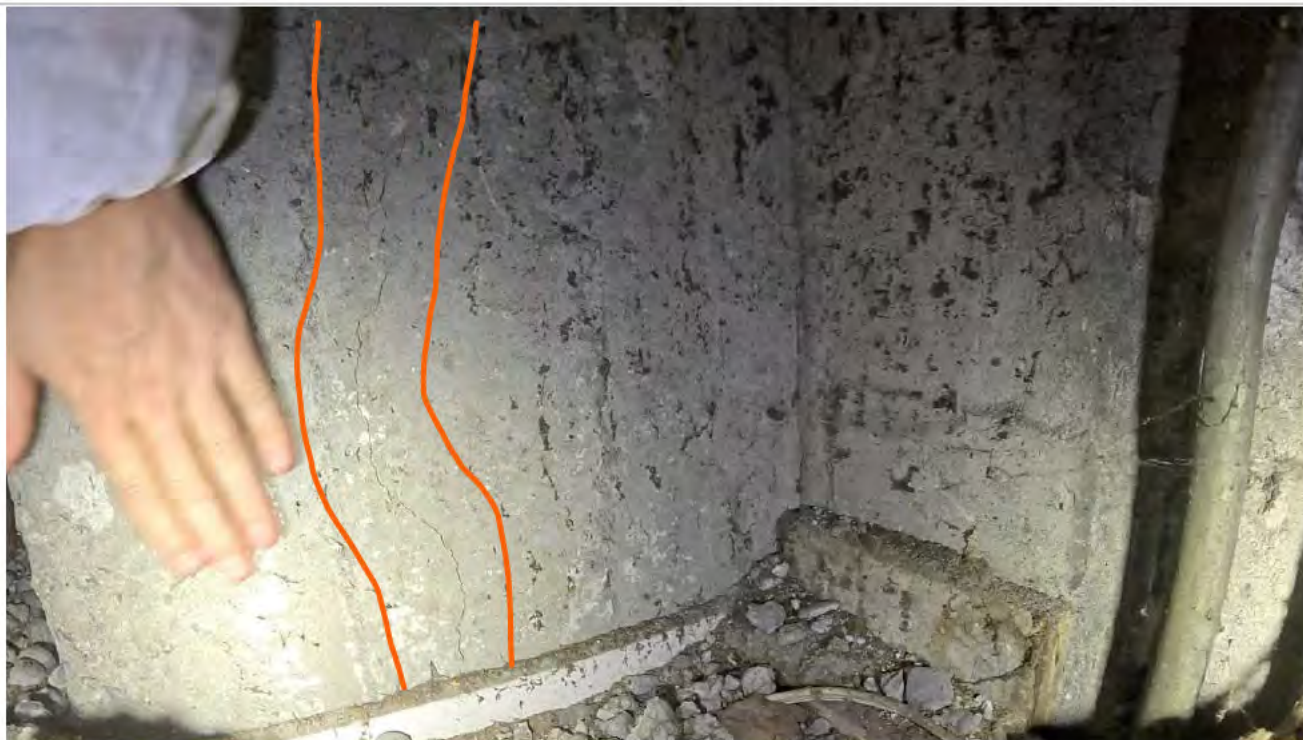
40: View of chimney with cracking.

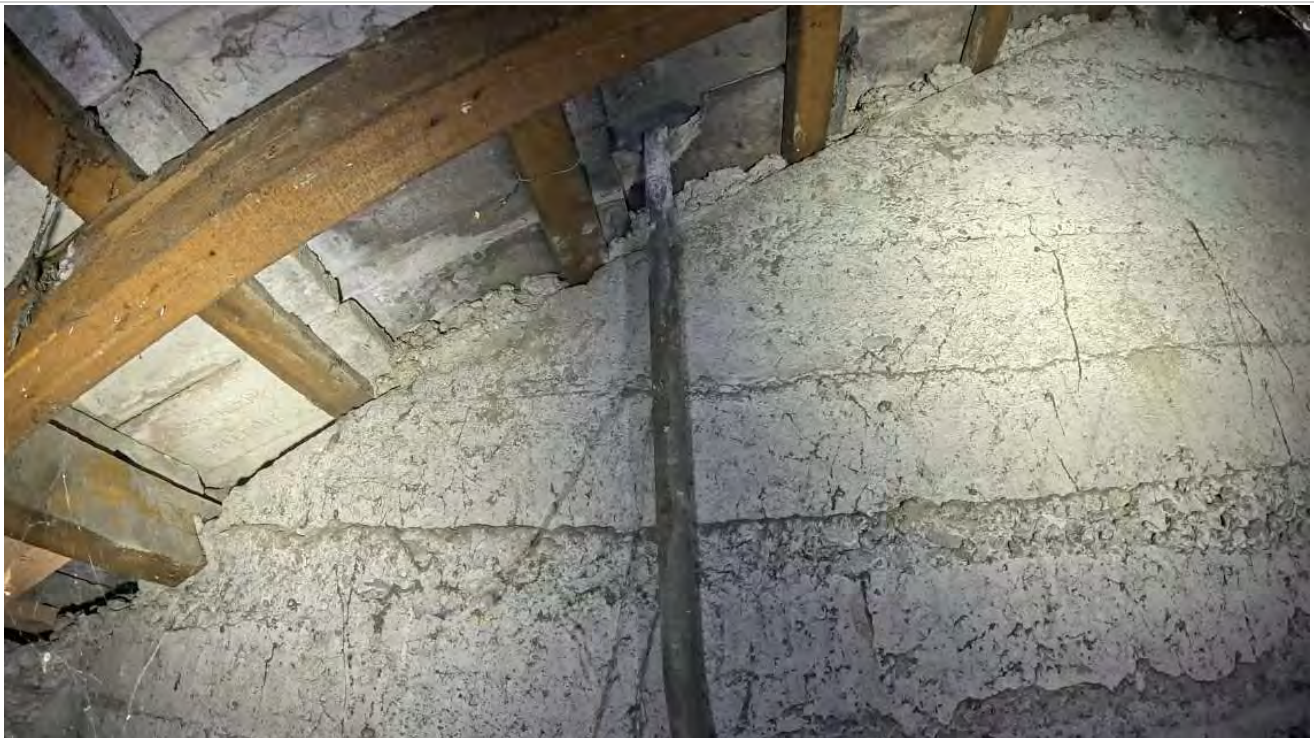
42: View of vent pipe.
