**GEOTECHNICAL REPORT – BUILDING FOUNDATION SOILS**

116 Richard Street  
OPOTIKI

Project Ref. 2630-1  
20 September 2024

## BUILDING CONDITION REPORT FOR RELOCATION

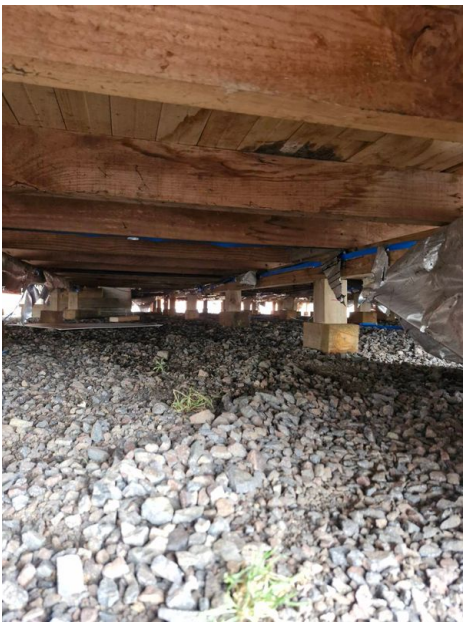
**Sub floor services: Plumbing**

PVC waste, Copper Water

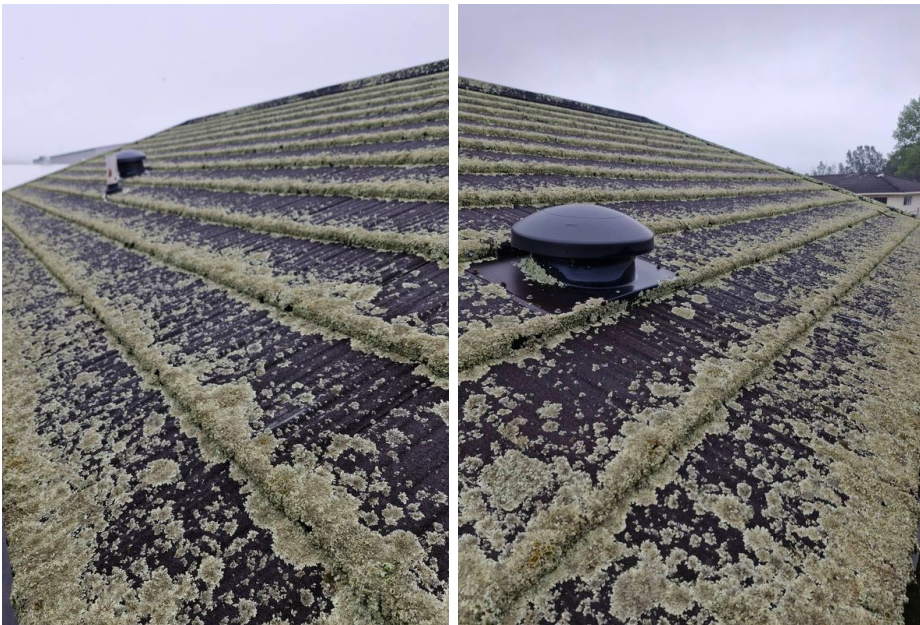
Metal, Tile

The roofing system is a modern-style texture coated pressed metal tile in relatively good condition with significant lichen growth visible that treatment may be required for.

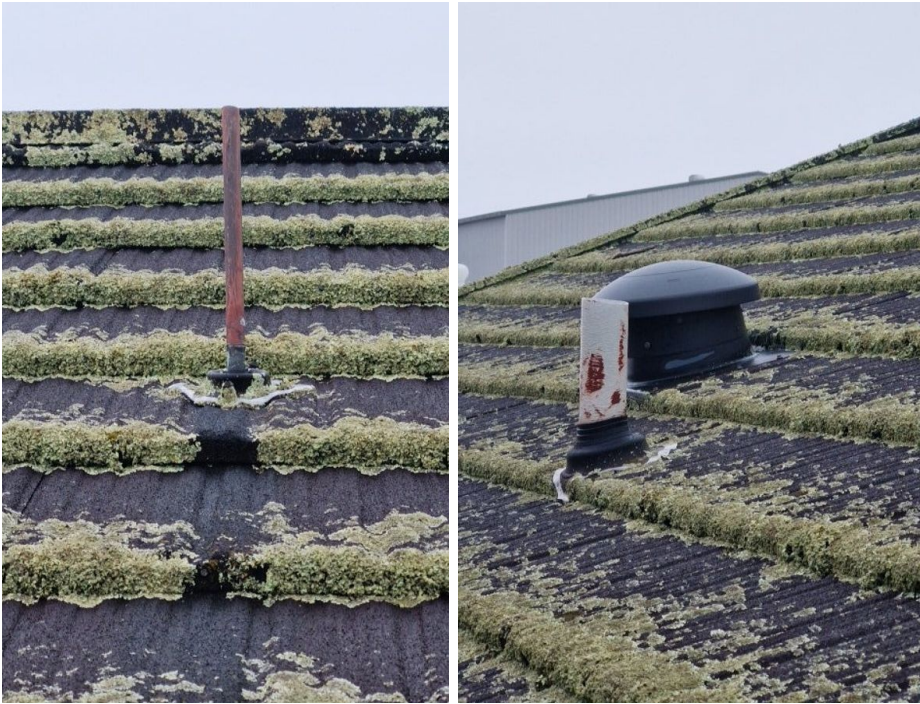
**Skylights, Chimneys & Other Roof Penetrations: Small Penetrations (under 85mm)**

Terminal vent pipe under 85 mm, How water pressure relief pipe

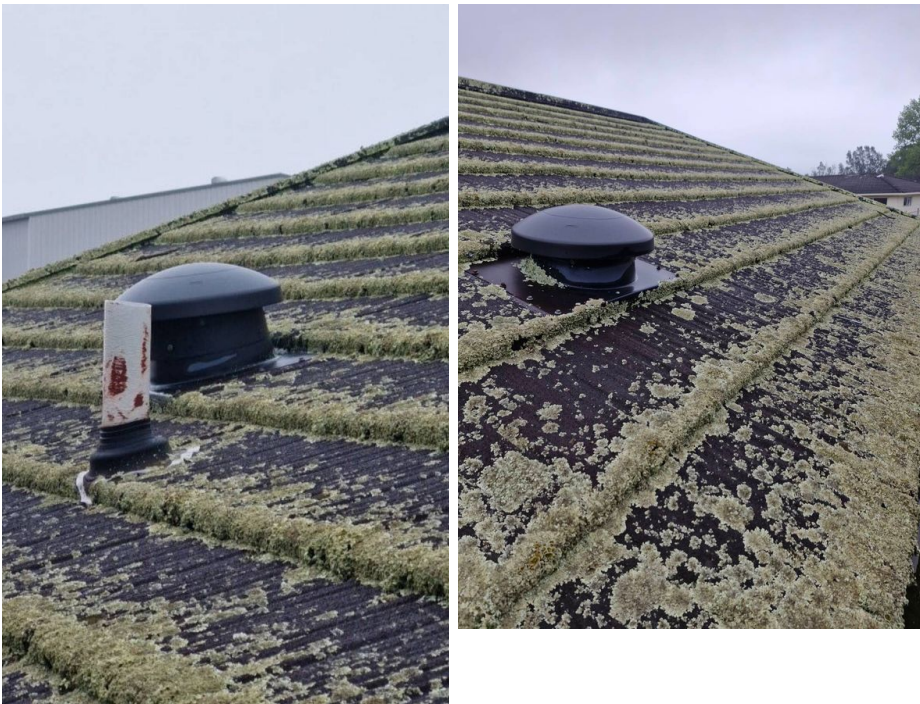
### Skylights, Chimneys & Other Roof Penetrations: Large Penetrations (Over 85mm)

Multiple large penetrations, Large extraction vent

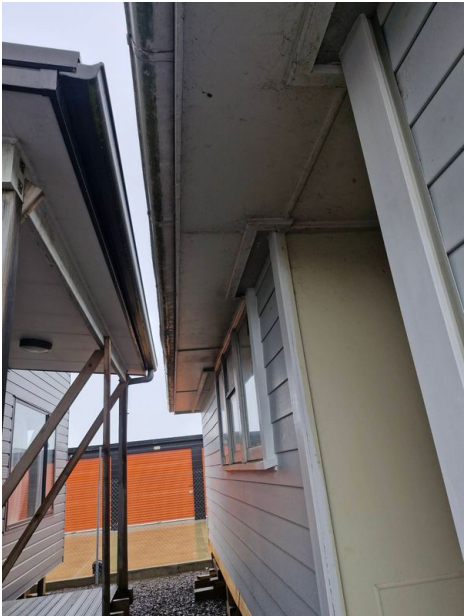
**Eaves, Soffits & Fascia: Fascia Material**  
Painted, Timber, In serviceable condition

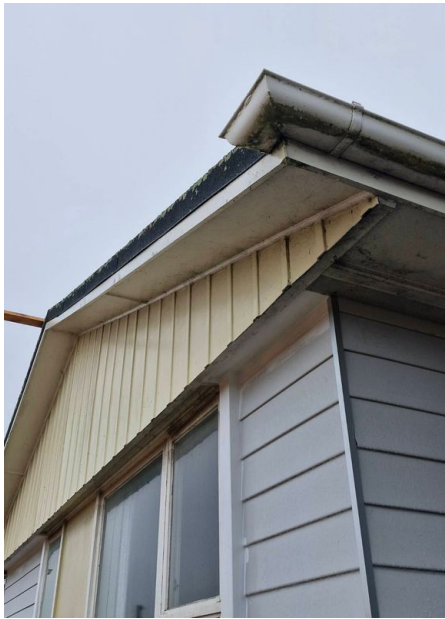
**Cladding, Flashing & Trim: Structure and Exterior Cladding System/s**  
Multiple systems

The building is a timber frame structure on a suspended timber floor structure.

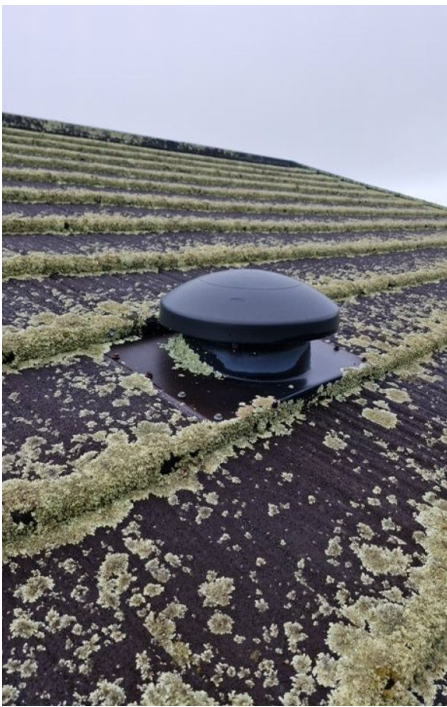
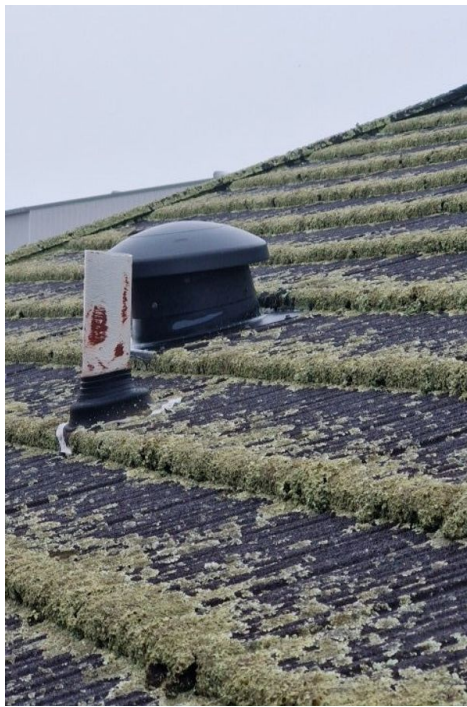
### Eaves, Soffits & Fascia: Ducting Vents and Outlets

Roof outlets

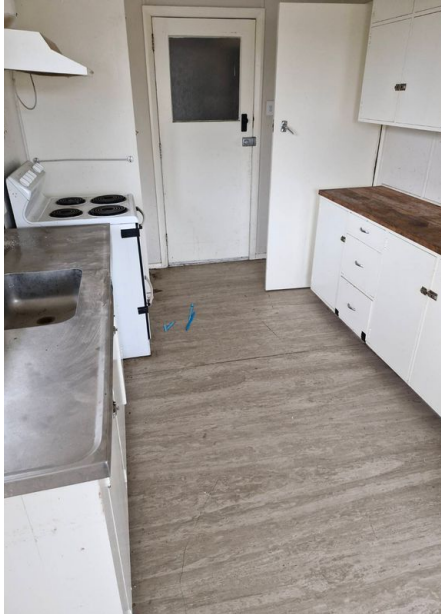
#### Bench tops & Cabinets: Kitchen Bench Tops

Stainless steel bench tops, Solid timber benchtops

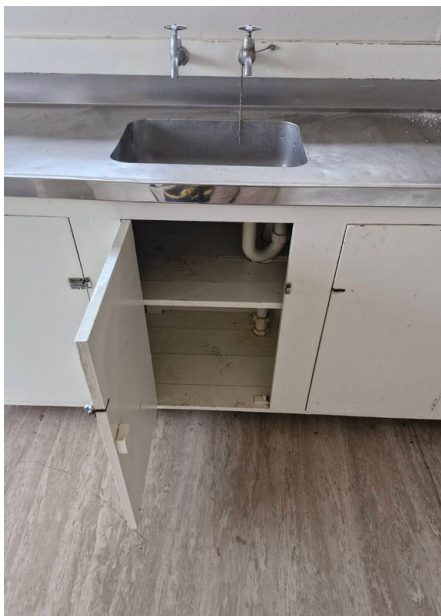
#### Sink & Services : Sink Type

Stainless Steel, Single Bowl

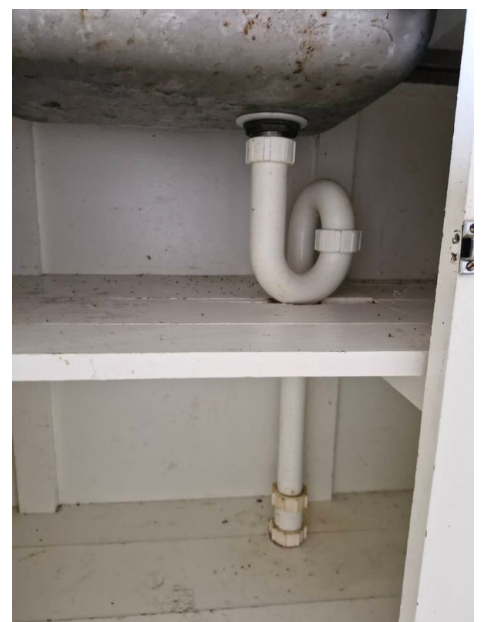
#### Sink & Services : Under Bench Plumbing

PVC Waste Pipes

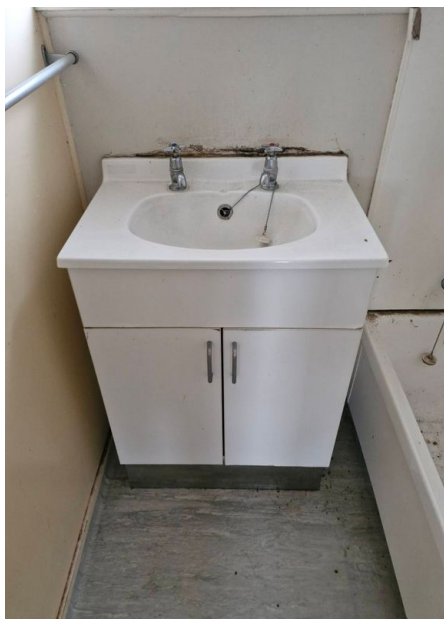
#### Cabinets & Basins : Sink Type

Single Bowl, China Bowl,  
Serviceable condition

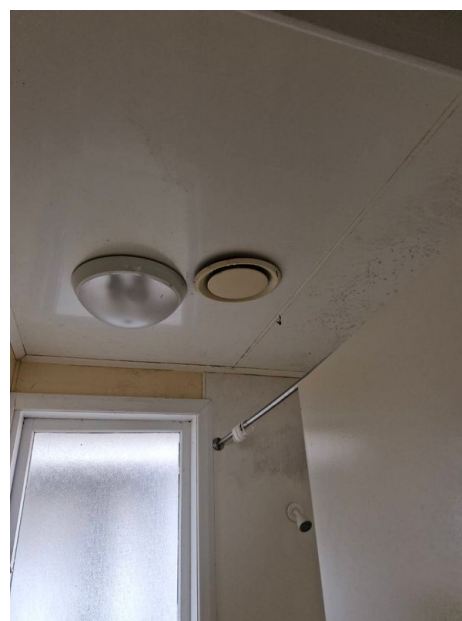
#### Drains & Ventilation : Extraction

Bathroom & Ensuite

Ceiling Fan, Appears to be  
ducted to the exterior
