## RED LBP PRE-PURCHASE REPORT

# CERTIFICATE OF INSPECTION IN ACCORDANCE WITH NZS 4306:2005

**Company:** GDDC Ltd trading as RedLBP NC.  
**Client:** Simon Ensor  
**Date of Inspection:** 17th June 2026  
**Site Address:** 10 Thomas Lane, Rangiora 7400  
**Inspector:** Gary Cassidy  
**Qualifications:** Advanced Trade Certificate Carpentry & Joinery. Licenced Building Practitioner.

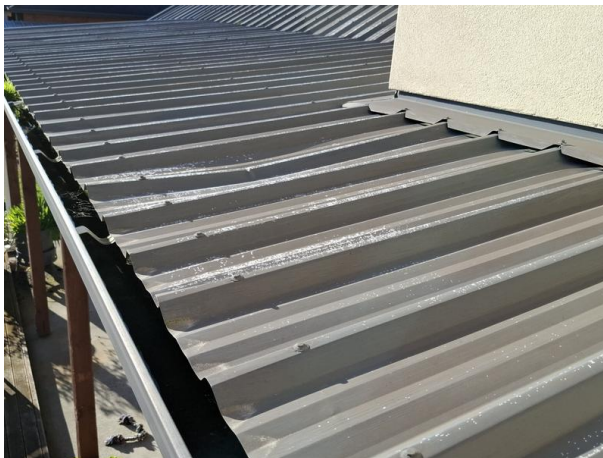
**Photo 8**  
Denting visible on verandah roof.

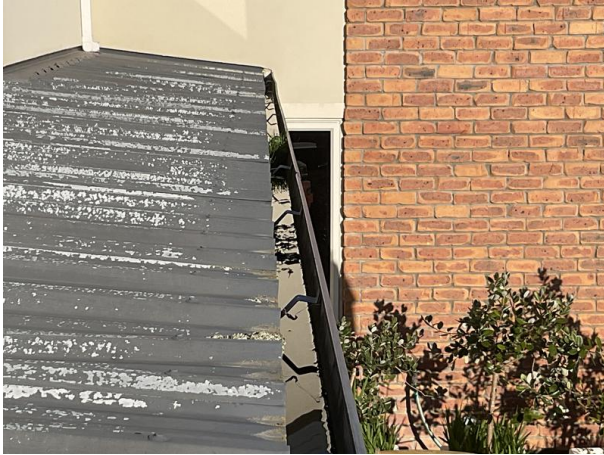
**Photo 10**  
Gutters need clearing in some areas.

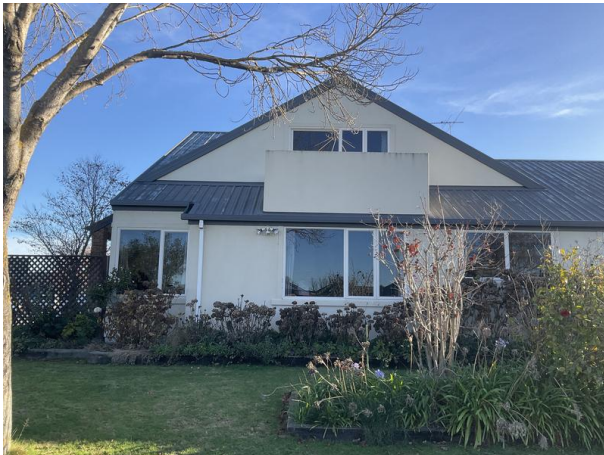
**Photo 18**

East elevation of exterior cladding.

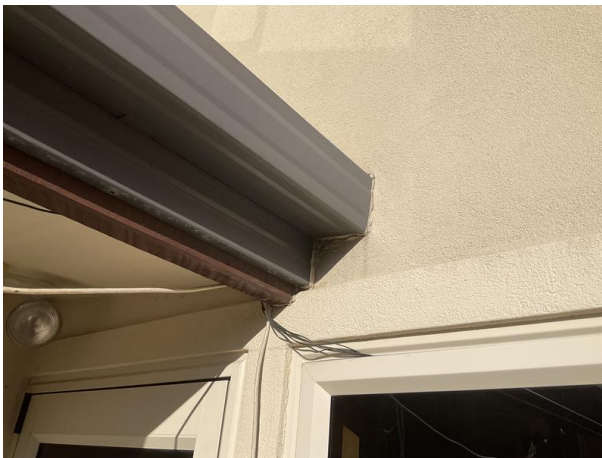
**Photo 23**  
Fascia board and guttering is  
penetrating the cladding above garage  
back door. Monitor and maintain  
sealants.

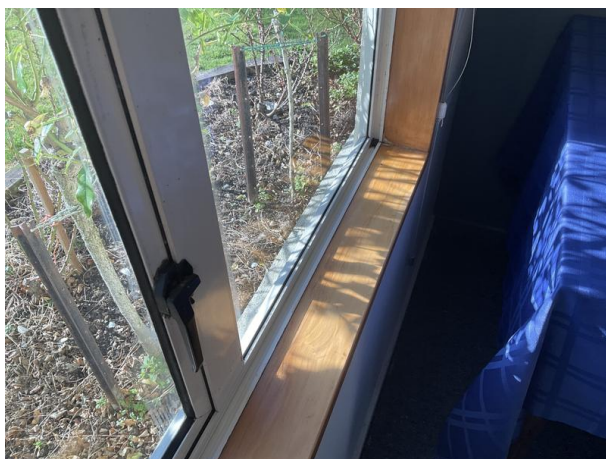
There is moisture staining to the timber reveals. However, when tested with the non-invasive moisture metre it indicated a normal reading where spot tested at the time of the inspection. This should be monitored for signs of moisture. This may be due to wind-driven rain or condensation.

**Photo 26**  
Typical window reveal.

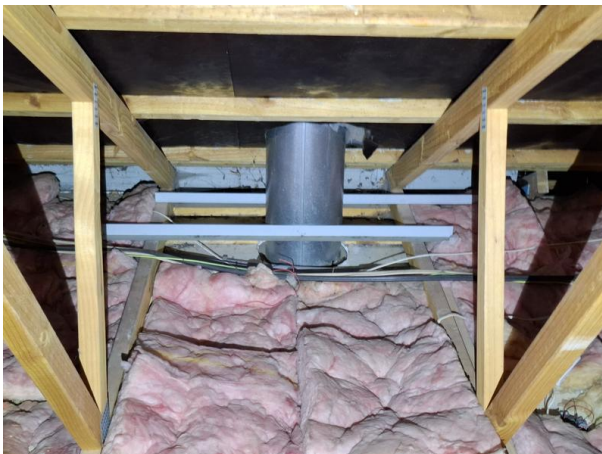
**Photo 33**  
Log burner flue penetration visible.

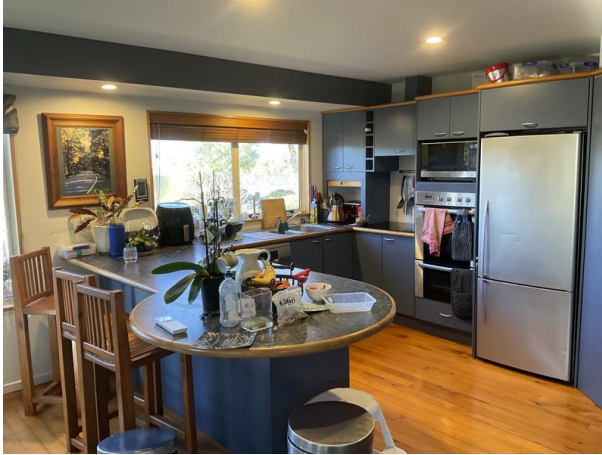
The junction between the kitchen benchtop and the adjoining wall is not sealed. Without proper sealing, water from regular use may track into concealed areas, leading to deterioration of wall linings, cabinetry, and adjacent floor finishes. To mitigate this risk, it is recommended that a durable, flexible sealant be applied and maintained at this junction to provide a watertight seal and protect the surrounding materials from moisture damage.

**Photo 47**  
Kitchen.

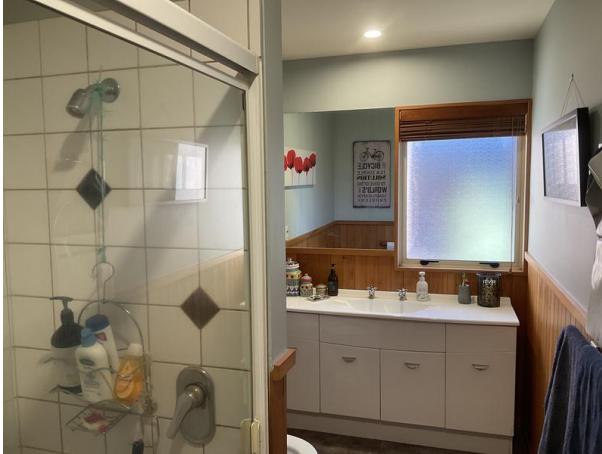
**Photo 57**  
Bathroom.

There is no externally vented mechanical ventilation system installed in the bathroom. It is recommended to install an externally vented mechanical extraction system suitable for the size and use of the bathroom.

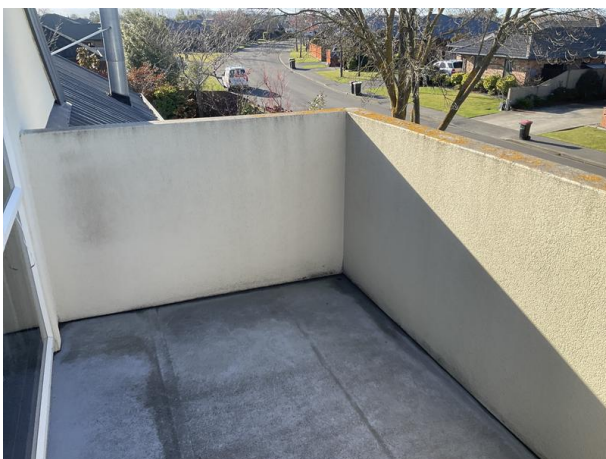
**Photo 70**

- Clad balustrade/wall junction
- Clad balustrade top
- Deck drainage/ no overflows
- Balustrade/deck junction
- Rainwater outlets

Balcony on east elevation.

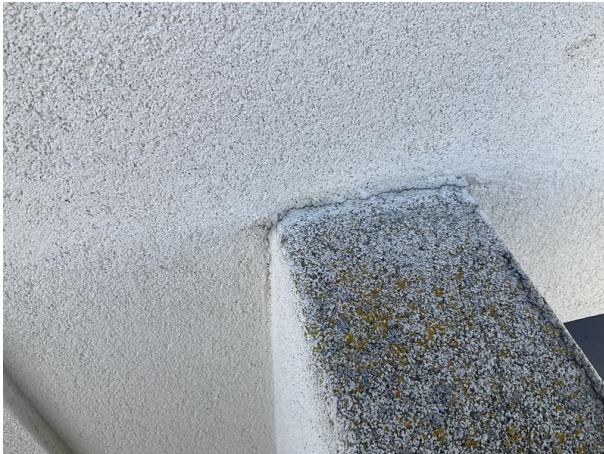
**Photo 72**

Deferred maintenance to top of and at balustrade and wall junction. Maintenance required.

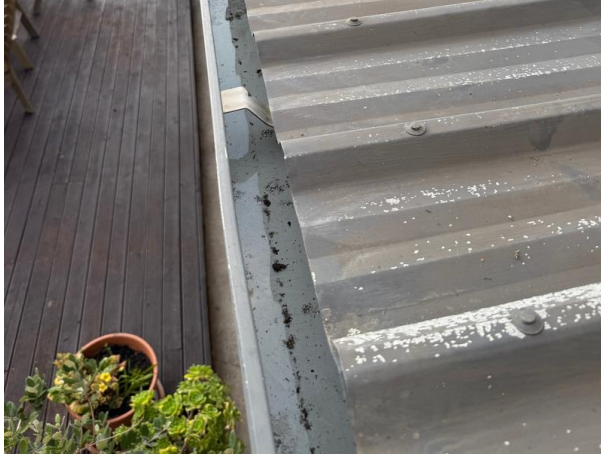
**Photo 74**

Gutters have been cleared.

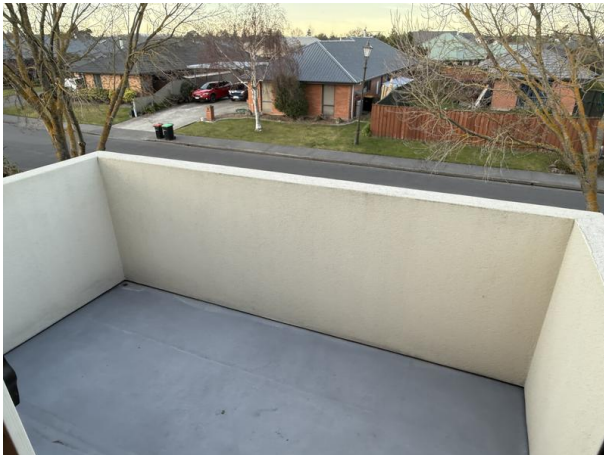
**Photo 79**  
Balcony and drain have been cleaned.

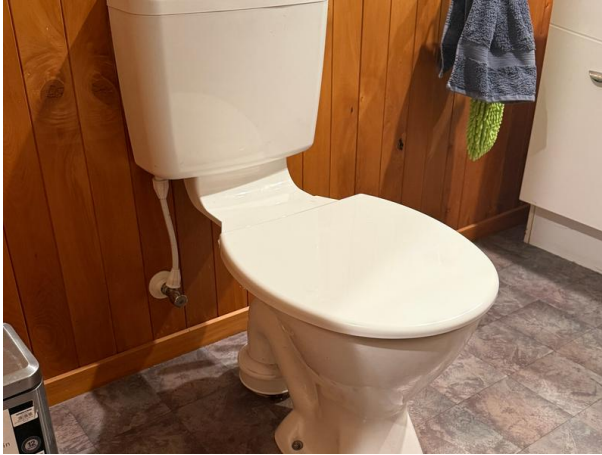
**Photo 80**  
New cistern and seat to bathroom toilet.

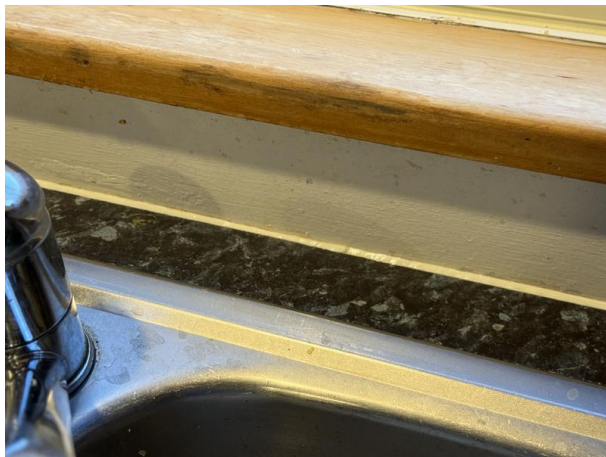
**Photo 85**  
Benchtop sealed to wall.

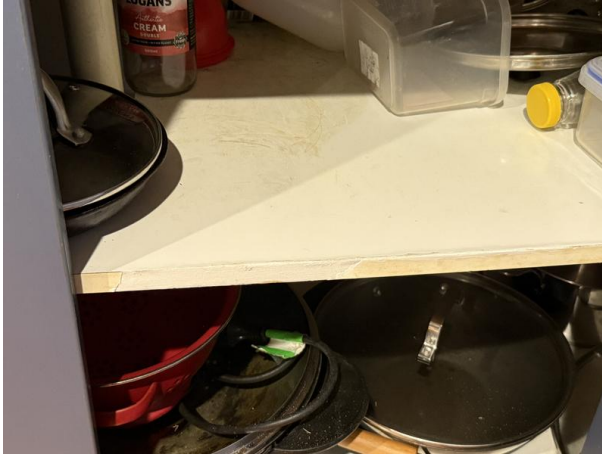
**Photo 86**  
Kitchen shelf edge sealed.

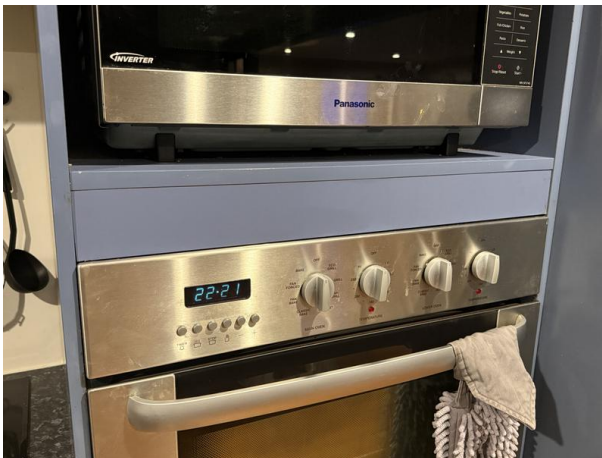
**Photo 87**  
Panel above oven has been secured.

Panel above oven is loose,  
maintenance recommended.

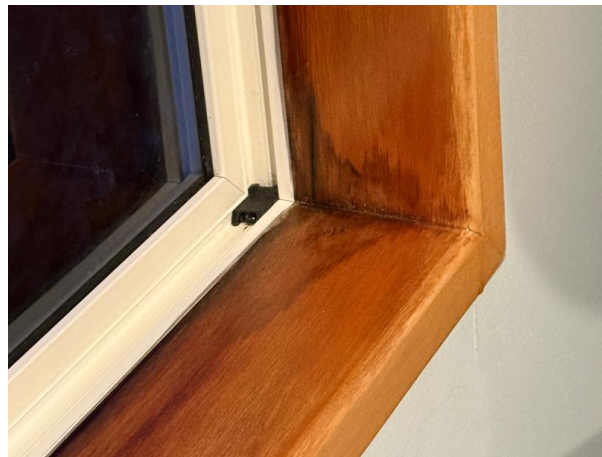
**Photo 88**  
Window reveal maintenance completed.

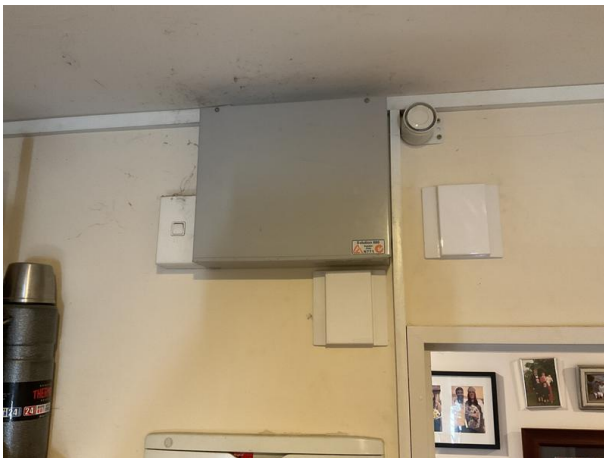
**Photo 110**  
Security box in laundry.

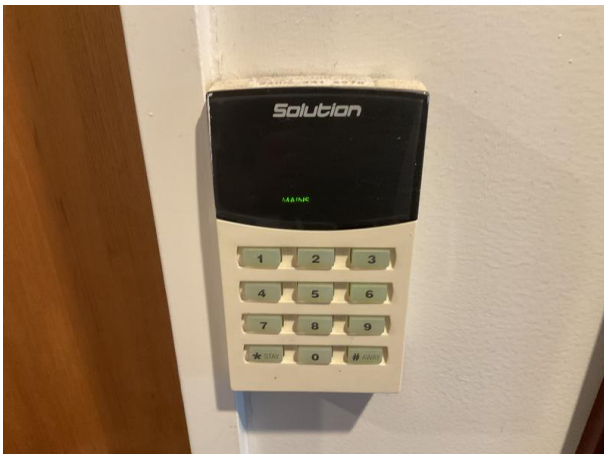
**Photo 111**  
Security keypad in entrance.

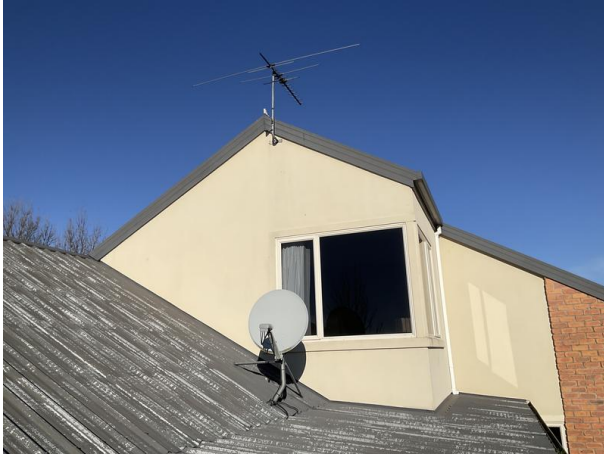
**Photo 112**

TV aerial and dish on north elevation.

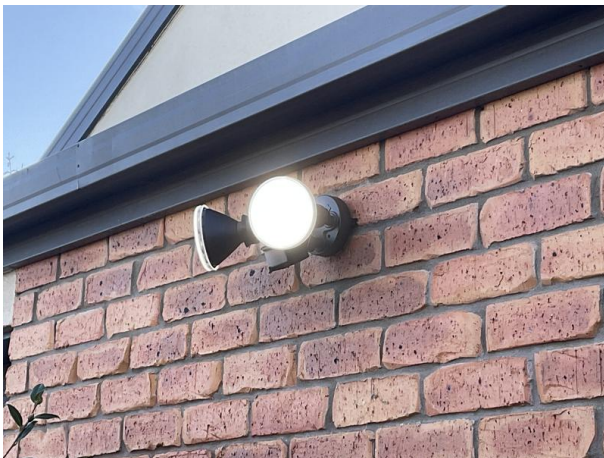
**Photo 113**

Security light beside entrance.

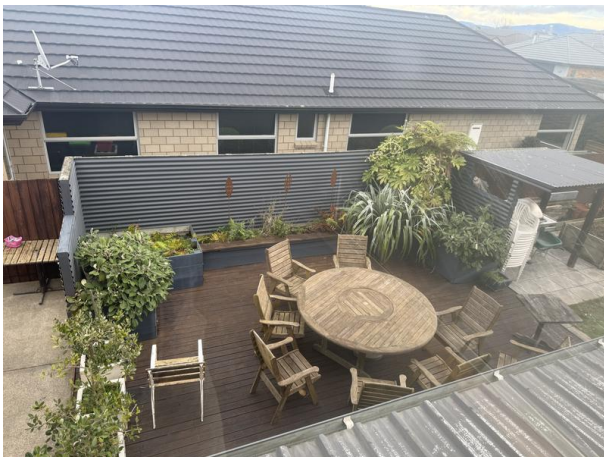
**Photo 116**  
Timber deck cleaned and recoated.

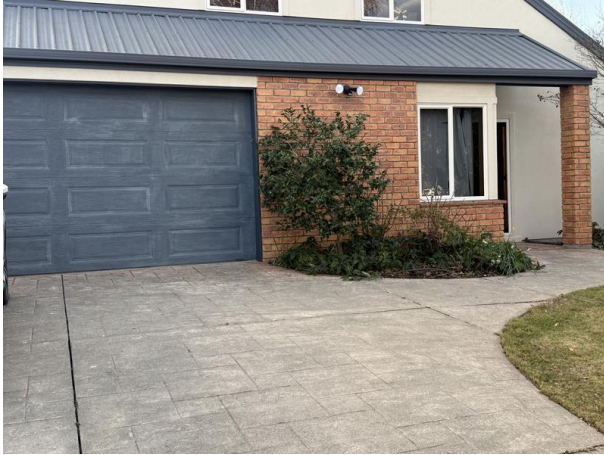
**Photo 117**  
Driveway and path cleaned.

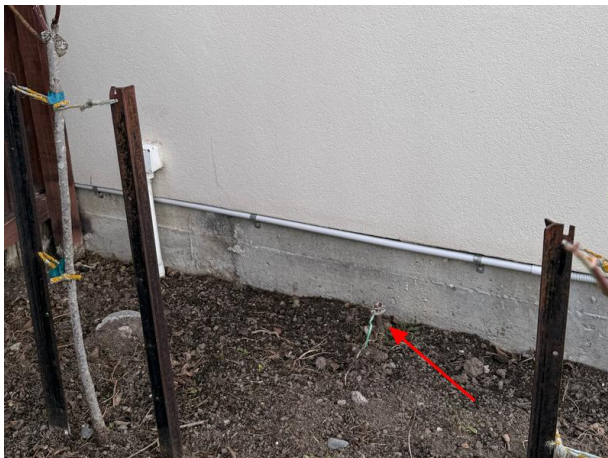
**Photo 118**  
Earth stake connection below meter box.
