# EARTHQUAKE REPAIR

## 425 & 427 ARMAGH STREET

**IN RESPECT OF:** Structural Design of Foundation Repair for 425 & 427, Internal Alterations at Nr. 425 only  
(Description of Building Work)

## TR001: Technical Report – Desktop Technical Review & Structural Inspection

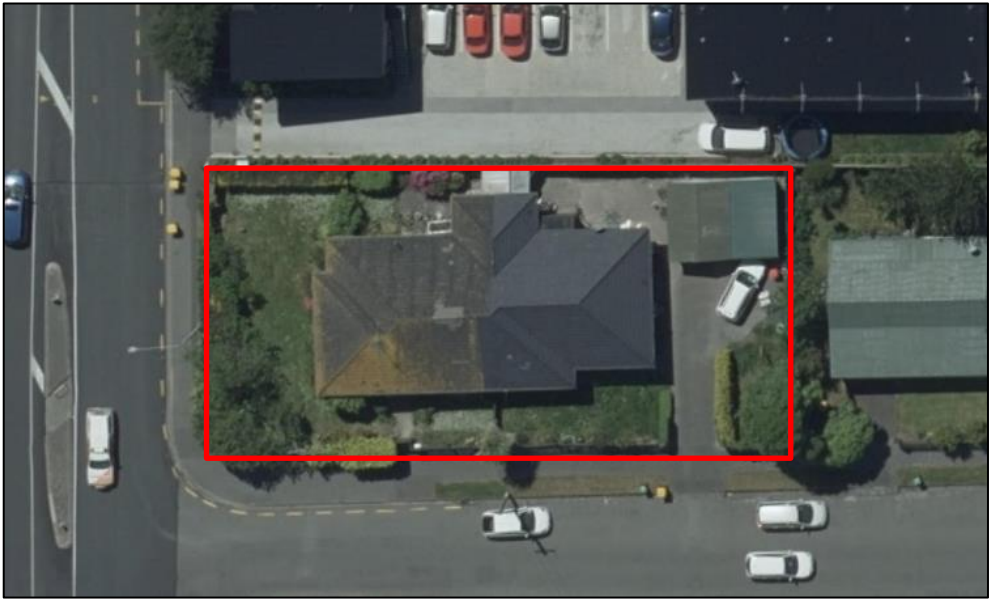
Photo 1F – 2015-2019 aerial imagery shows the chimney has been removed down to the roof level post 2011 earthquakes..

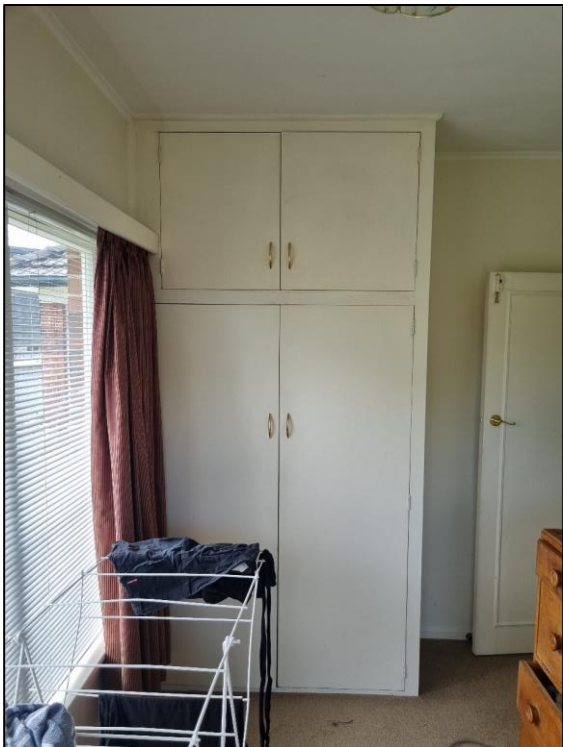
Photo 4B –Built in wardrobe was tilting in direction the floor slope but the framing was measured to be level over the sloping floor.

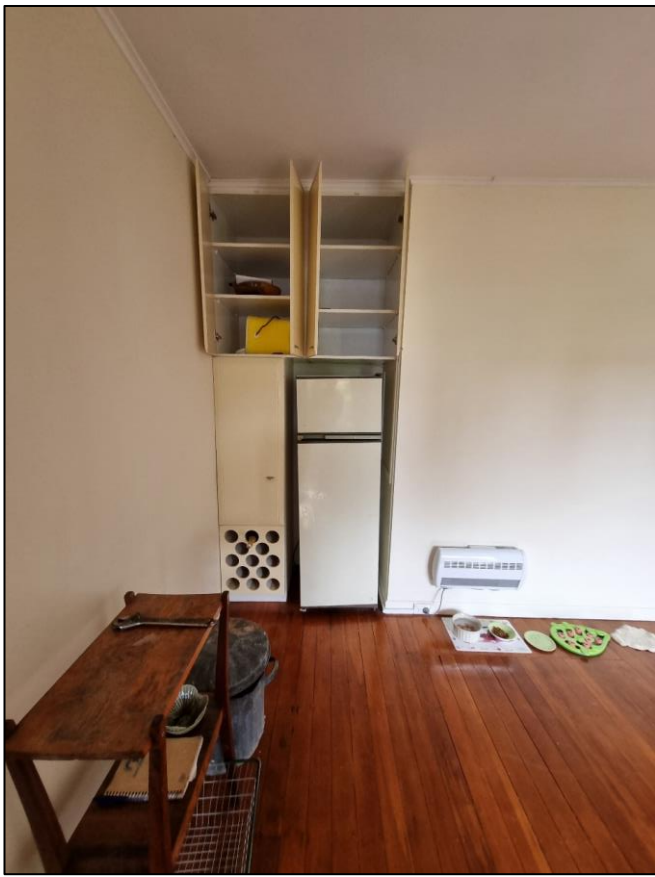
Photo 4C –Built in storage units in the south west of corner of the dining room. Floor falls 20mm/m, to a greater degree than the wall mounted units.

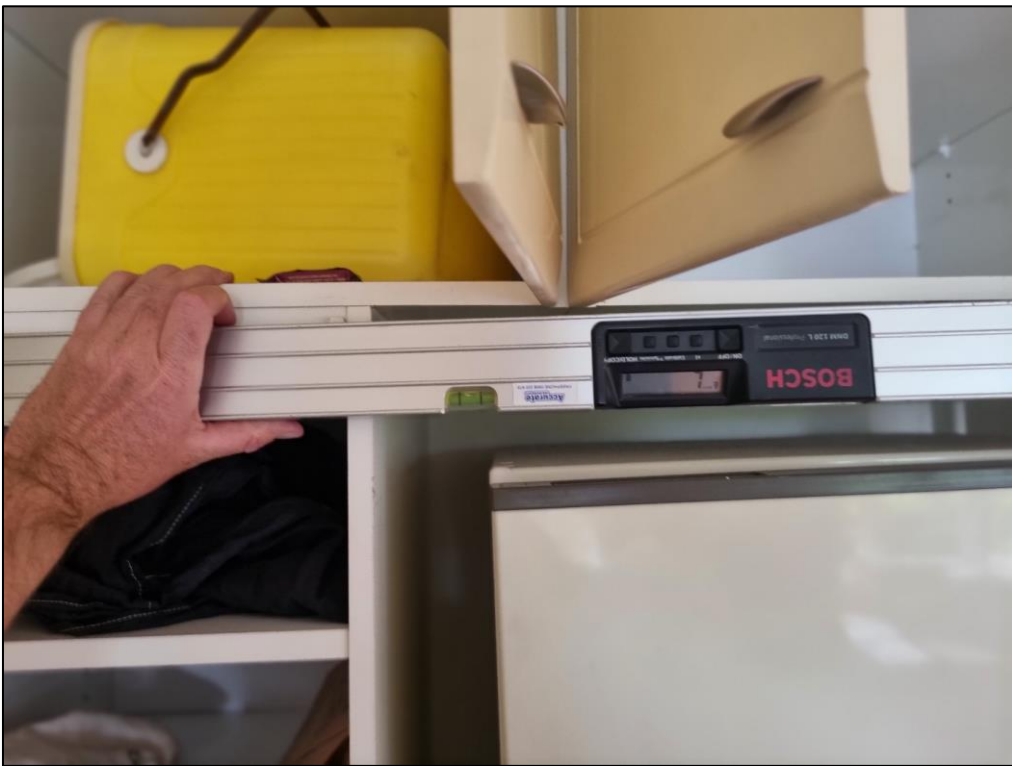
Photo 4D – underside of the storage units sloping toward the partition wall by 7mm/m

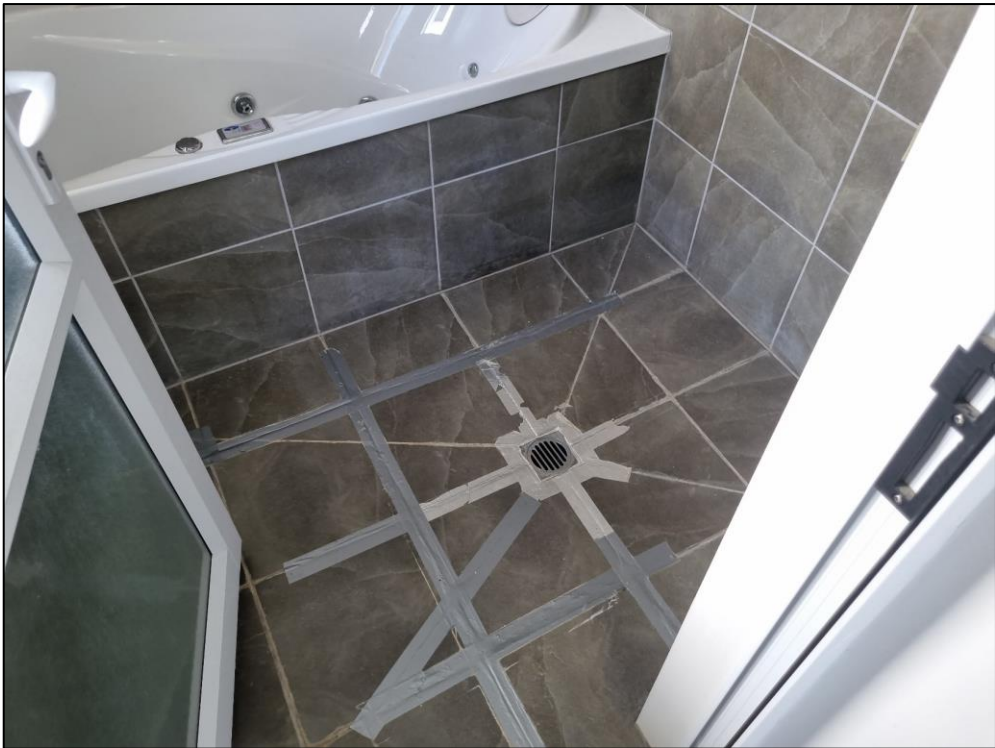
- We understand that the shower room, which is accessed through the kitchen, was called the laundry at the time of the 2011 earthquake. This room is believed to have been modified since that time, with new wall and floor tiles installed. Photo 5A show that a spa bath has been installed, and the floor appears to have been modified to form a wet room with a drain in the center of the room. The grout lines are masked with tape, and it appears the works in this room were ongoing at the time of our assessment. The door to this room also appears to have been fitted since the earthquakes. These modifications were not found in the property files. Cracks to the Block partition wall in this room was identified in the post-earthquake scopes and a mortar repair was recommended. The width and length of the cracking was not specified in the original assessment document. Step cracking suggests that some differential settlement occurred to this partition wall.

Photo 5A – Laundry room converted to a wet room with a spa bath installed after 2011. Grout repairs were ongoing at the time of our site assessment.

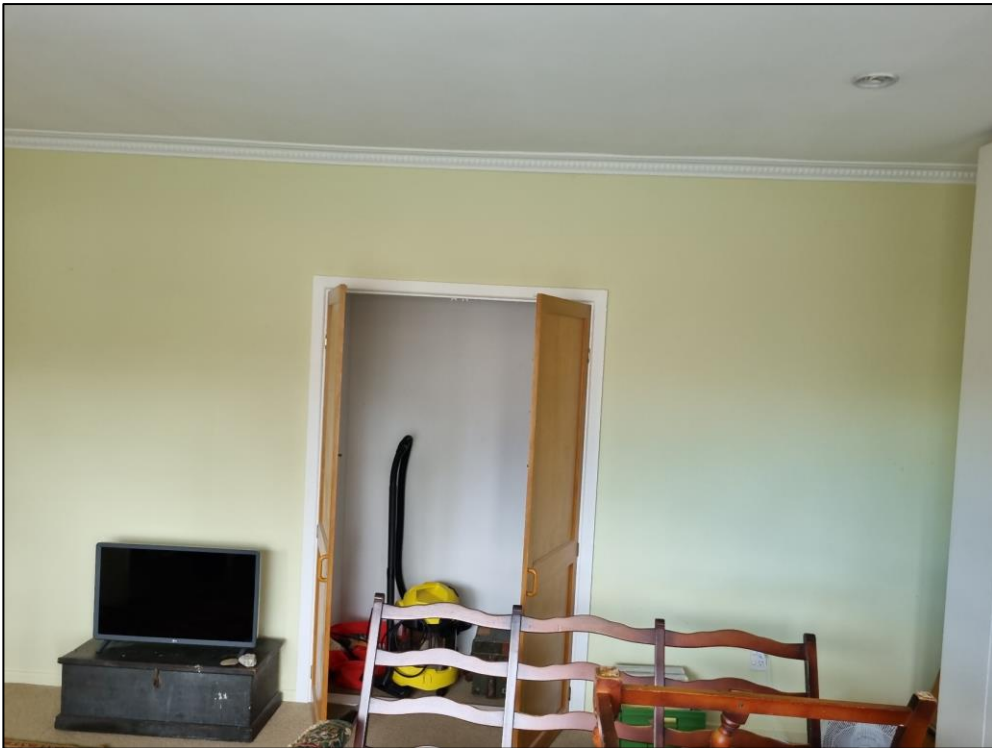
Photo 5B –Storage closet installed in place of old concrete chimney that was removed as part of post-earthquake repairs. Wall linings around the opening were also replaced.

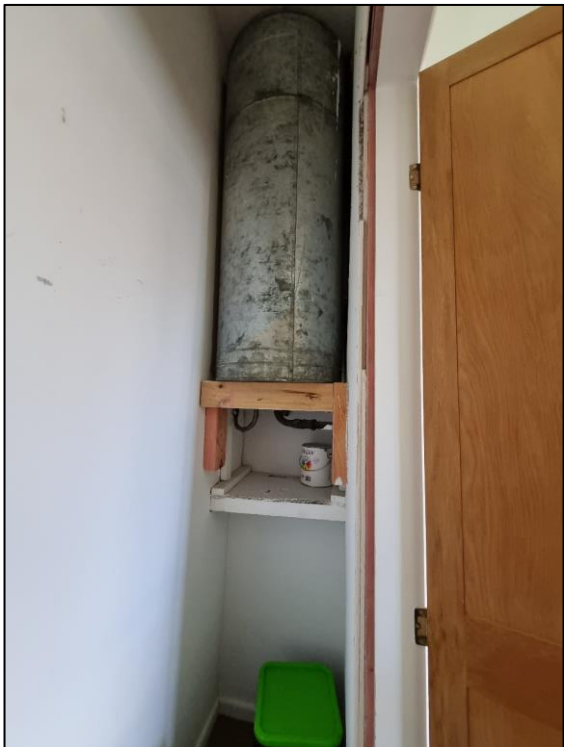
Photo 5C –HWC without restraints inside the lounge closet.

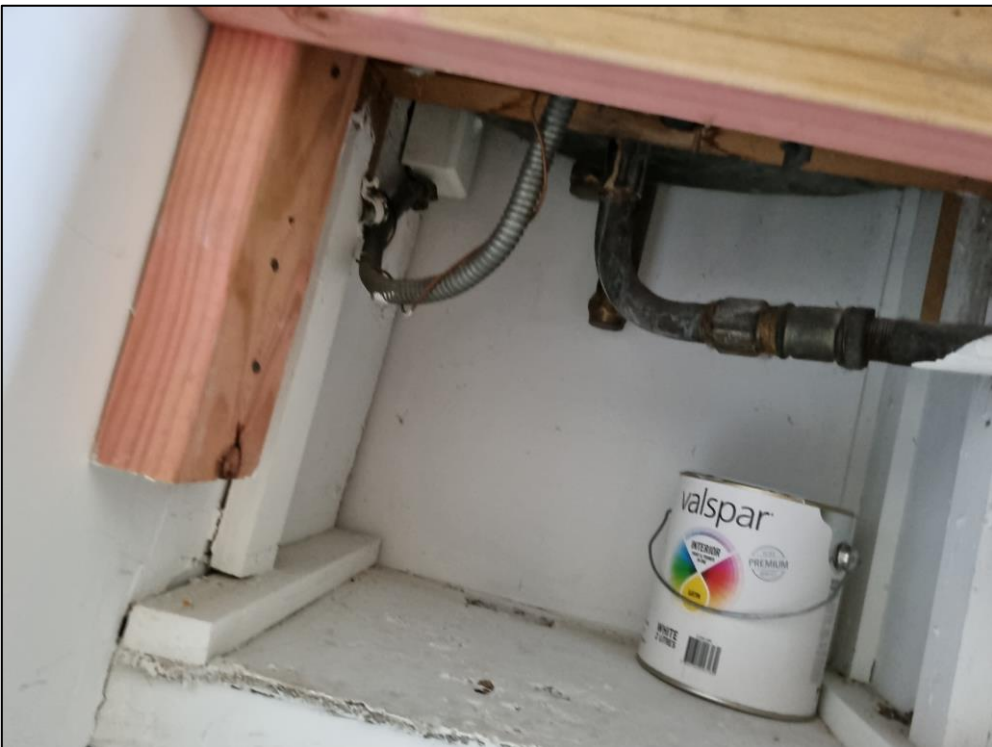
Photo 5D – HWC timber support framing should be replaced/ strengthened.

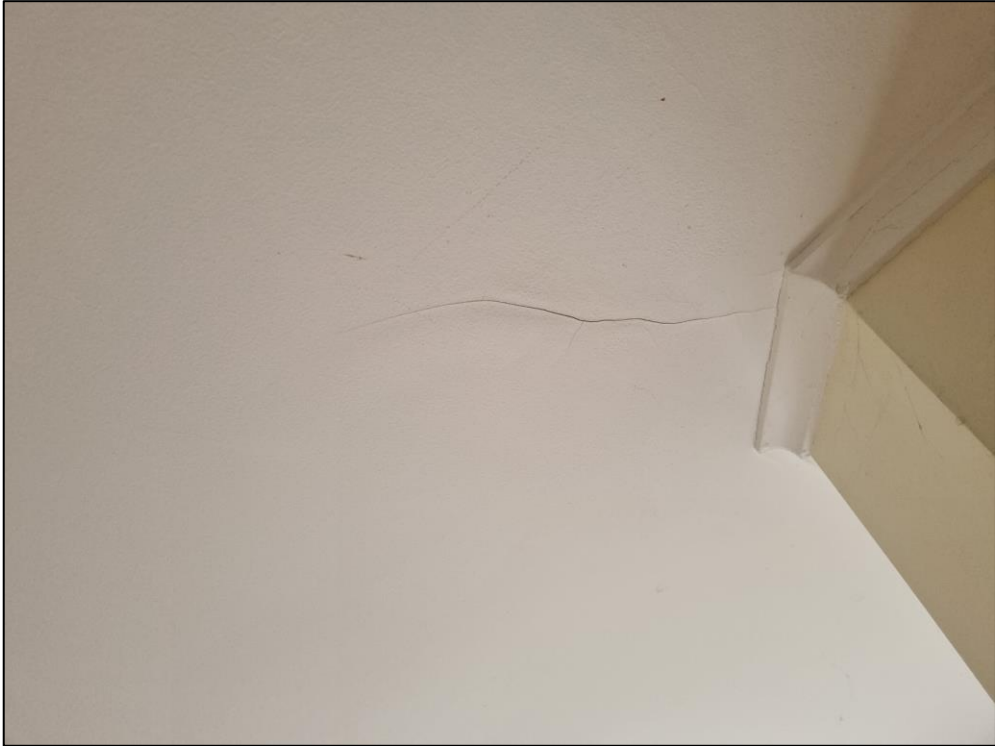
- The internal ceilings are lined with plasterboard. It is understood that only cosmetic repairs were originally required as part of earthquake-managed repairs, with no localized lining replacement deemed necessary following the CES. Minor cracks were observed in the dining room ceilings (Photo 5E).
- The owners informed us that the external gutters have been fully replaced within the past year across both dwellings at 425 and 427 Armagh Street.

Photo 5E – Ceiling cracking in dingy room beside entrance to kitchen.

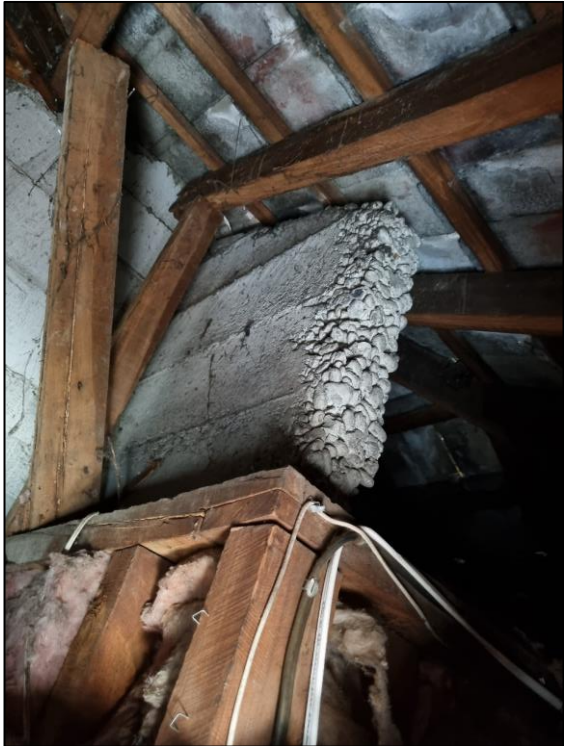
Photo 6A – Poured concrete partition wall above the ceiling level.

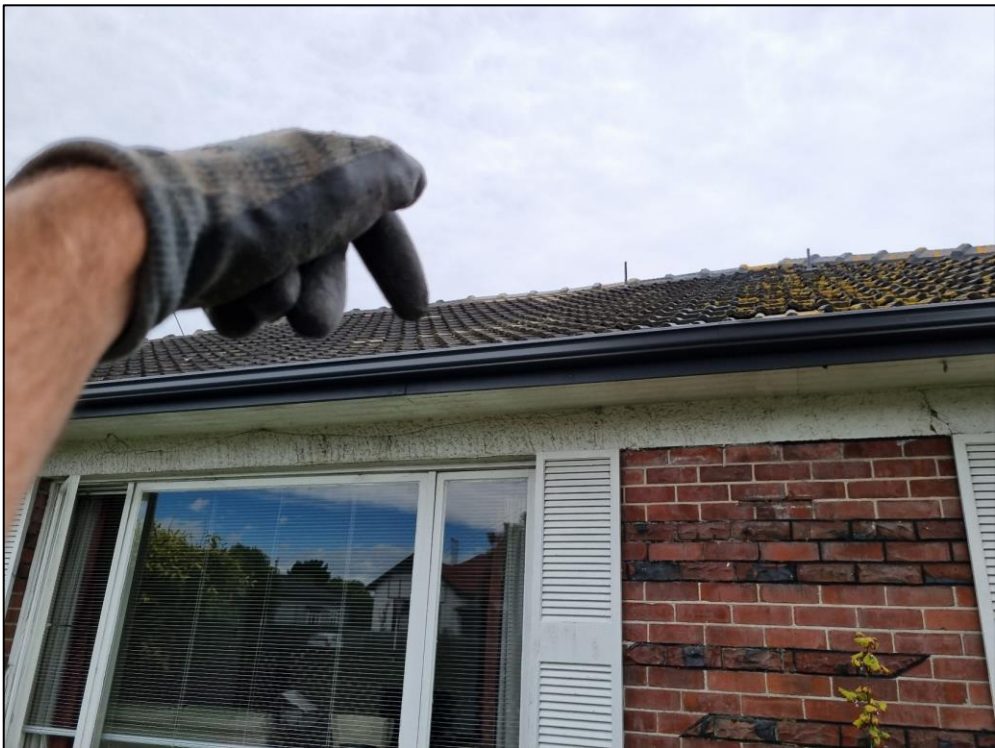
Photo 6C – Roof plane sagging towards the middle due to inadequate underpurlin support .

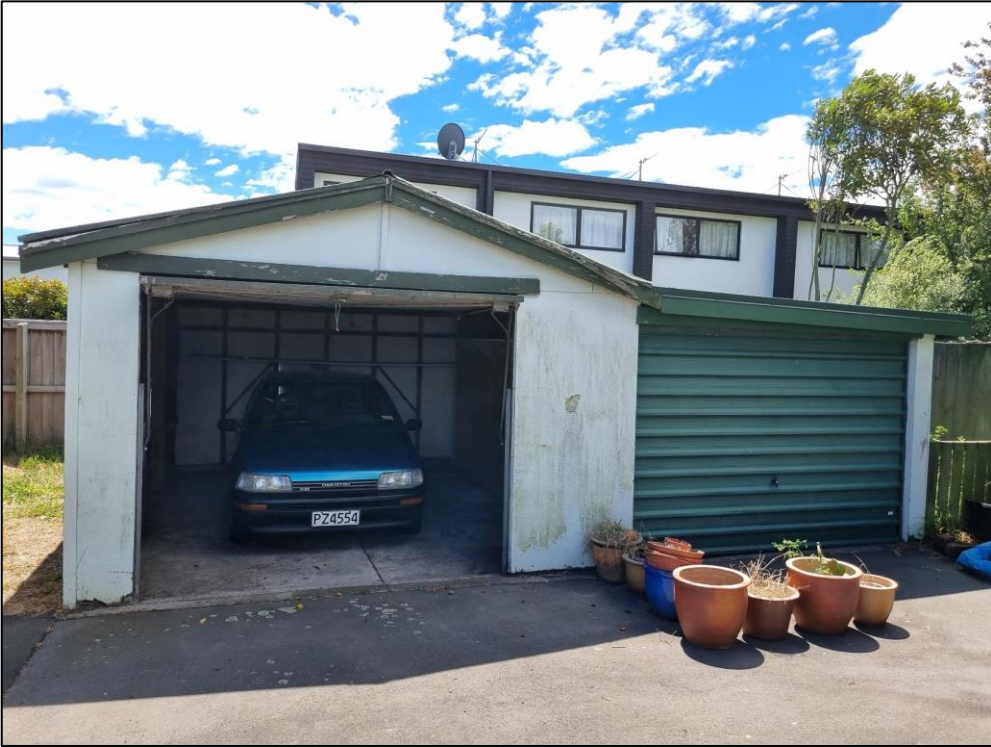
Photo 7A – South elevation of adjoining garages.

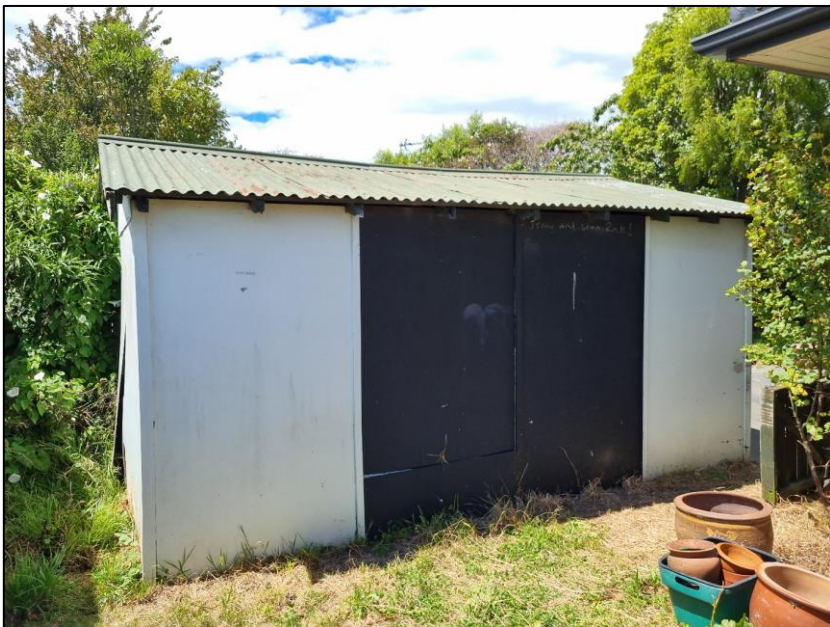
Photo 7C –Garage West elevation

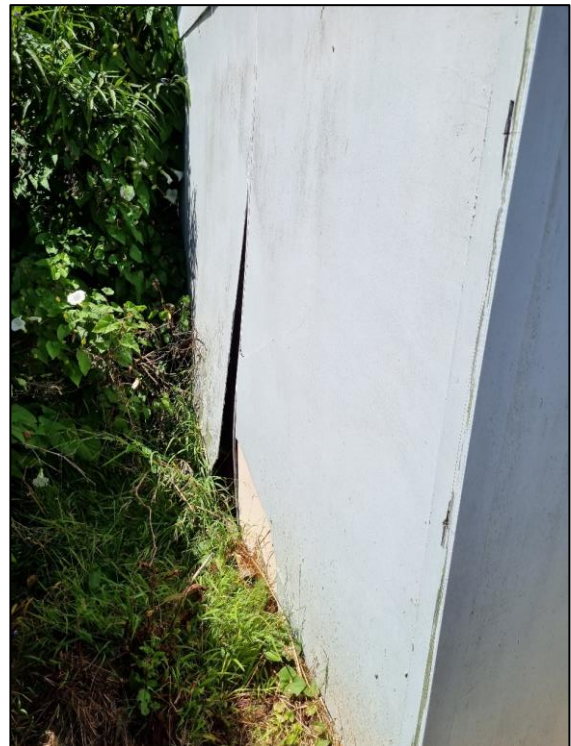
Photo 7D – North Elevation. Cladding sheet need to be refixed.

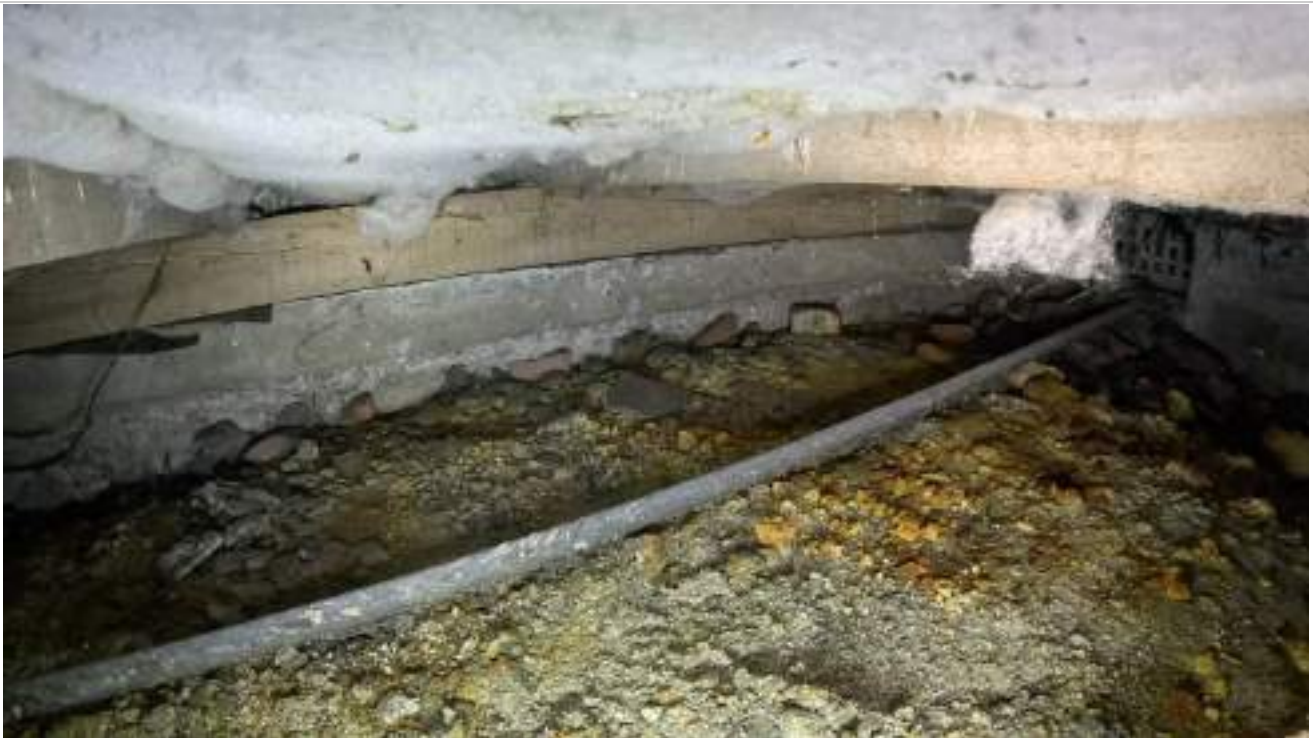
3: View of foundation.

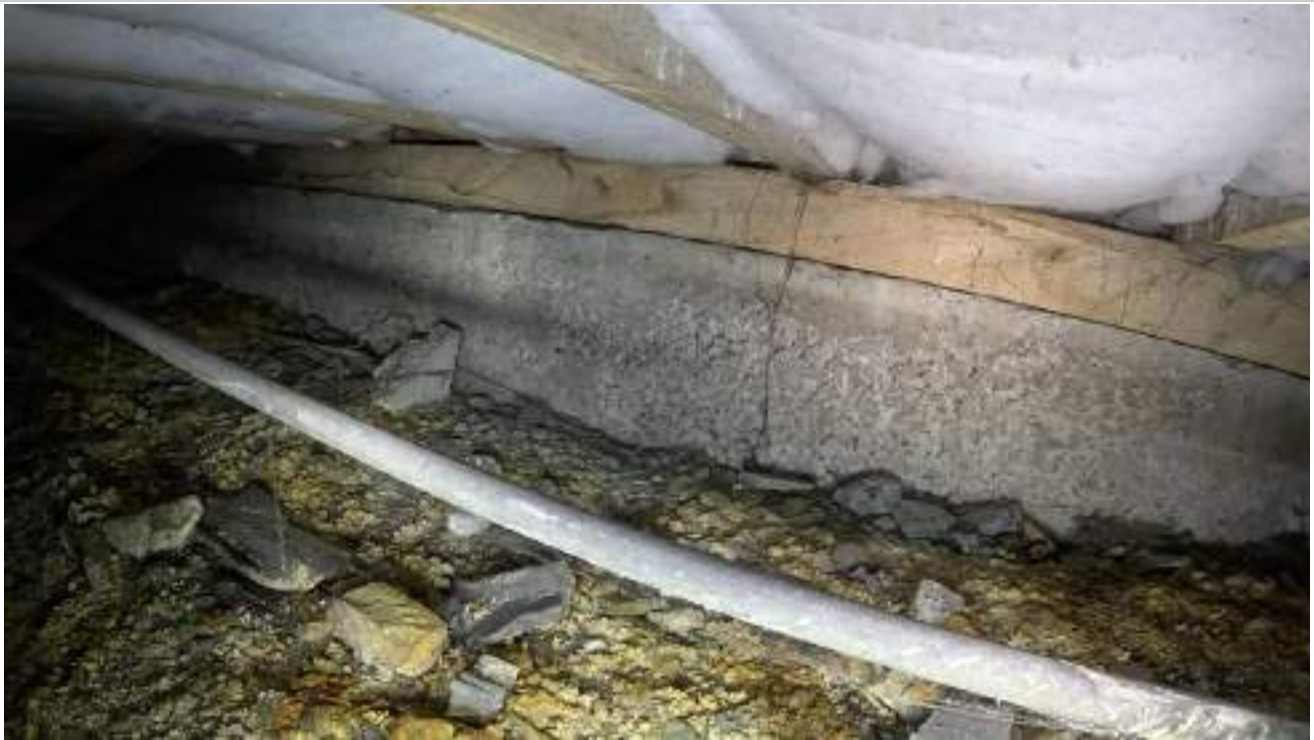
4: View along foundation with chimney breast to the left.

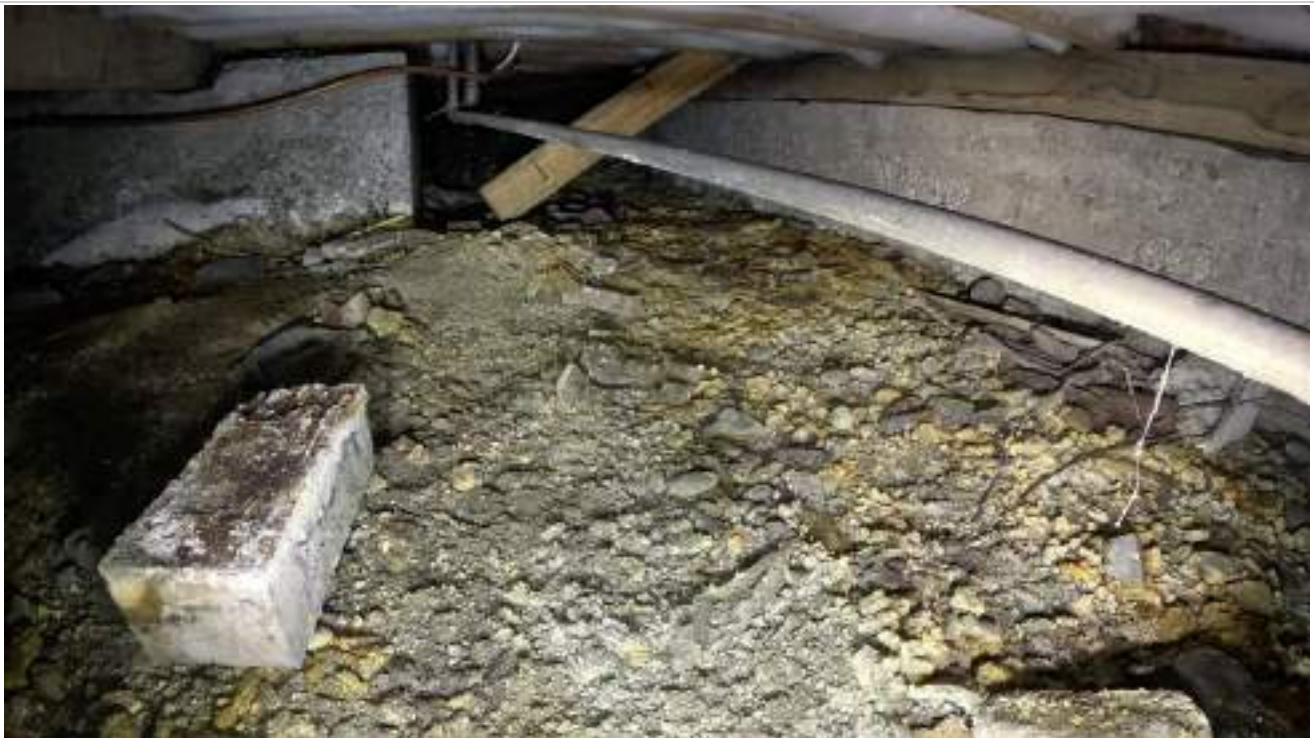
5: View of the chimney breast.

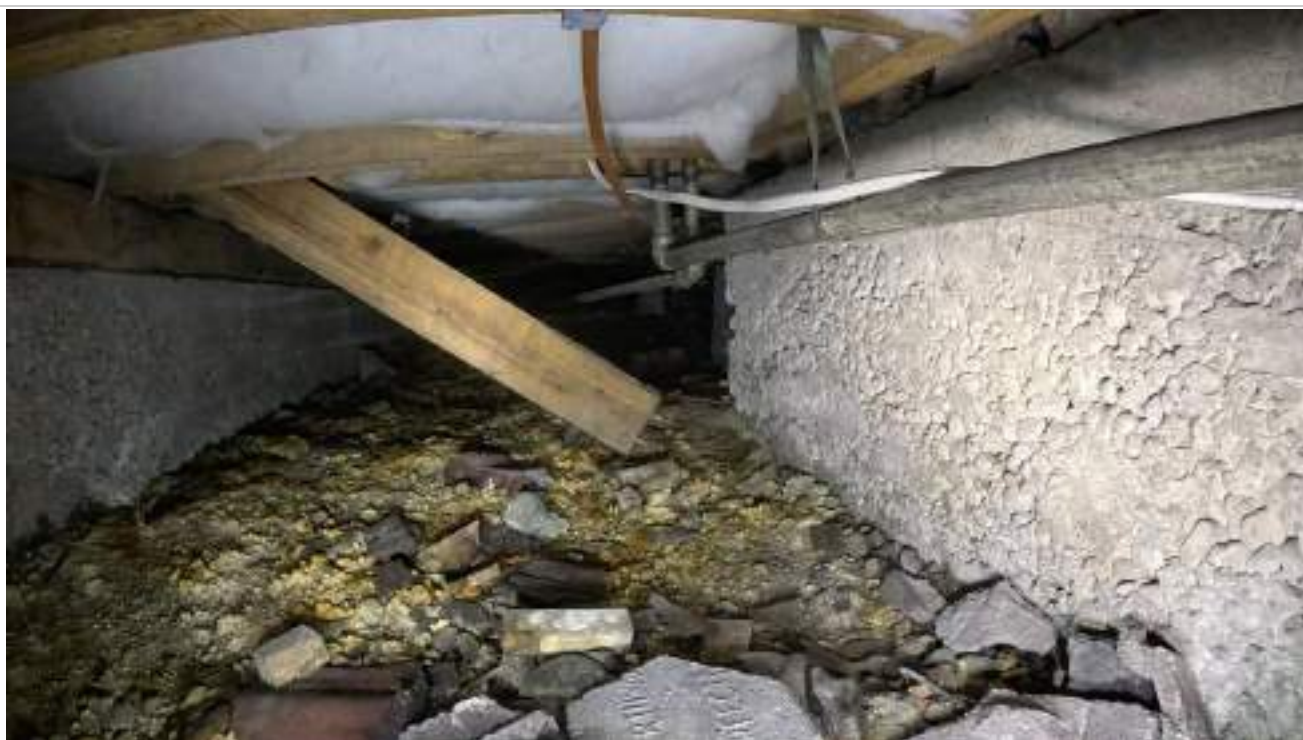
6: View of foundation.

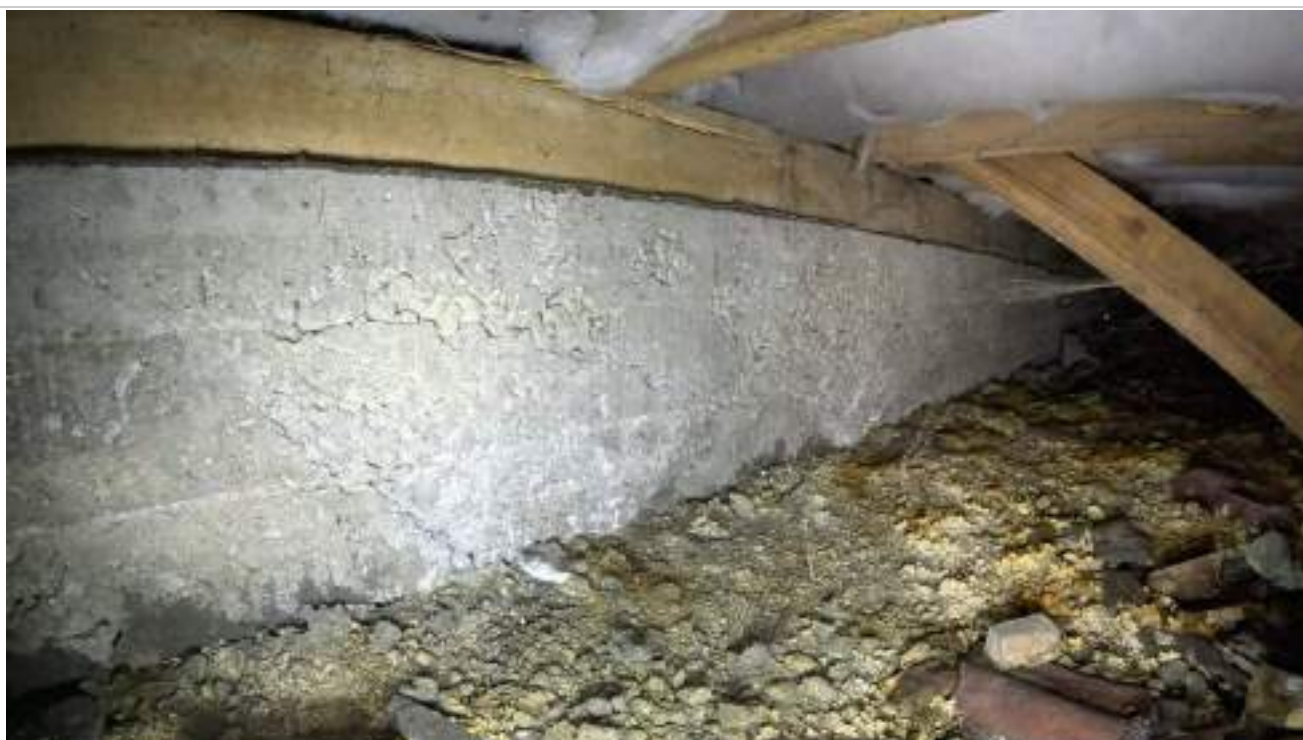
7: View of foundation.

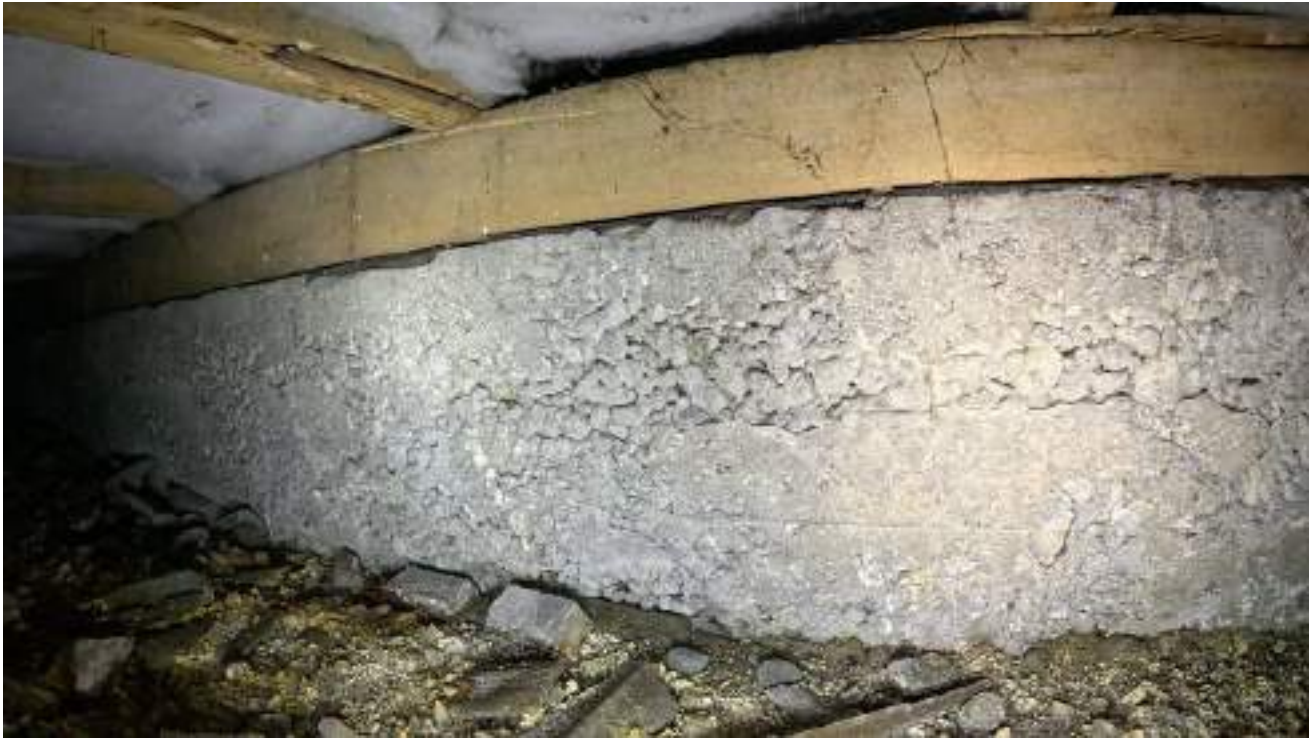
8: View of foundation.

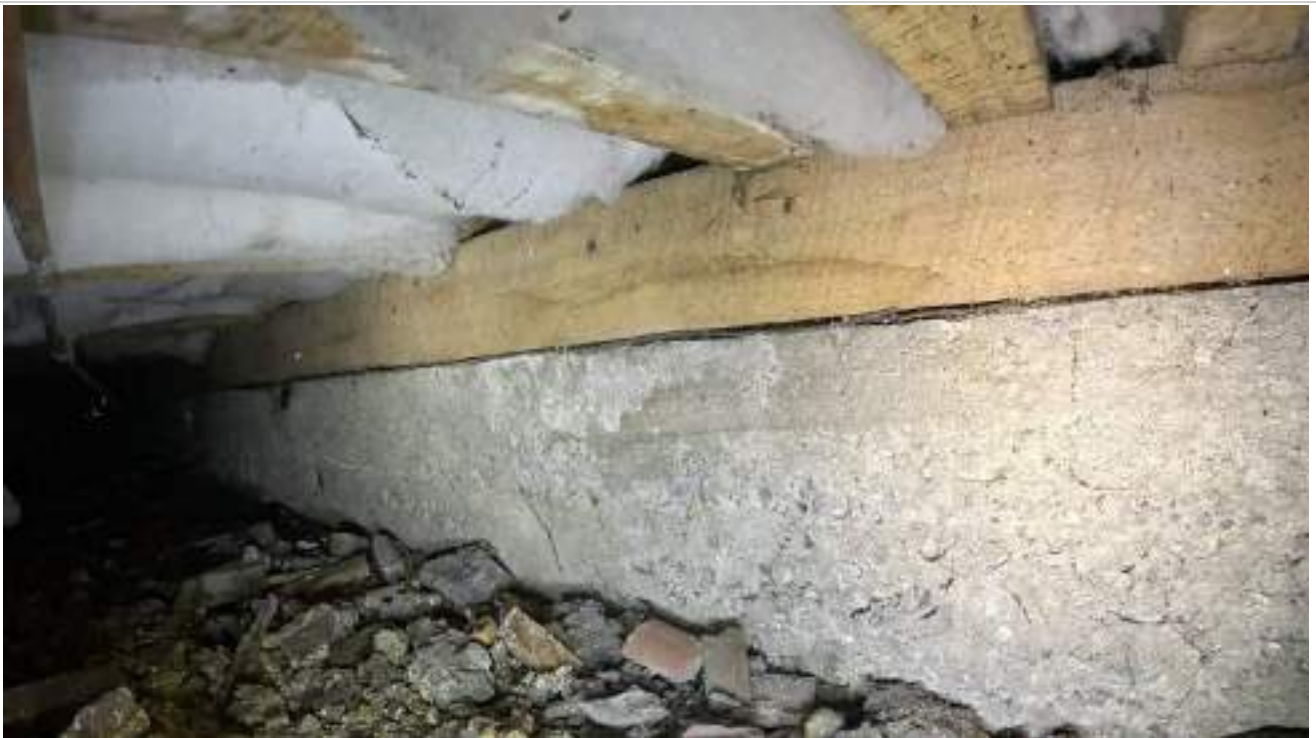
9: View along ring foundation and we can see a vent, but the foundation appears to finish before the vent.

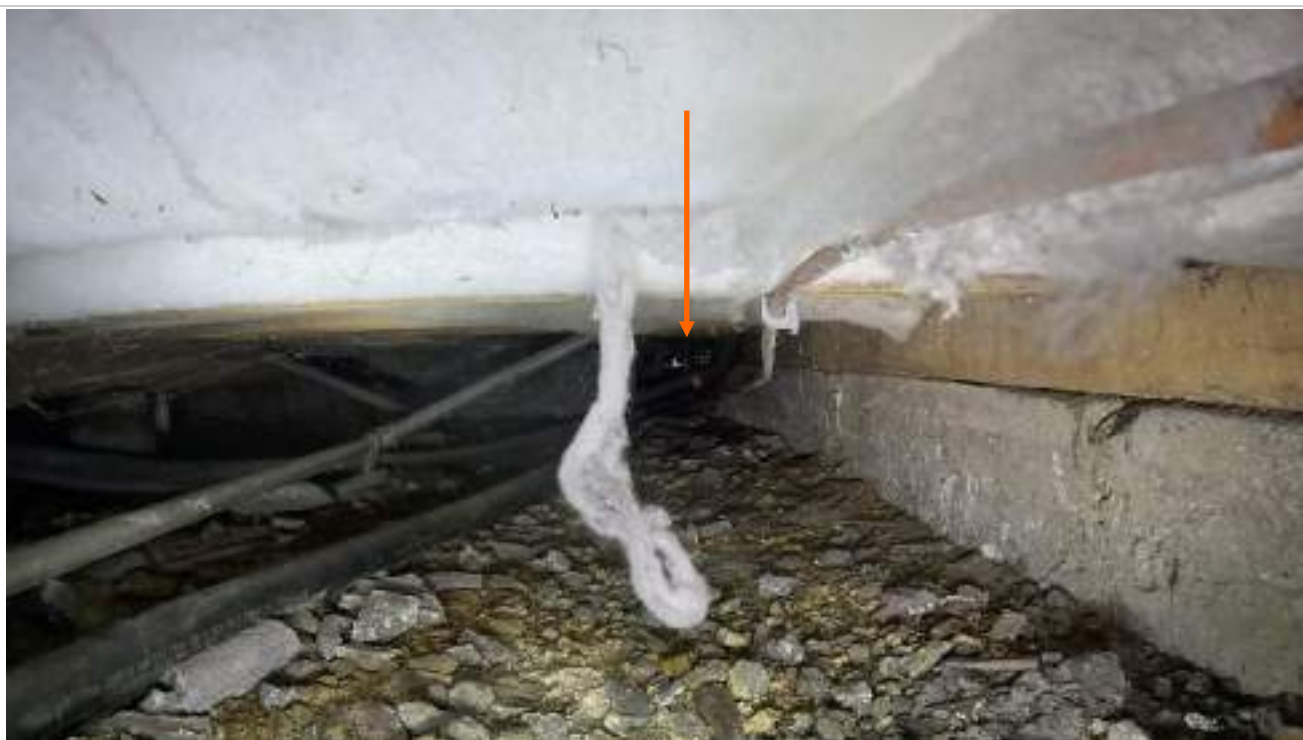
10: There appears to be a concrete base here.

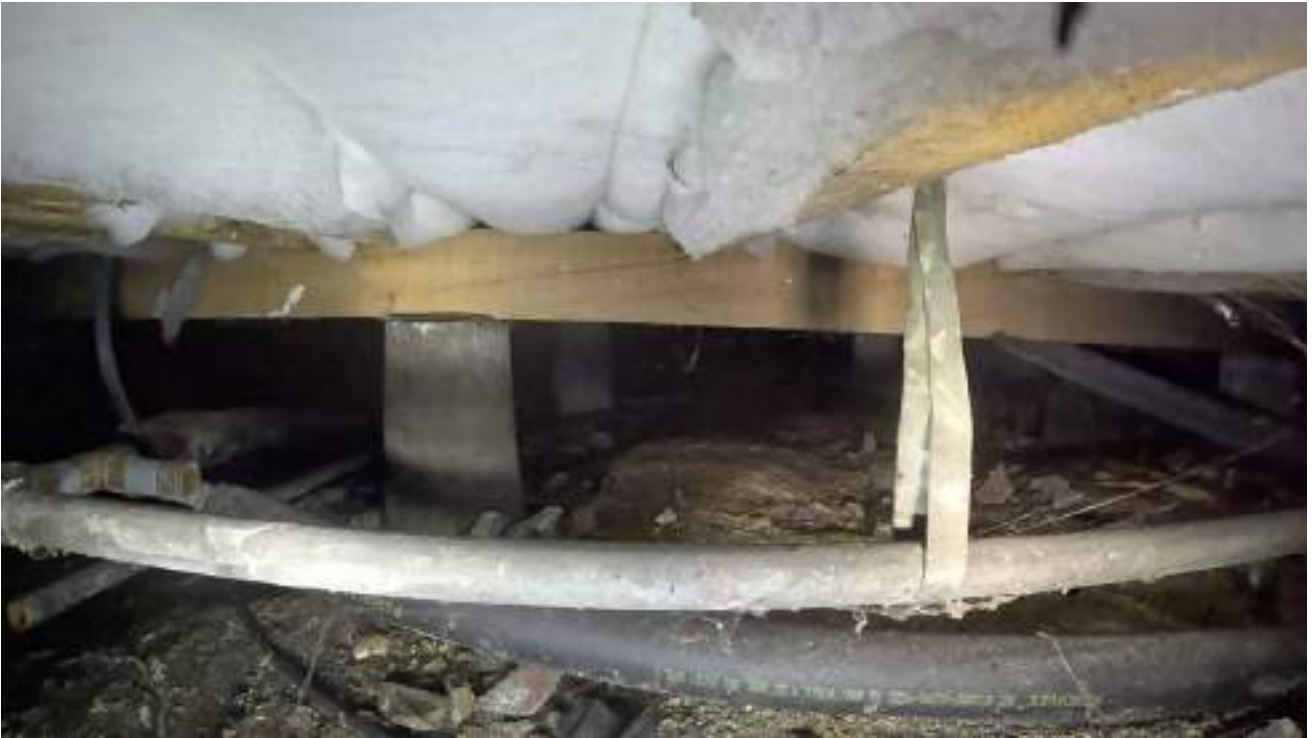
12: Precast concrete pile with no connection.

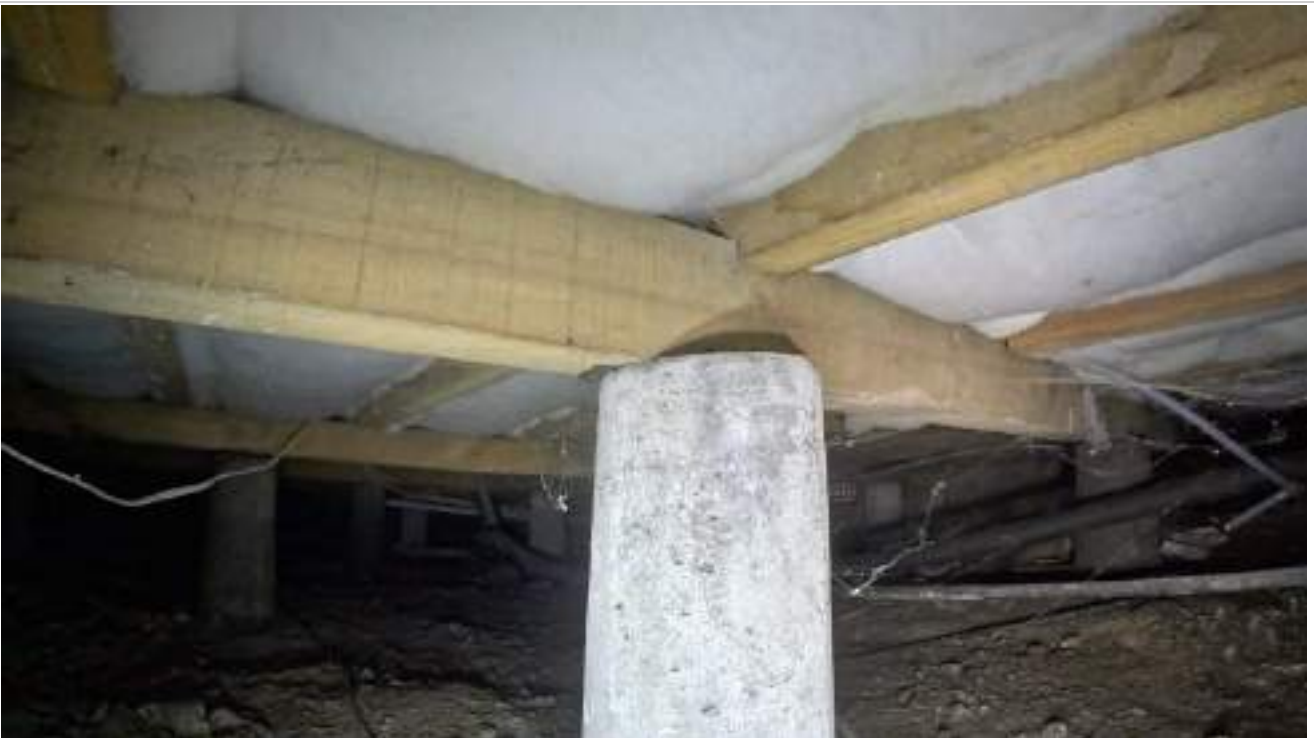
13: View of bearer meeting chimney breast. There are some non-compliant issues with the wiring seen in this home. They could also be a significant hazard to anybody operating under the floor. This relates specifically to unclipped wires. An electrical inspector could be consulted regarding this.

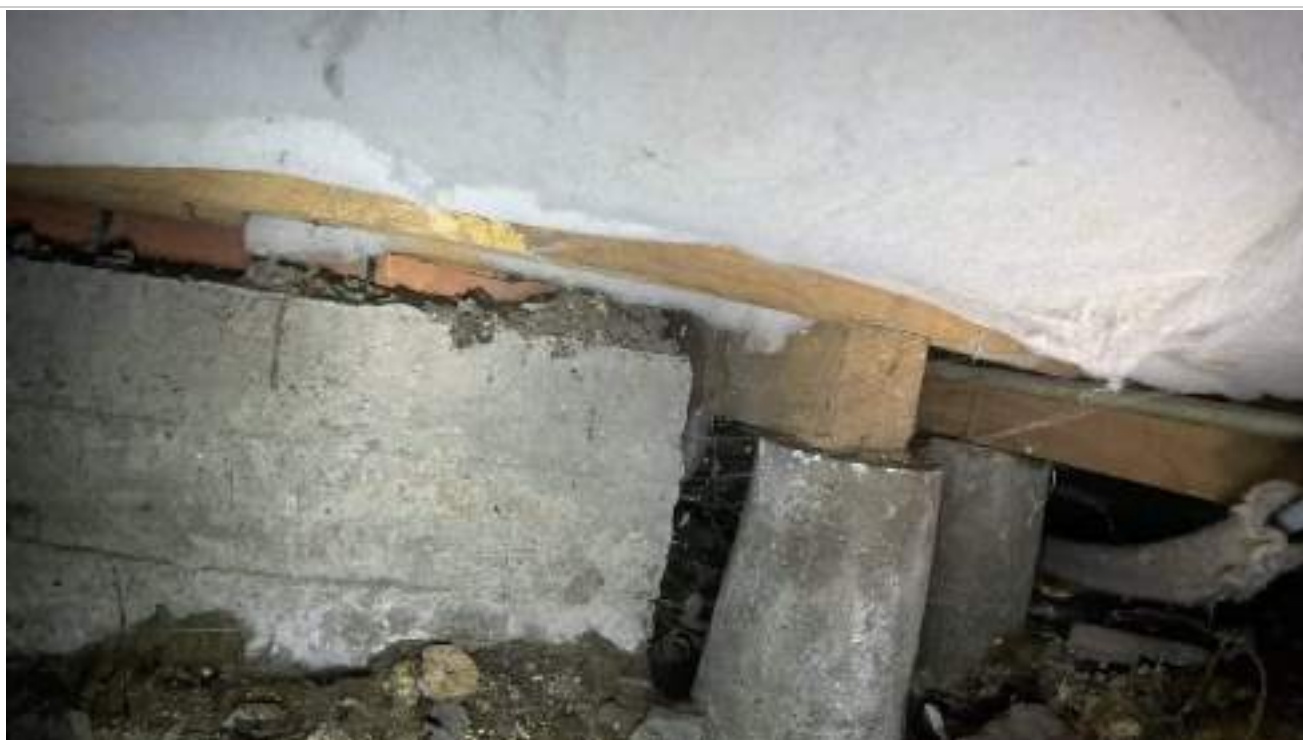
15: Precast concrete pile with no connection.

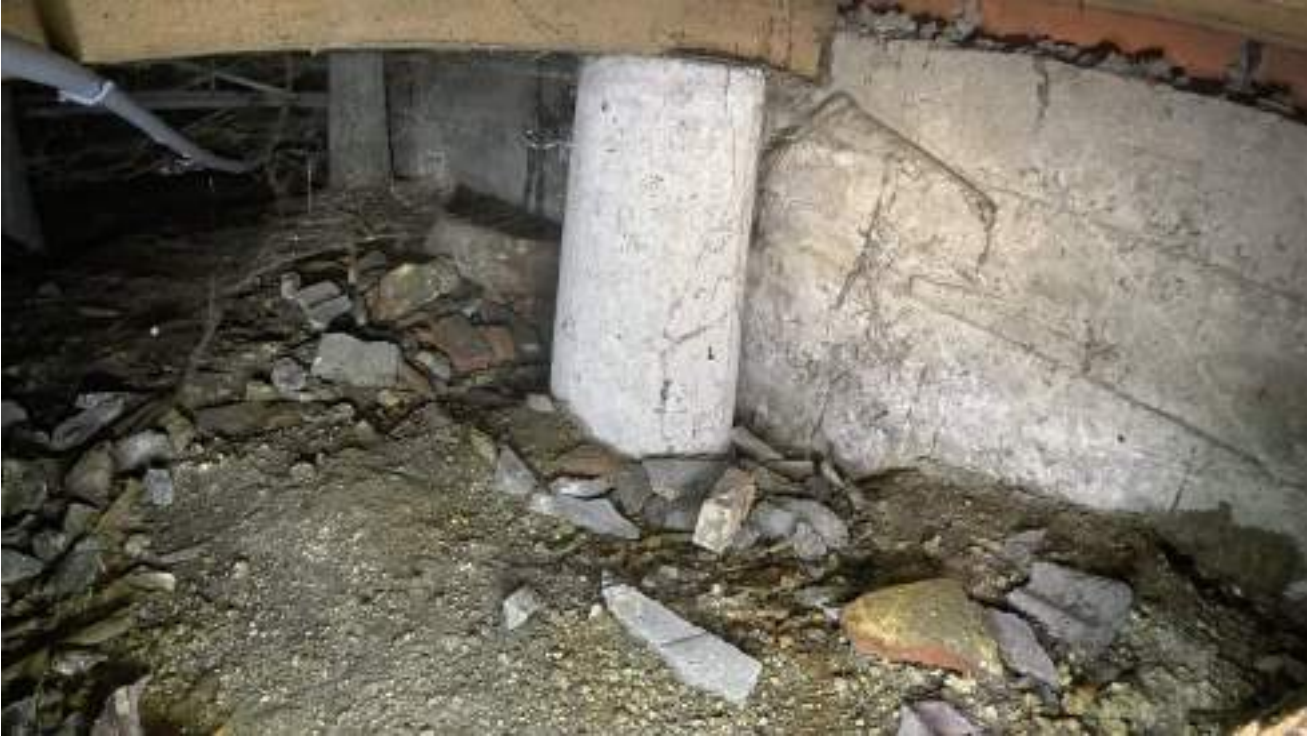
16: Precast concrete pile with no connection.

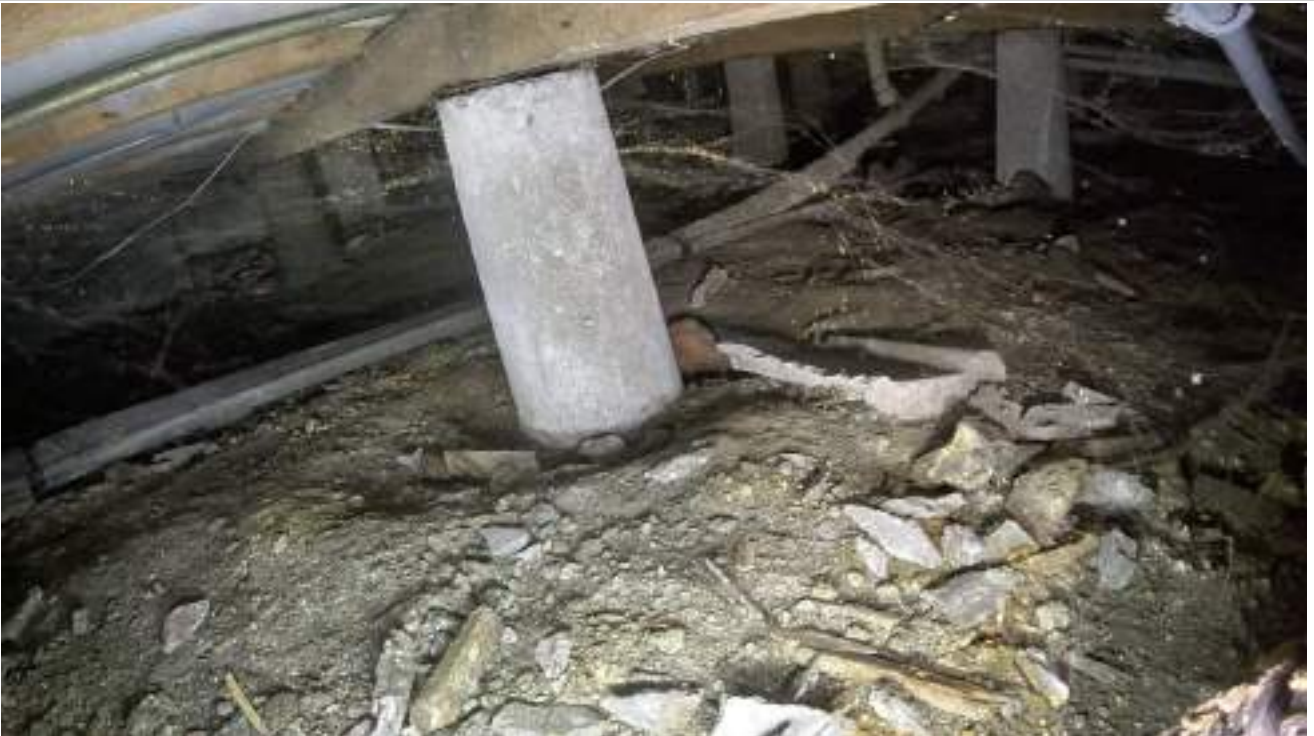
17: View of foundation with what may be a crack.

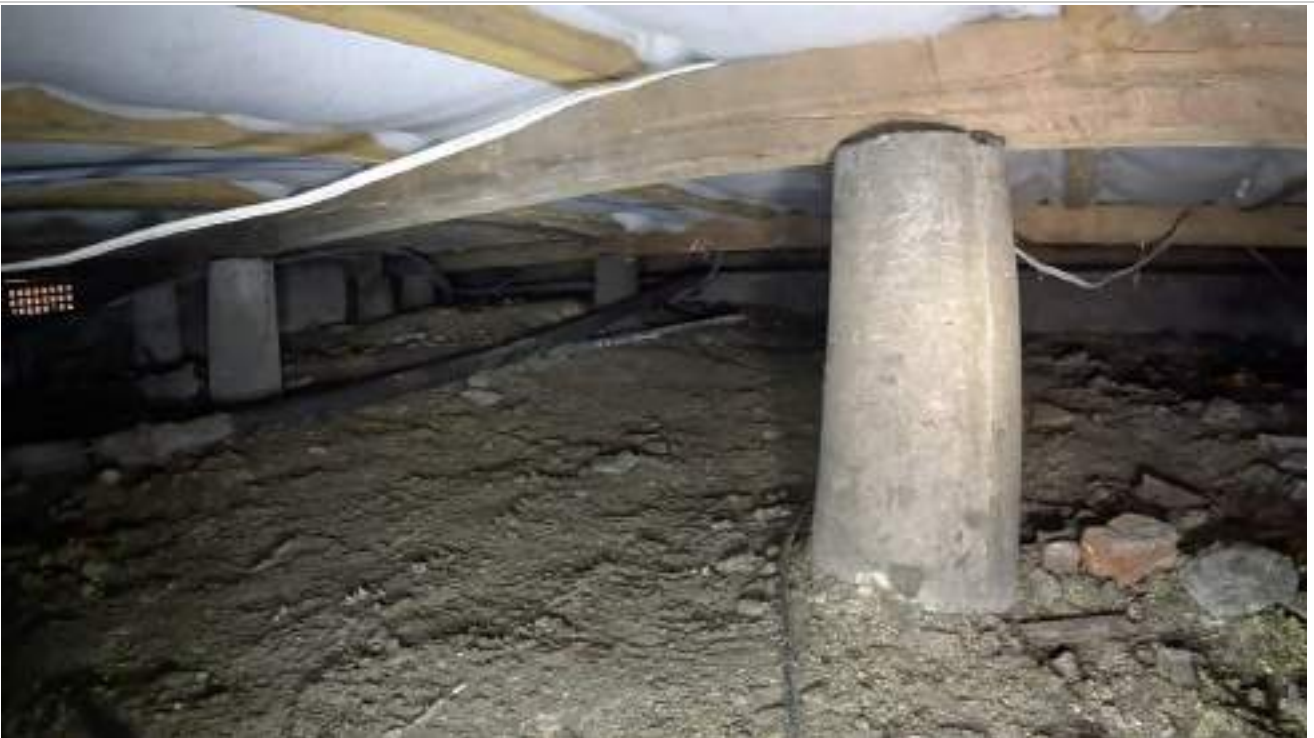
19: View of bearer meeting chimney breast.
