# EARTHQUAKE REPAIR

## 425 & 427 ARMAGH STREET

**IN RESPECT OF:** Structural Design of Foundation Repair for 425 & 427, Internal Alterations at Nr. 425 only  
(Description of Building Work)

## TR001: Technical Report – Desktop Technical Review & Structural Inspection

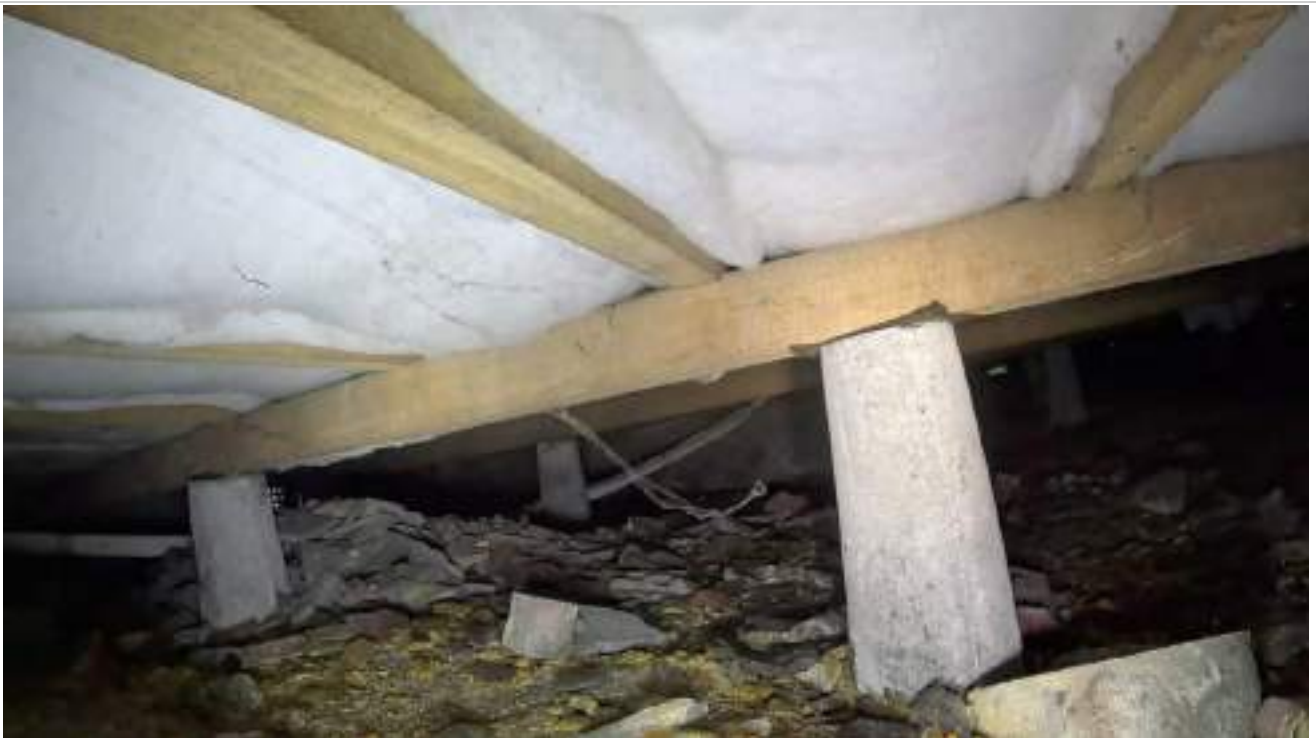
23: Precast concrete pile with no connection. There are several large piles of tile rubbish as seen here.

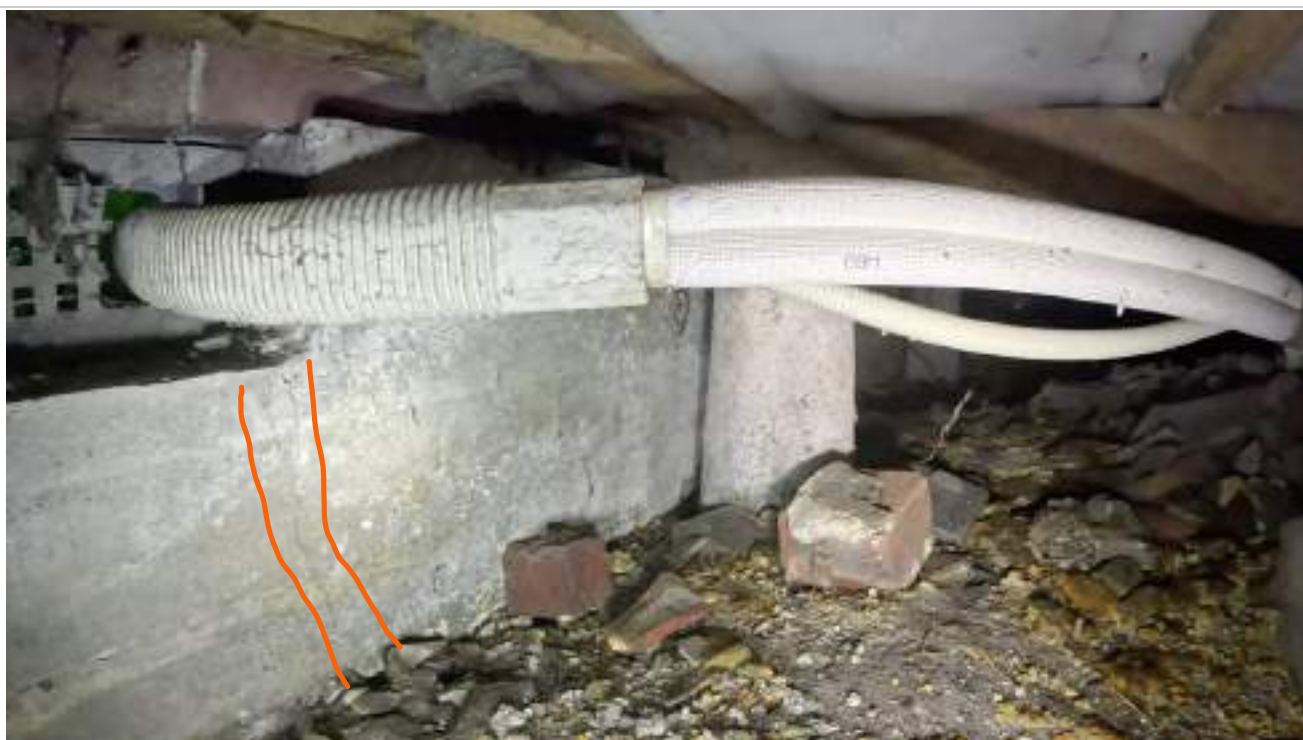
25: Precast concrete pile with no connection.

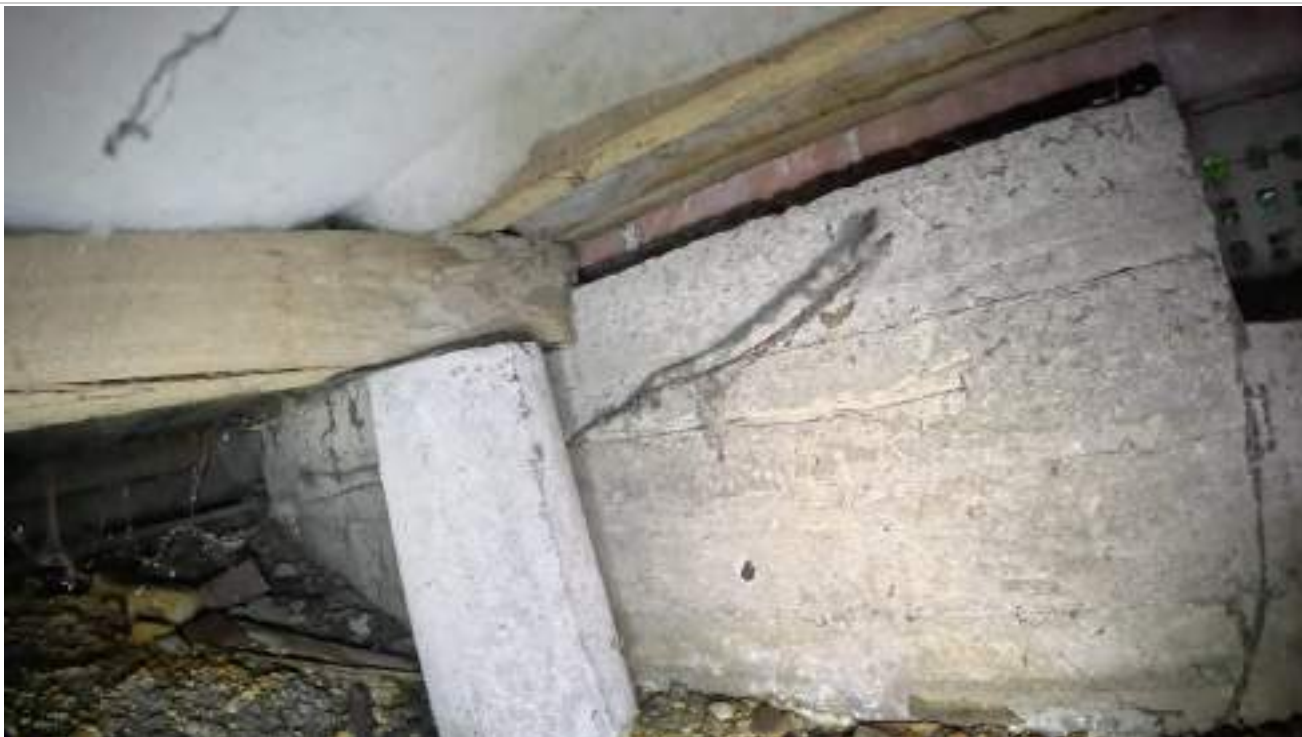
26: Precast concrete pile with no connection.

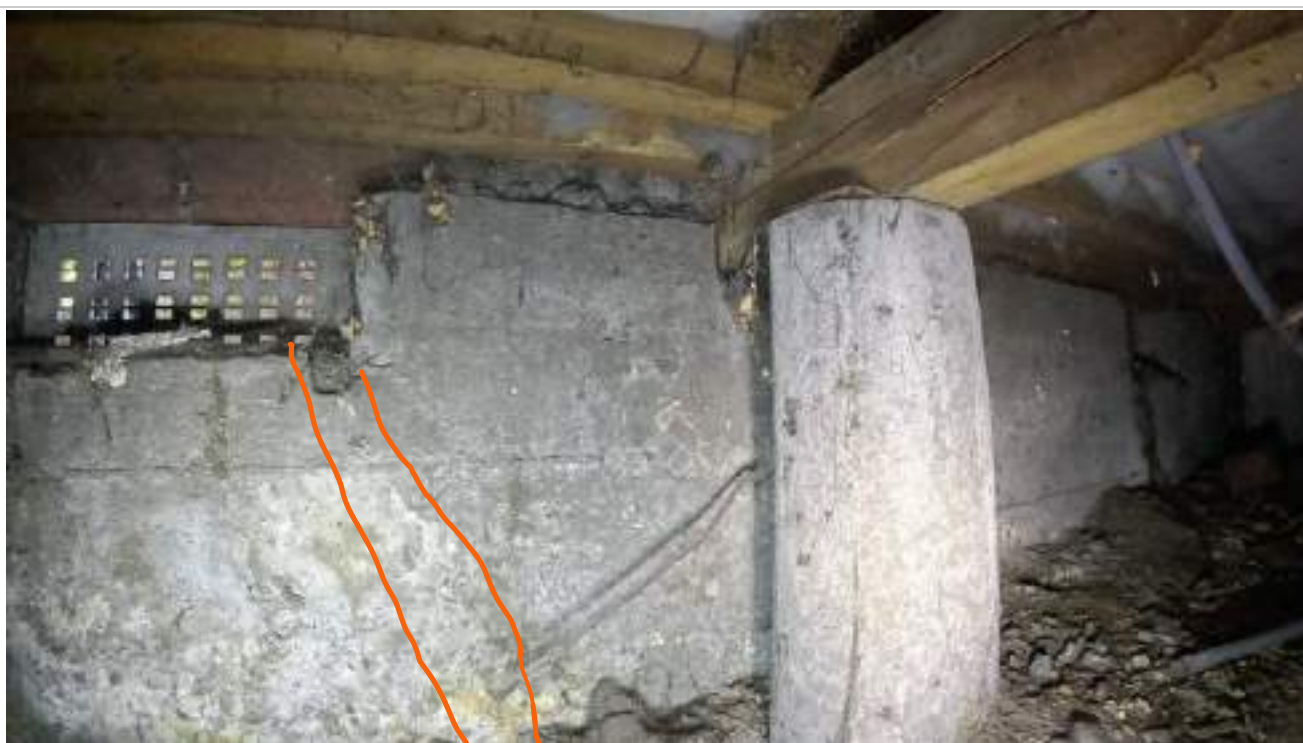
29: Precast concrete pile with no connection.

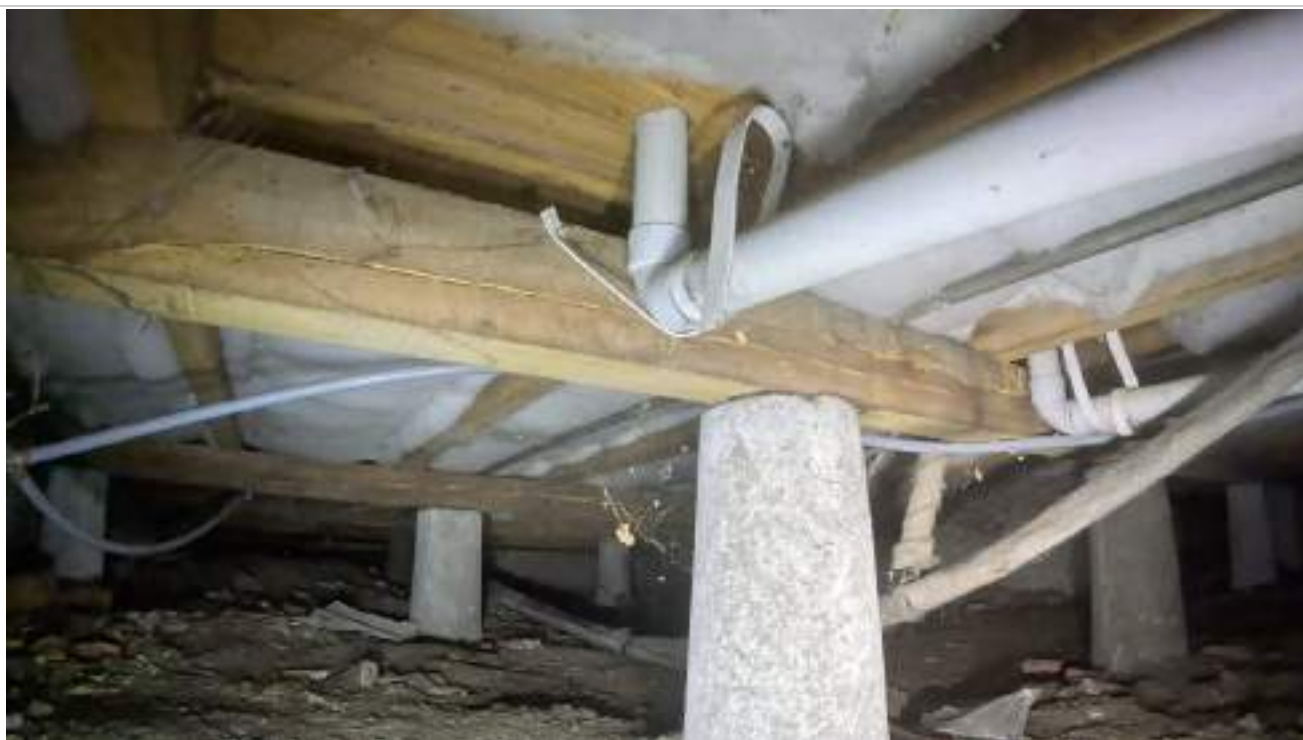
30: Precast concrete pile with no connection.

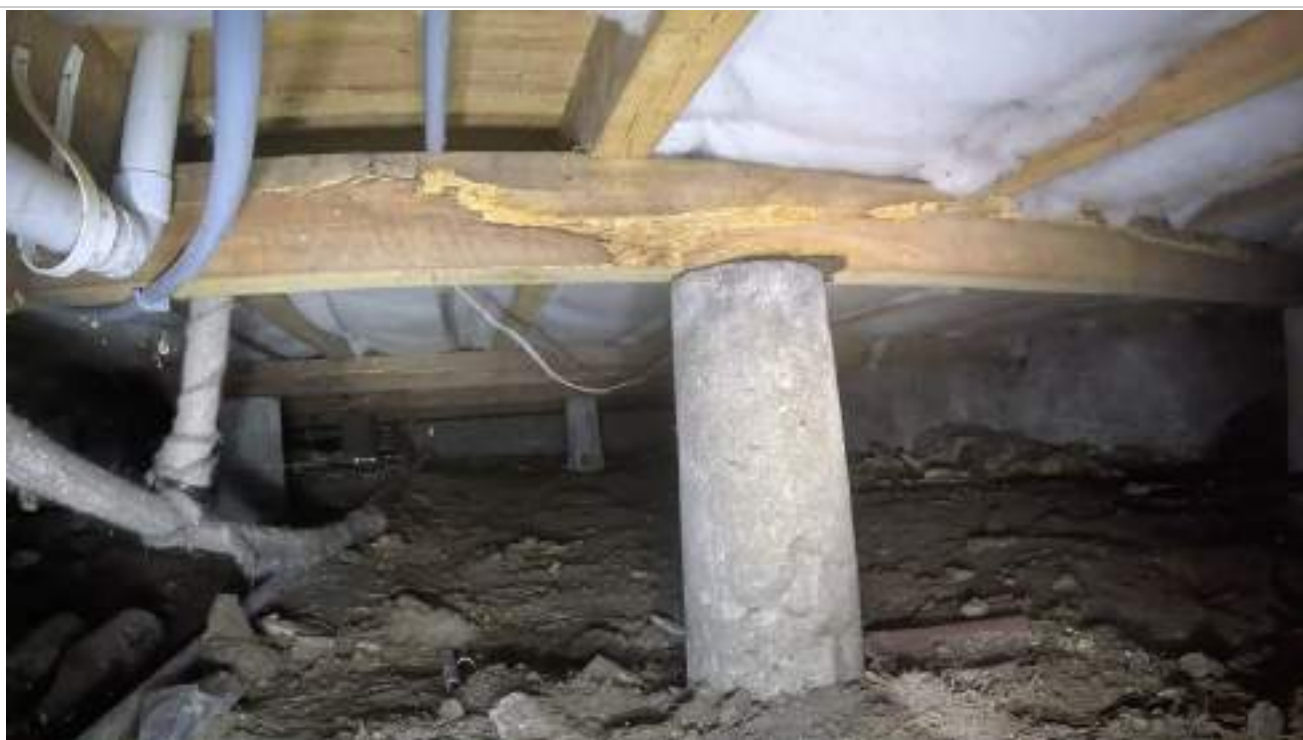
31: Precast concrete pile with no connection.

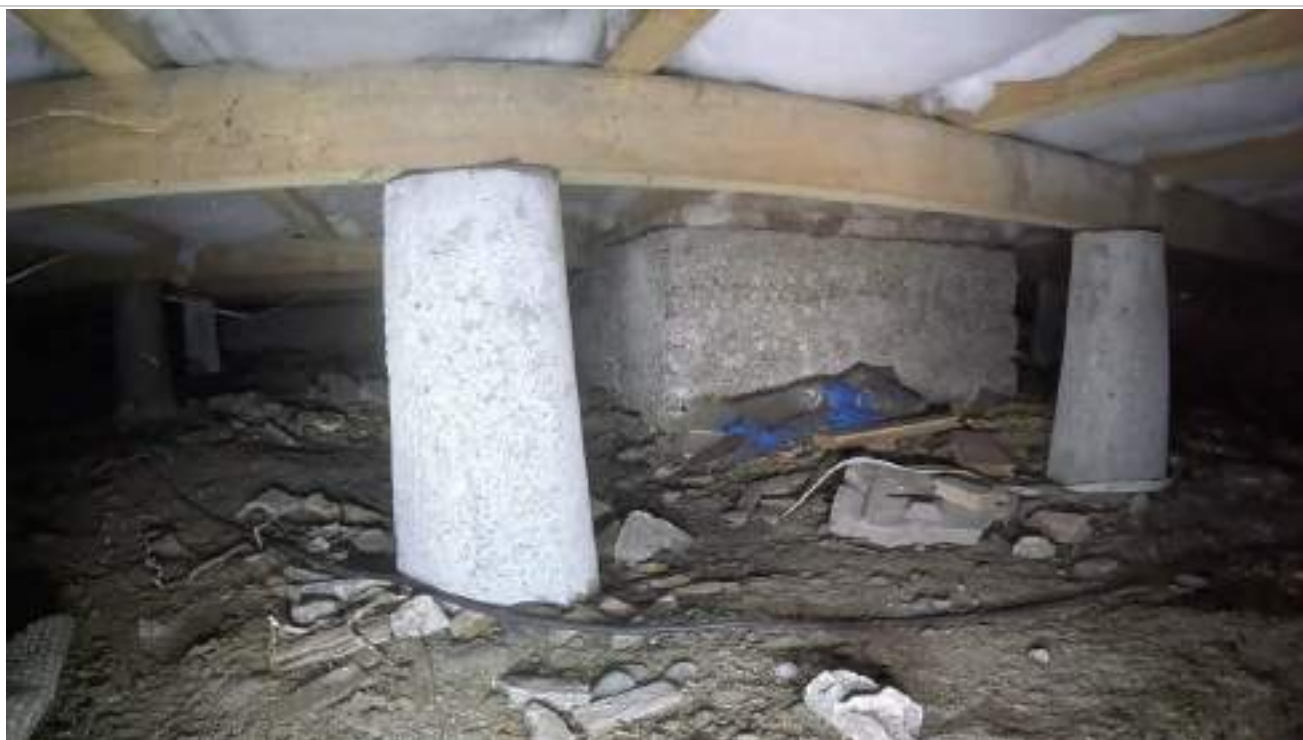
32: Precast concrete pile with no connection.

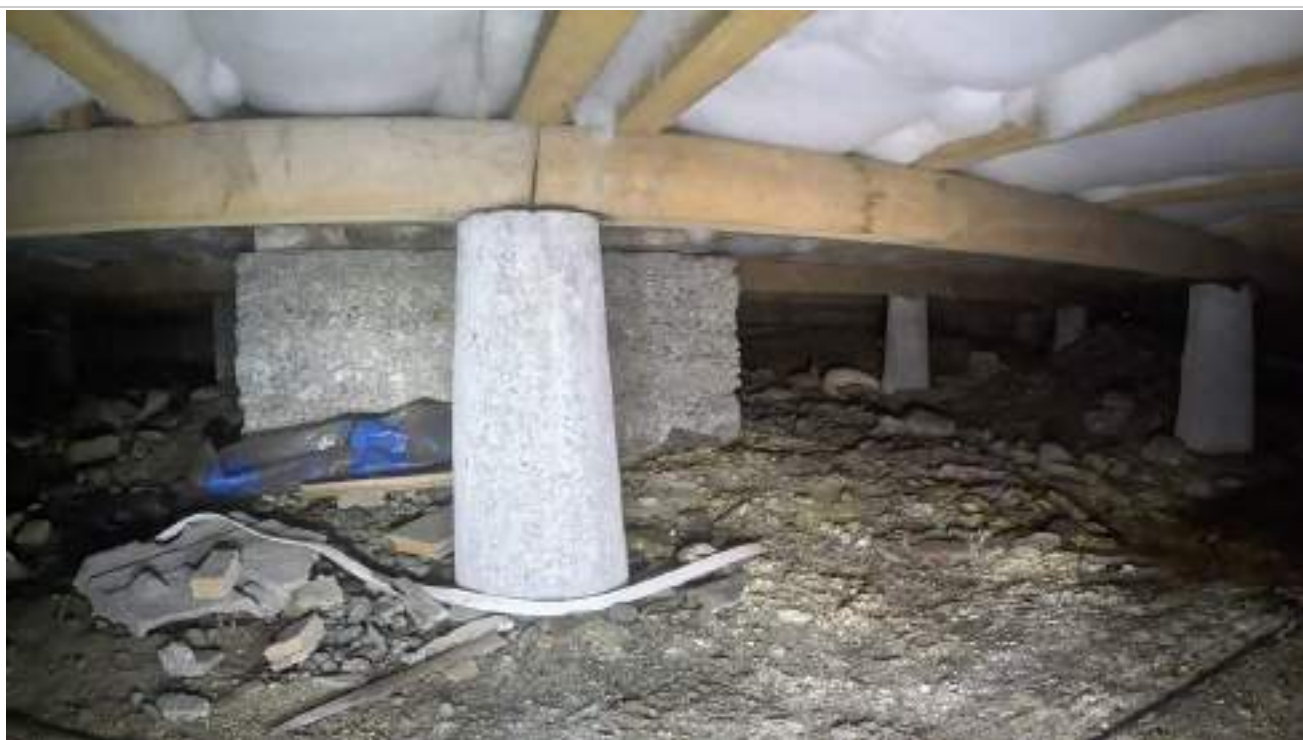
33: Precast concrete pile with no connection.

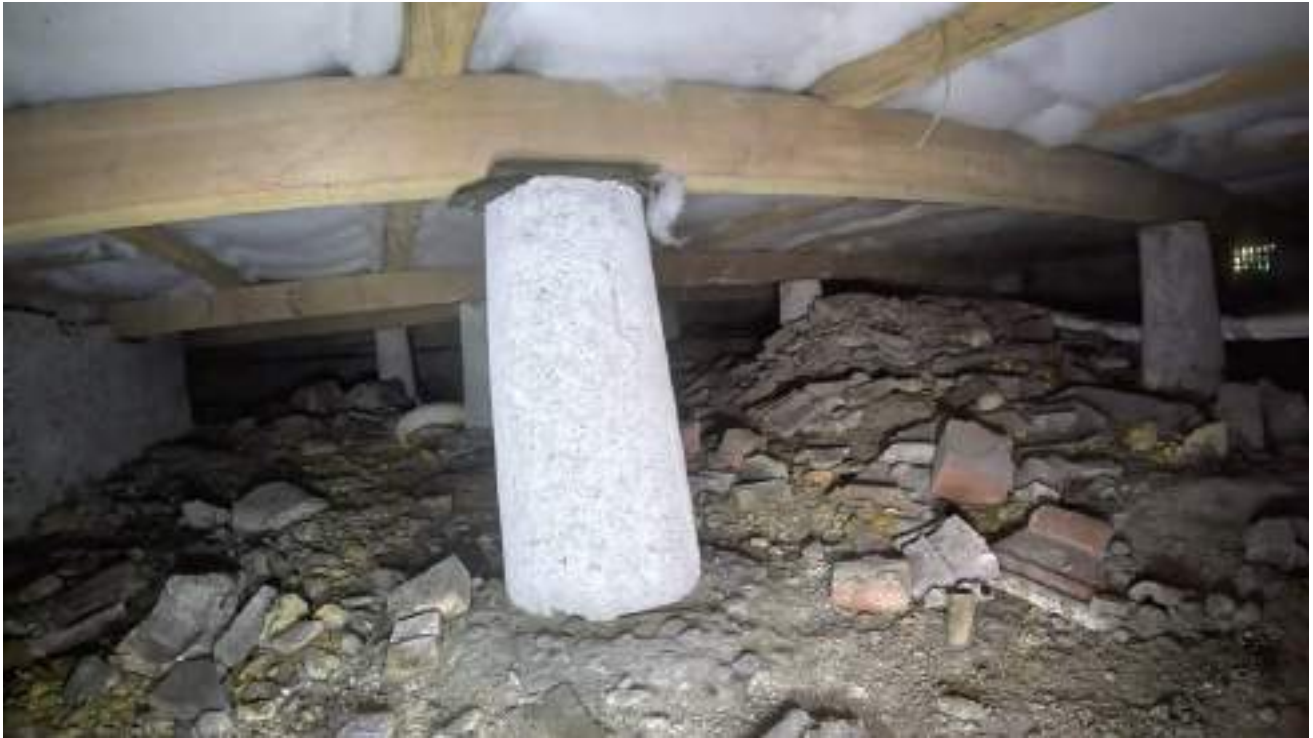
34: Precast concrete pile with no connection. I would note that the heat pump drain is wrapped in these wires which go up to exit the subfloor, meaning the drain would be ineffective.

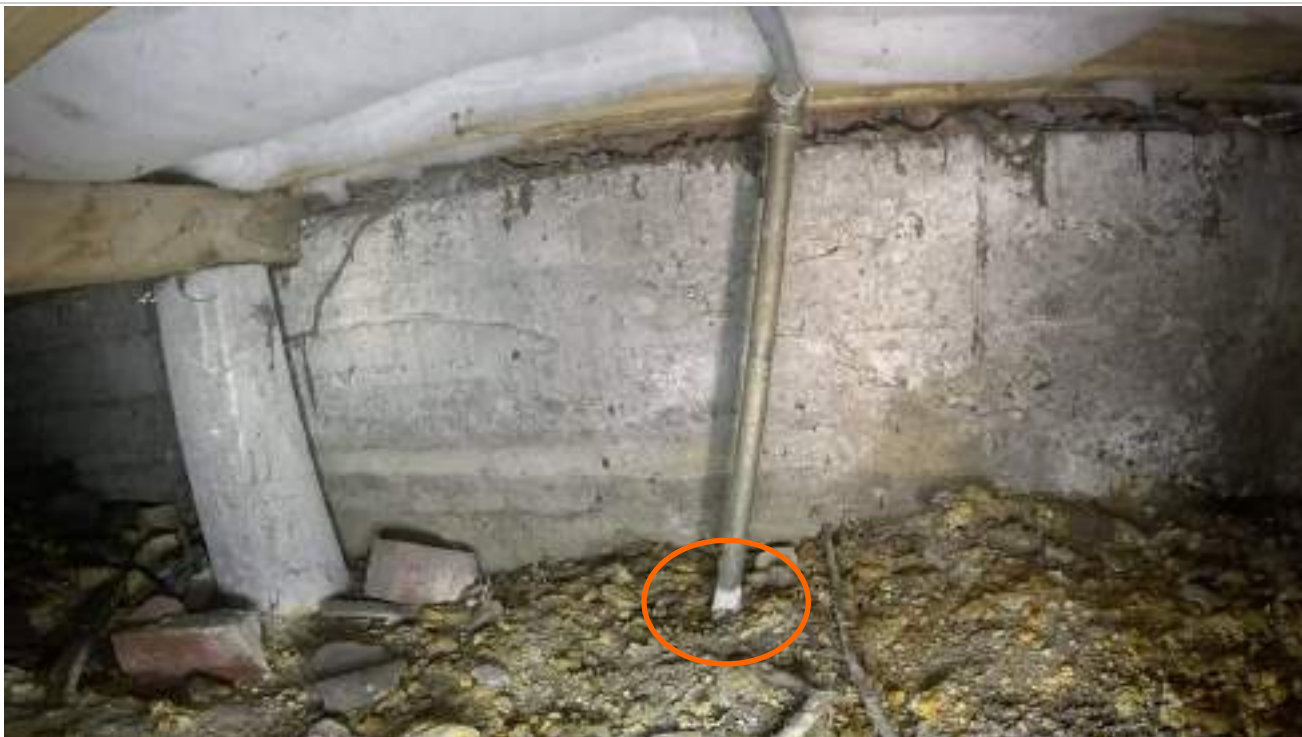
35: View of ring foundation with main water pipe into the home and there are indications that the pipe is heavily corroded in ground and may be either leaking, or close to leaking.

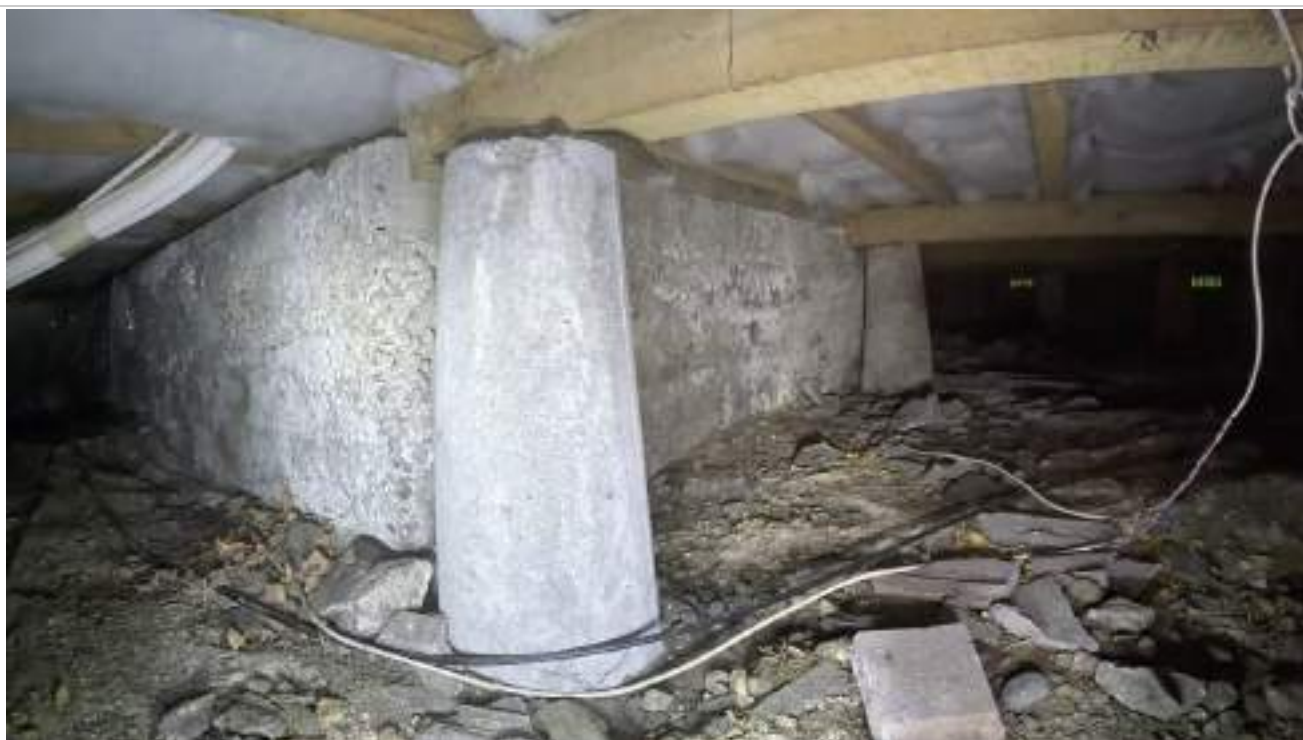
38: Precast concrete pile with no connection. The communication cable has not been laid in a compliant manner and would easily be damaged by people accessing the subfloor.

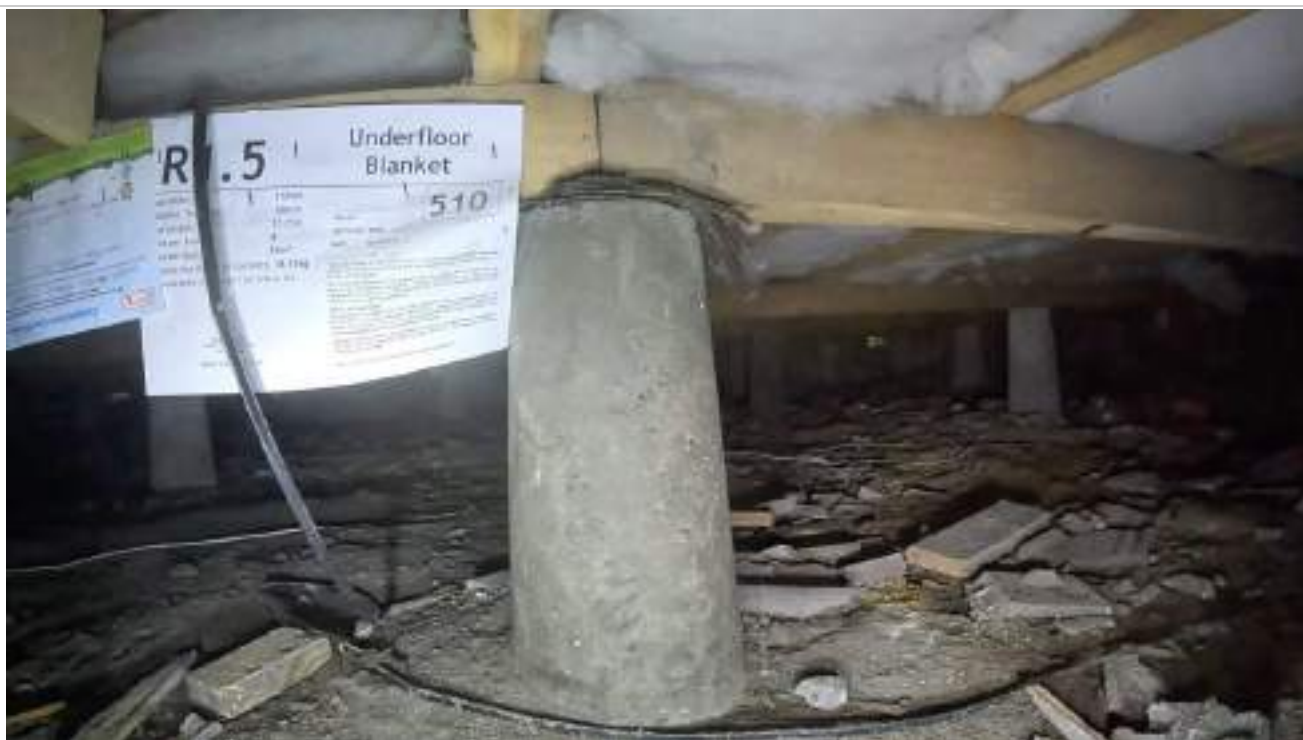
40: Precast concrete pile with no connection.

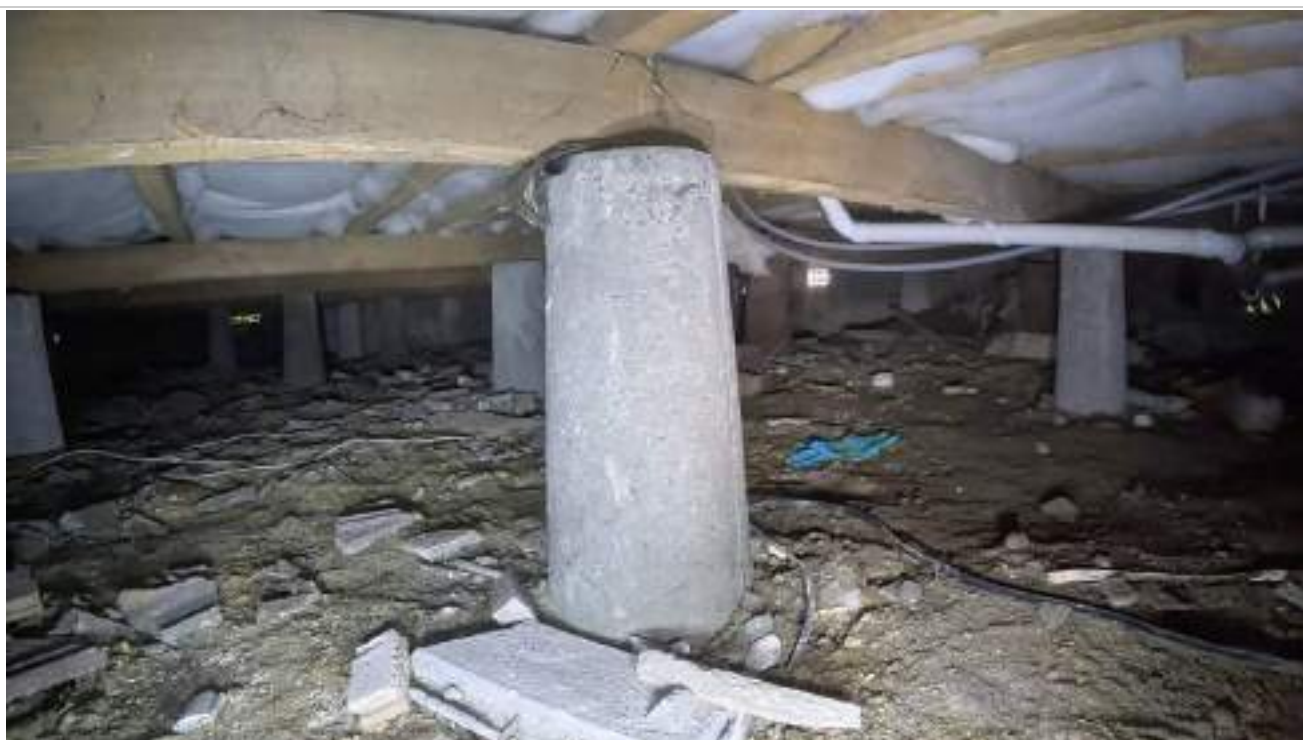
41: Precast concrete pile with no connection.

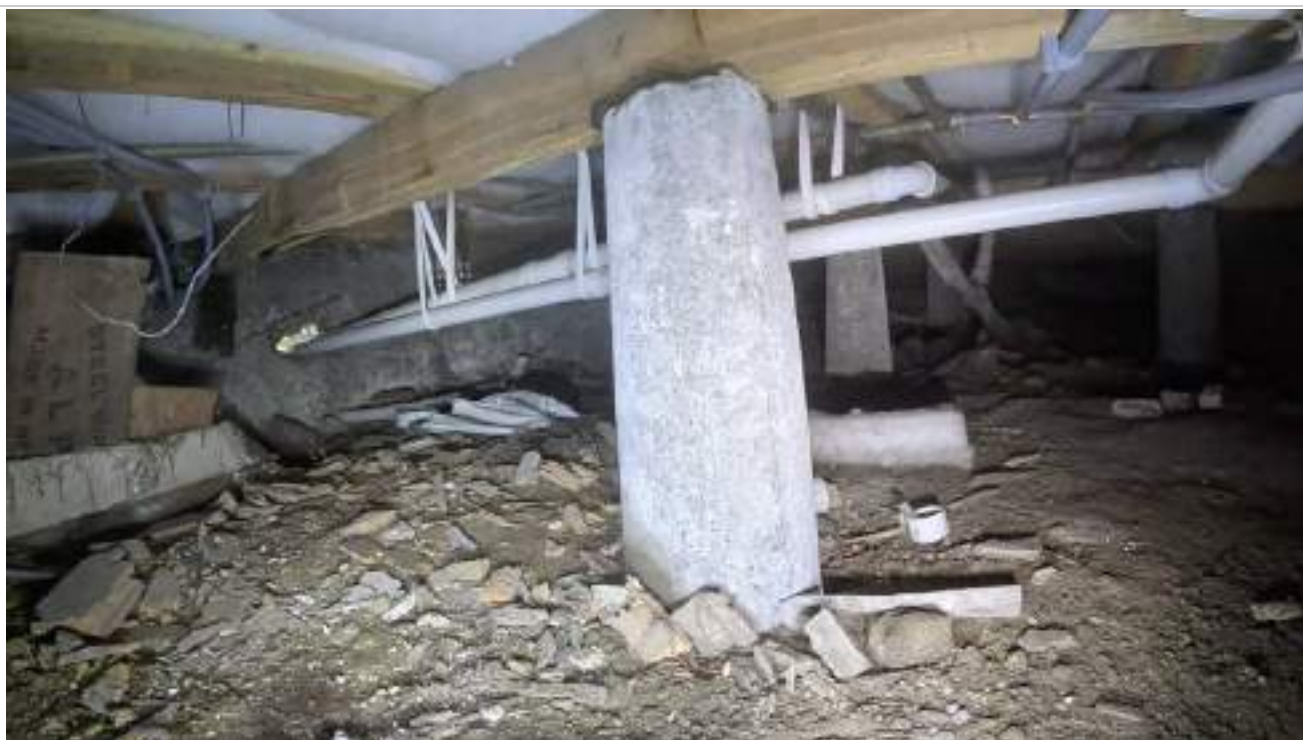
42: View of toilet stump. The taller these are the more likely it is that they will snap at ground level. Evidence of this can usually be seen as dampness on the ground around the stump. This is not evident here but as the sewage pipes away from here are clay, it would be a good idea to check these.

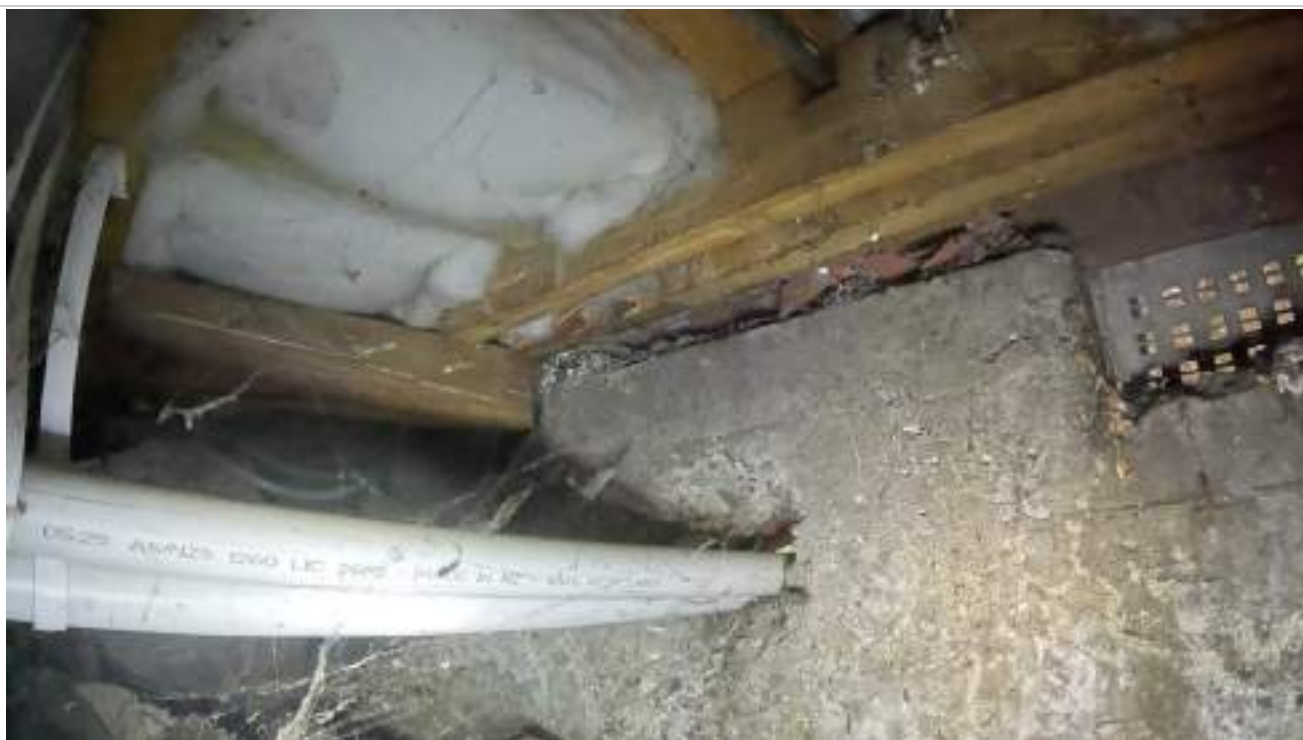
44: Precast concrete pile with no connection.

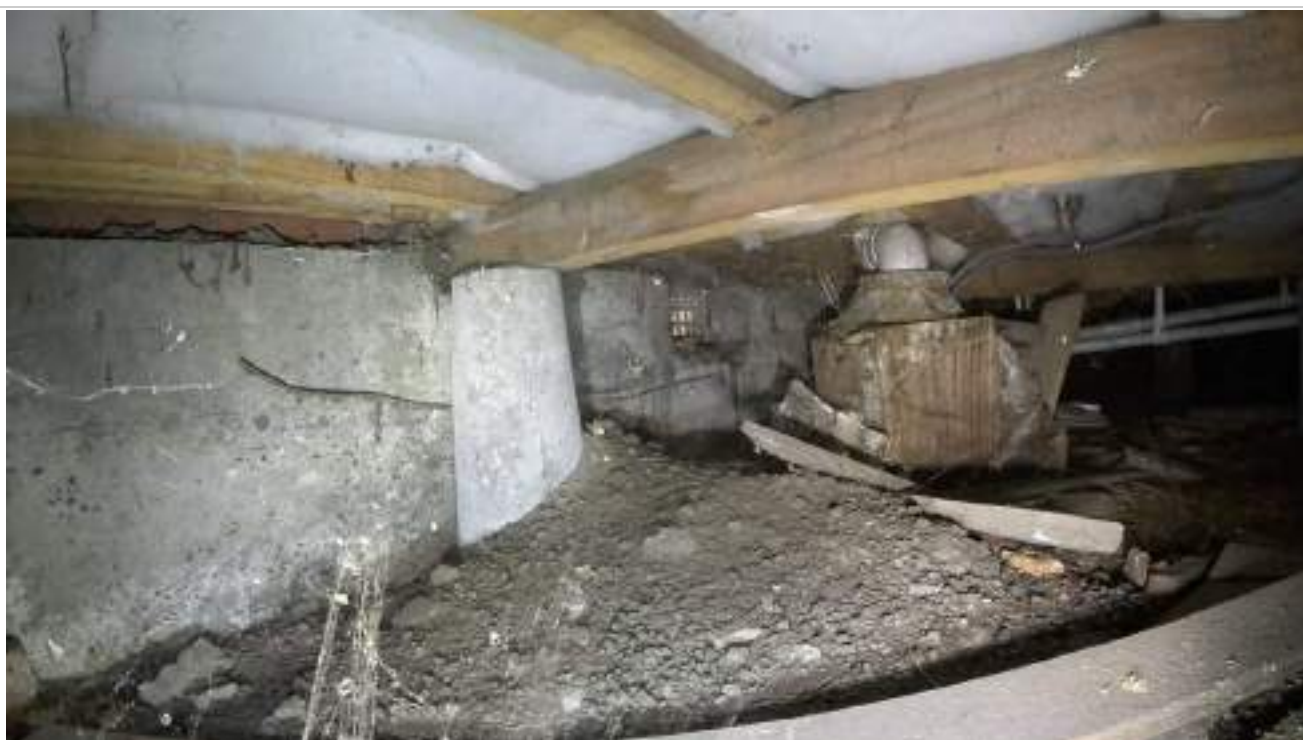
45: Precast concrete pile with no connection.

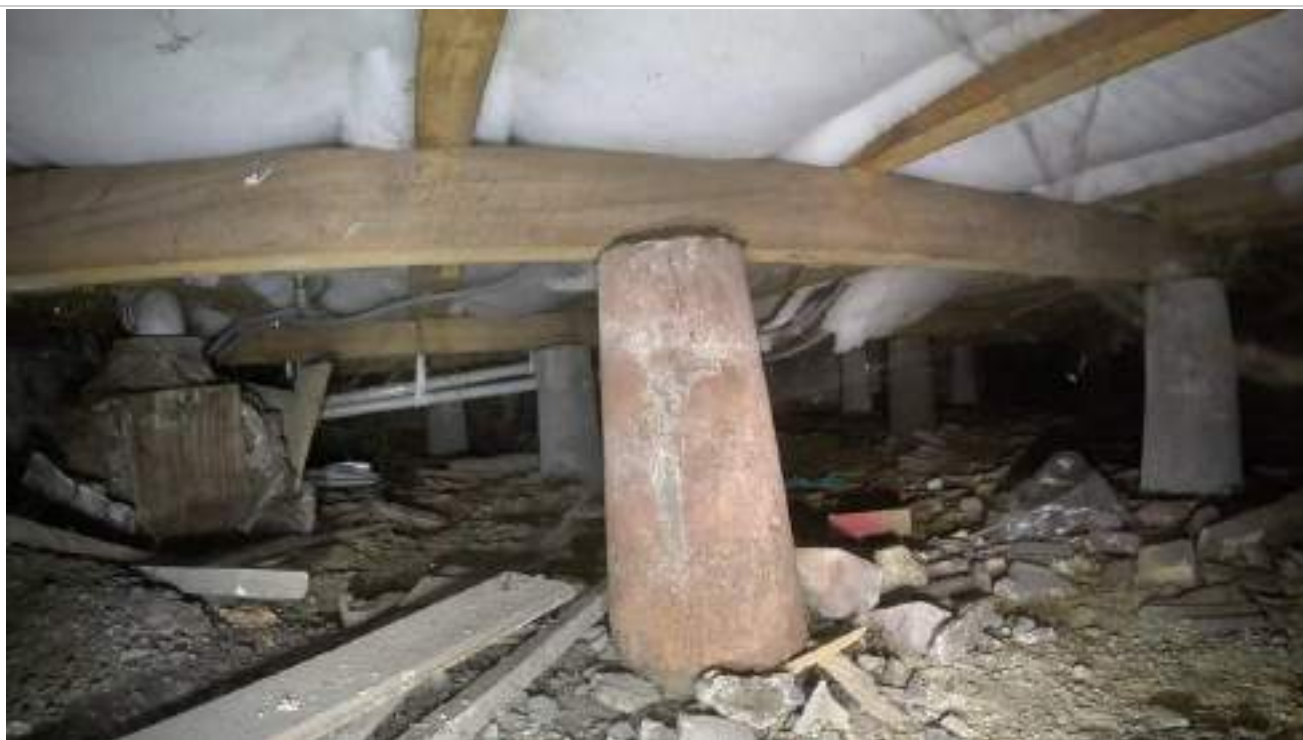
46: Precast concrete pile with no connection.

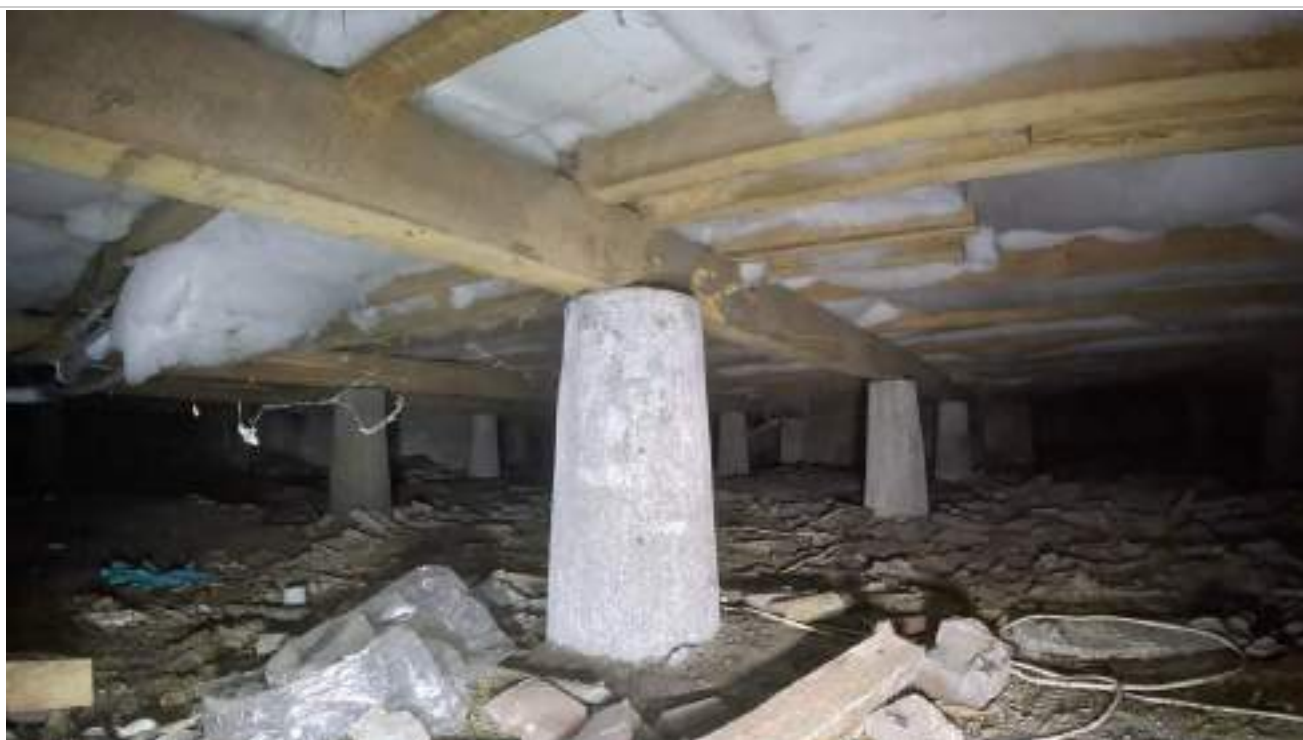
47: Precast concrete pile with no connection.

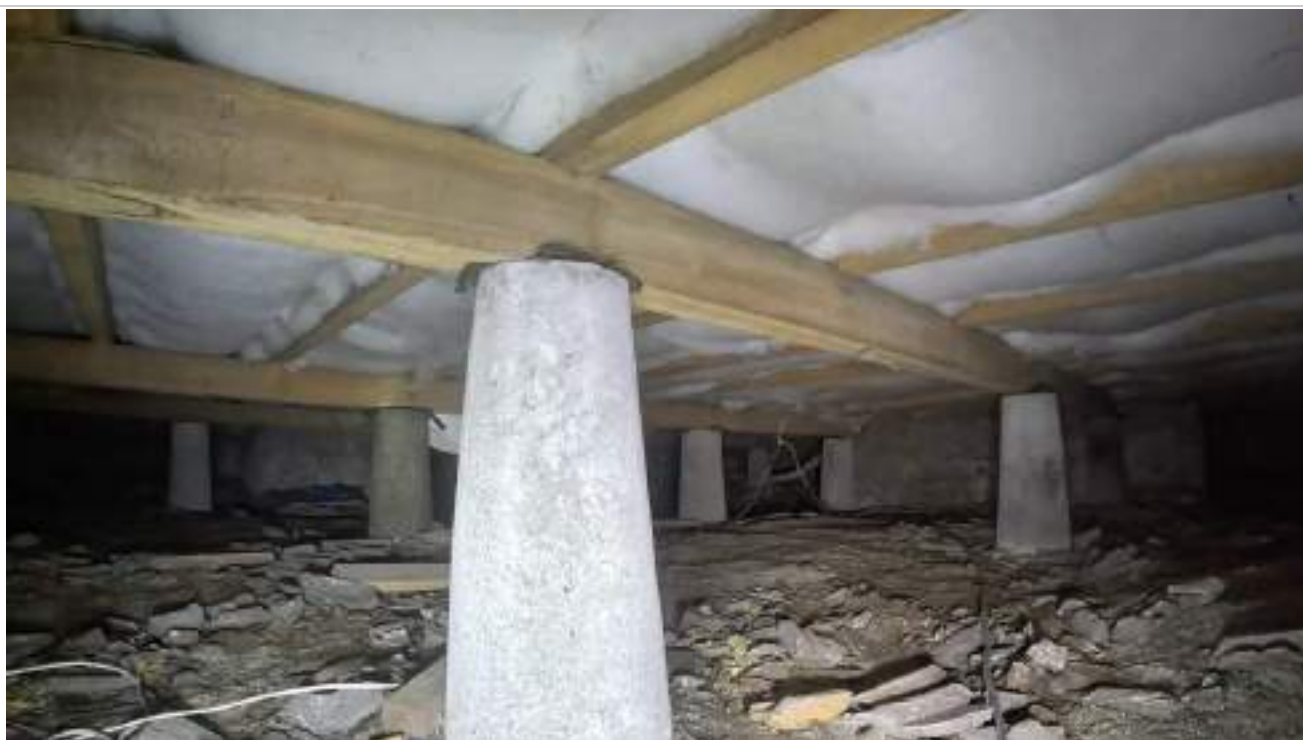
48: Precast concrete pile with no connection.

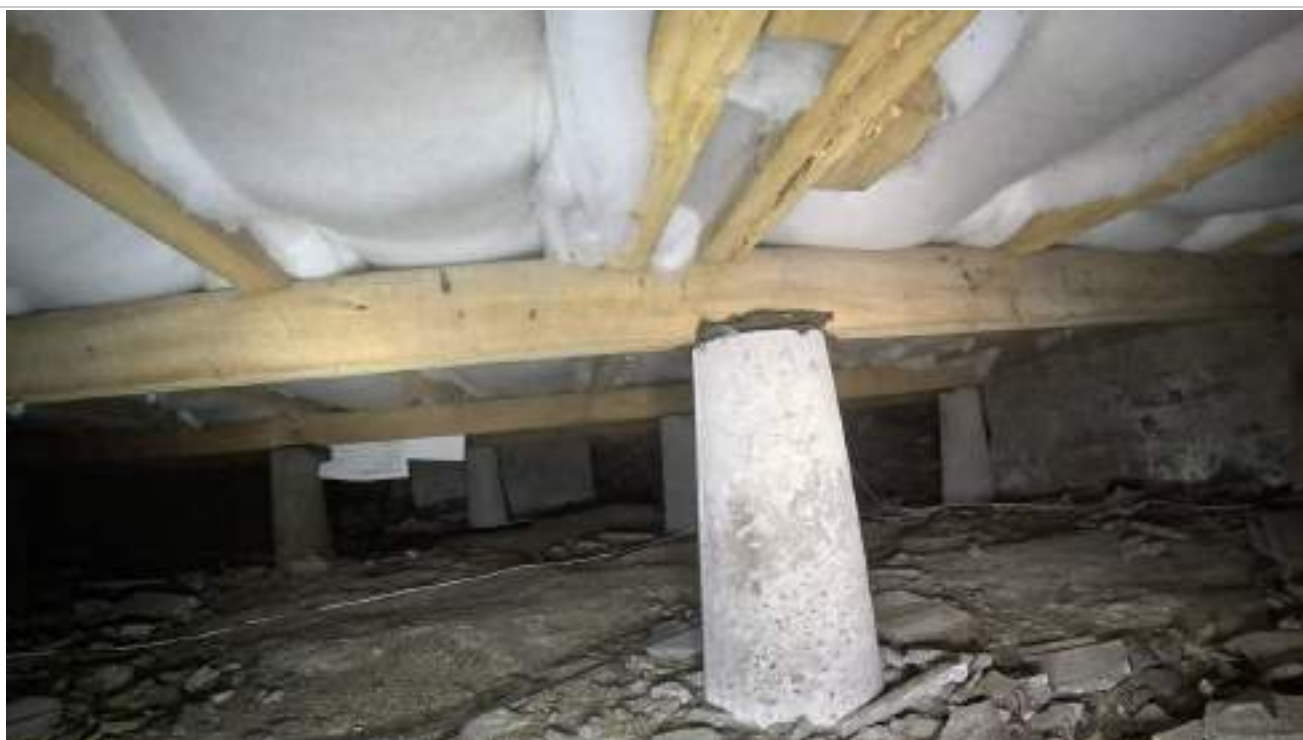
49: Precast concrete pile with no connection.

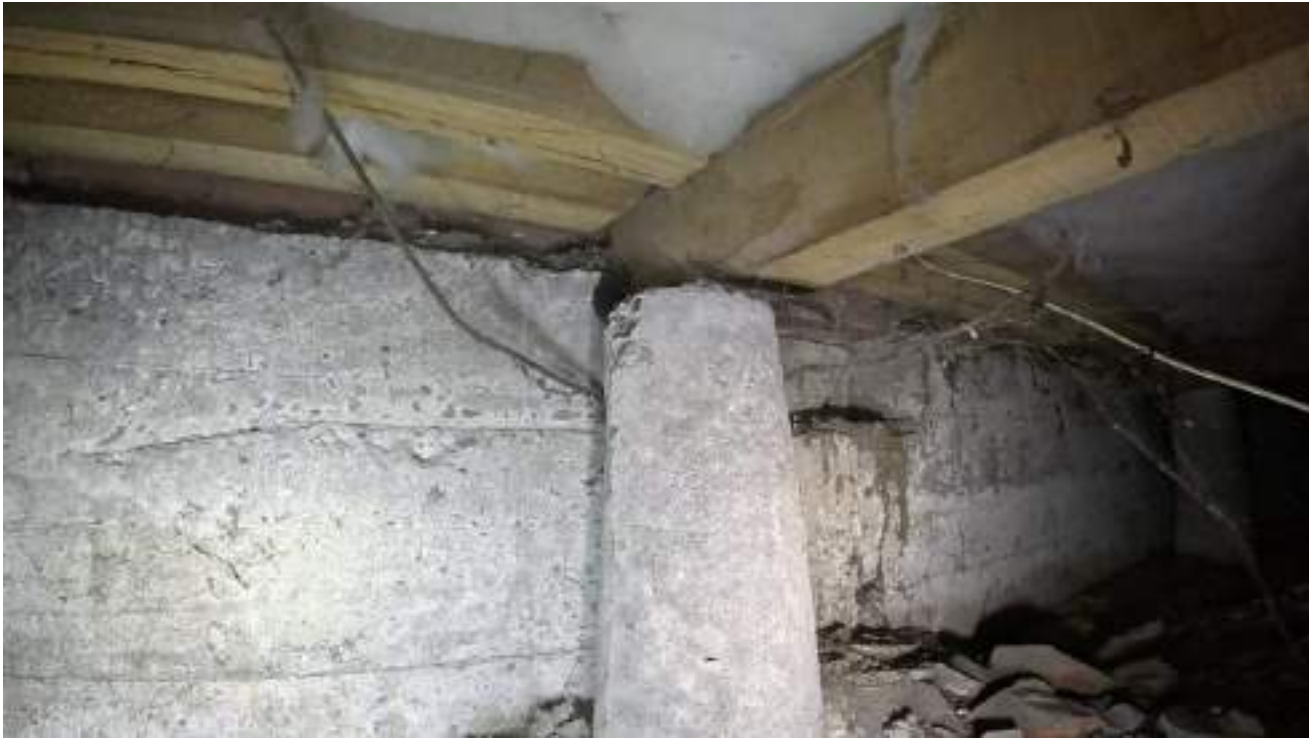
54: Precast concrete pile with no connection.

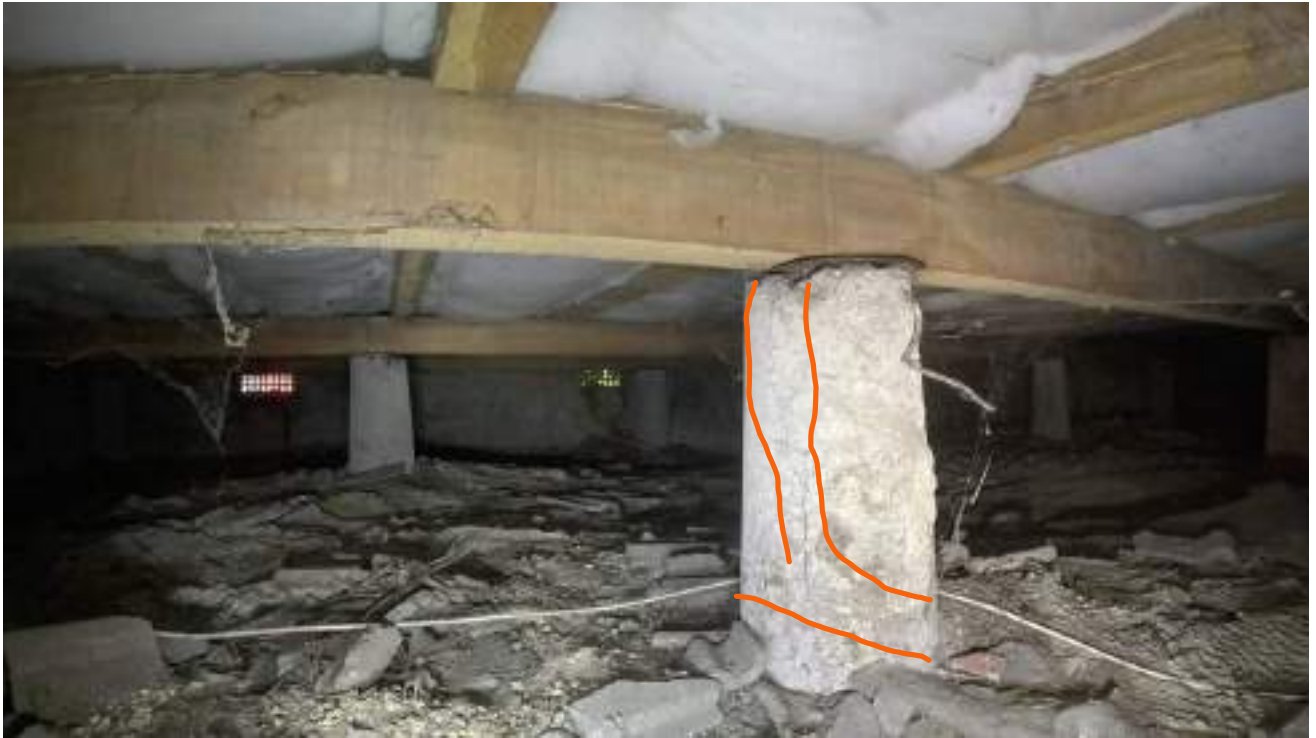
56: Precast concrete pile with no connection.

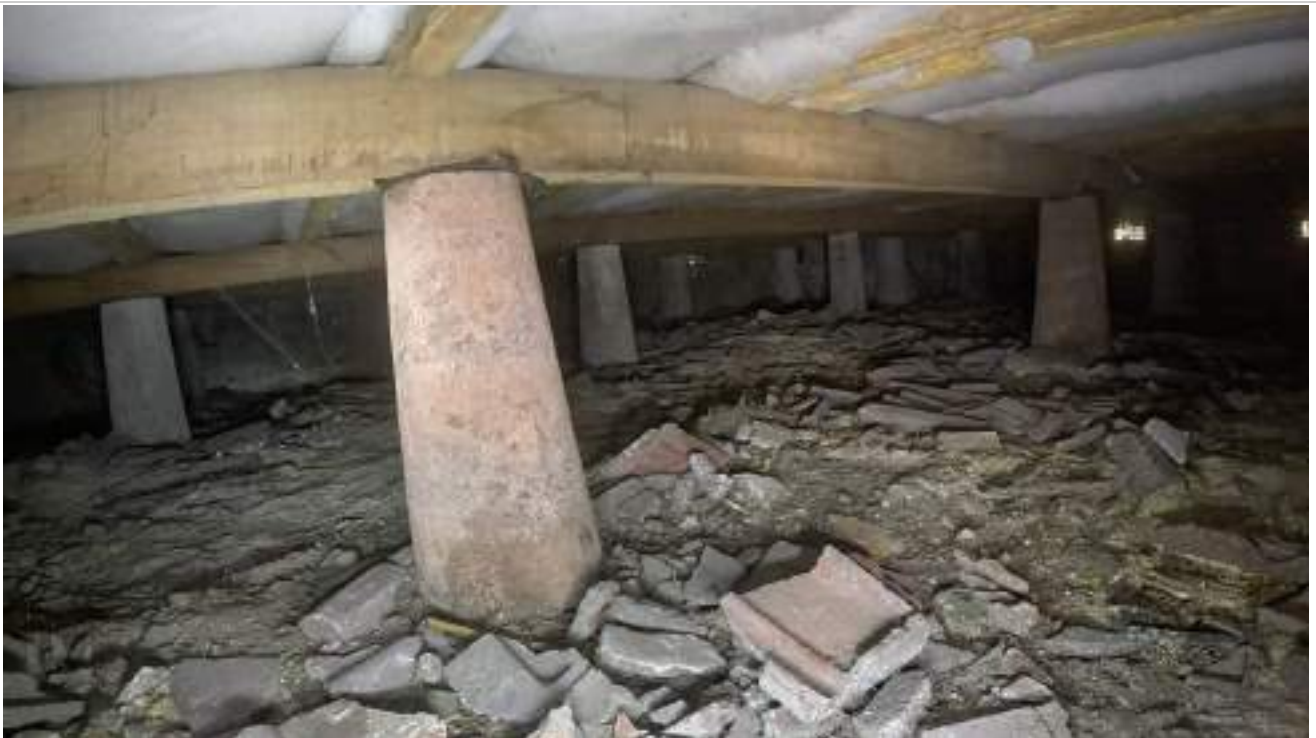
57: Precast concrete pile with no connection.
