# EARTHQUAKE REPAIR

## 425 & 427 ARMAGH STREET

**IN RESPECT OF:** Structural Design of Foundation Repair for 425 & 427, Internal Alterations at Nr. 425 only  
(Description of Building Work)

## TR001: Technical Report – Desktop Technical Review & Structural Inspection

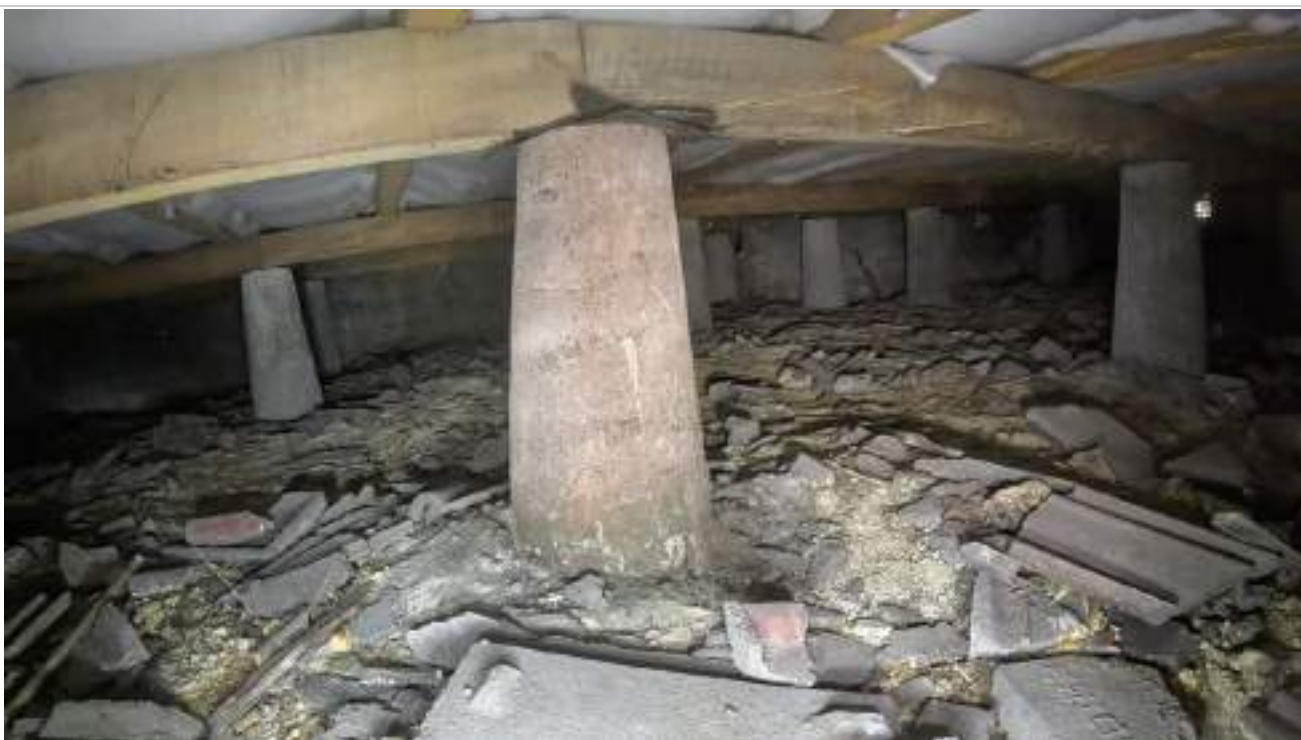
58: Precast concrete pile with no connection.

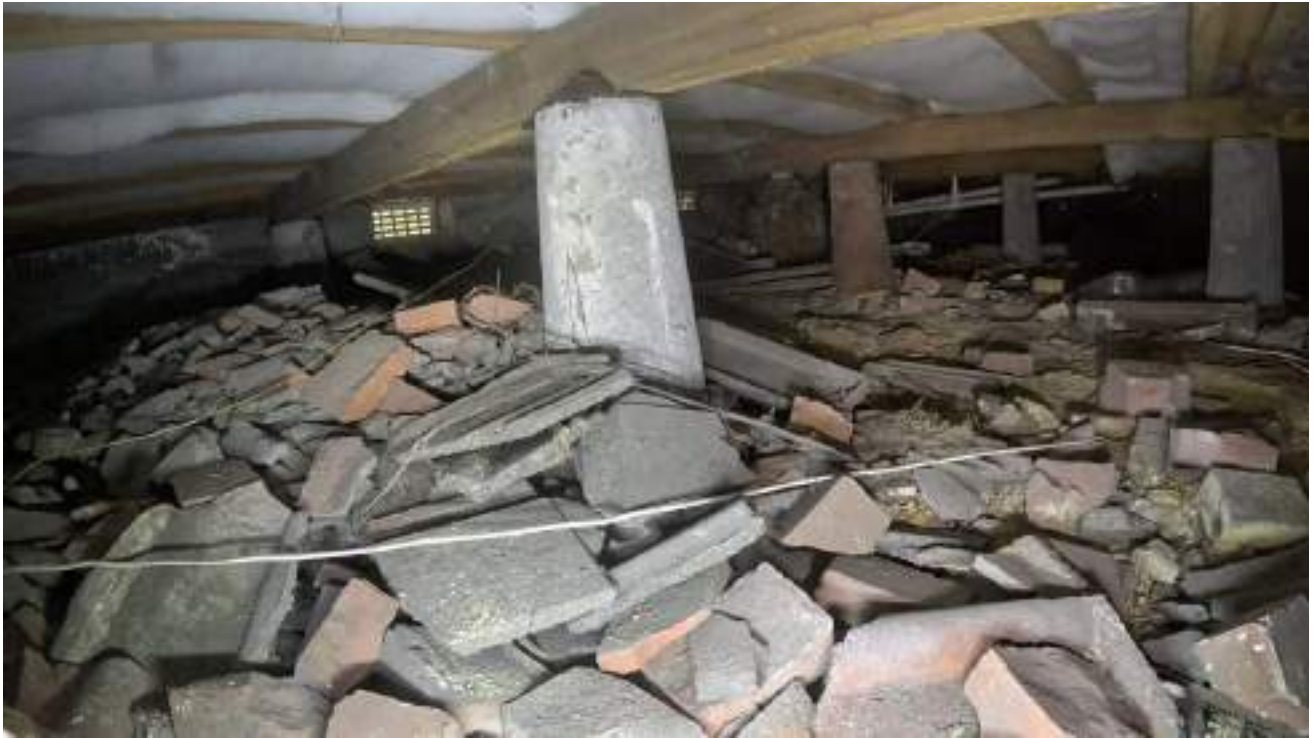
59: Precast concrete pile with no connection.

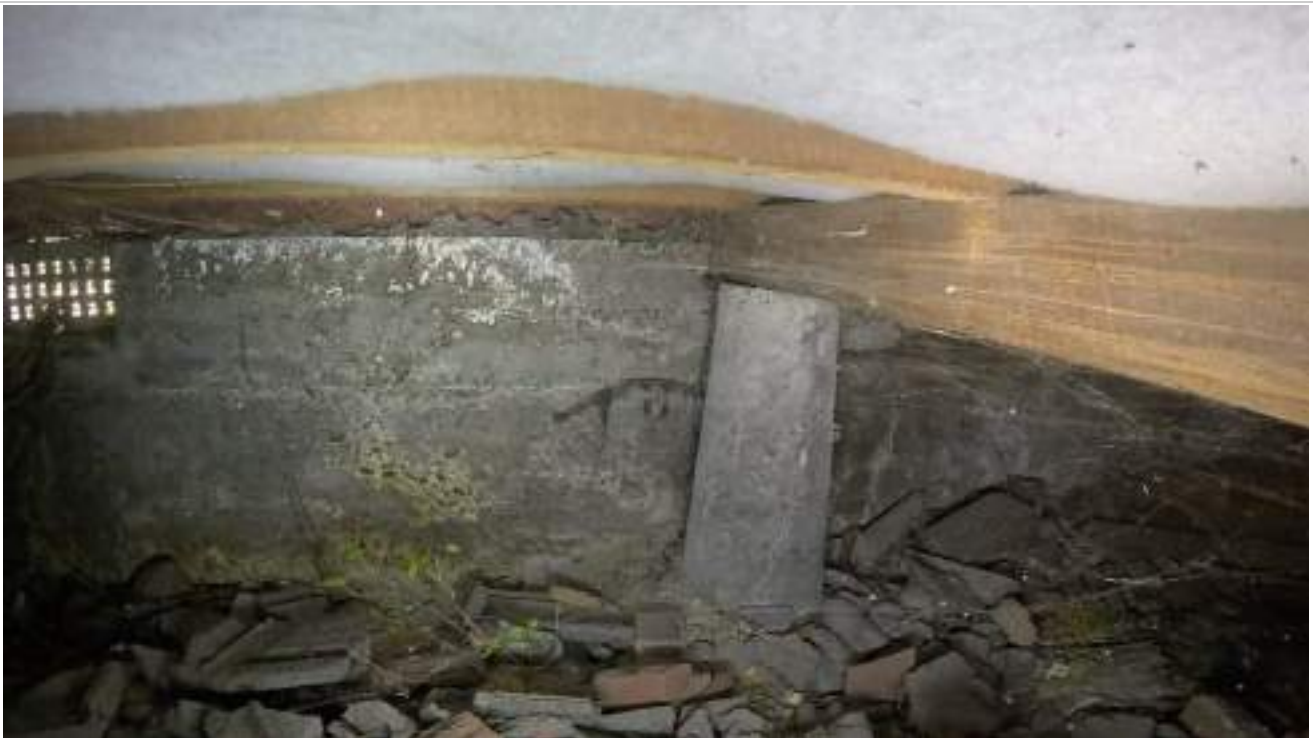
60: Precast concrete pile with no connection.

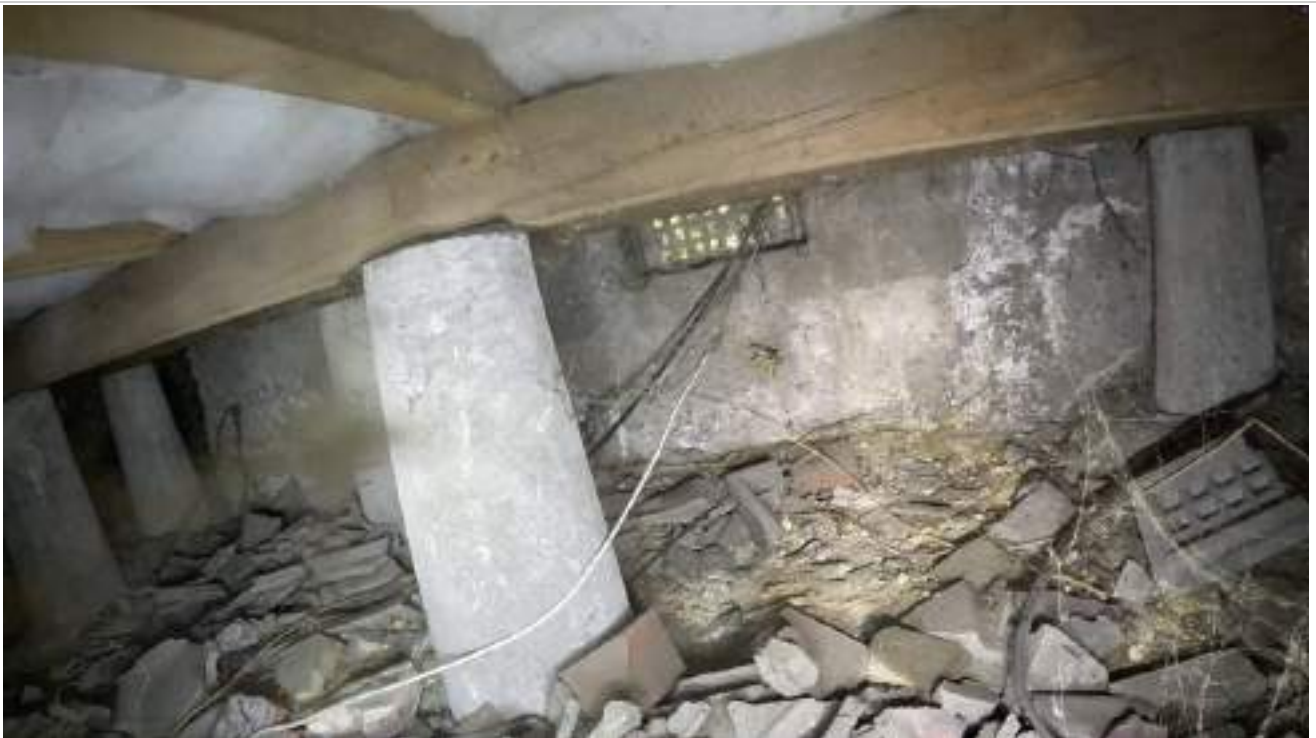
62: Precast concrete pile with no connection.

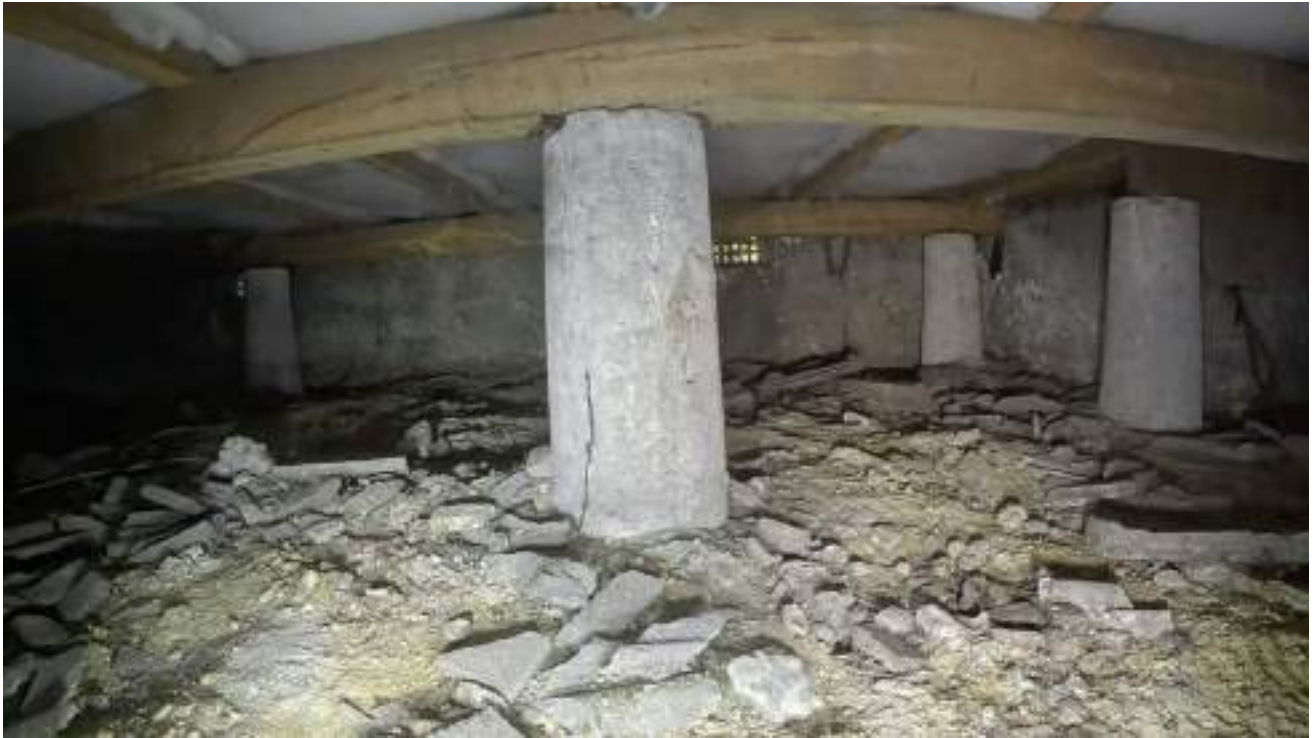
65: Precast concrete pile with no connection.

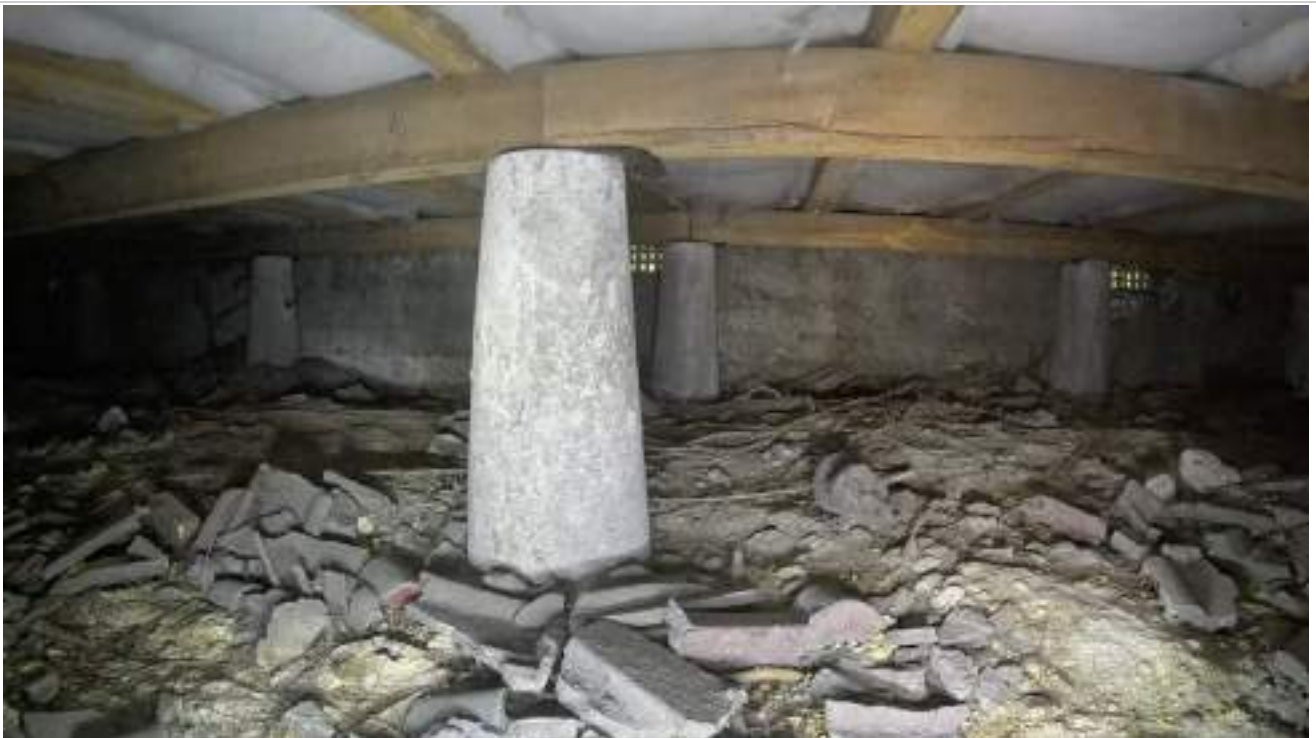
66: Precast concrete pile with no connection.

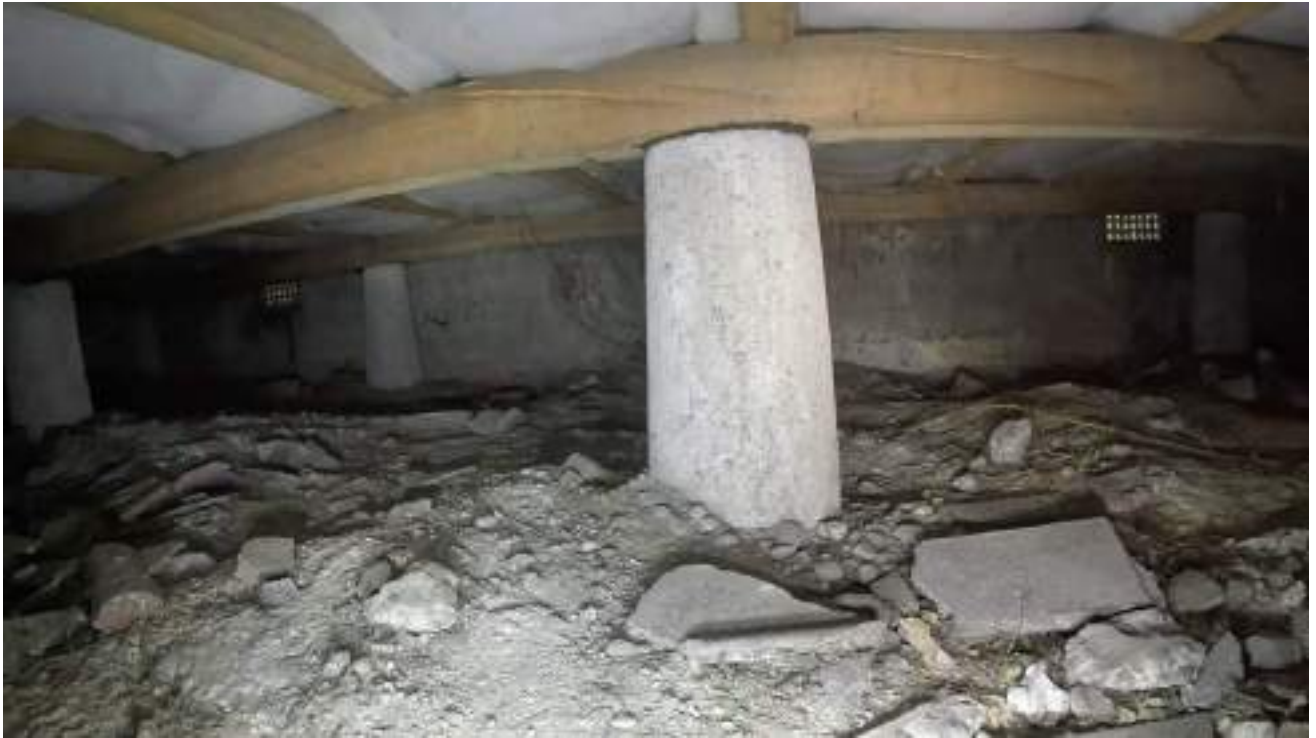
67: Precast concrete pile with no connection.

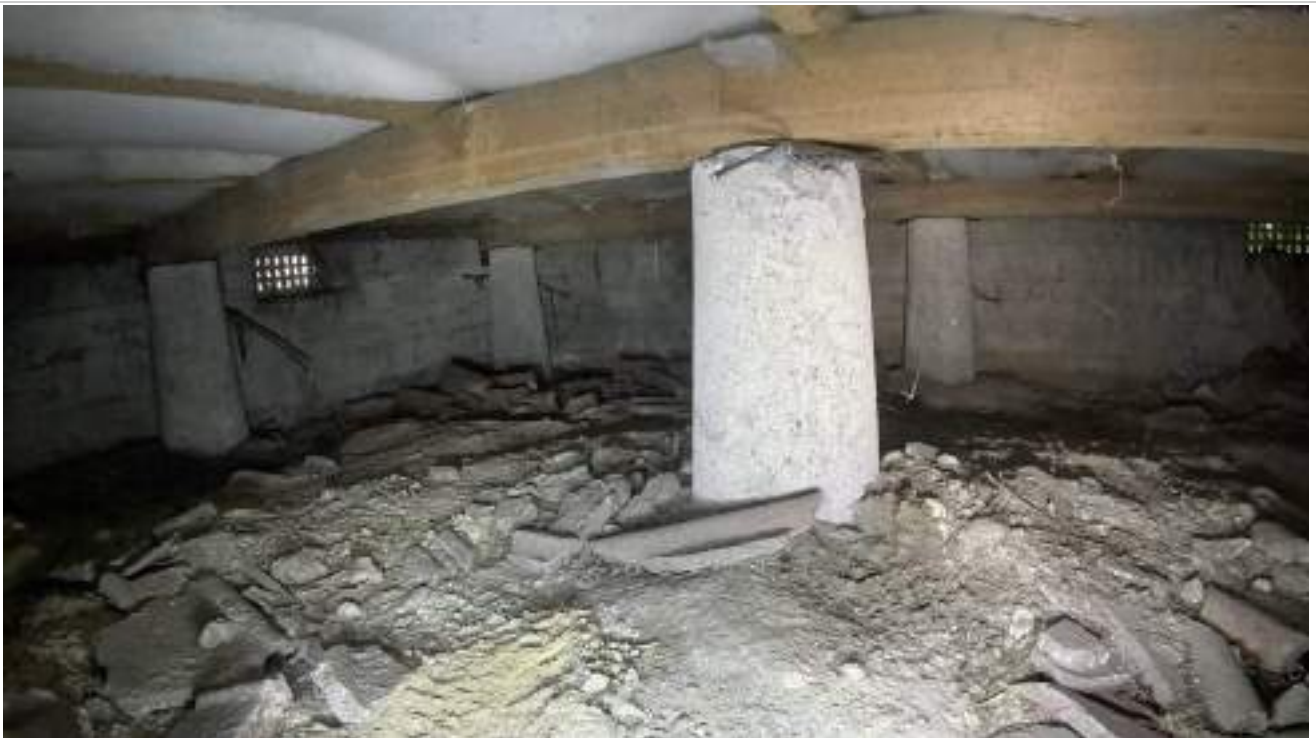
68: Precast concrete pile with no connection.

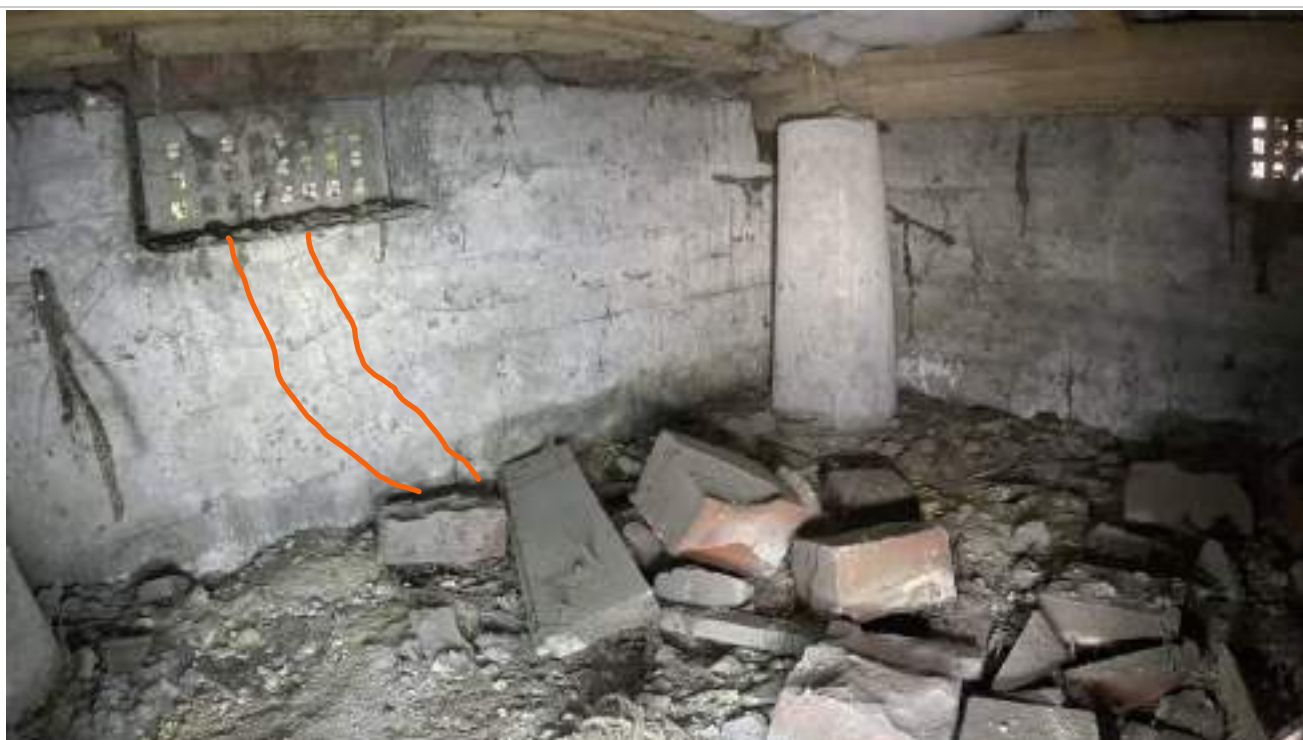
70: View of ring foundation with cracking.

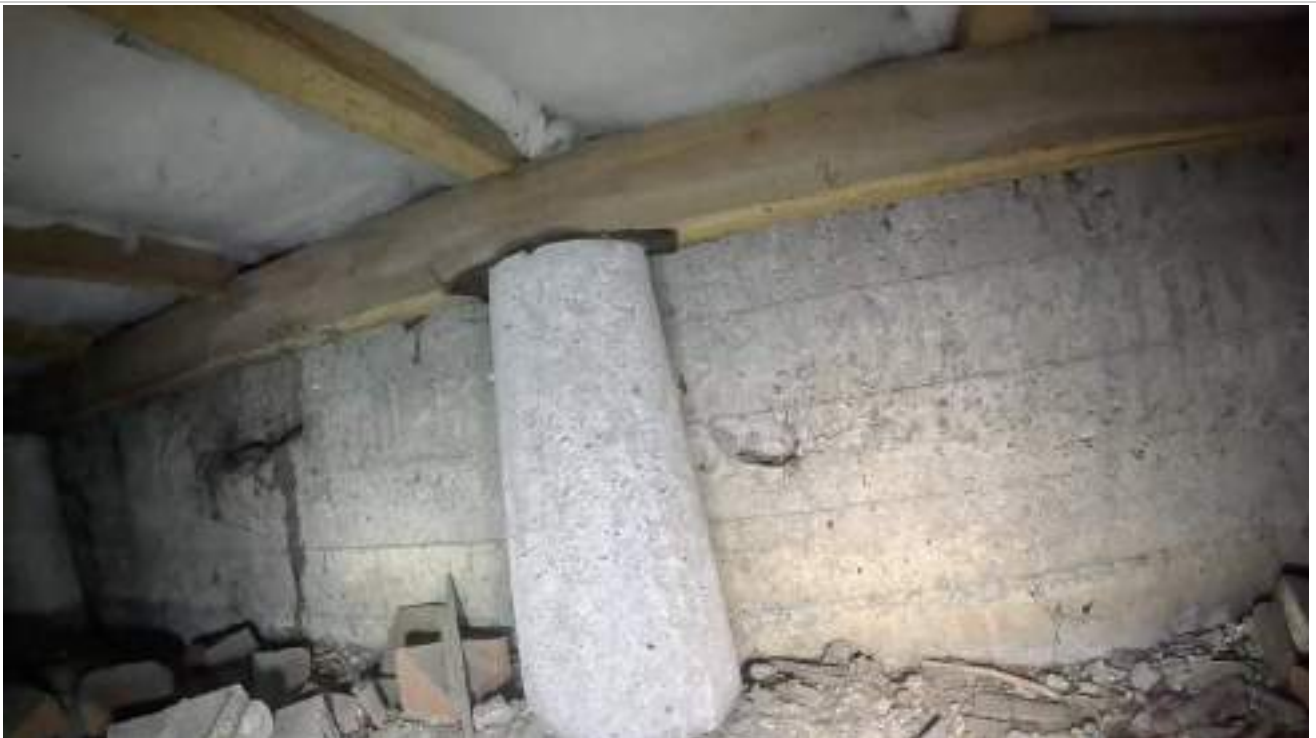
72: Precast concrete pile with no connection.

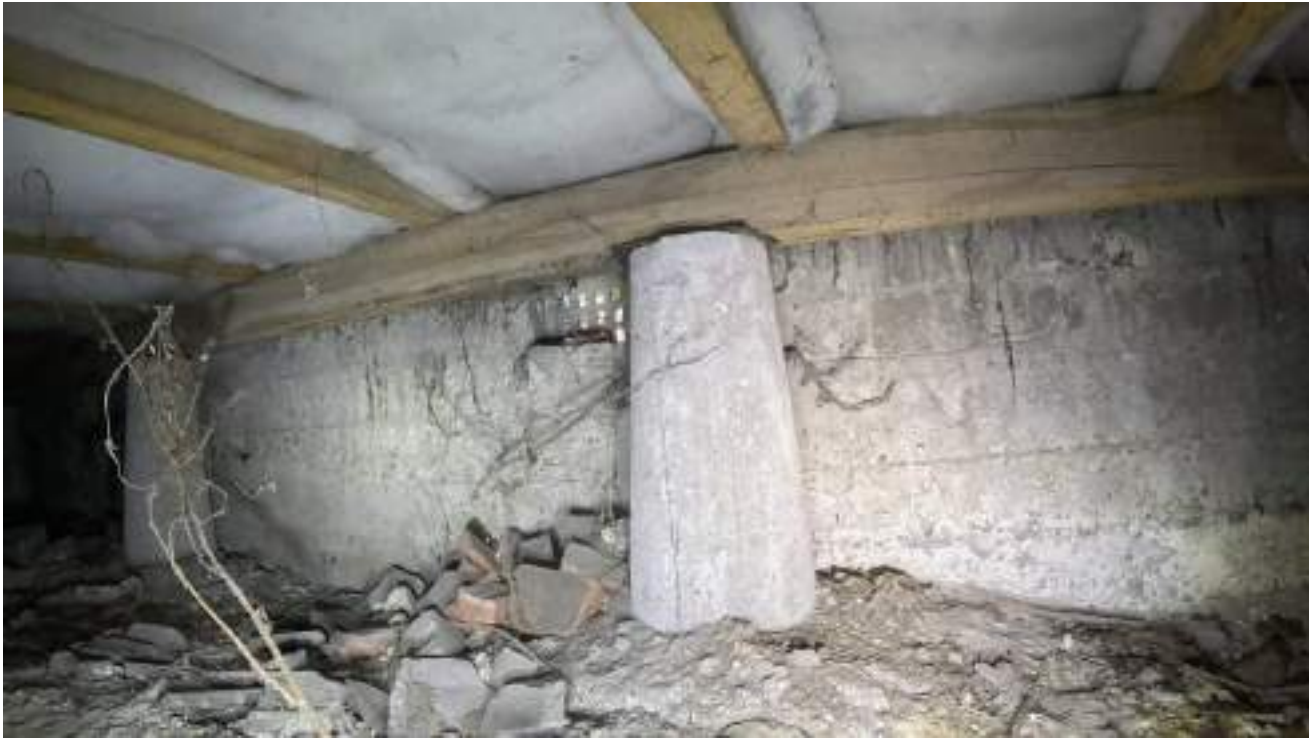
73: Precast concrete pile with no connection.

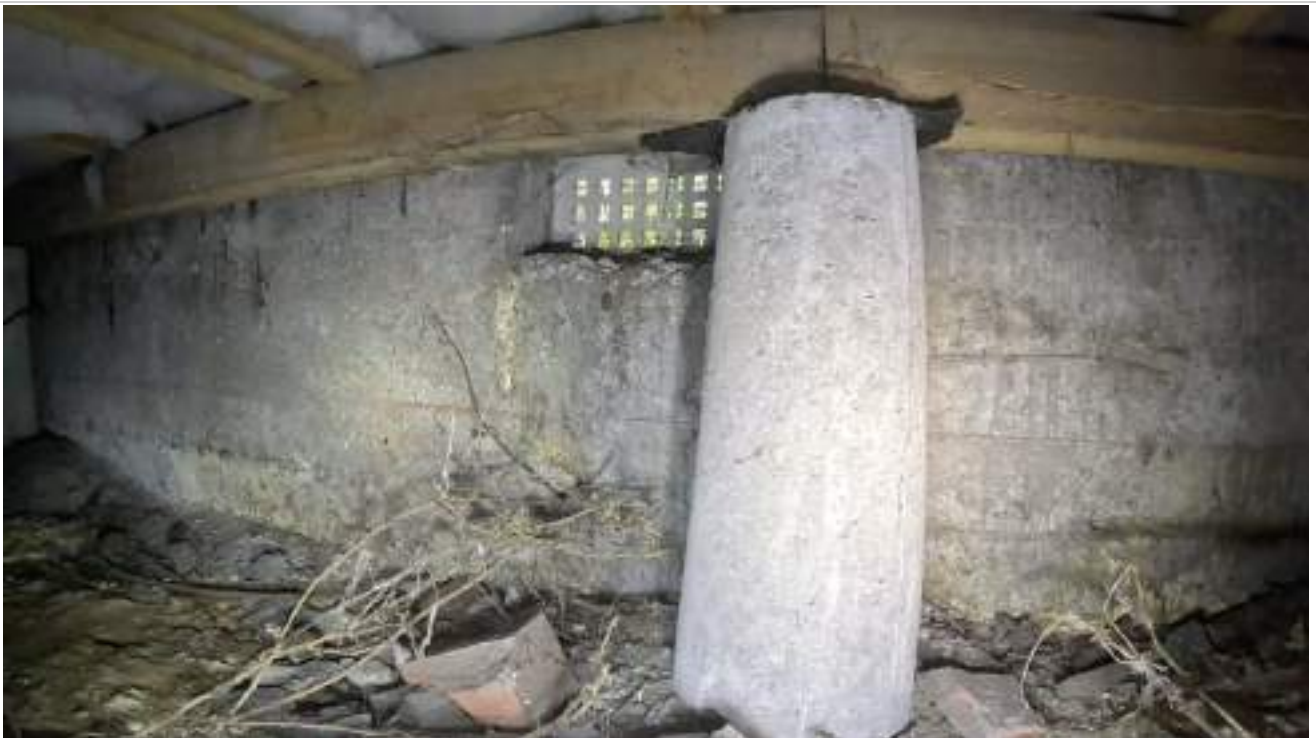
74: Precast concrete pile with no connection.

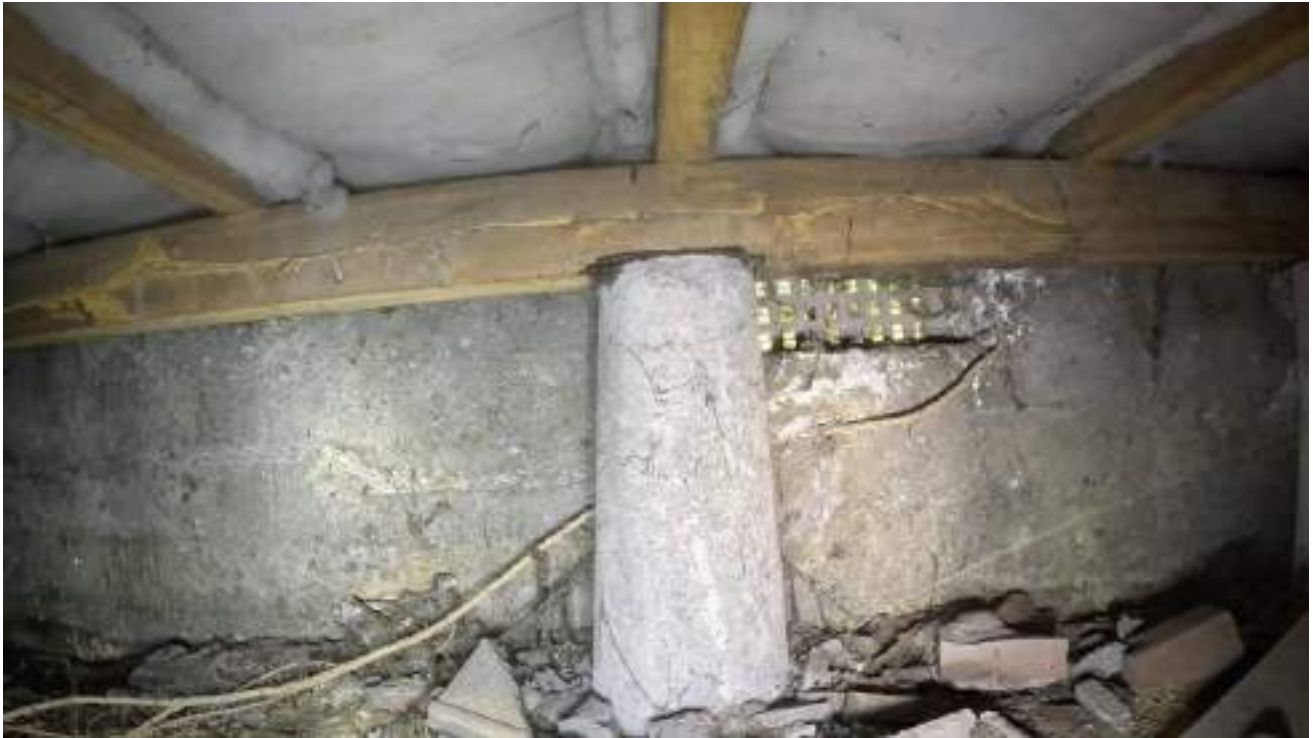
75: Precast concrete pile with no connection.

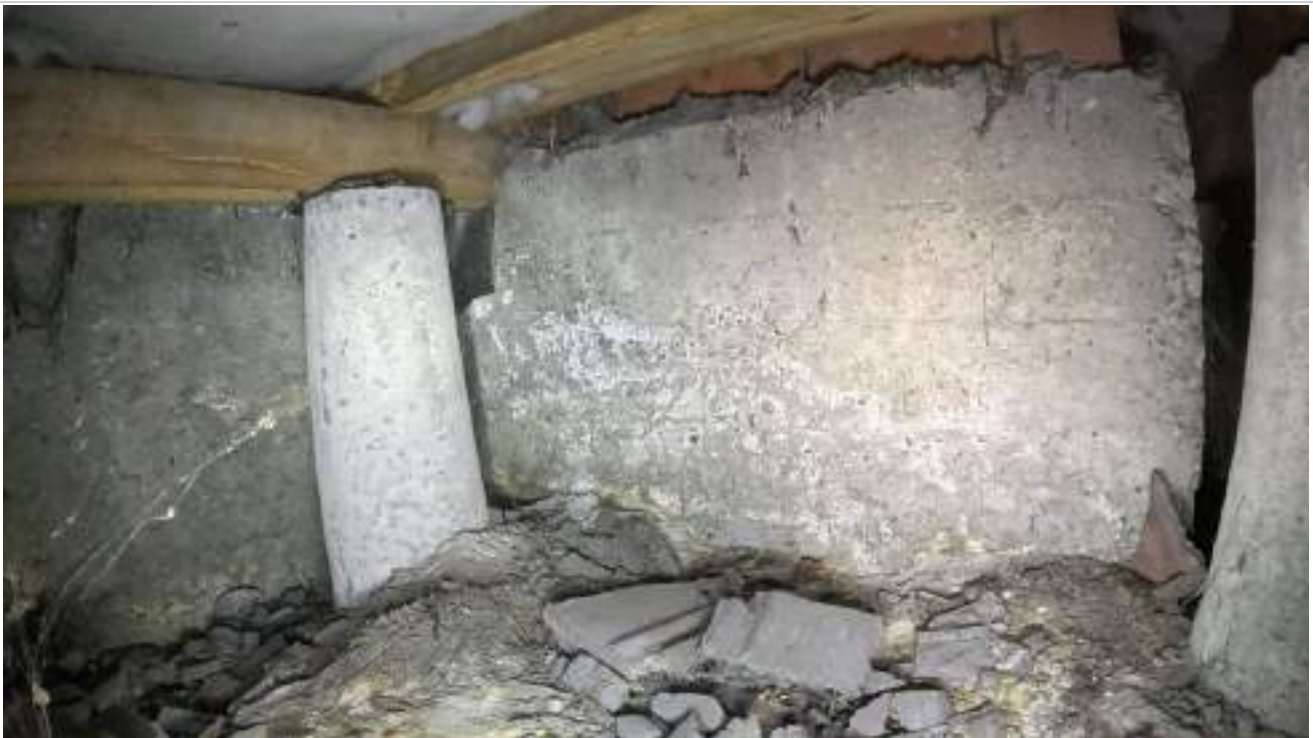
76: Precast concrete pile with no connection.

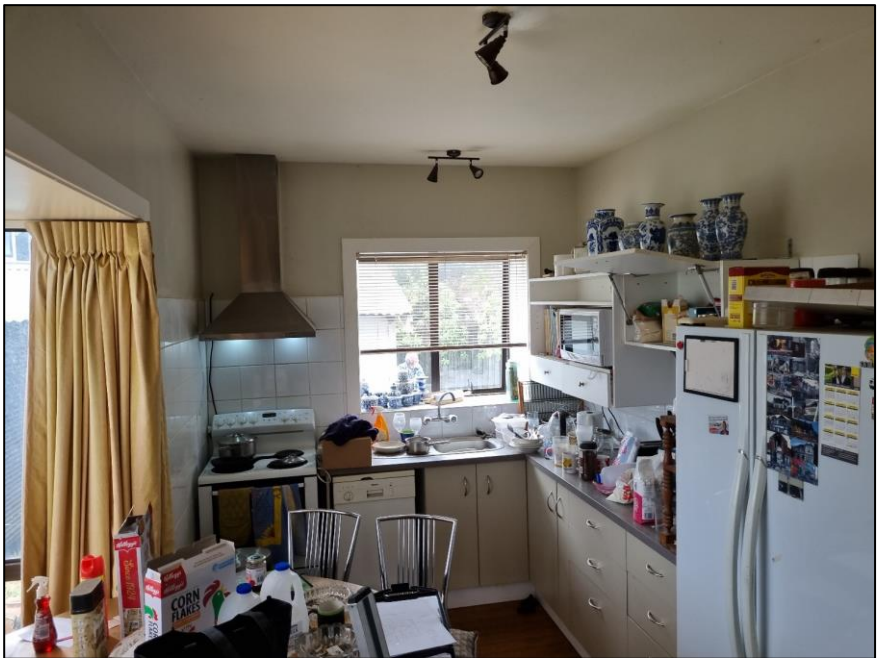
Photo 4A –Kitchen floors , ceilings and built in benchtops all fall to the north.

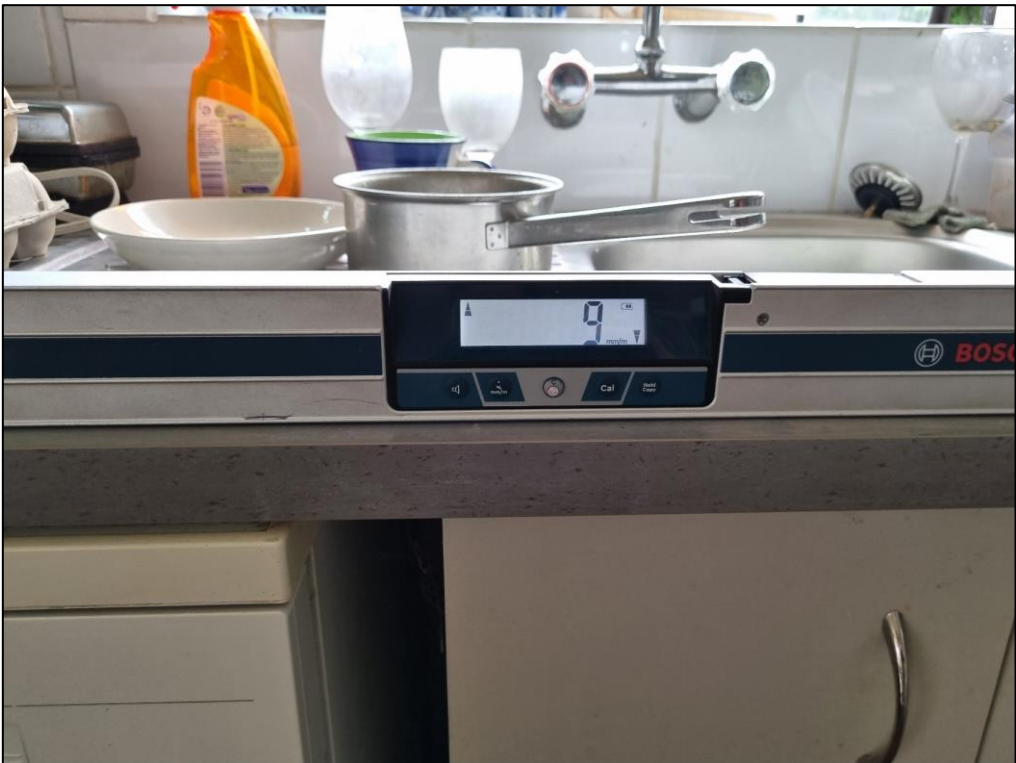
Photo 4B Kitchen bench along the eastern wall falling to the north by 9mm/m , following the floor and ceilings.

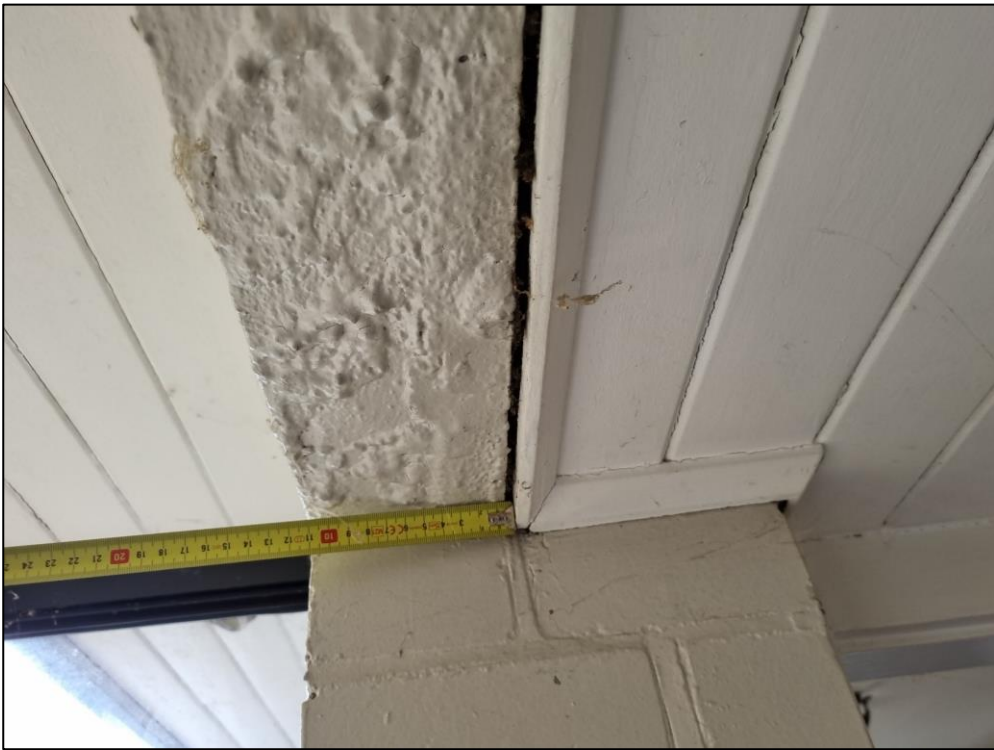
Photo 4D –Minor separation between the timber trim and the concrete lintel above the porch.

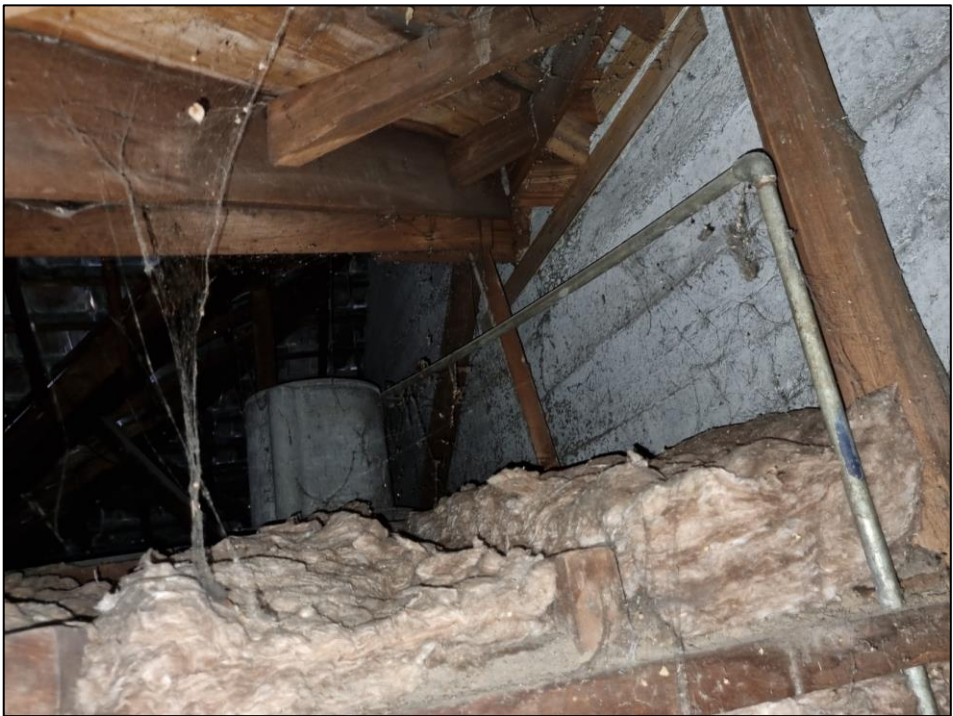
Photo 6A – Unrestrained Concrete water tank in the roof space .

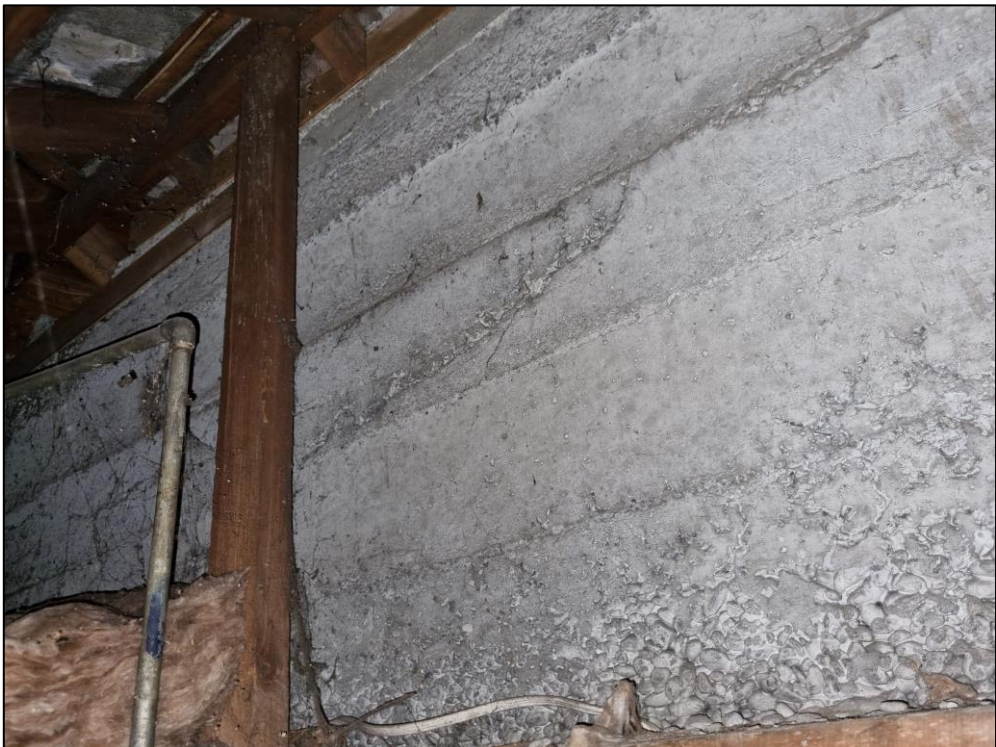
Photo 6B – Partition wall is partly constructed from poured in situ concrete above the ceiling line. Concrete pour joins ( cold joins) can be seen.

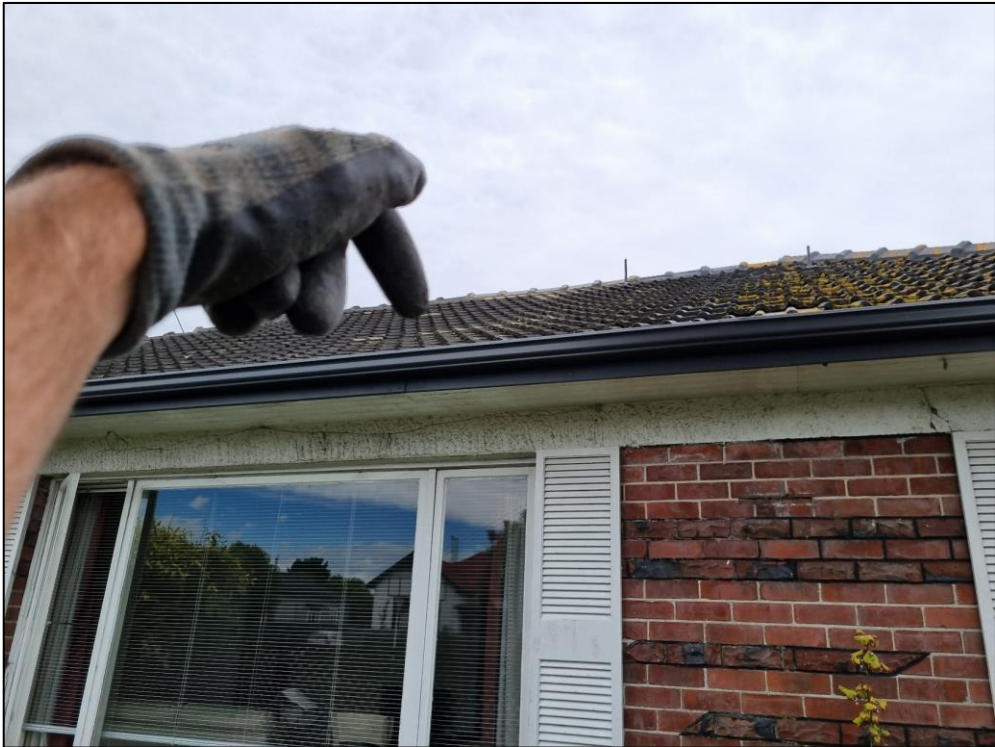
Photo 6C – Roof plane sagging towards the middle due to inadequate underpurlin support .

Photo 6C – Roof plane sagging towards the middle due to inadequate roof framing underpurlin support .

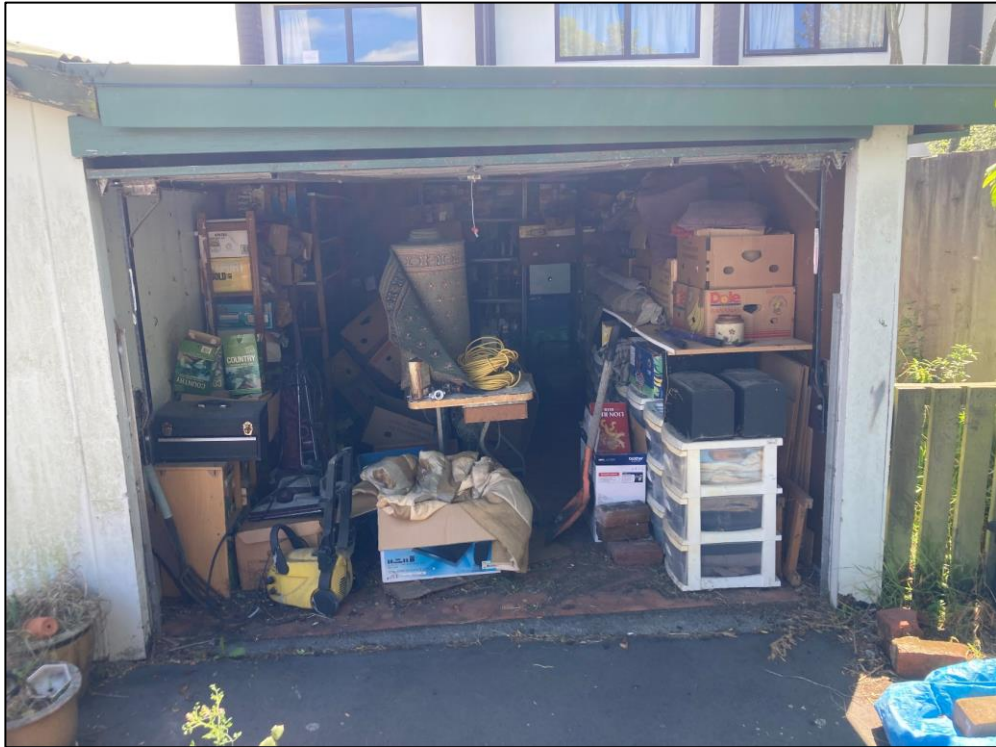
Photo 7B – Garage was full of storage at the time of the assessment. Door head was measured to be level over sloping concrete slab.

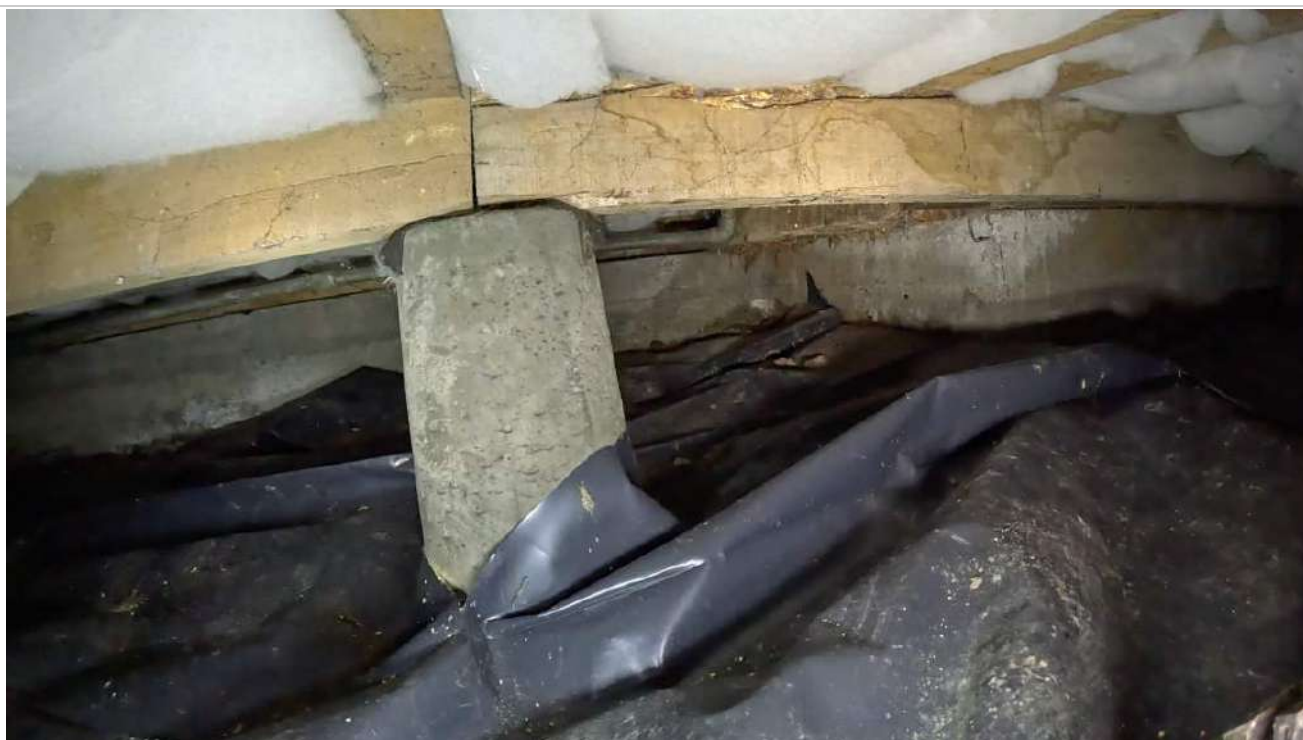
10: Precast concrete pile with no connection.

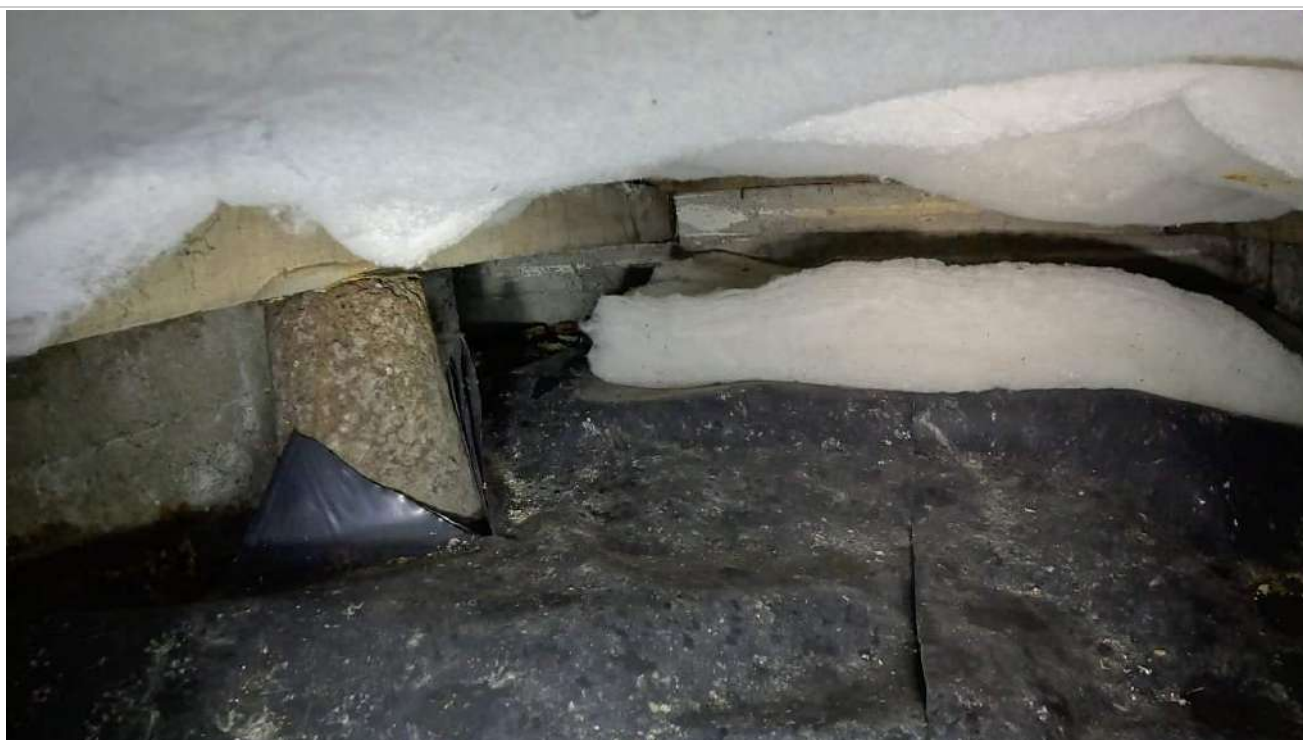
11: I think that there is a concrete base here, but I am not completely sure of the layout.

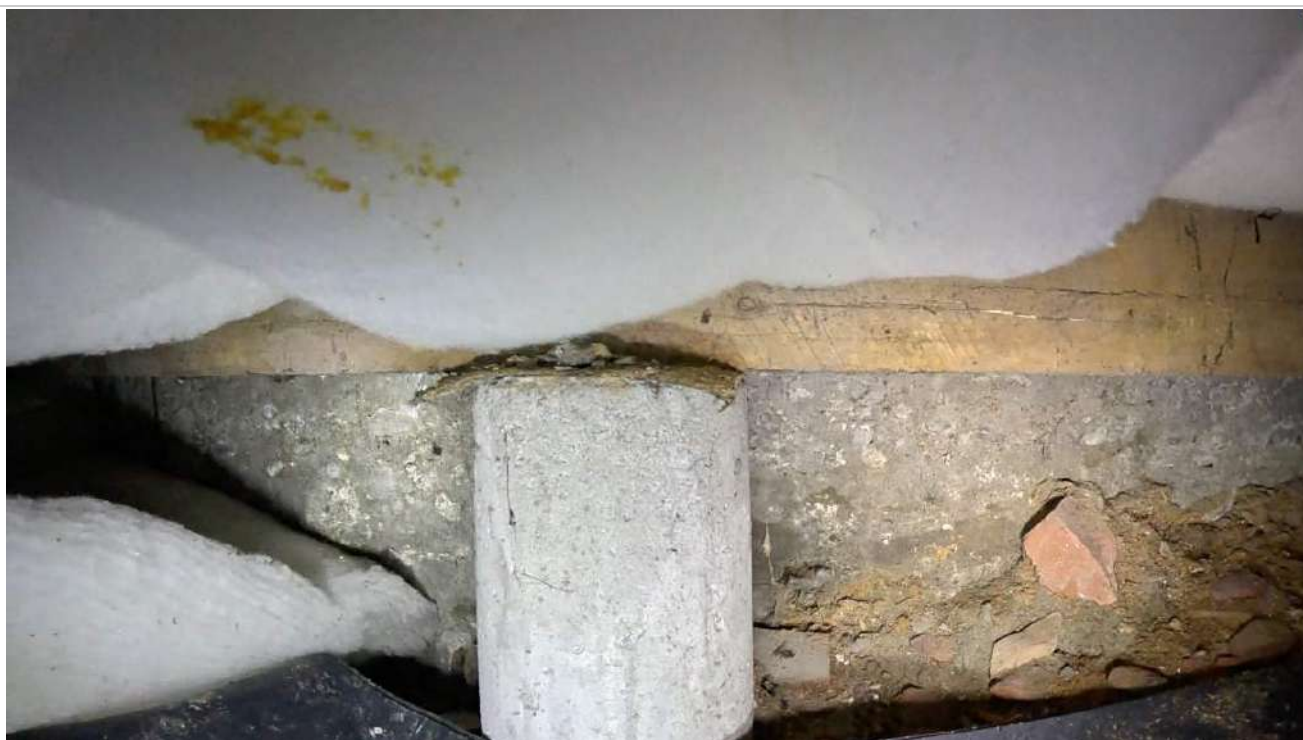
14: View of bearer meeting concrete base.

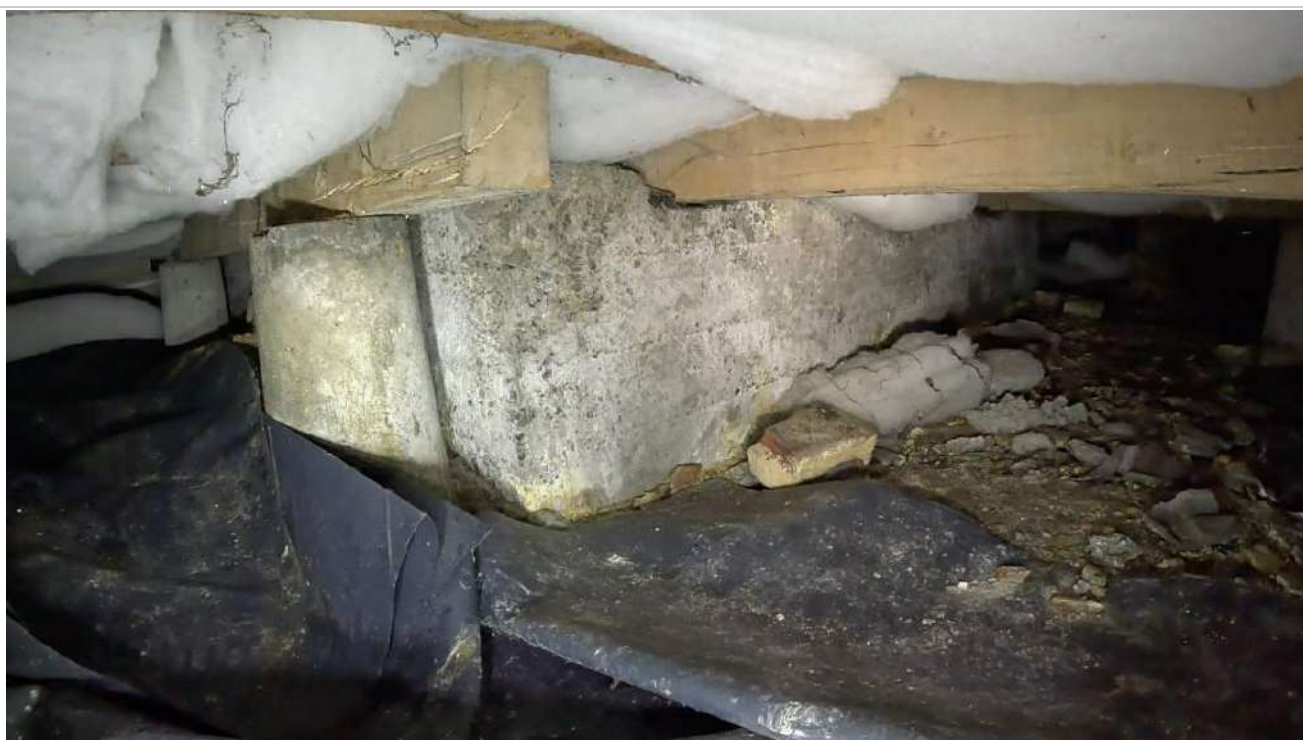
15: Precast concrete pile with no connection.
