# EARTHQUAKE REPAIR

## 425 & 427 ARMAGH STREET

**IN RESPECT OF:** Structural Design of Foundation Repair for 425 & 427, Internal Alterations at Nr. 425 only  
(Description of Building Work)

## TR001: Technical Report – Desktop Technical Review & Structural Inspection

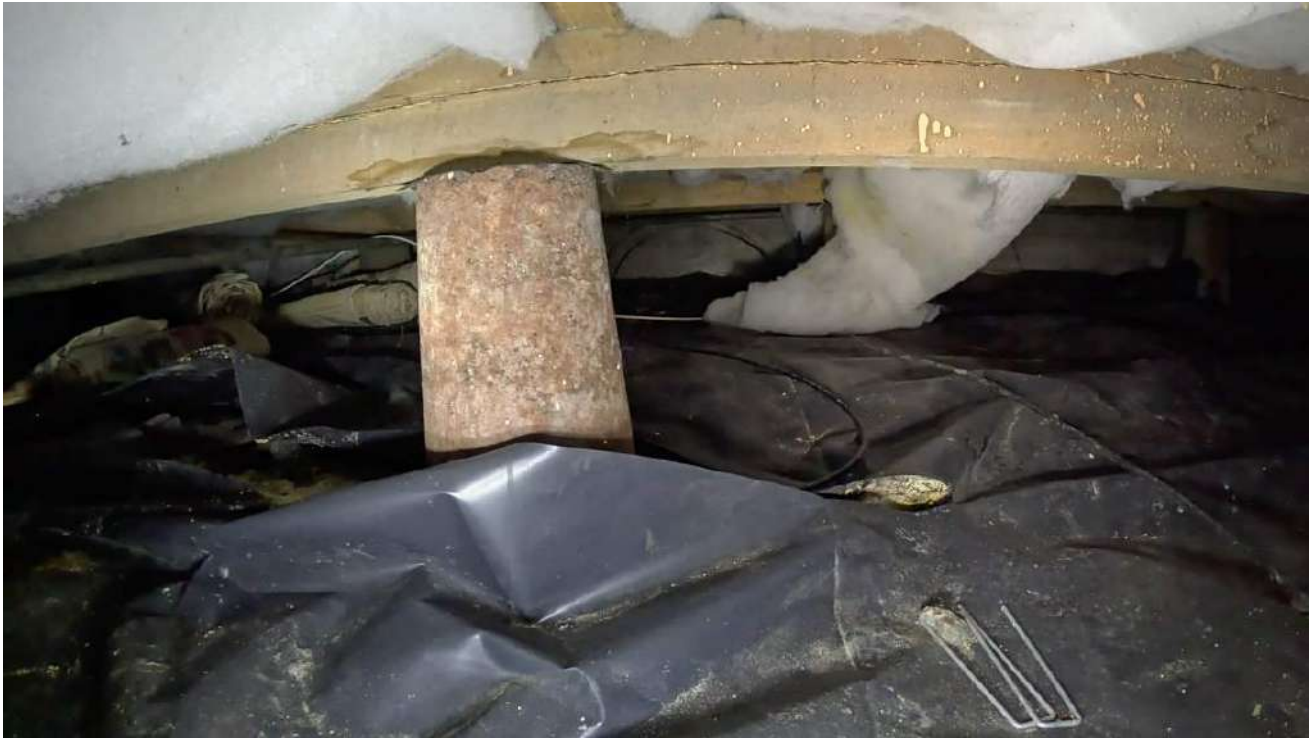
18: Precast concrete pile with no connection.

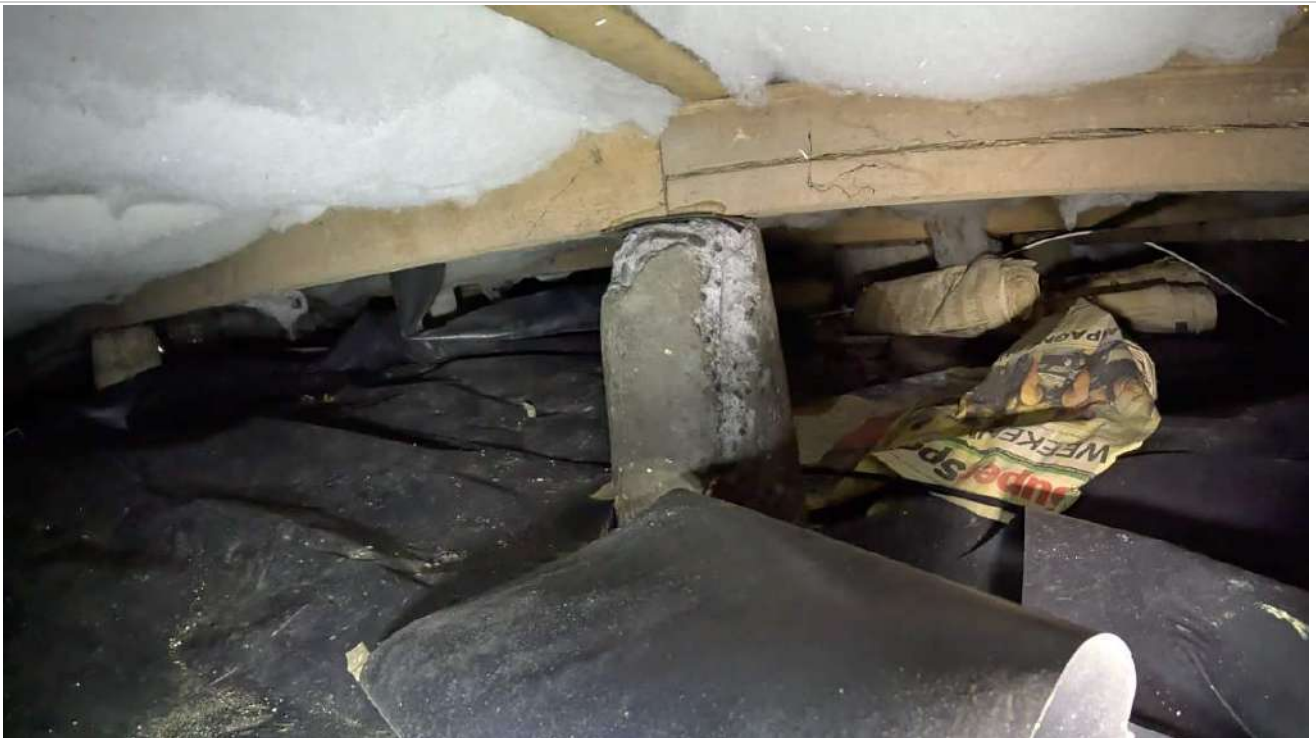
19: Precast concrete pile with no connection.

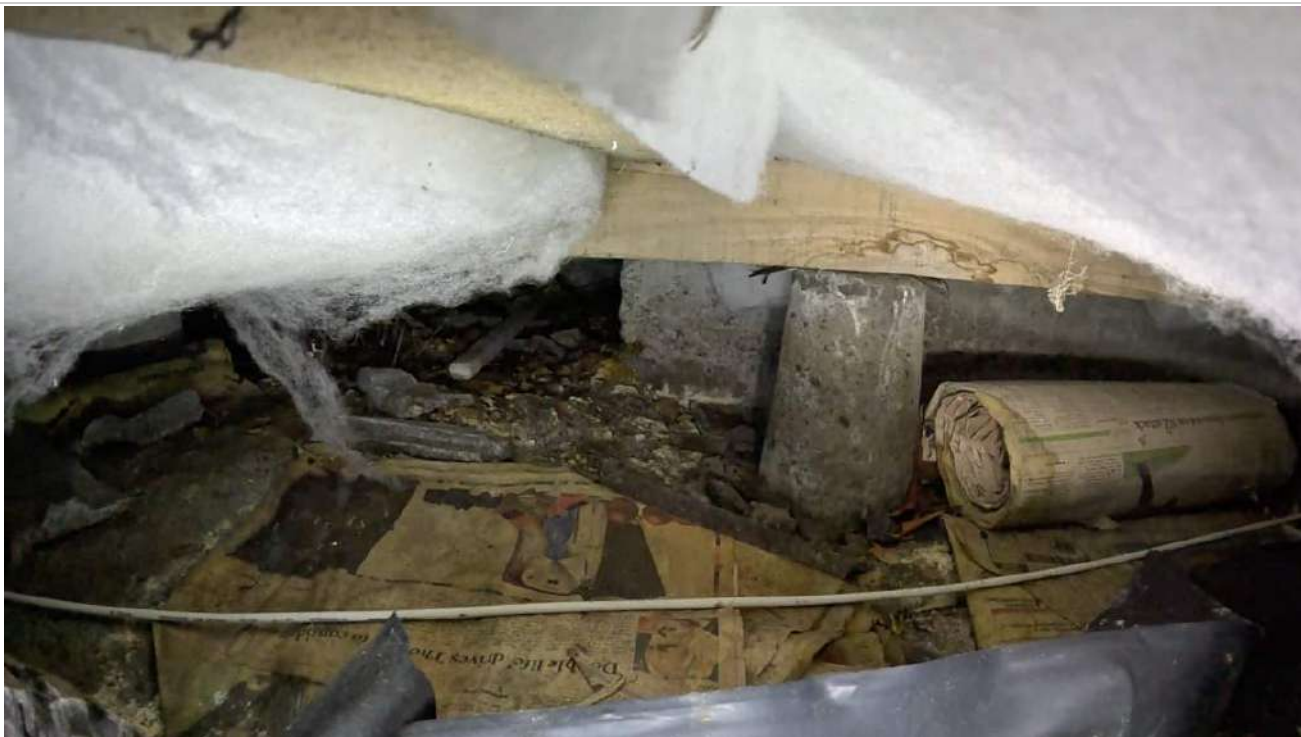
22: We couldn't get into this area.

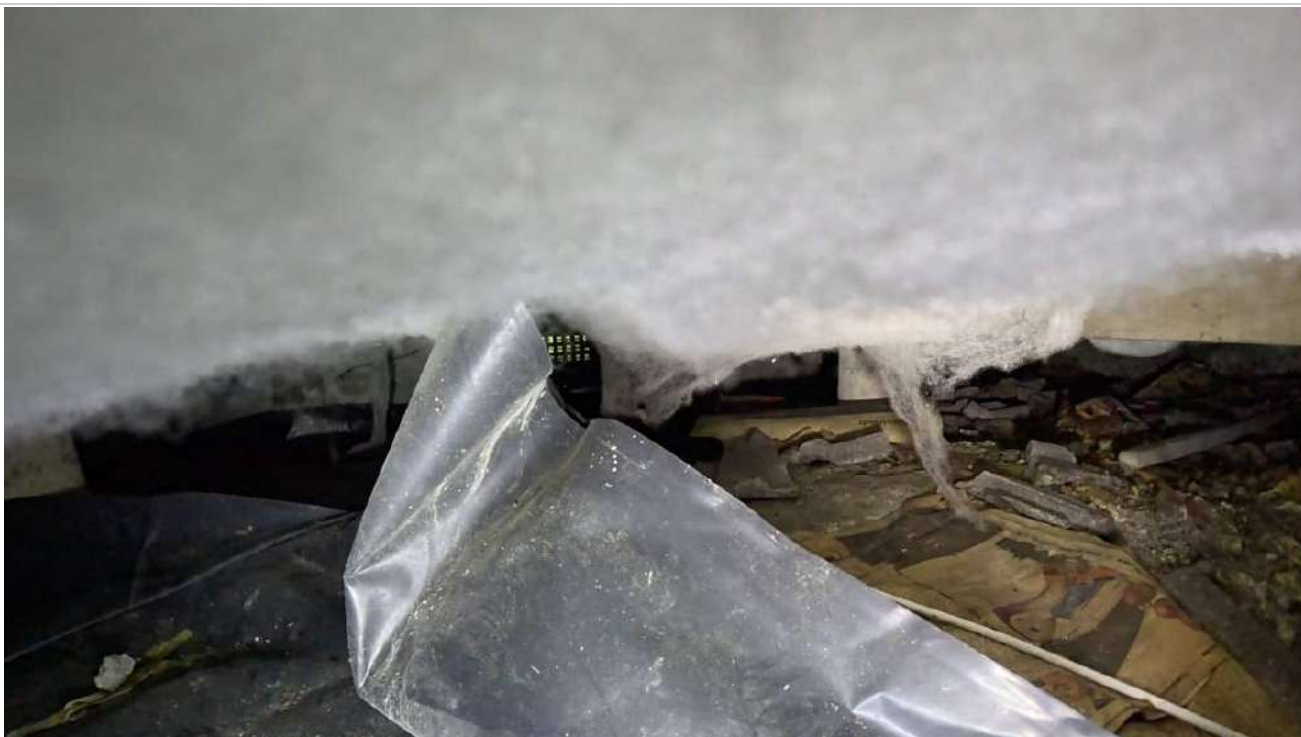
23: View of piles.

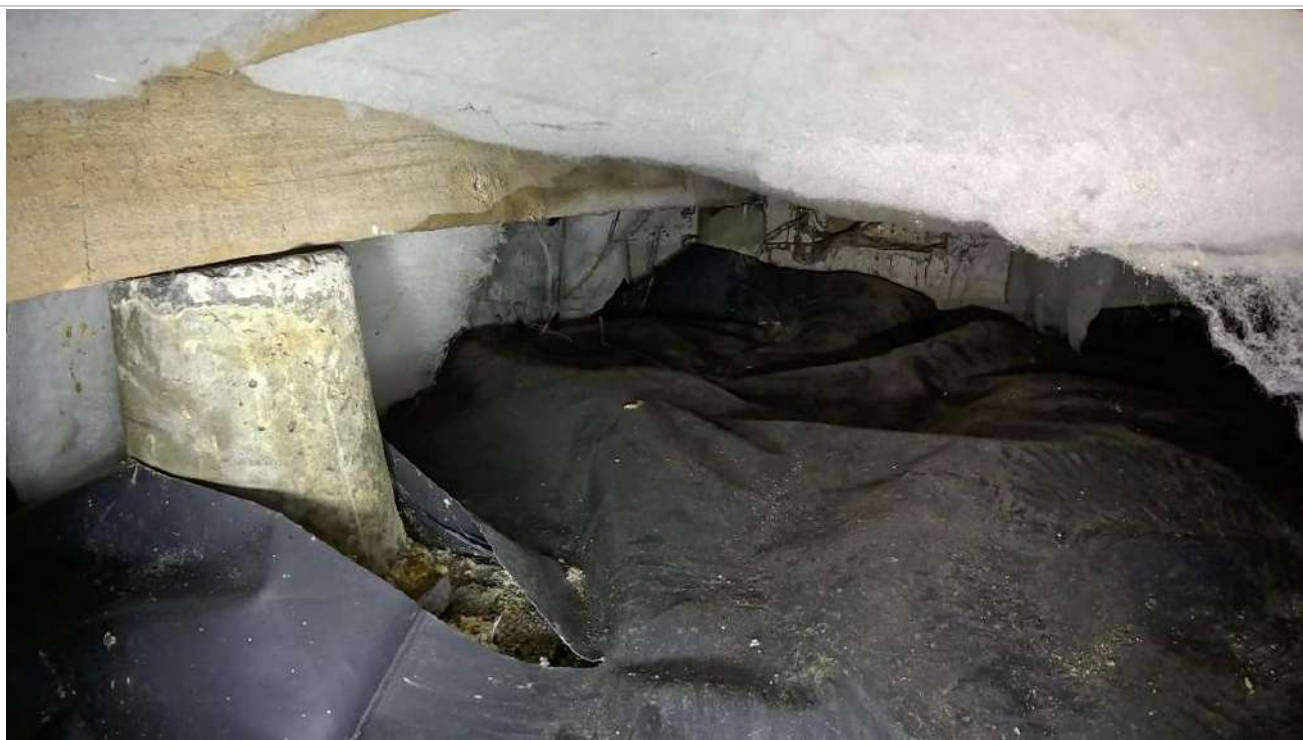
24: View of foundation.

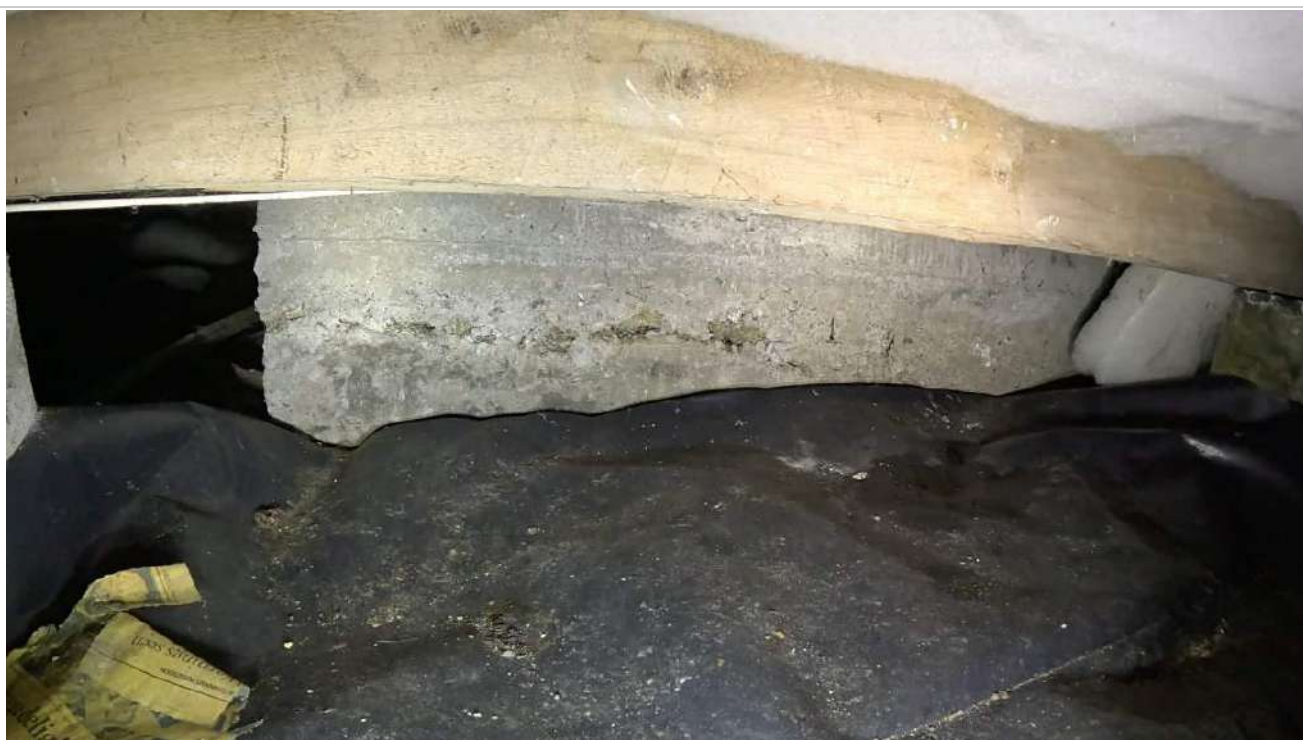
25: Precast concrete pile with no connection.

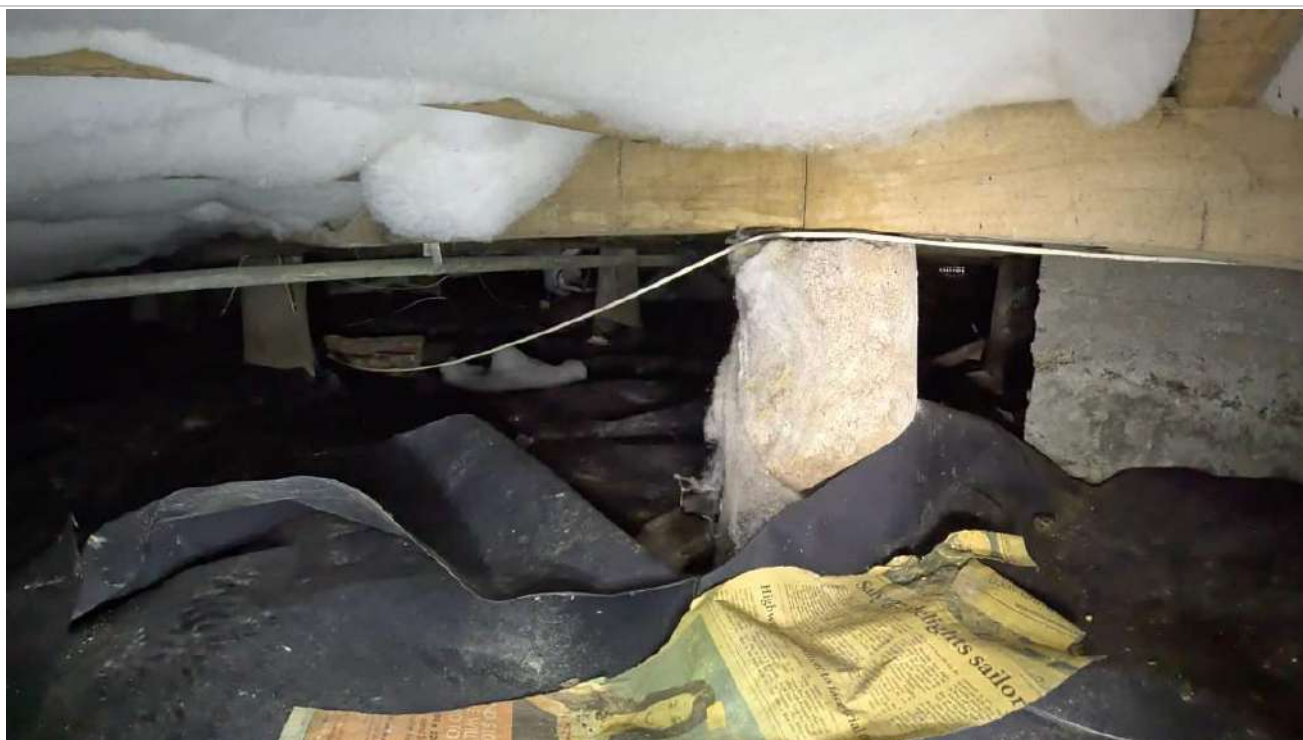
26: Precast concrete pile with no connection.

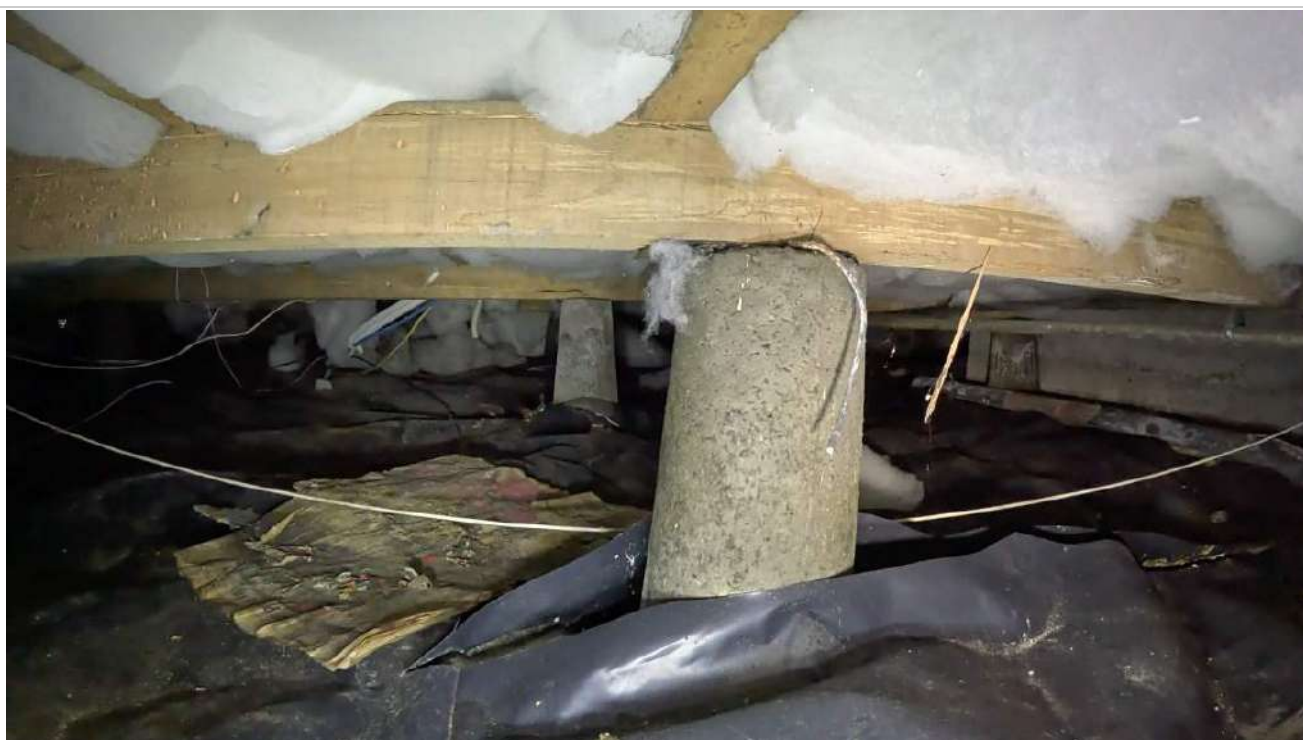
27: Precast concrete pile with no connection.

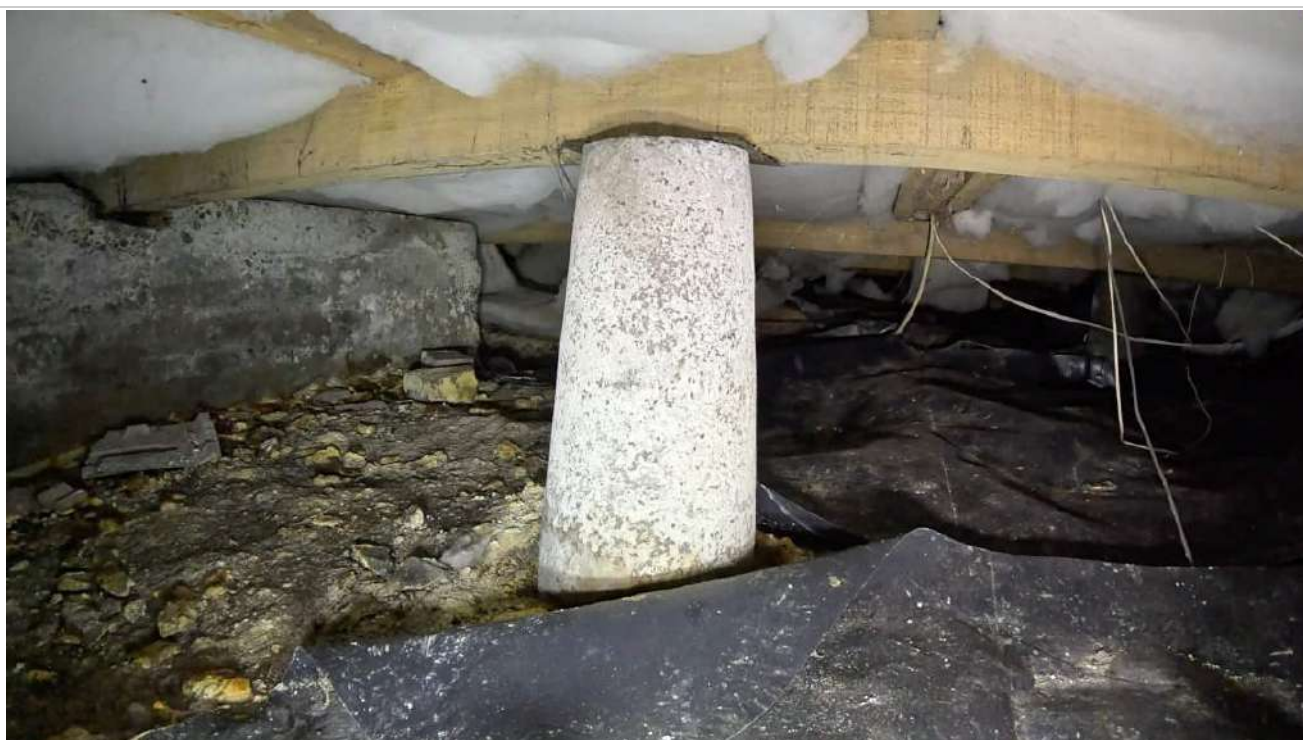
28: Precast concrete pile with no connection.

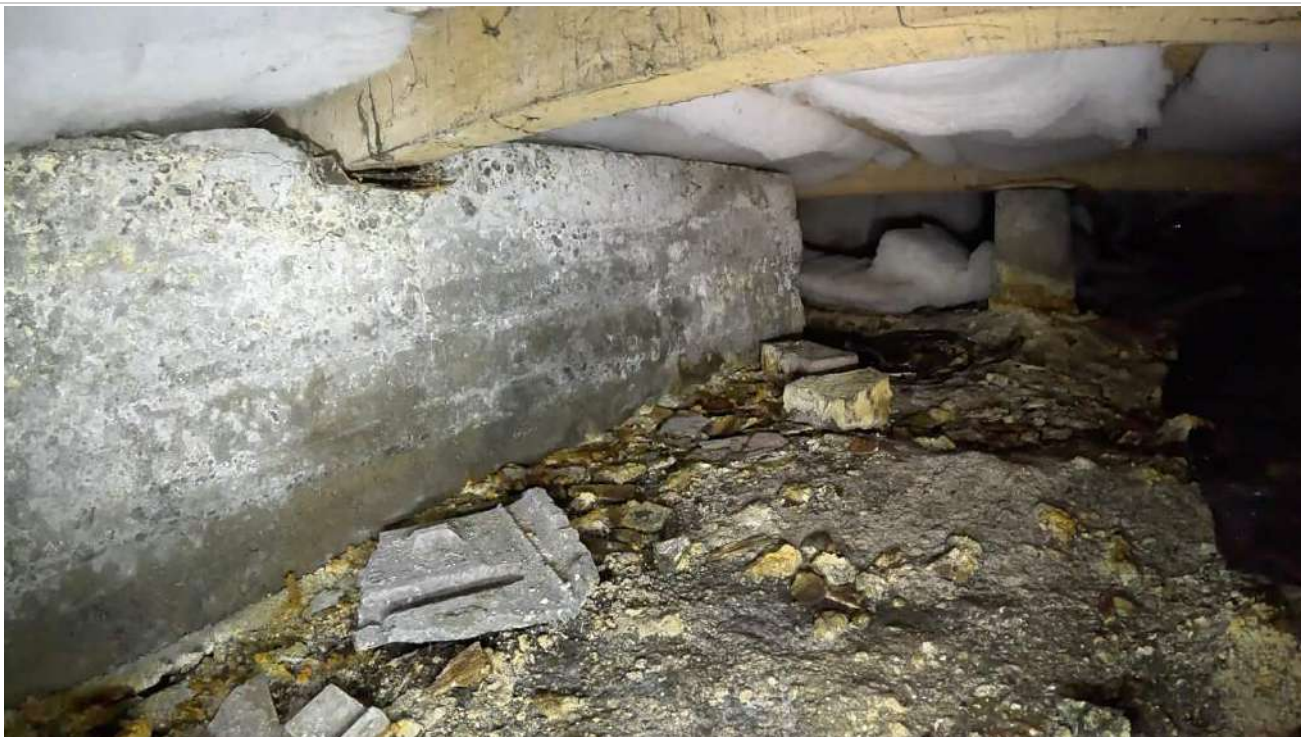
29: View of bearer meeting concrete base.

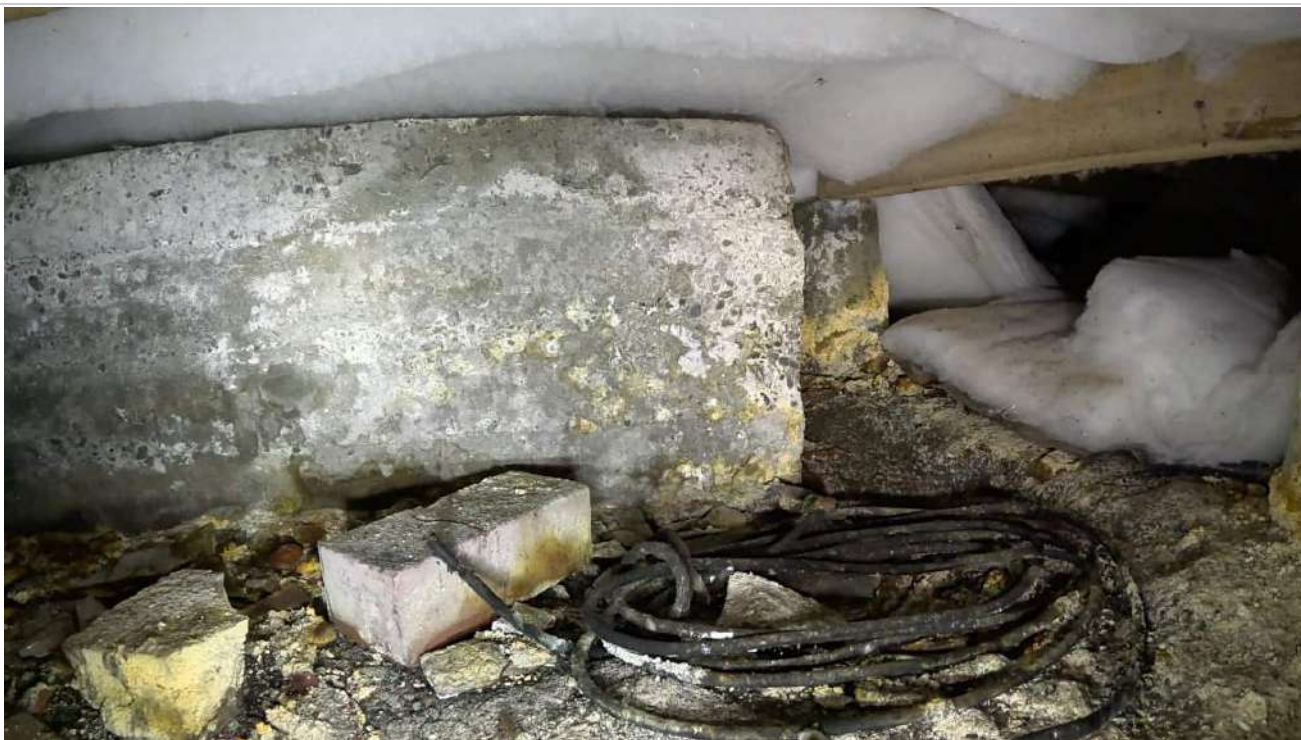
30: View of concrete base.

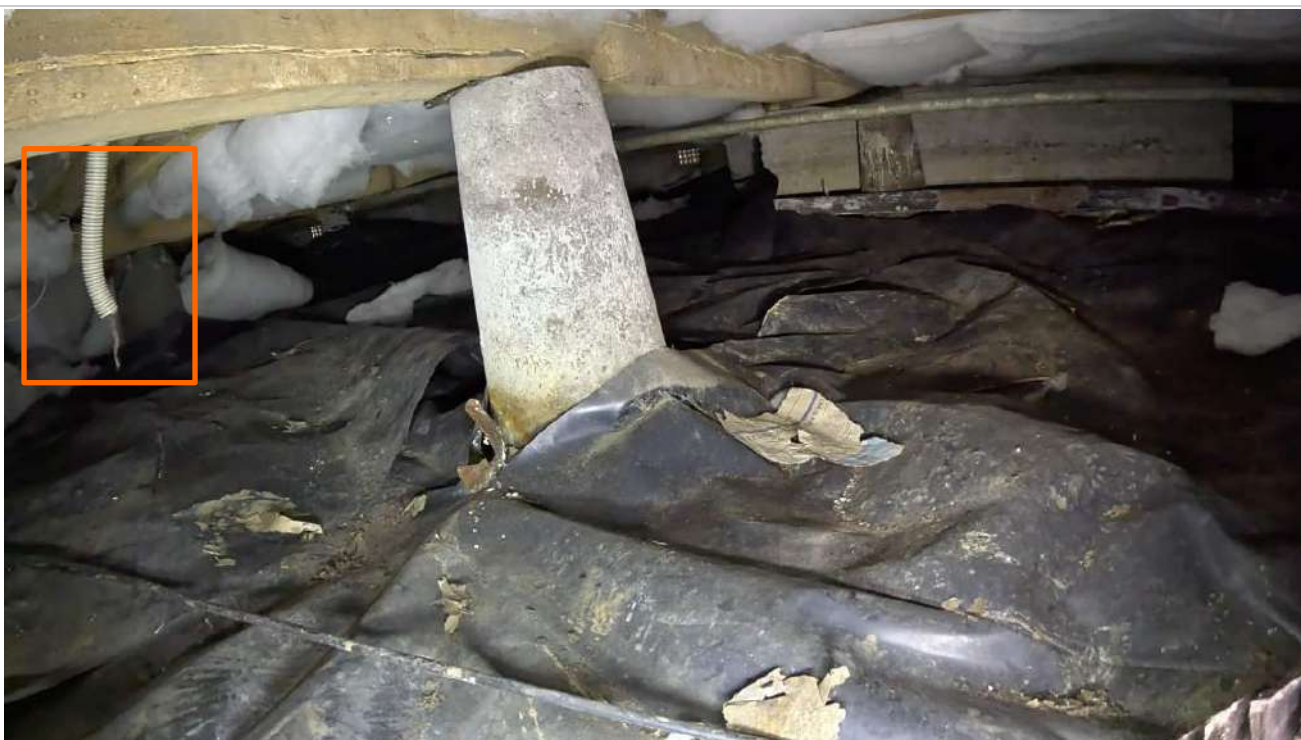
33: Precast concrete pile with no connection. Here we see a heat pump drain. It is discharging to ground but should be vented to the outside.

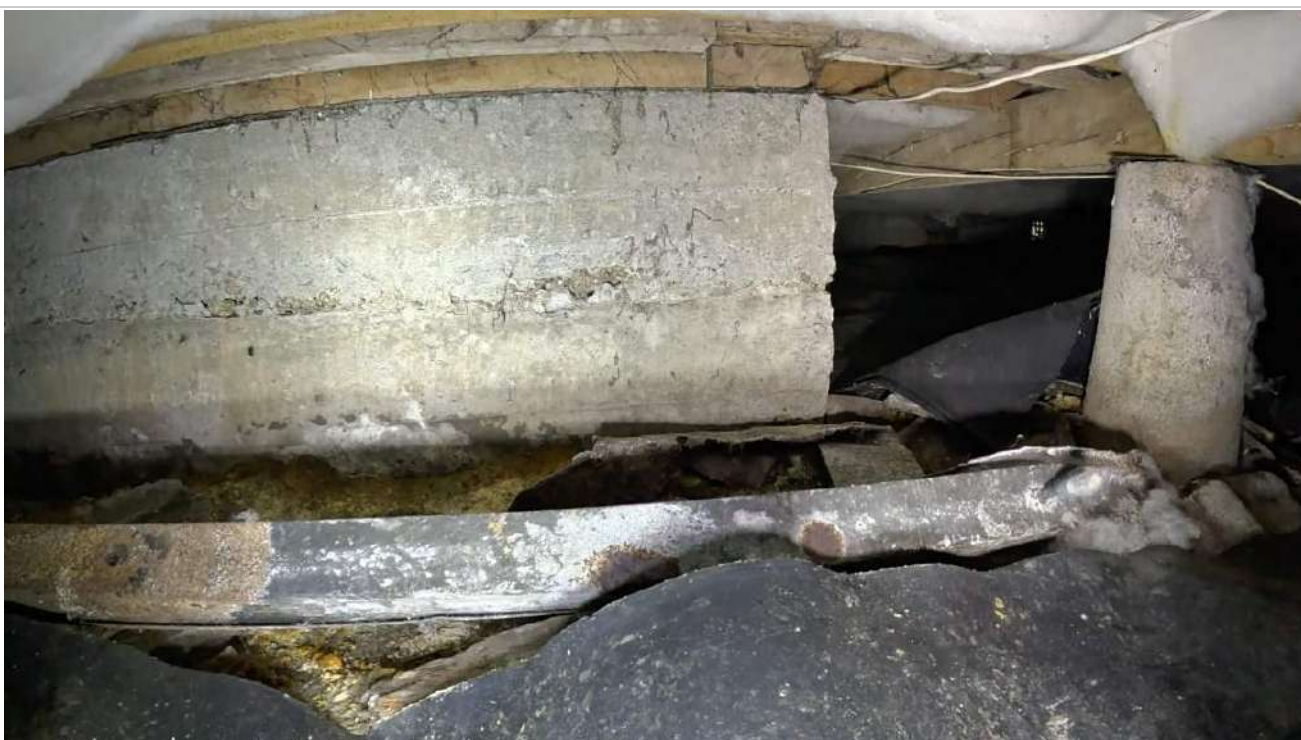
34: View of concrete base.

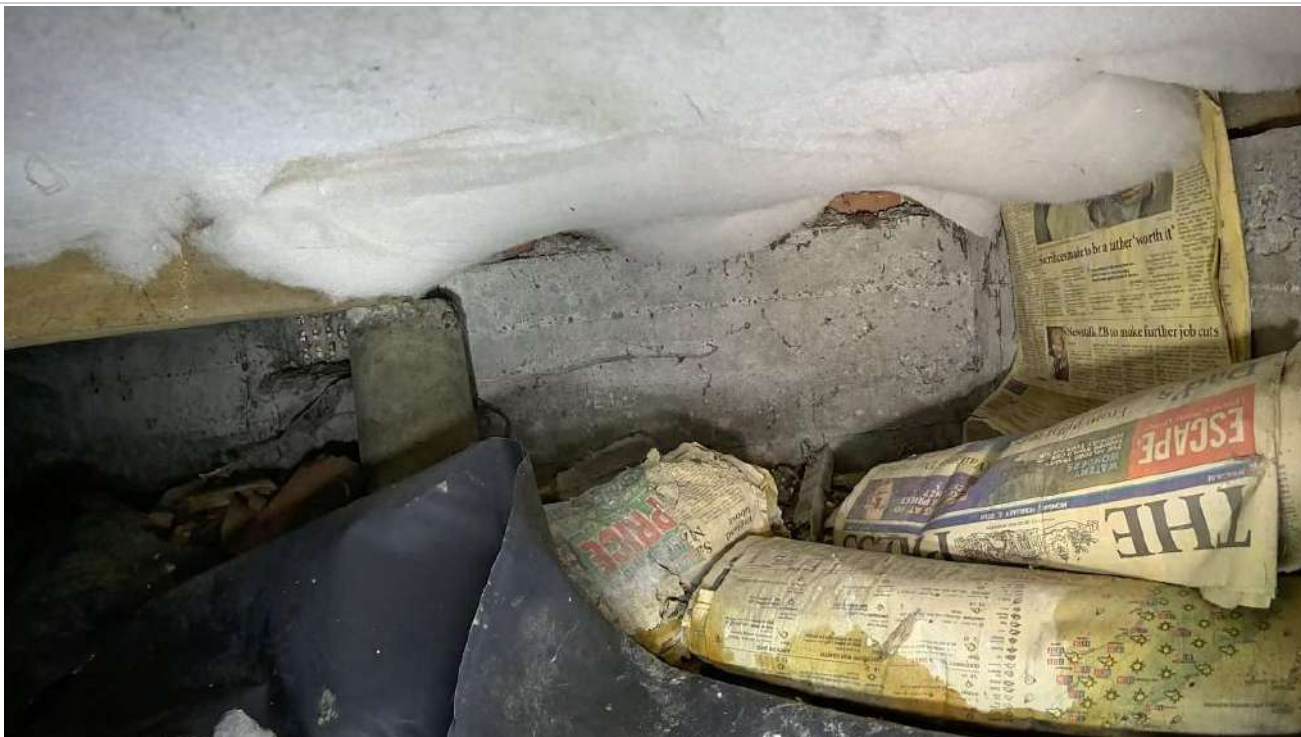
37: Precast concrete pile with no connection.

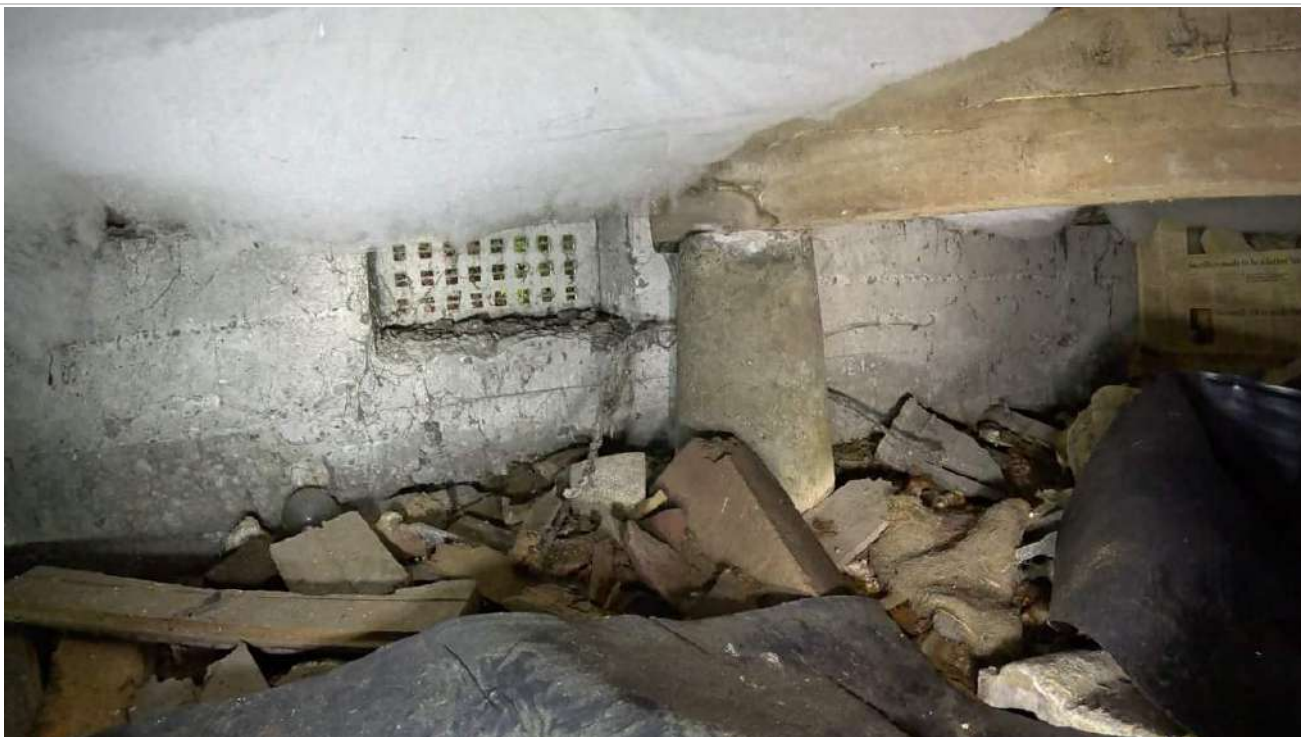
38: Precast concrete pile with no connection.

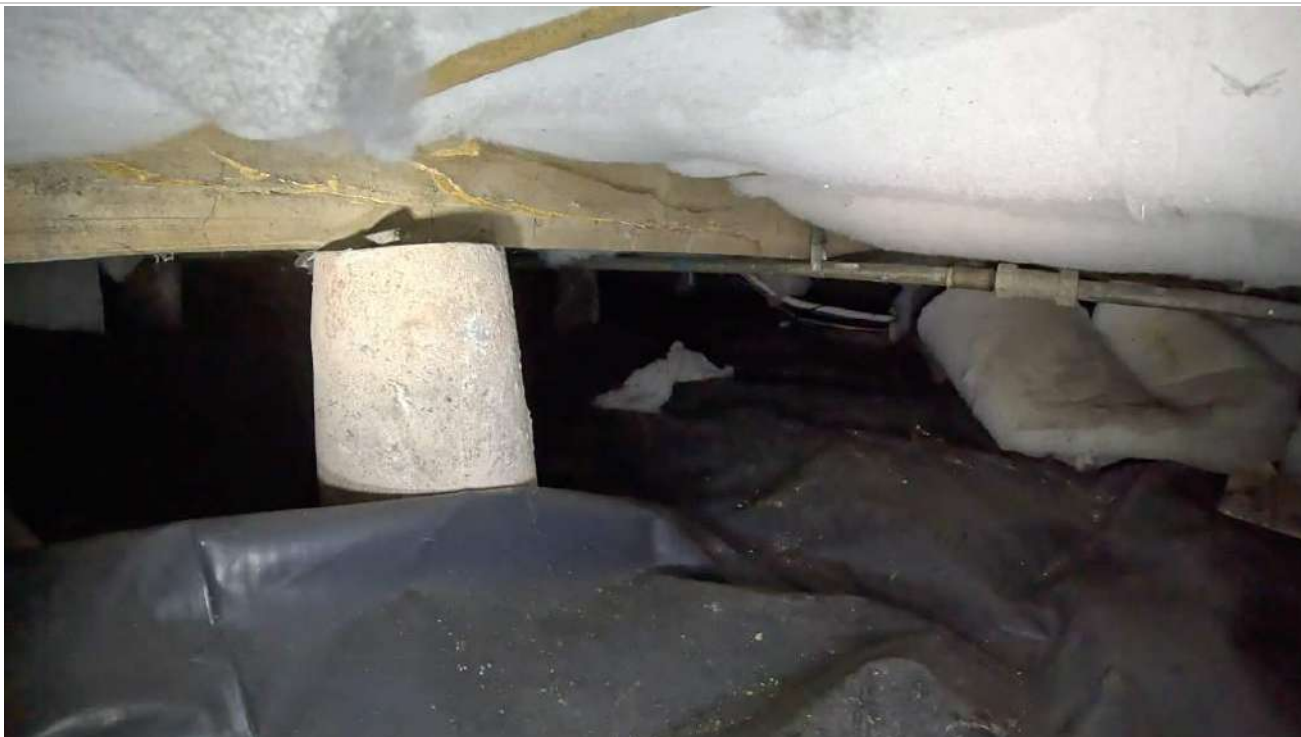
39: Precast concrete pile with no connection.

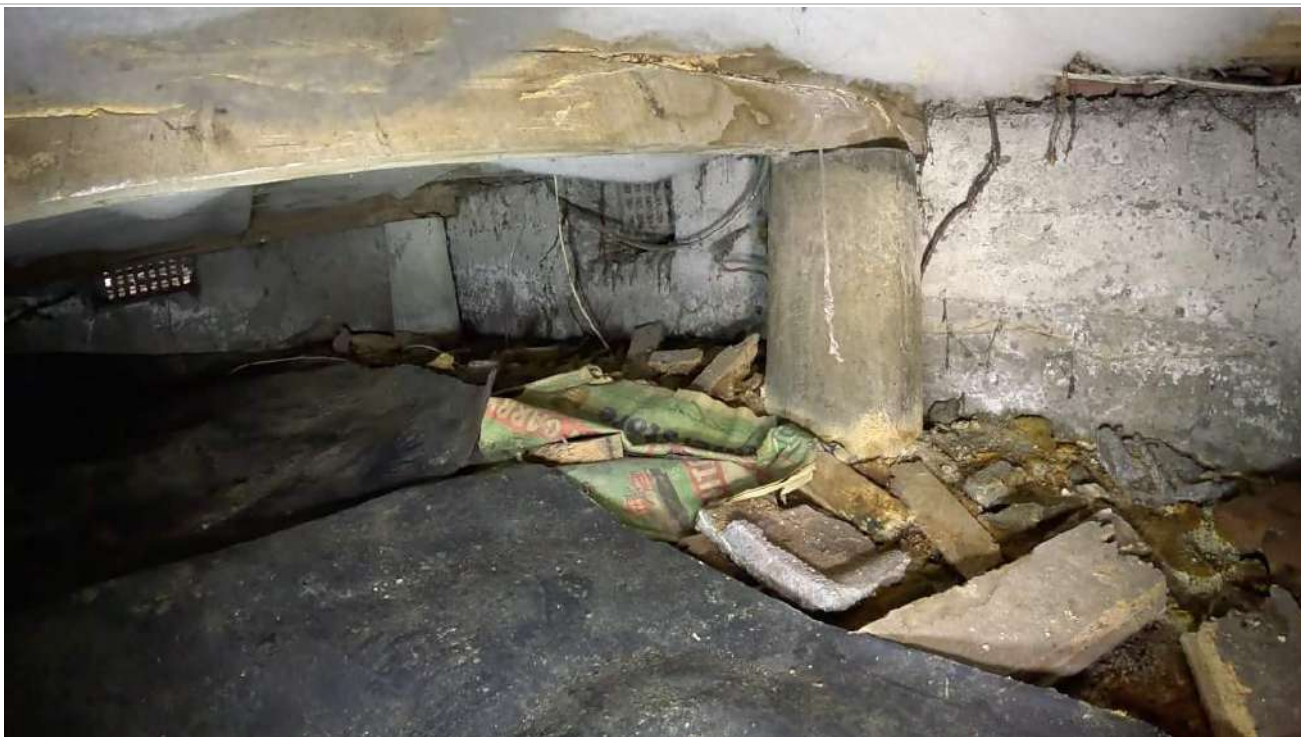
40: Precast concrete pile with no connection.

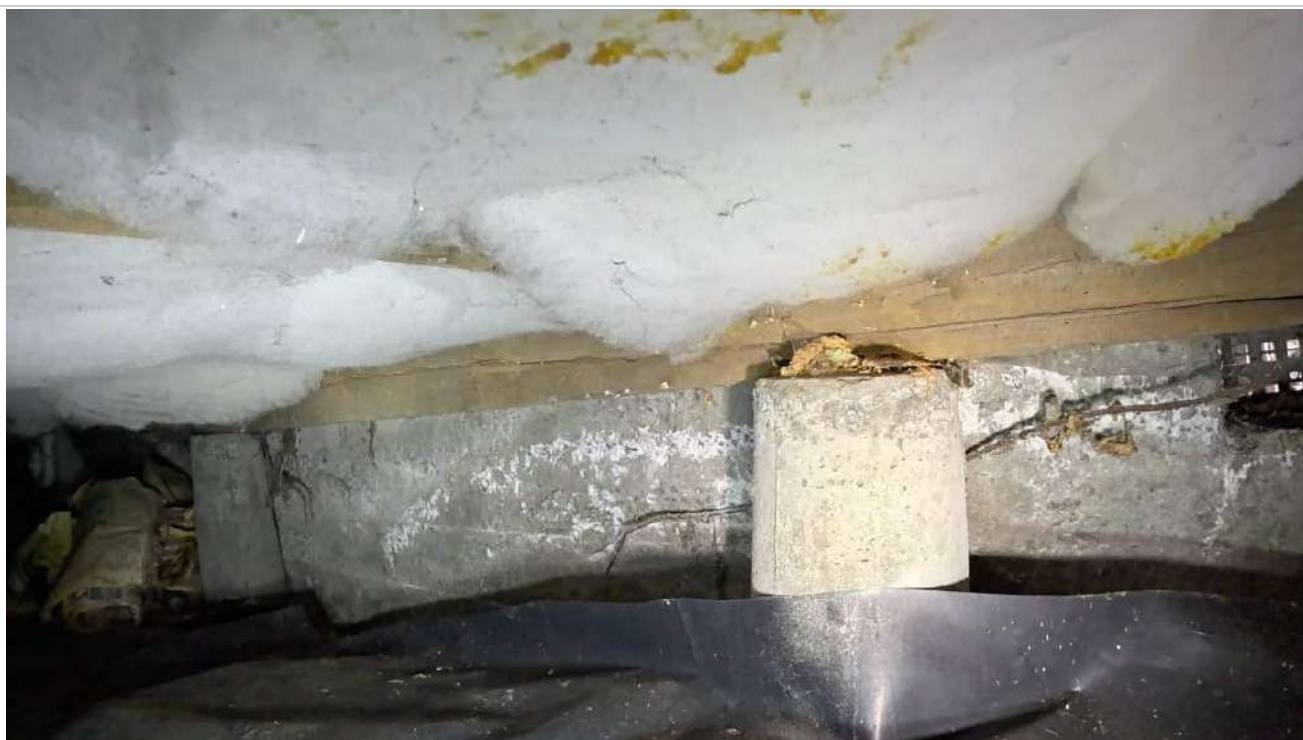
43: Precast concrete pile with no connection and the pile leans to the right.

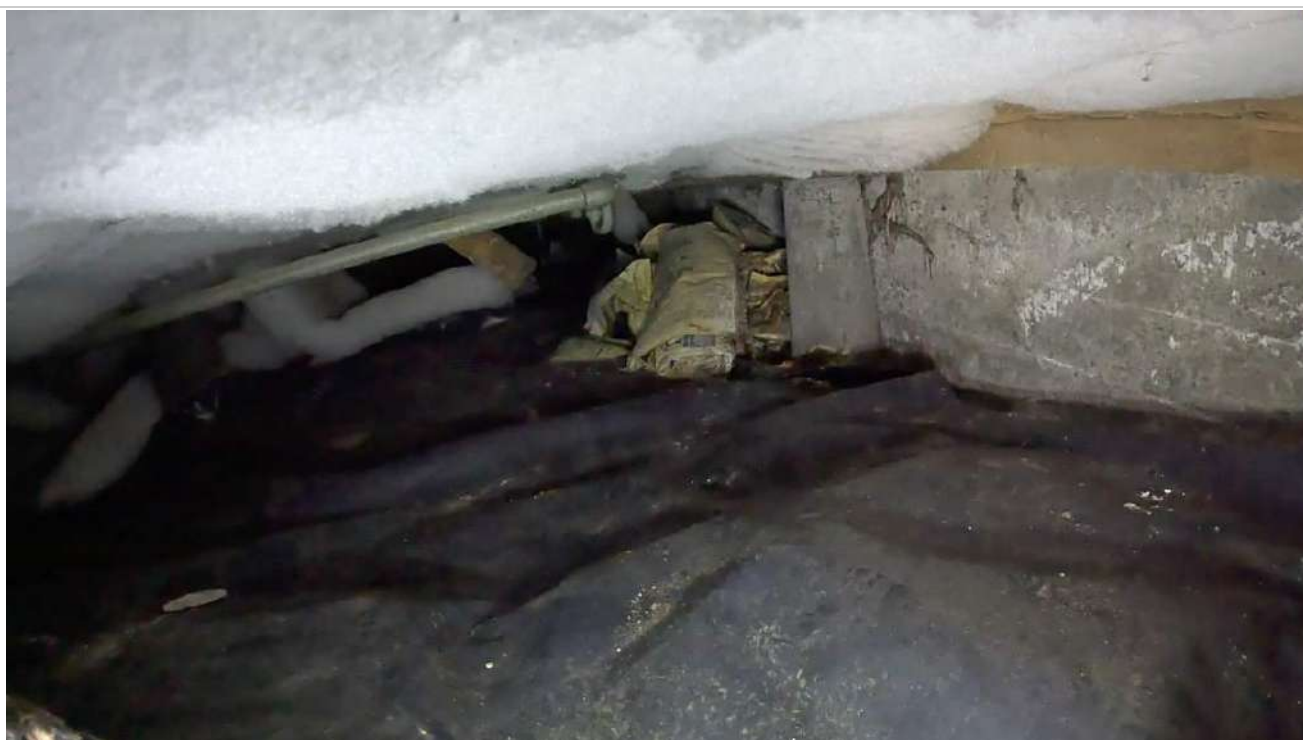
44: The ground level appears to drop in this area.

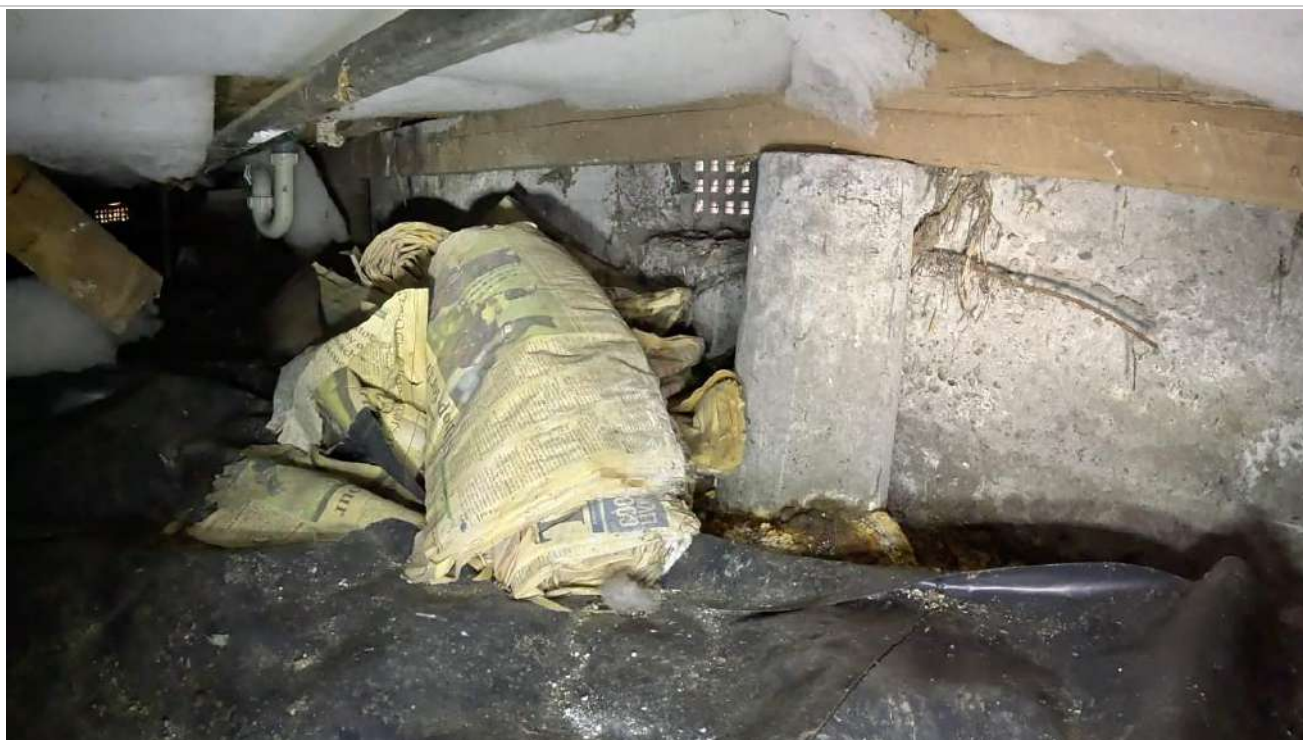
45: Precast concrete pile with no connection and the pile leans to the right.

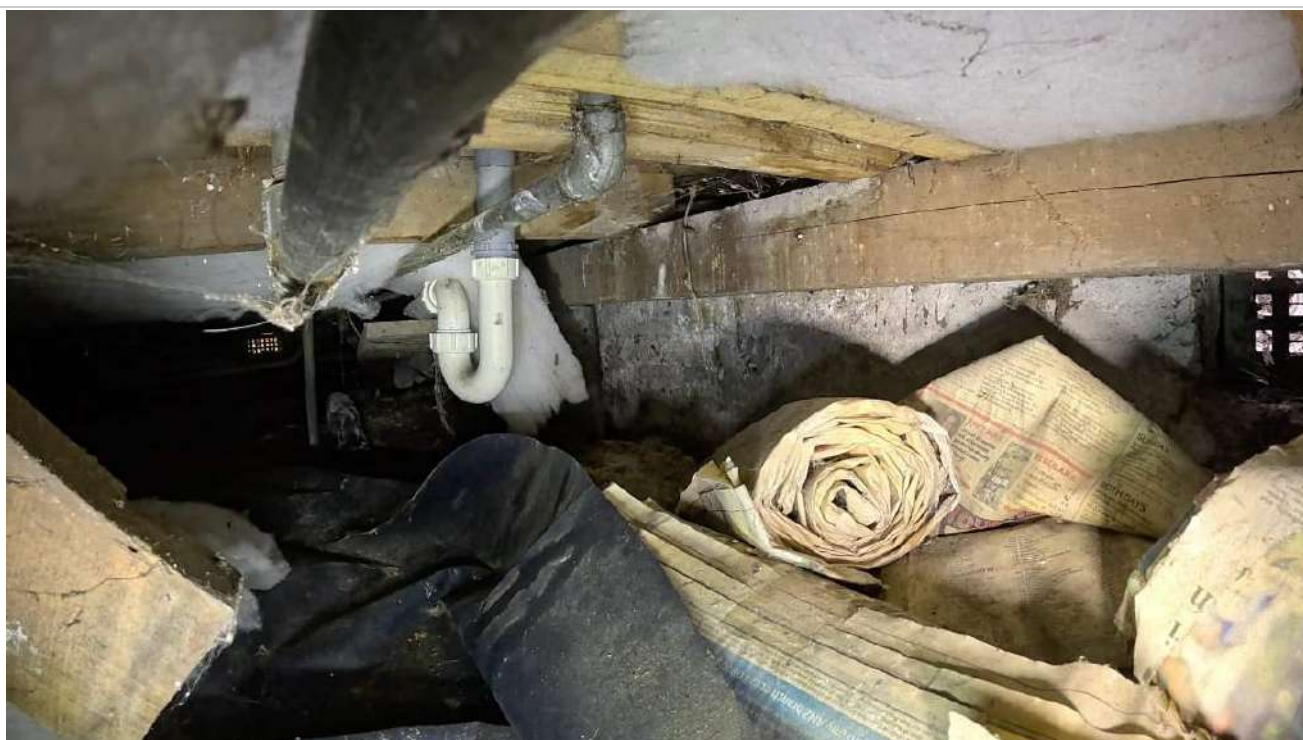
46: View along ring foundation with services.

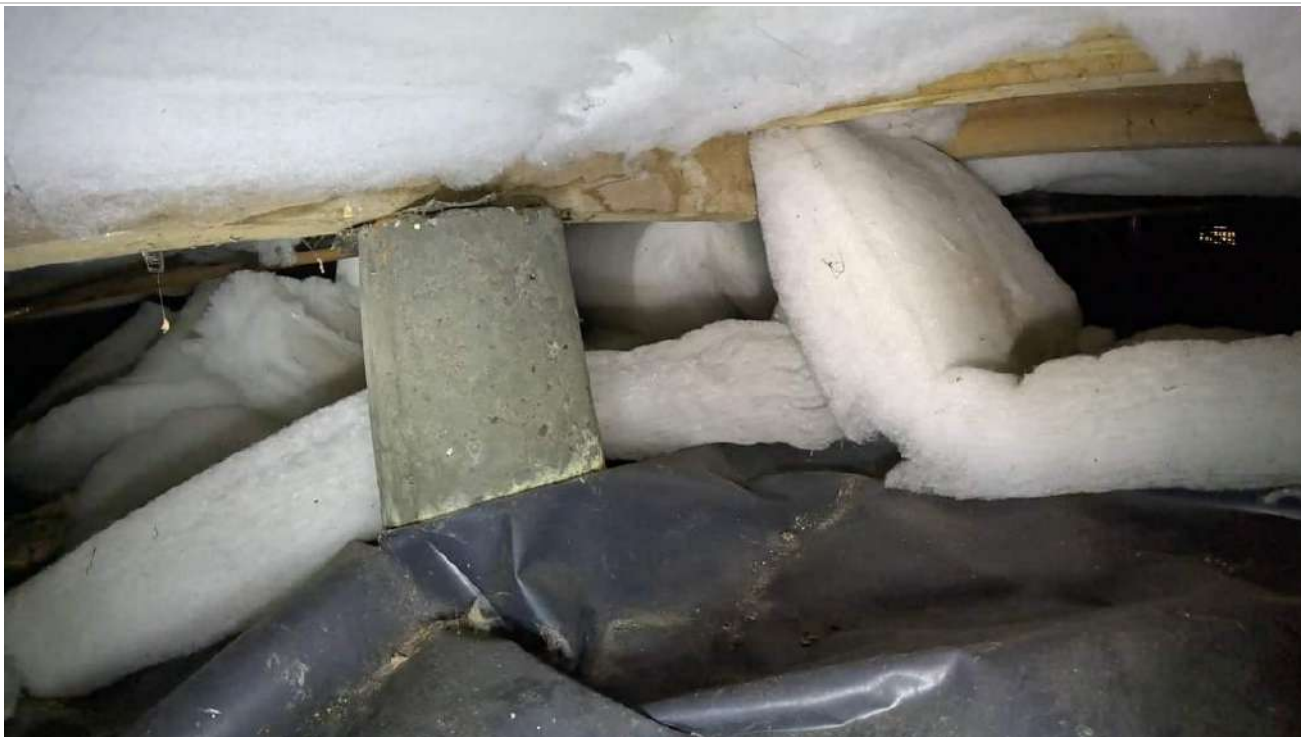
47: Precast concrete pile with no connection.

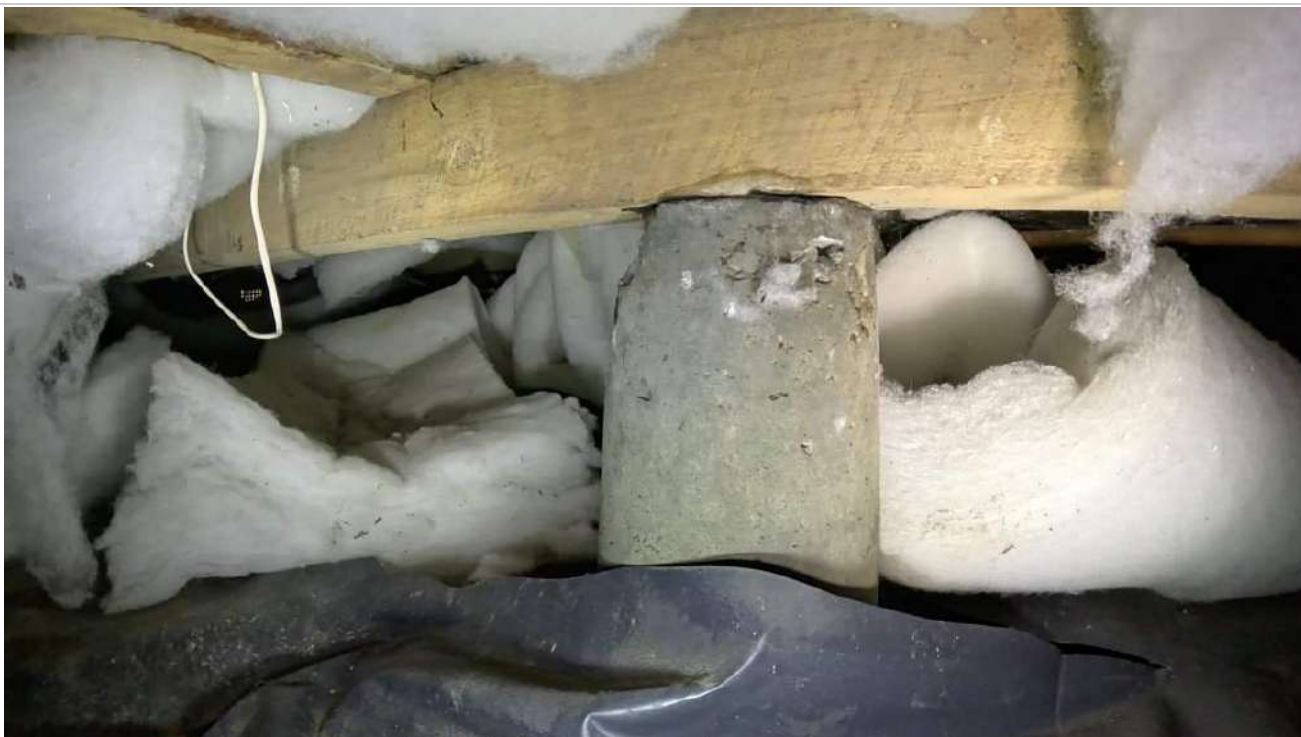
48: Precast concrete pile with no connection.
