# EARTHQUAKE REPAIR

## 425 & 427 ARMAGH STREET

**IN RESPECT OF:** Structural Design of Foundation Repair for 425 & 427, Internal Alterations at Nr. 425 only  
(Description of Building Work)

## TR001: Technical Report – Desktop Technical Review & Structural Inspection

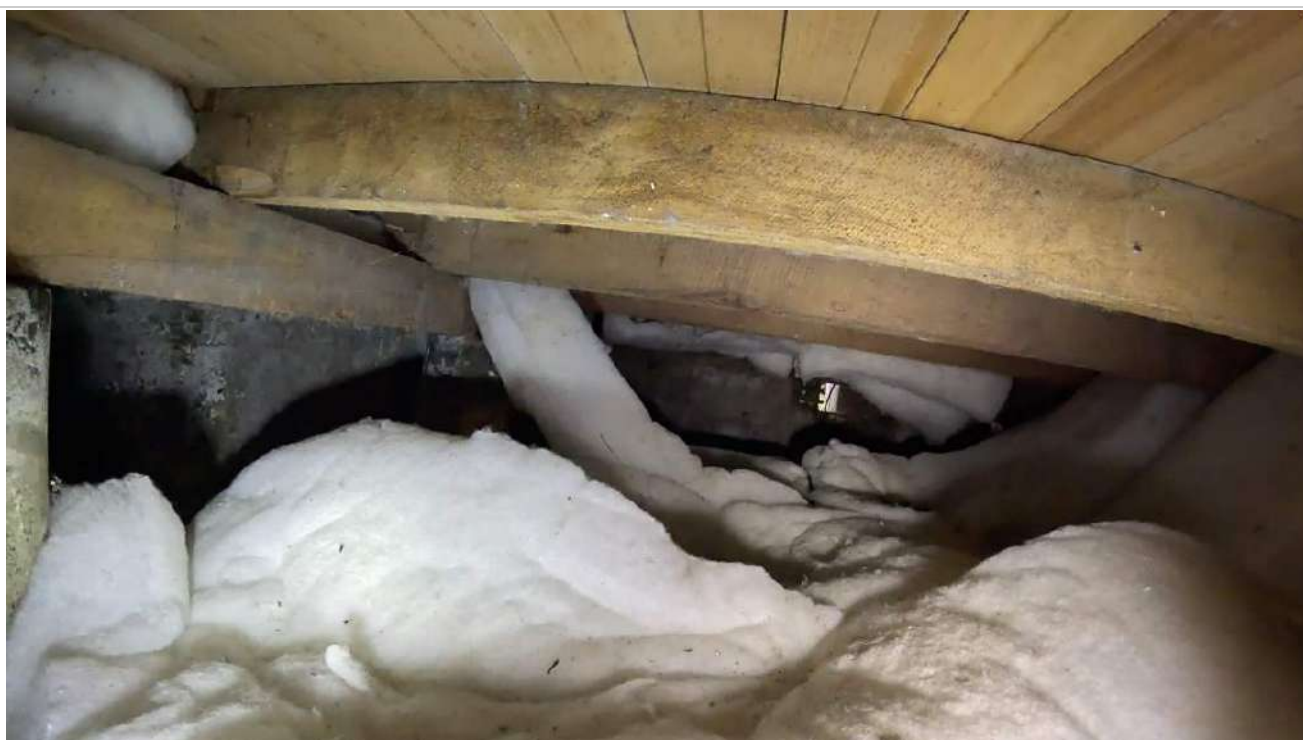
50: We were unable to proceed any further.
