| <b>Date</b> | 26 March 2025 | <b>Job Ref.</b> | CLM/2011/122912 |
| <b>Address</b> | 427 Armagh Street, Linwood, Christchurch 8011 | <b>Author</b> | J McCloskey |

## TR001: Technical Report – Desktop Technical Review & Structural Inspection

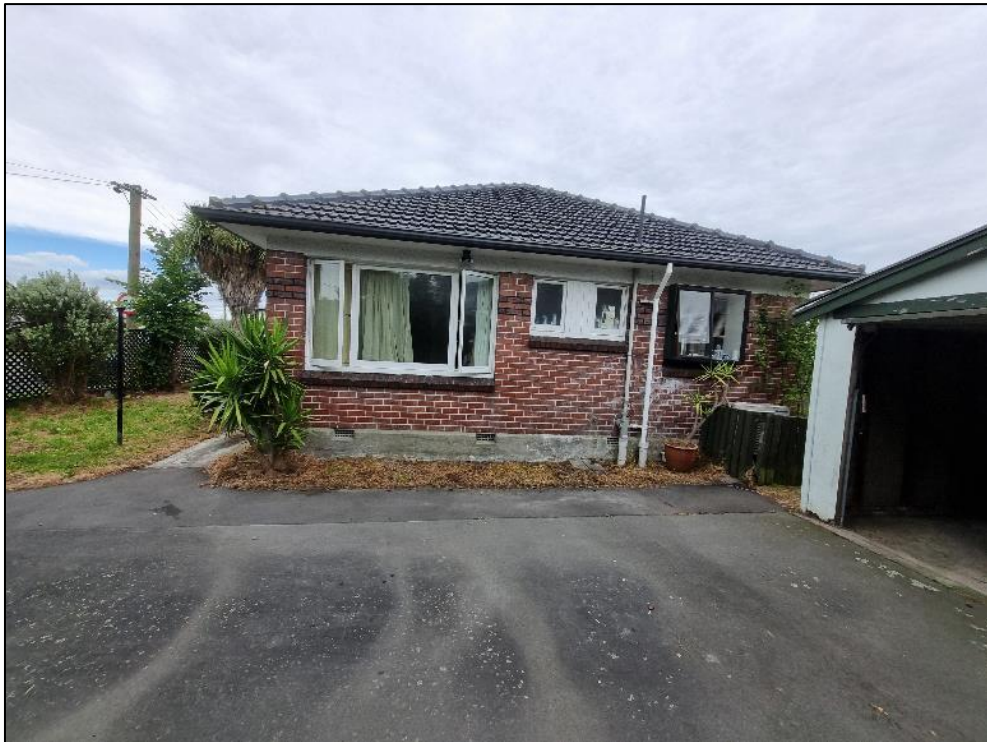
Photo 2B – East elevation.

- Brick cladding cracking and separations were identified along the concrete beams that are seated on top of the veneer along the eastern elevation (Photos 3E and 3F). This damage was noted in the post-earthquake scopes and EQC land assessment. It appears that some of these repairs were carried out, however several of the separations along the top of the wall remain unrepaired.

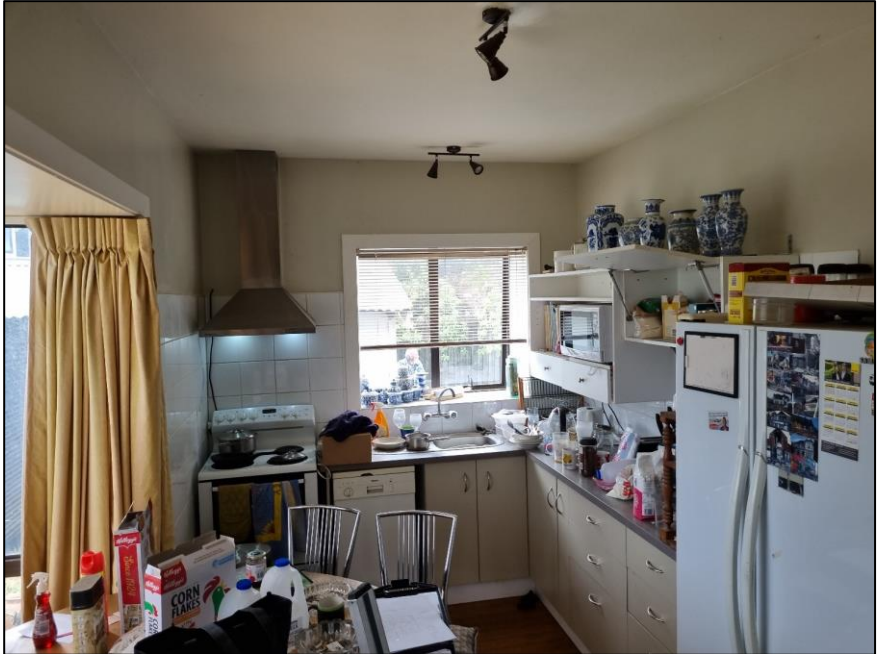
Photo 4A –Kitchen floors , ceilings and built in benchtops all fall to the north.

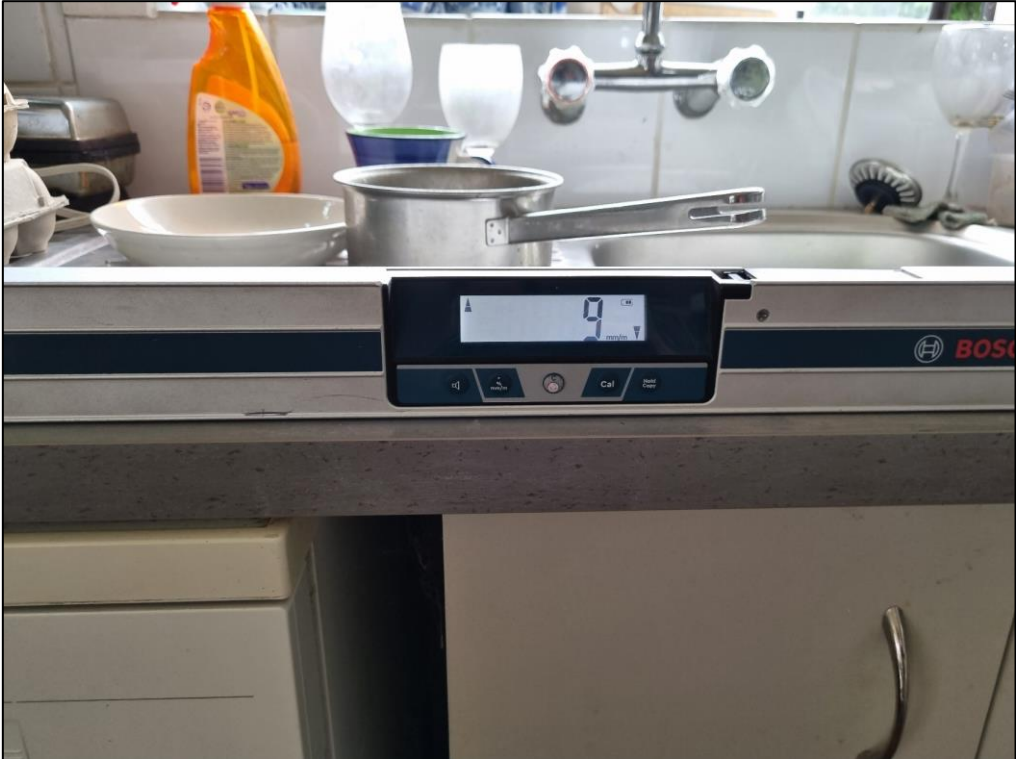
Photo 4B Kitchen bench along the eastern wall falling to the north by 9mm/m , following the floor and ceilings.

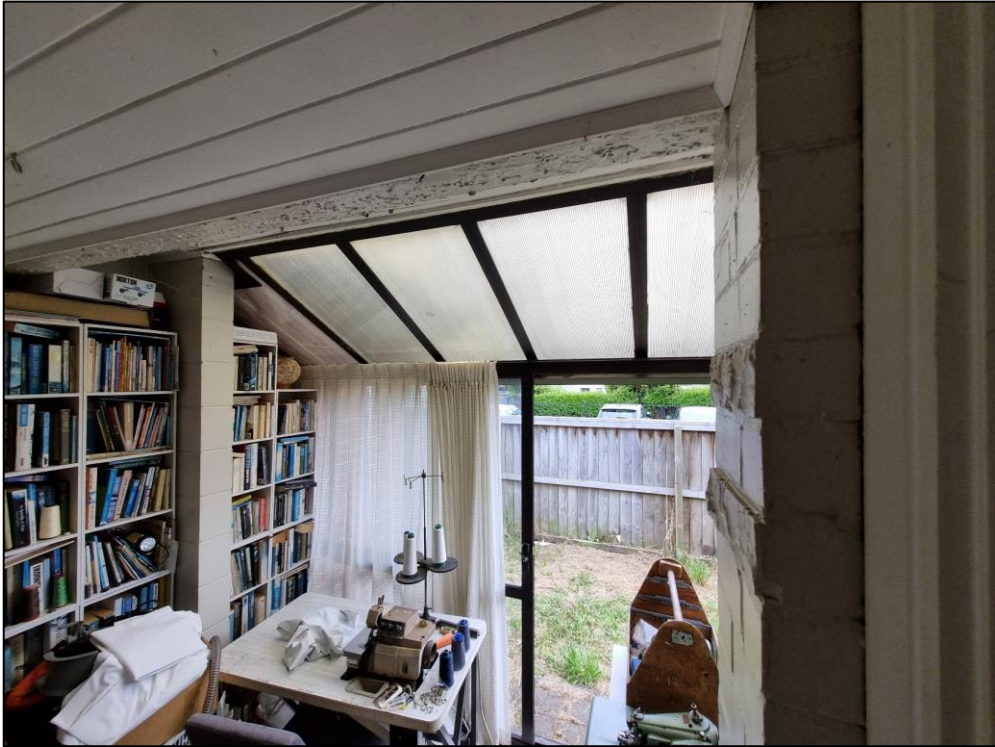
Photo 4C – Porch area used as storage.

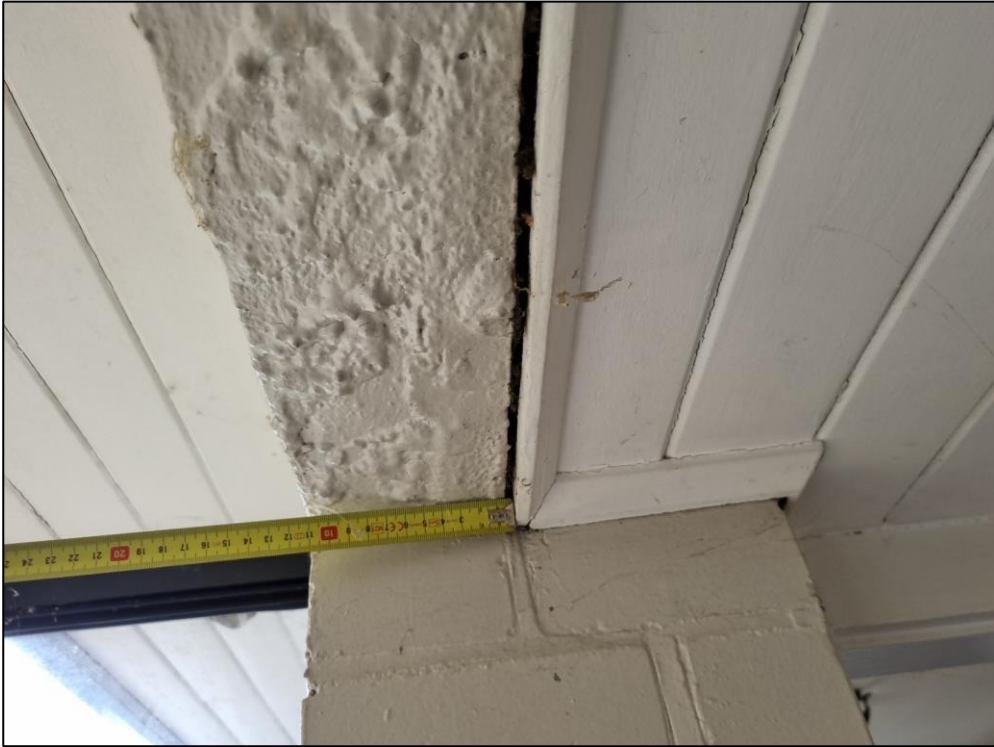
- The porch is founded on a concrete slab-on-grade and is a step down from the kitchen and laundry floor level. The slab was scanned using a Hilti PS50 Multidetector and no reinforcing was detected. Photo 4D shows minor separations between the concrete lintel and the soffit framing.
- The partition wall dividing the two dwellings forms the west and north wall of the laundry. The post-earthquake scopes allowed for mortar crack repairs to the blockwork and for the wall to be repainted which suggests some differential settlement occurred along this wall during the CES. No cracks were identified along the visible area of wall during the NZCSE assessment.

Photo 4D –Minor separation between the timber trim and the concrete lintel above the porch.

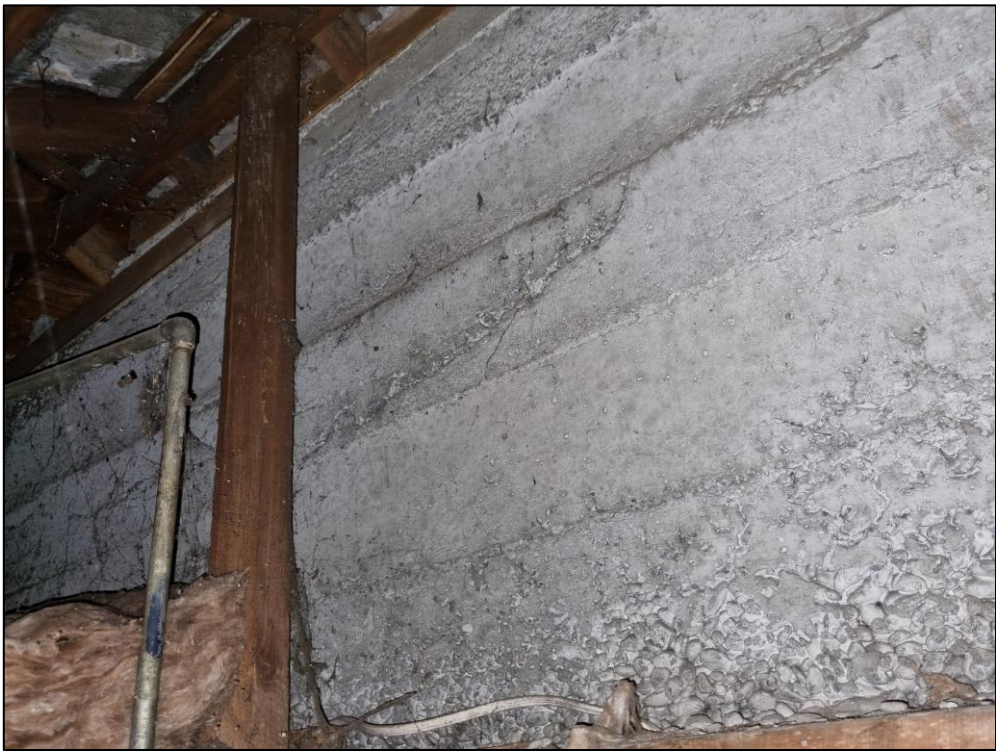
Photo 6B – Partition wall is partly constructed from poured in situ concrete above the ceiling line. Concrete pour joints ( cold joints) can be seen.

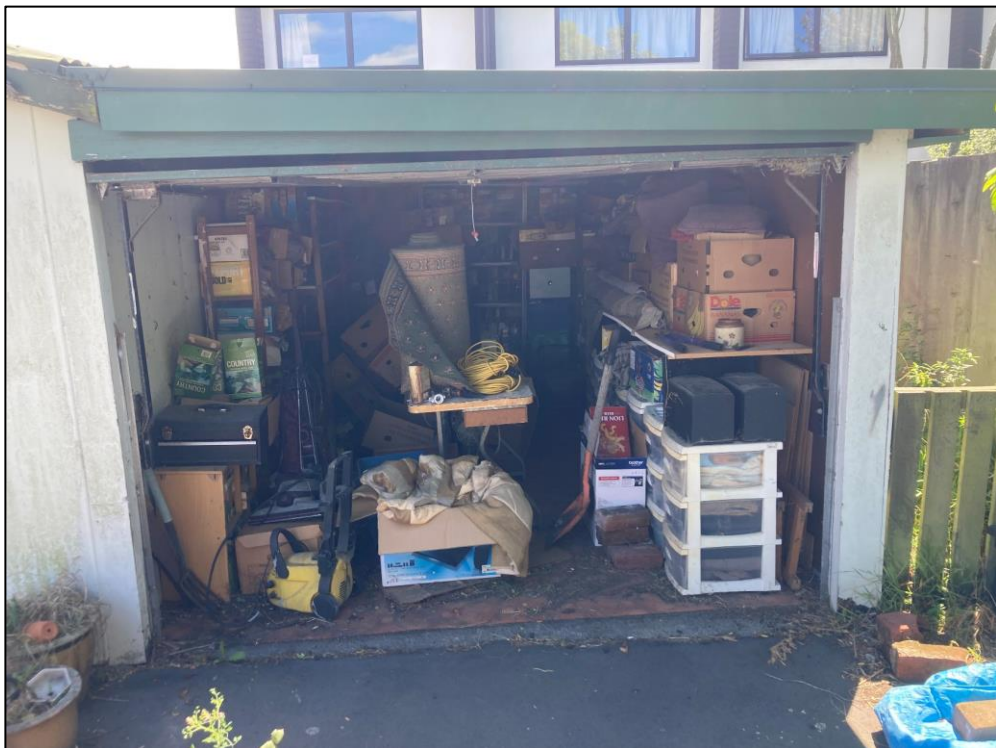
Photo 7B – Garage was full of storage at the time of the assessment. Door head was measured to be level over sloping concrete slab.

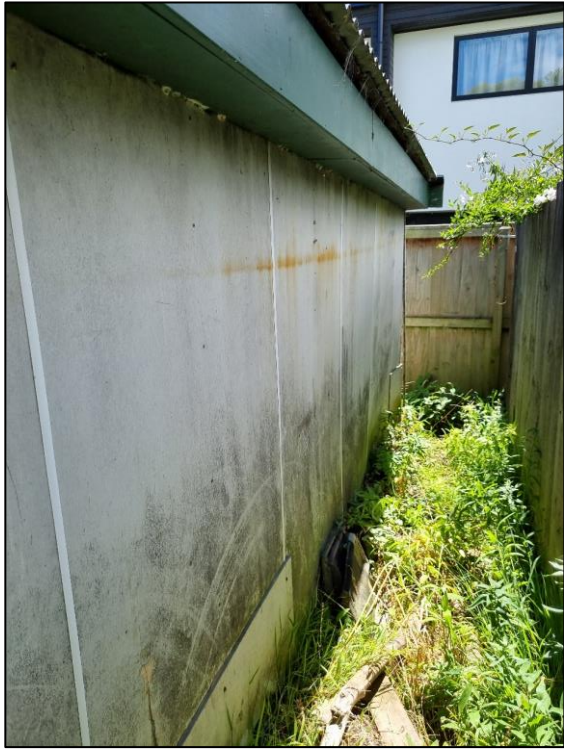
Photo 7C –Garage east elevation . Cladding is undamaged,. No stormwater guttering has been fitted.

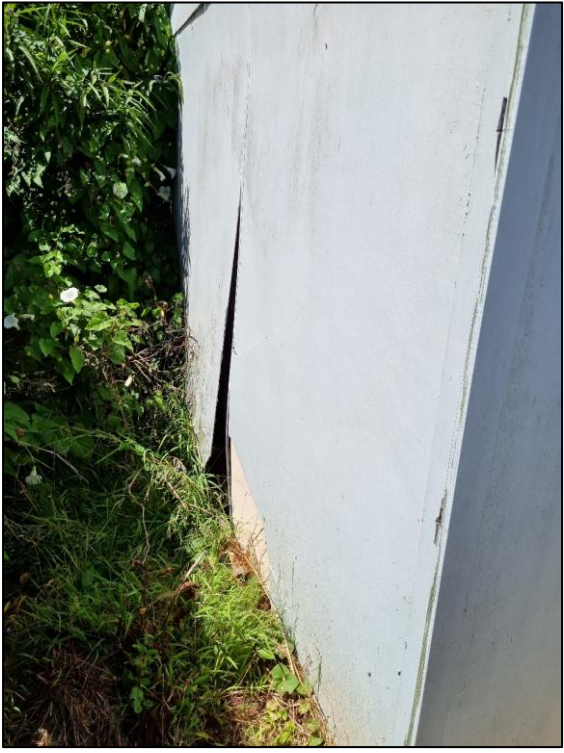
Photo 7D – North Elevation. Cladding sheet need to be refixed.

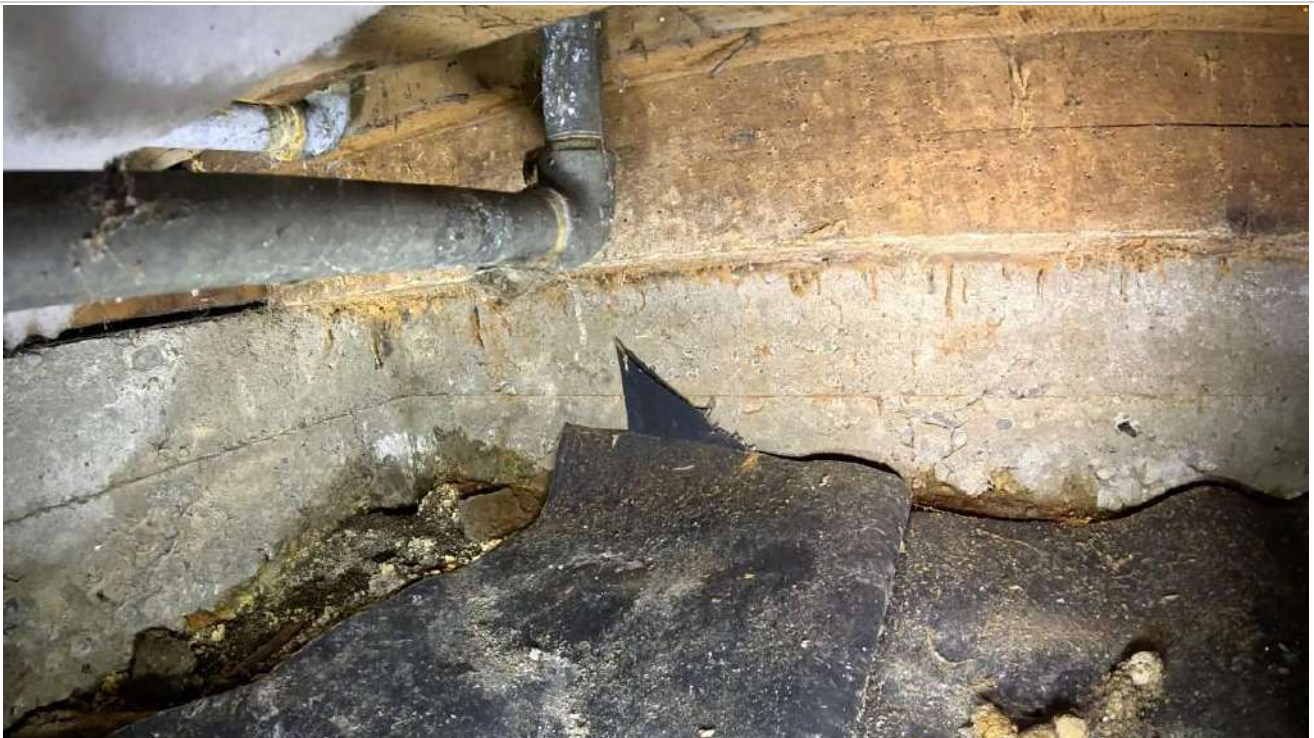
3: View along party wall foundation.

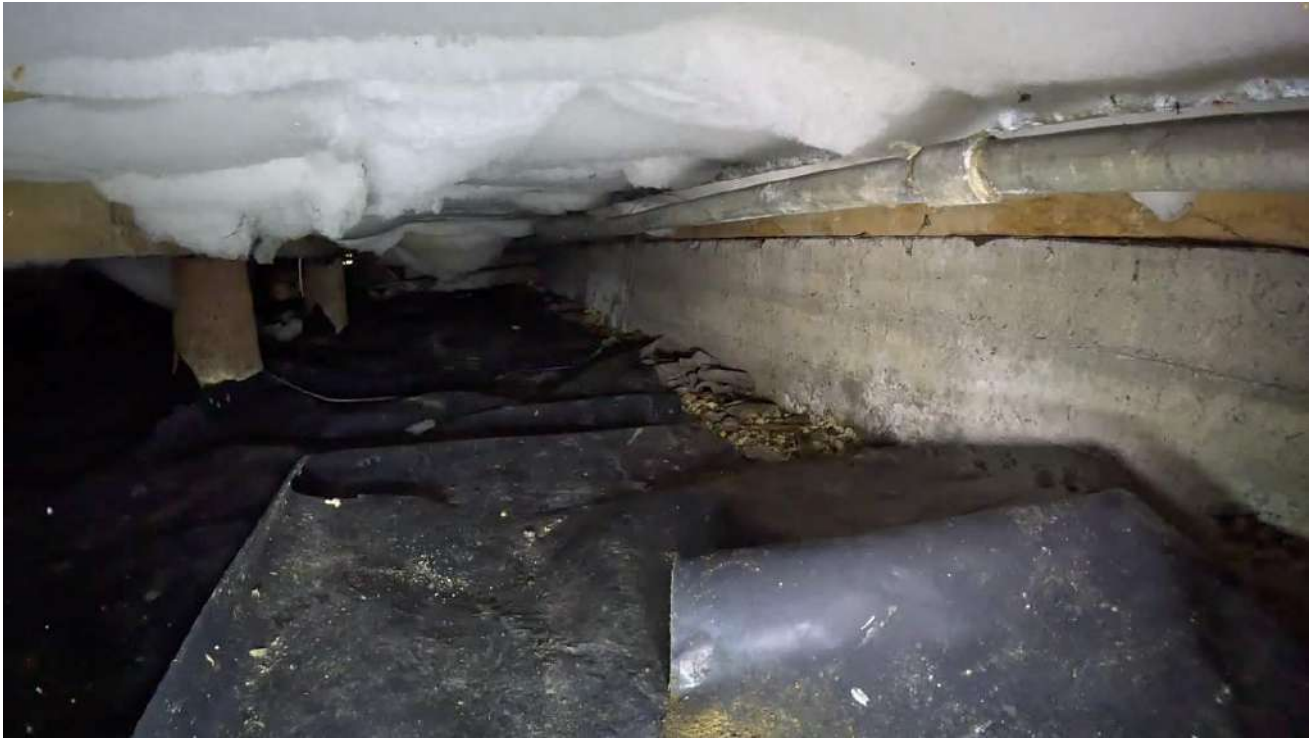
4: View of foundation.

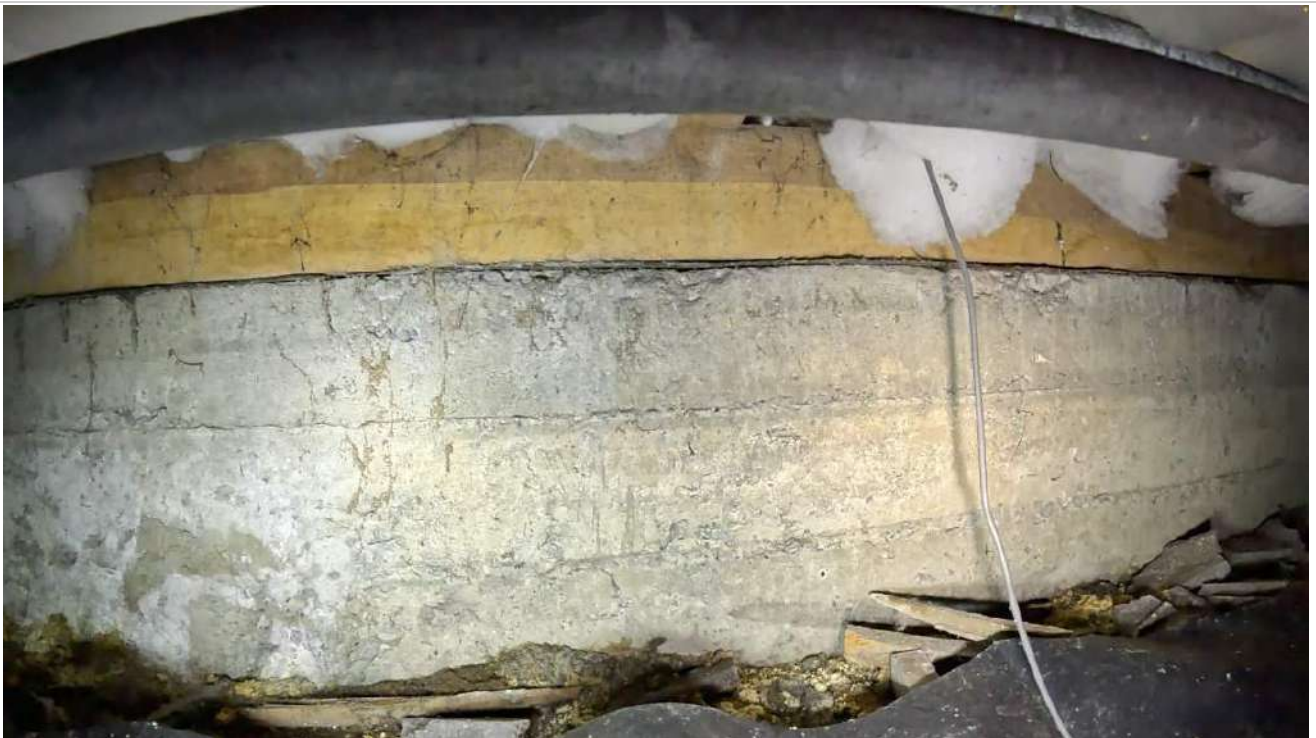
5: There are a lot of services and batts that have been pulled down that obstructed our access.

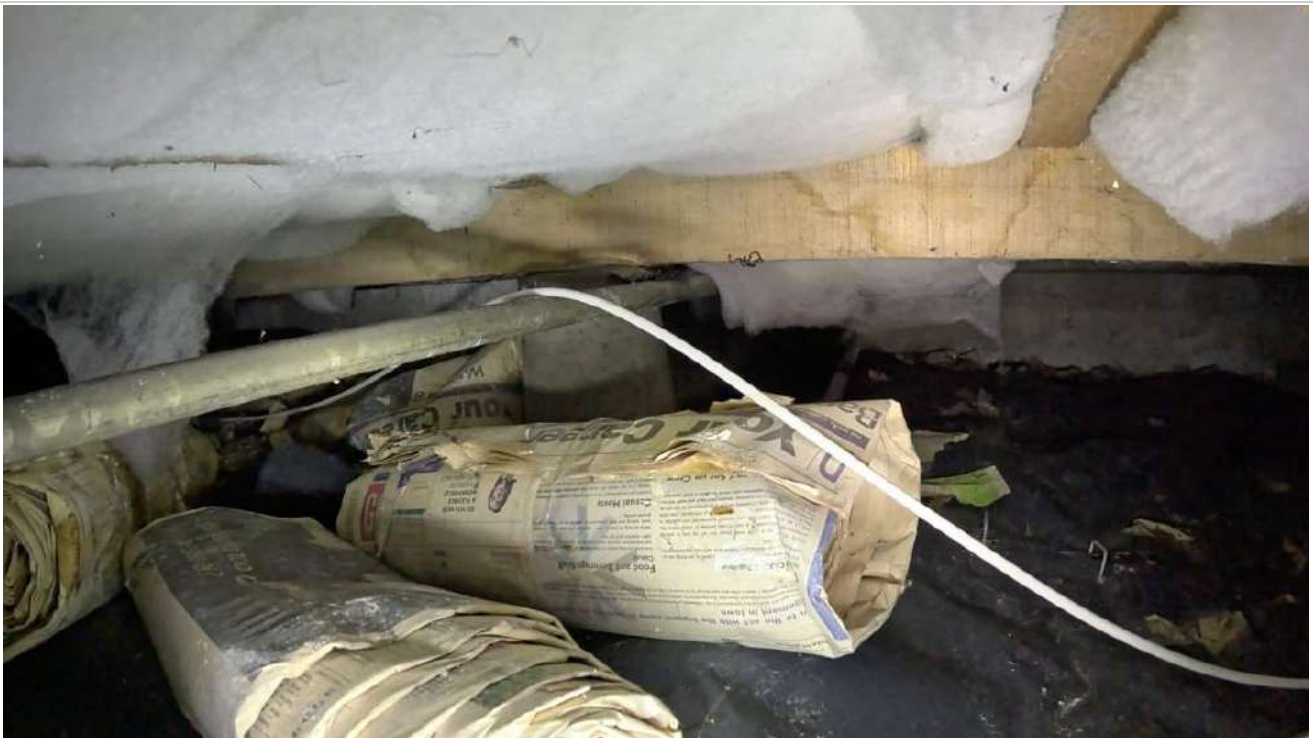
7: Precast concrete pile with no connection.

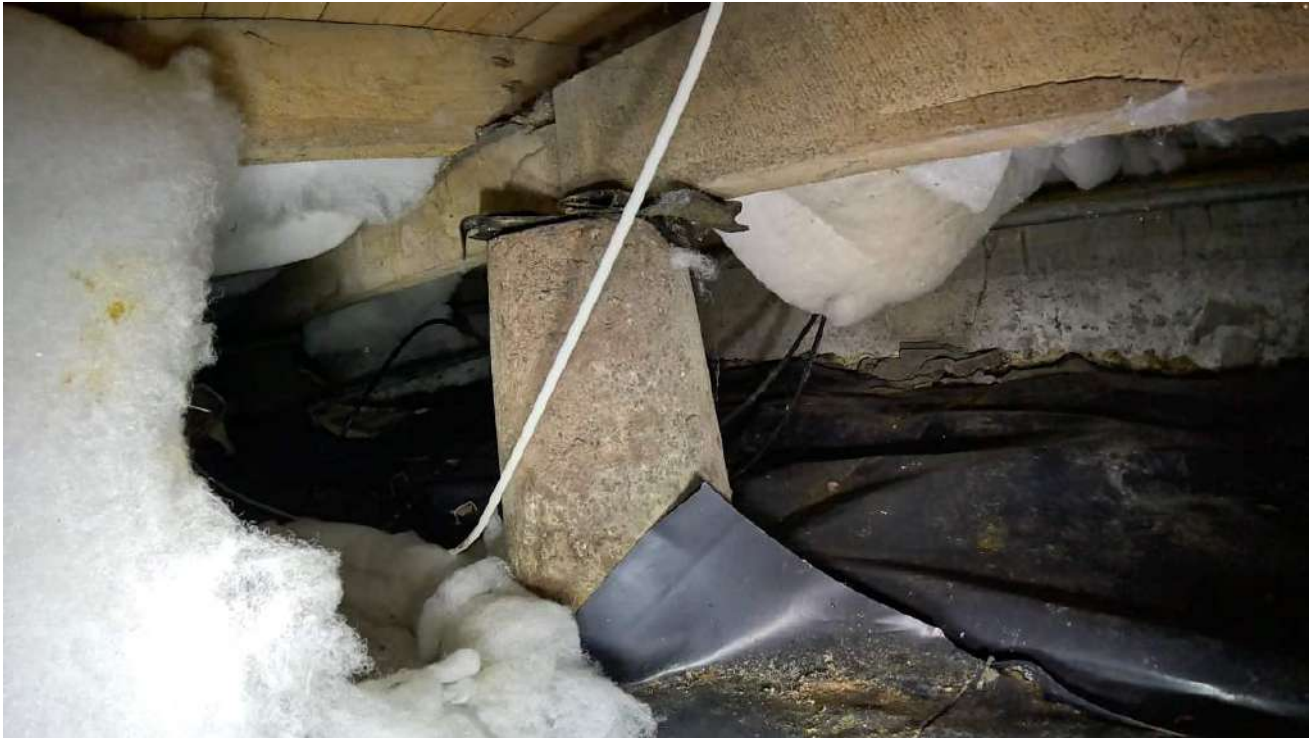
8: Precast concrete pile with no connection.

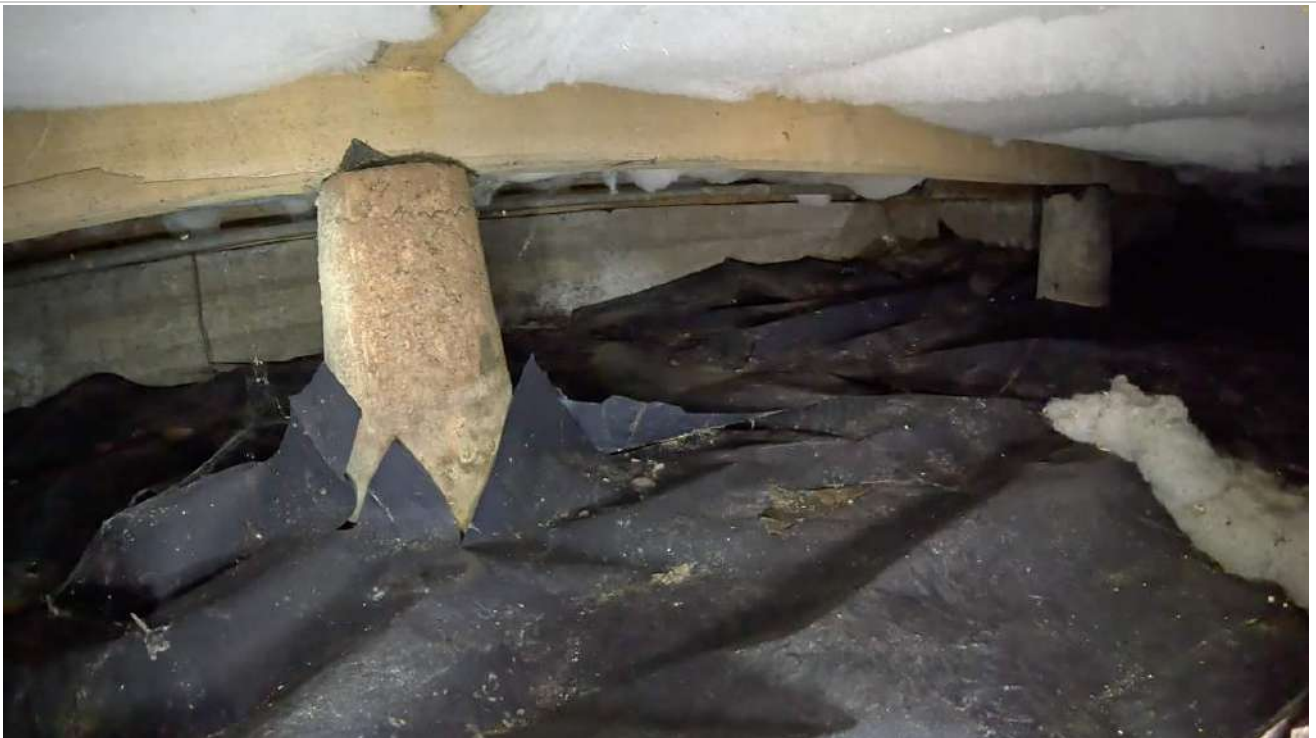
9: Precast concrete pile with no connection.

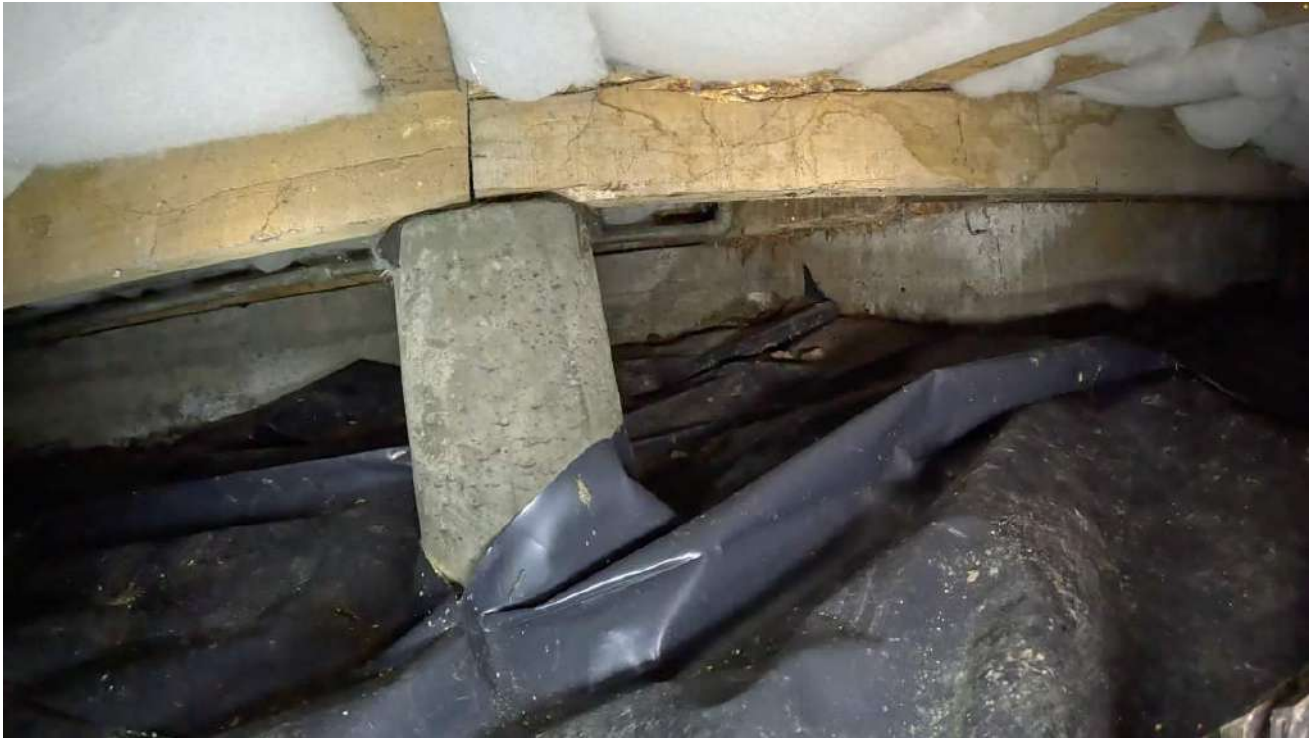
10: Precast concrete pile with no connection.

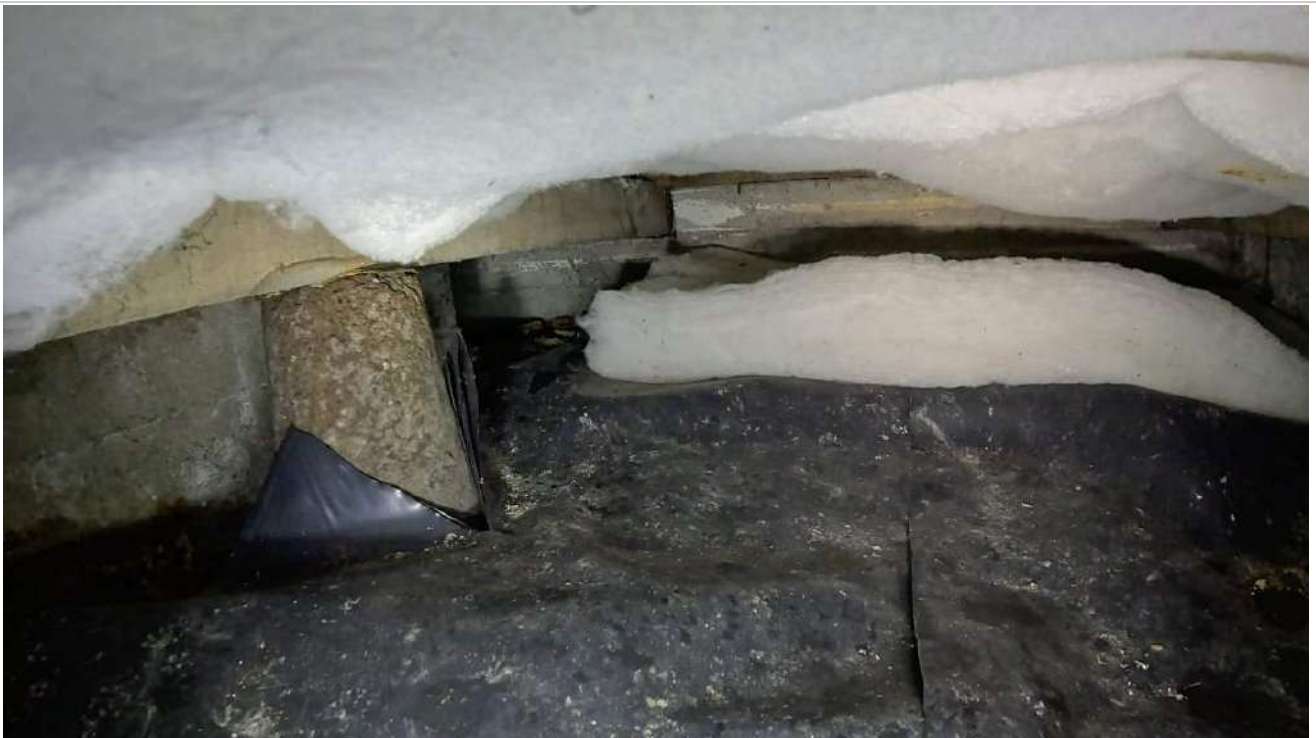
11: I think that there is a concrete base here, but I am not completely sure of the layout.

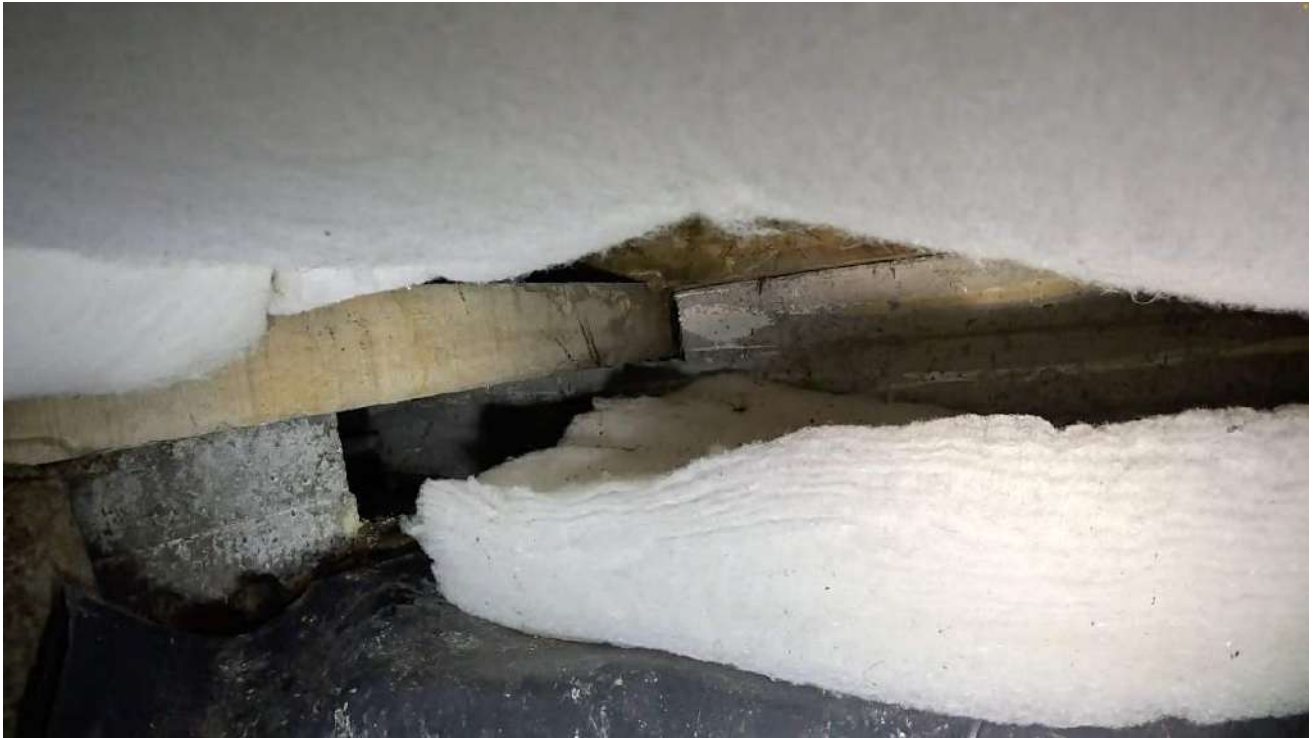
12: View of foundation.

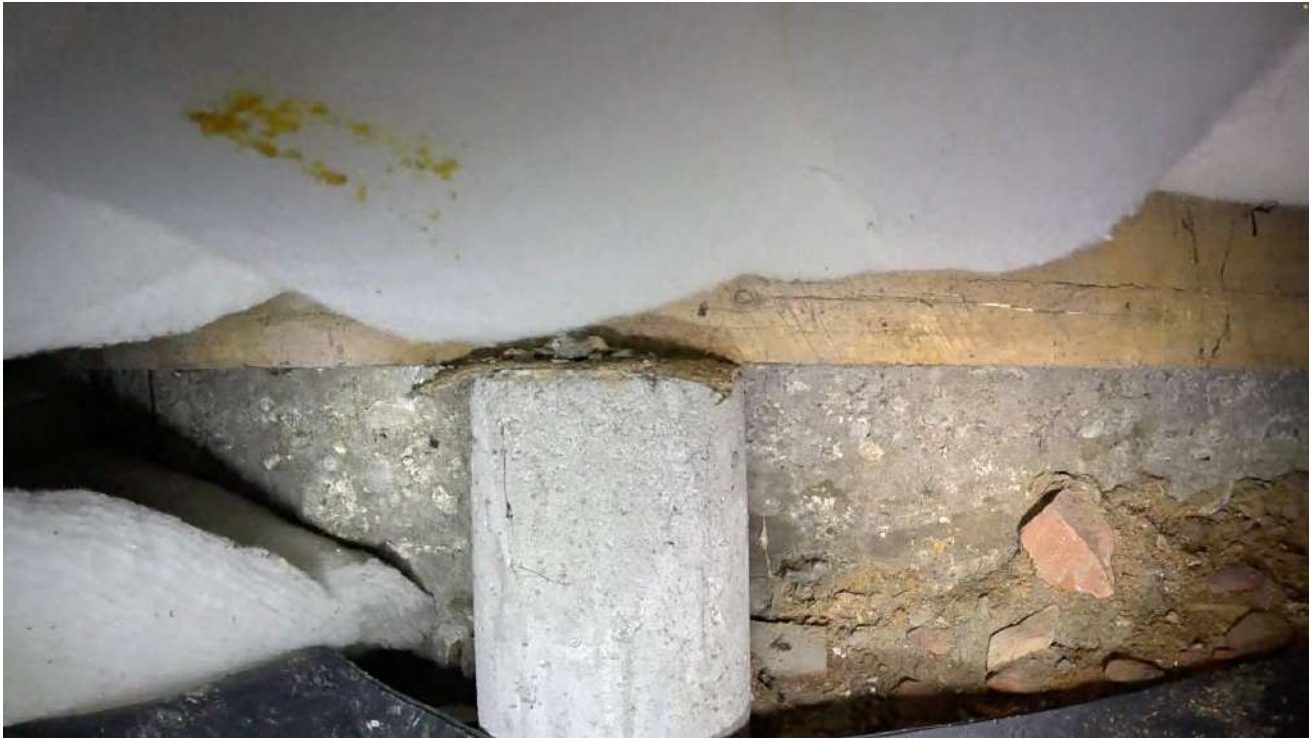
14: View of bearer meeting concrete base.

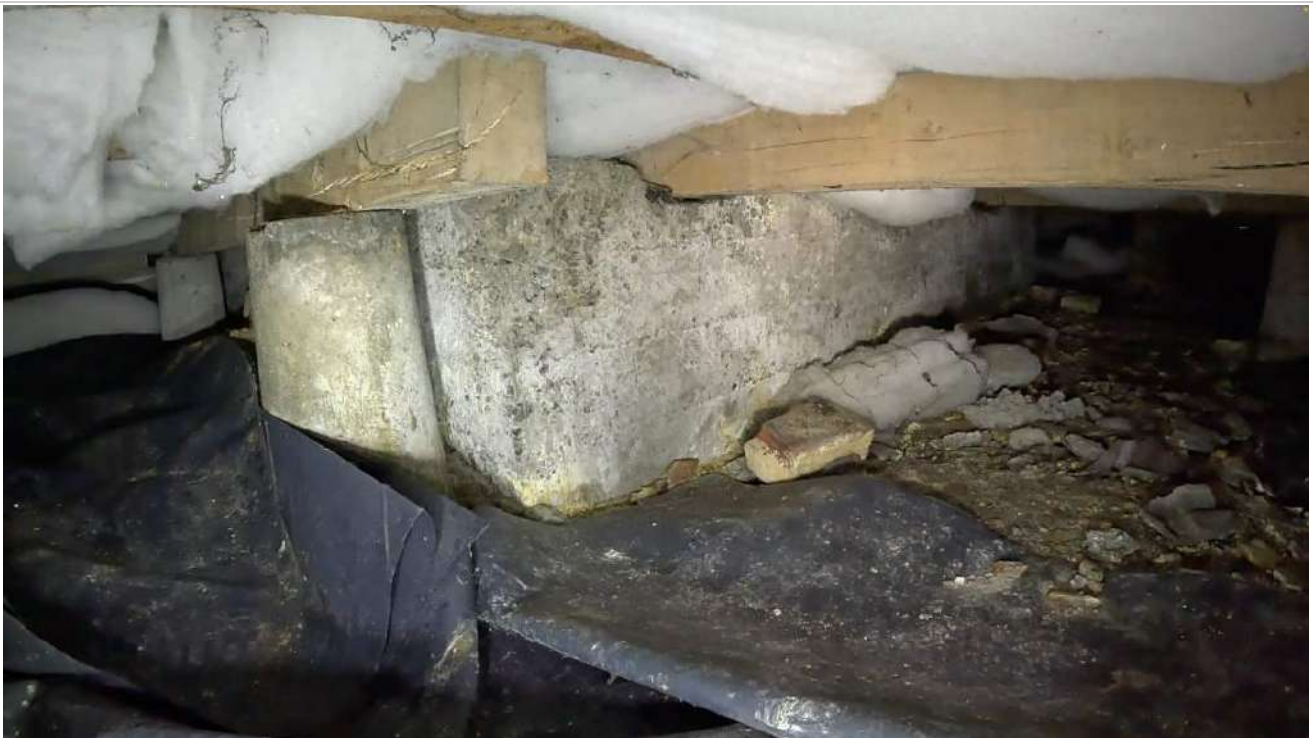
15: Precast concrete pile with no connection.

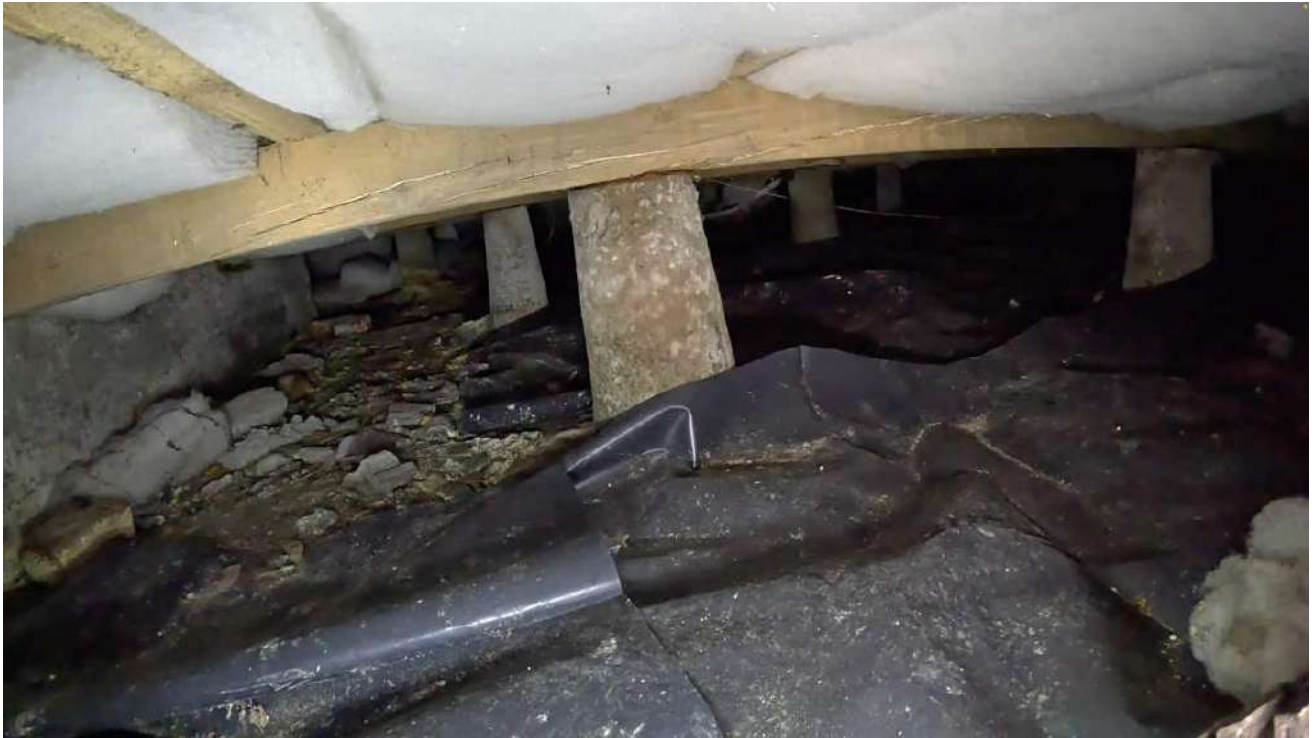
16: Precast concrete pile with no connection.

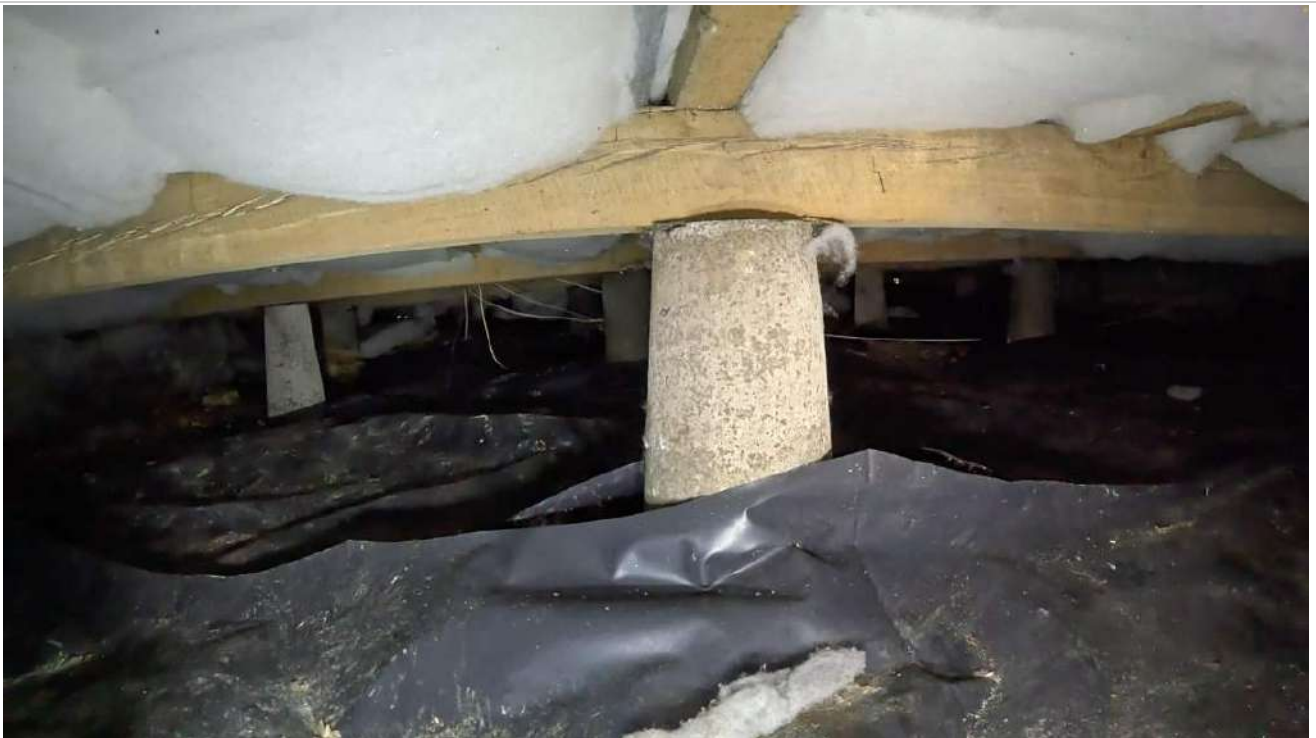
17: Precast concrete pile with no connection.

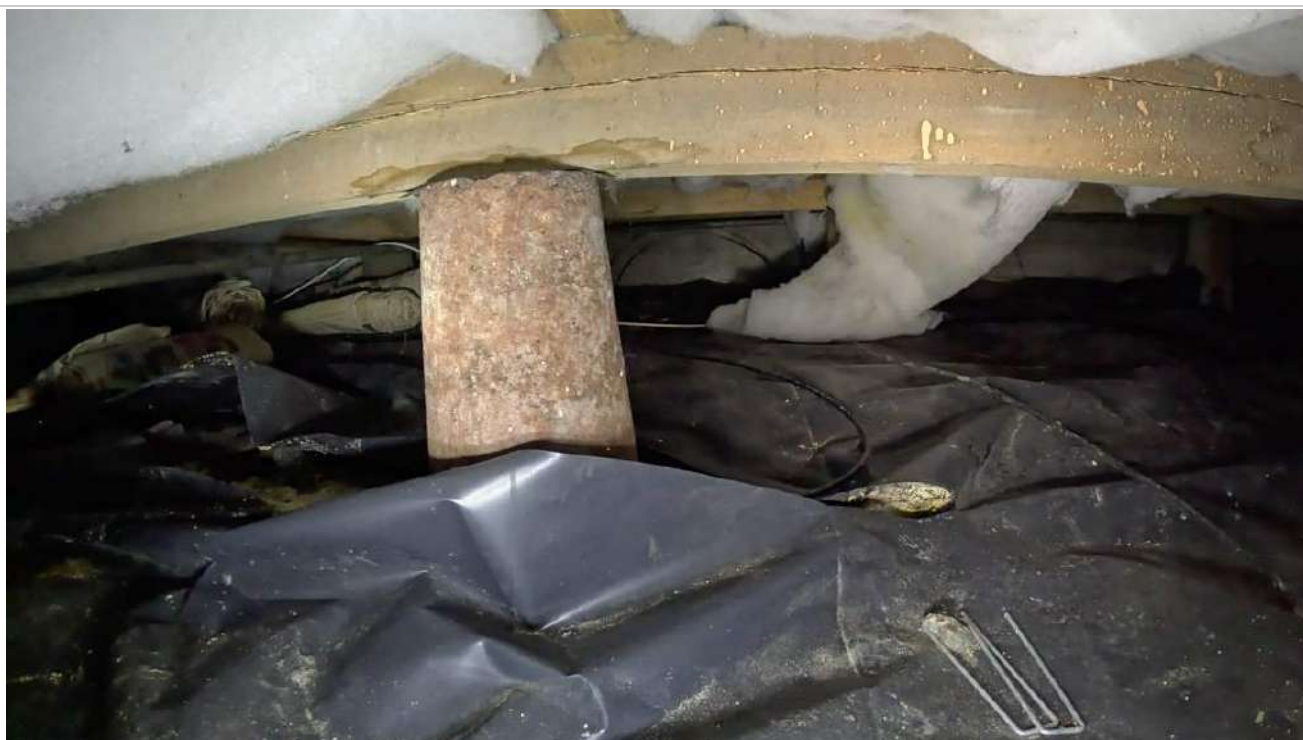
18: Precast concrete pile with no connection.

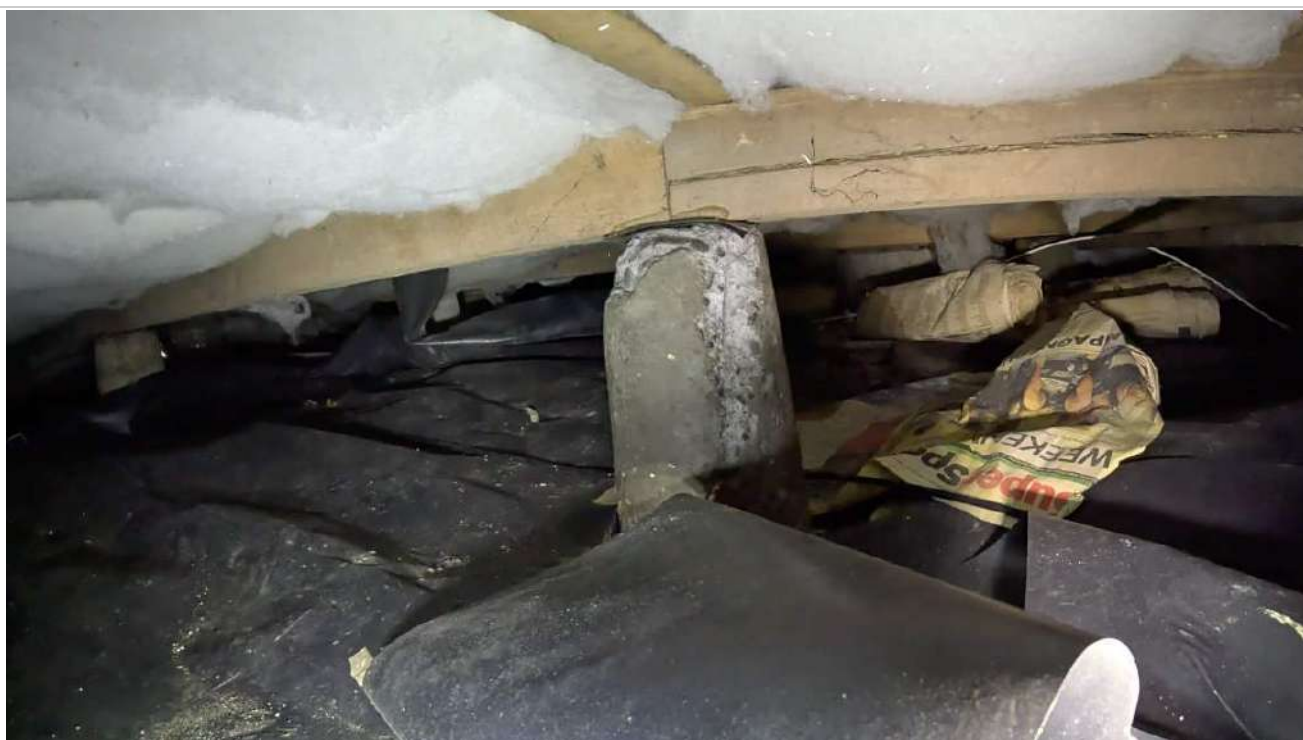
19: Precast concrete pile with no connection.

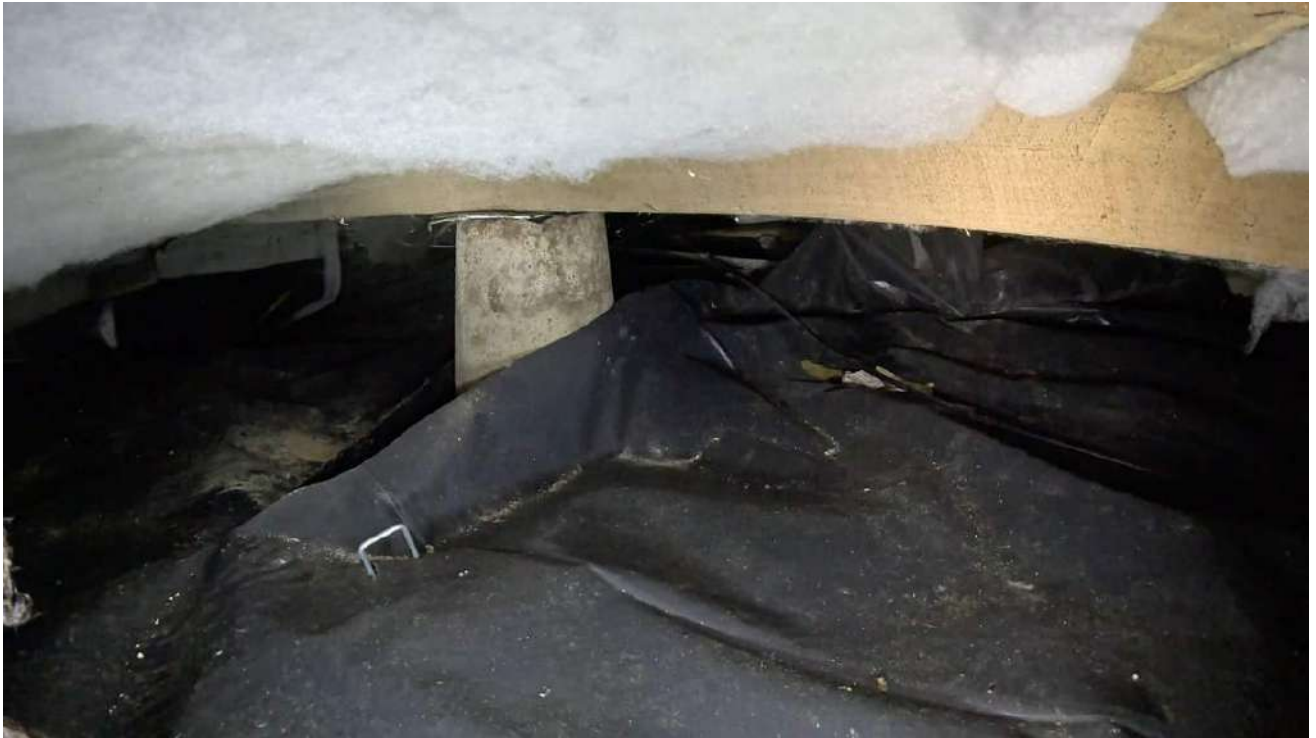
20: View of concrete base with pile to the left.

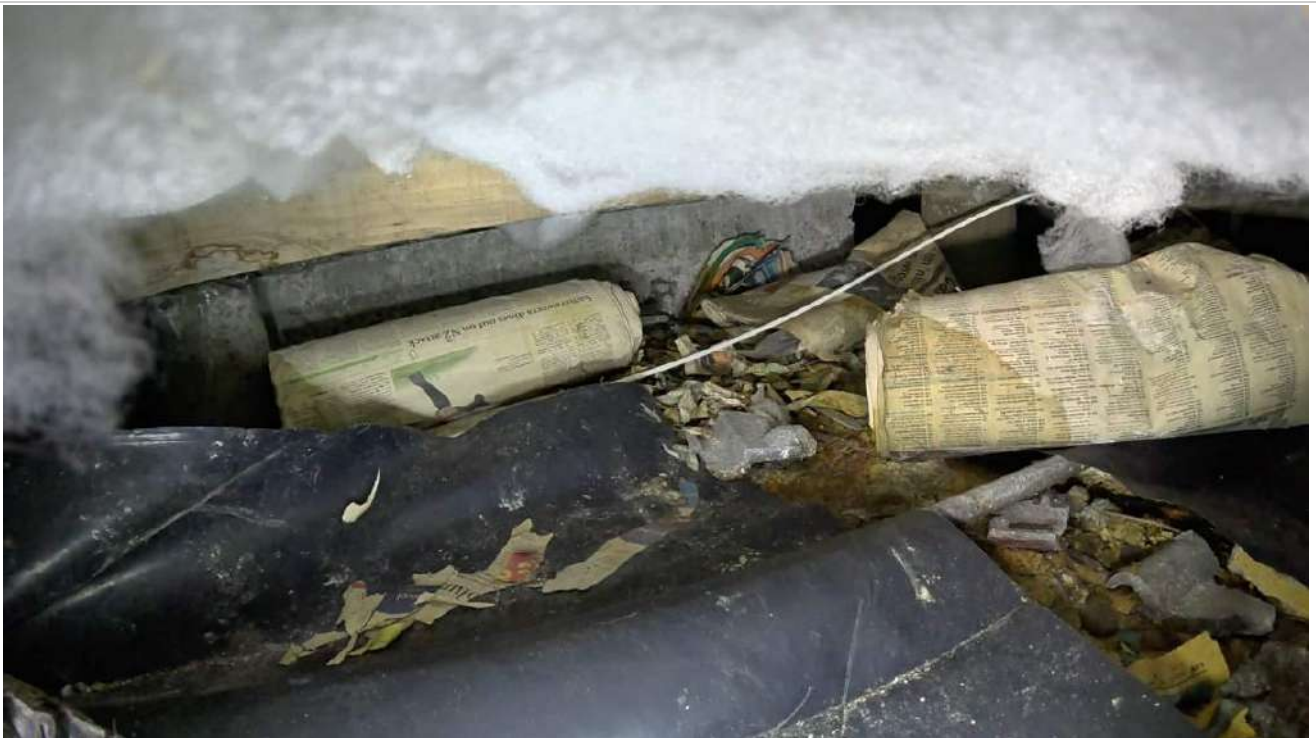
21: Precast concrete pile with no connection.
