| <b>Date</b> | 26 March 2025 | <b>Job Ref.</b> | CLM/2011/122912 |
| <b>Address</b> | 427 Armagh Street, Linwood, Christchurch 8011 | <b>Author</b> | J McCloskey |

## TR001: Technical Report – Desktop Technical Review & Structural Inspection

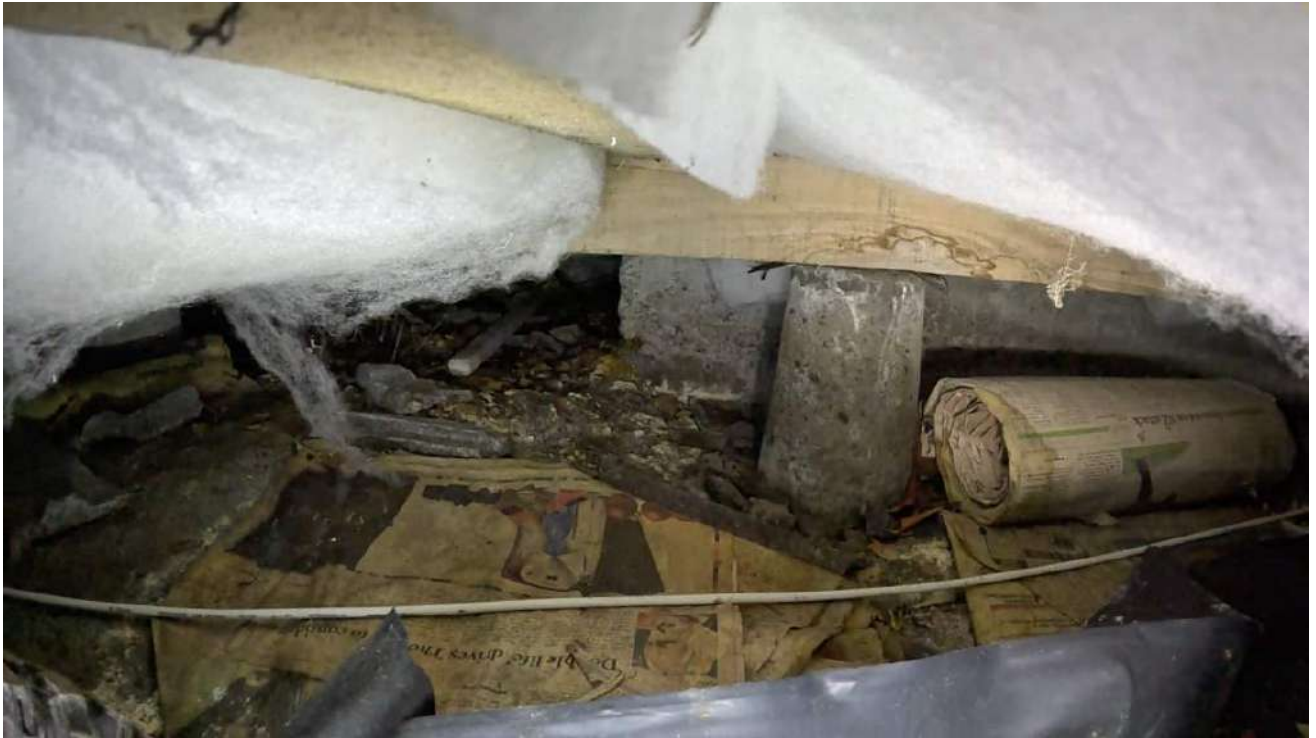
22: We couldn't get into this area.

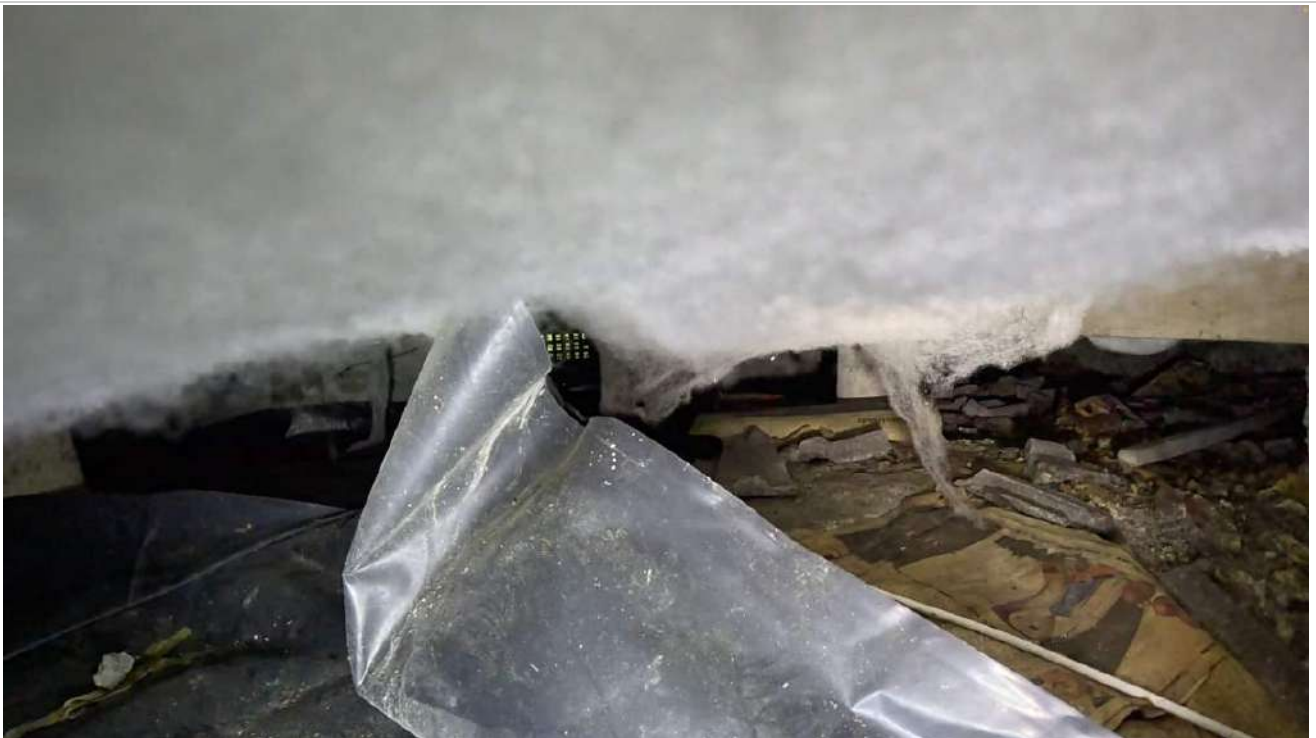
23: View of piles.

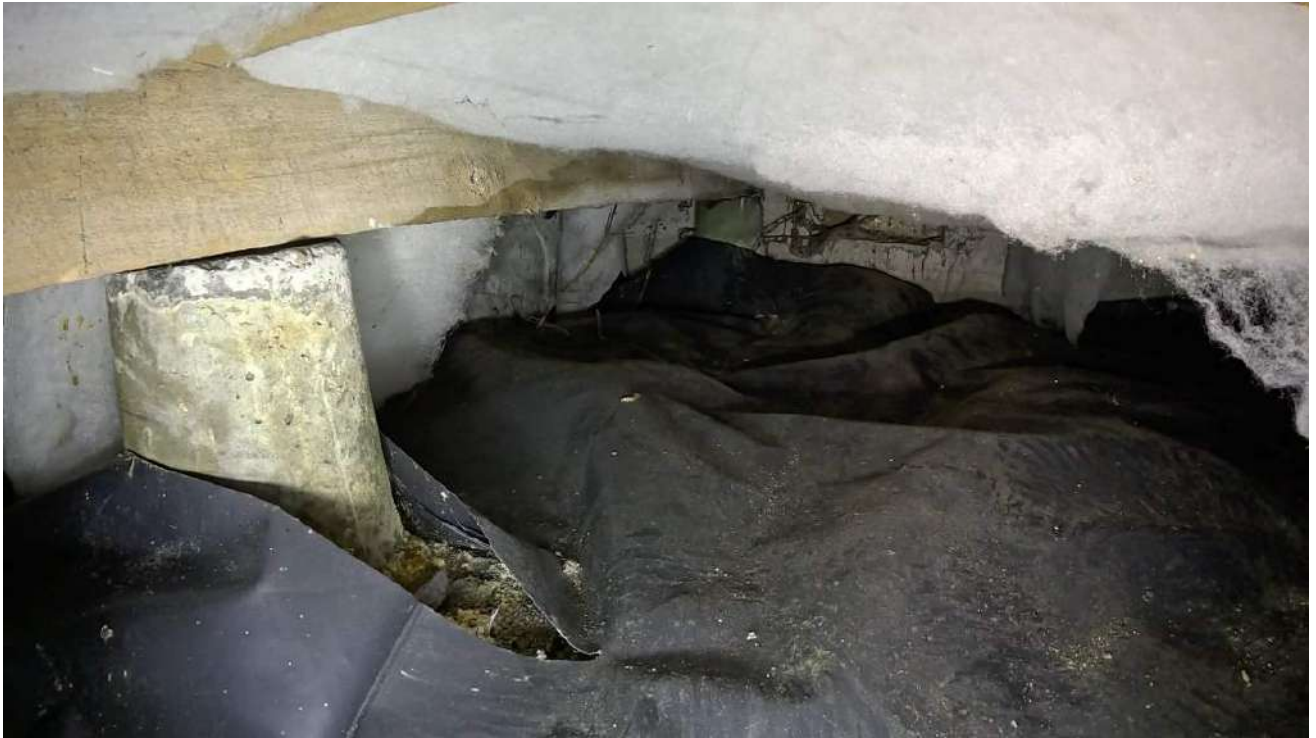
24: View of foundation.

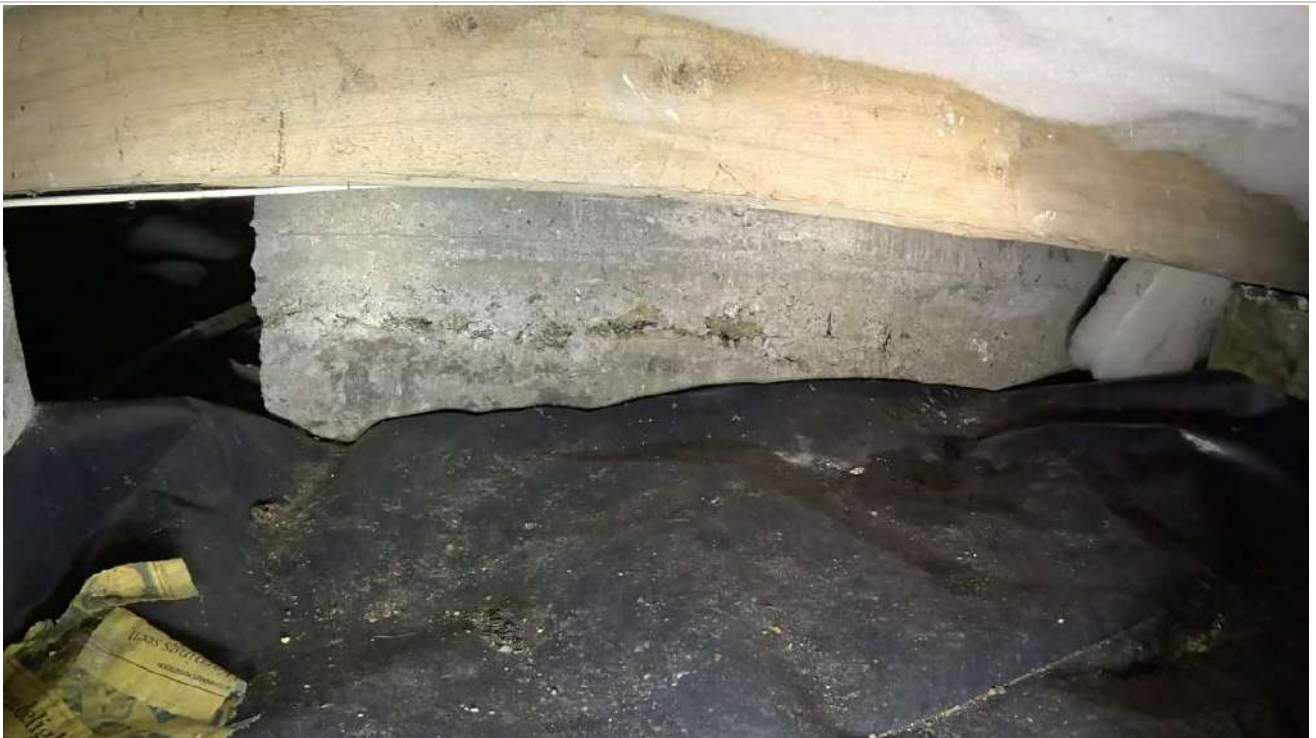
25: Precast concrete pile with no connection.

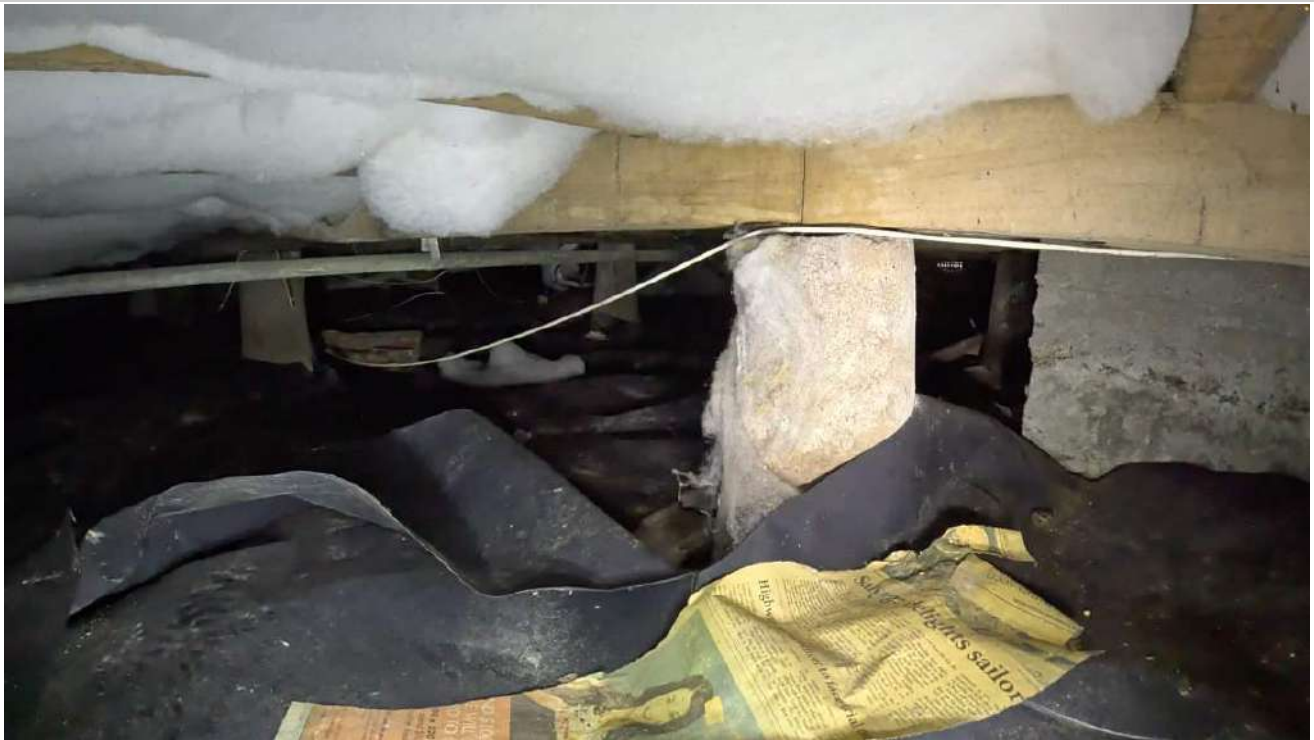
26: Precast concrete pile with no connection.

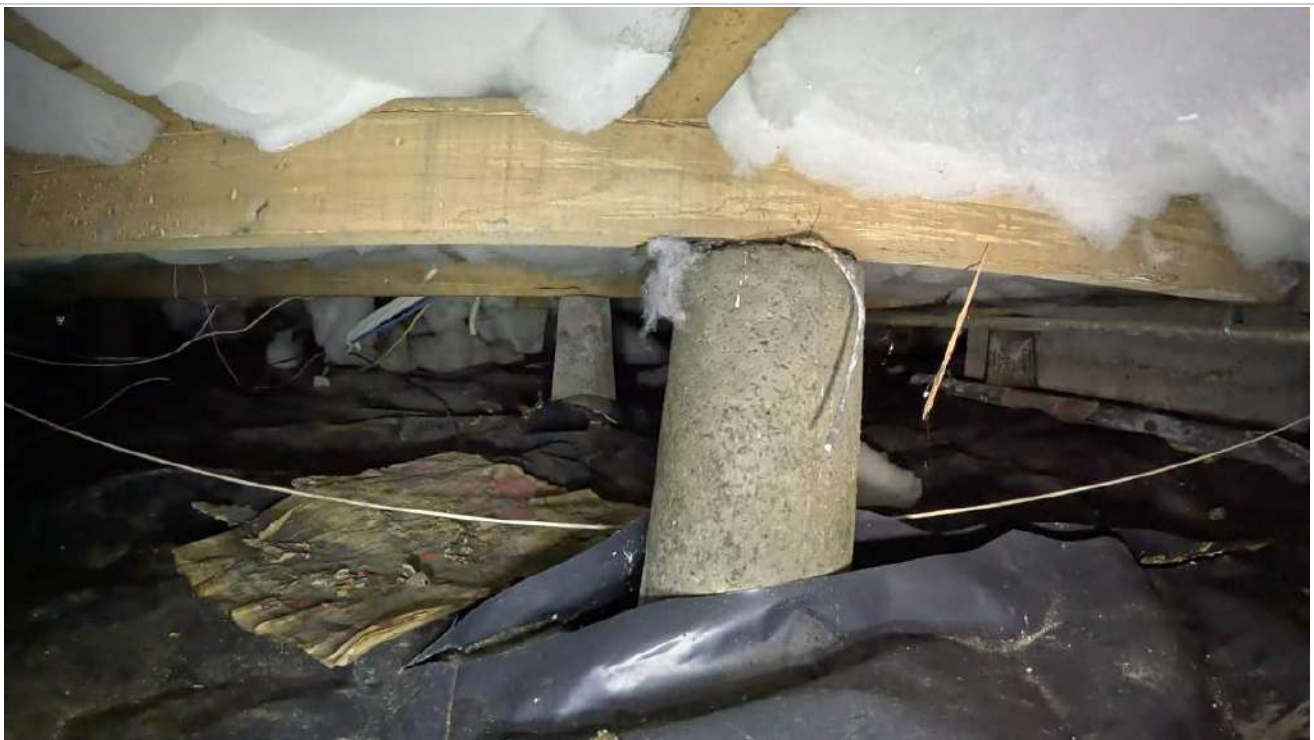
27: Precast concrete pile with no connection.

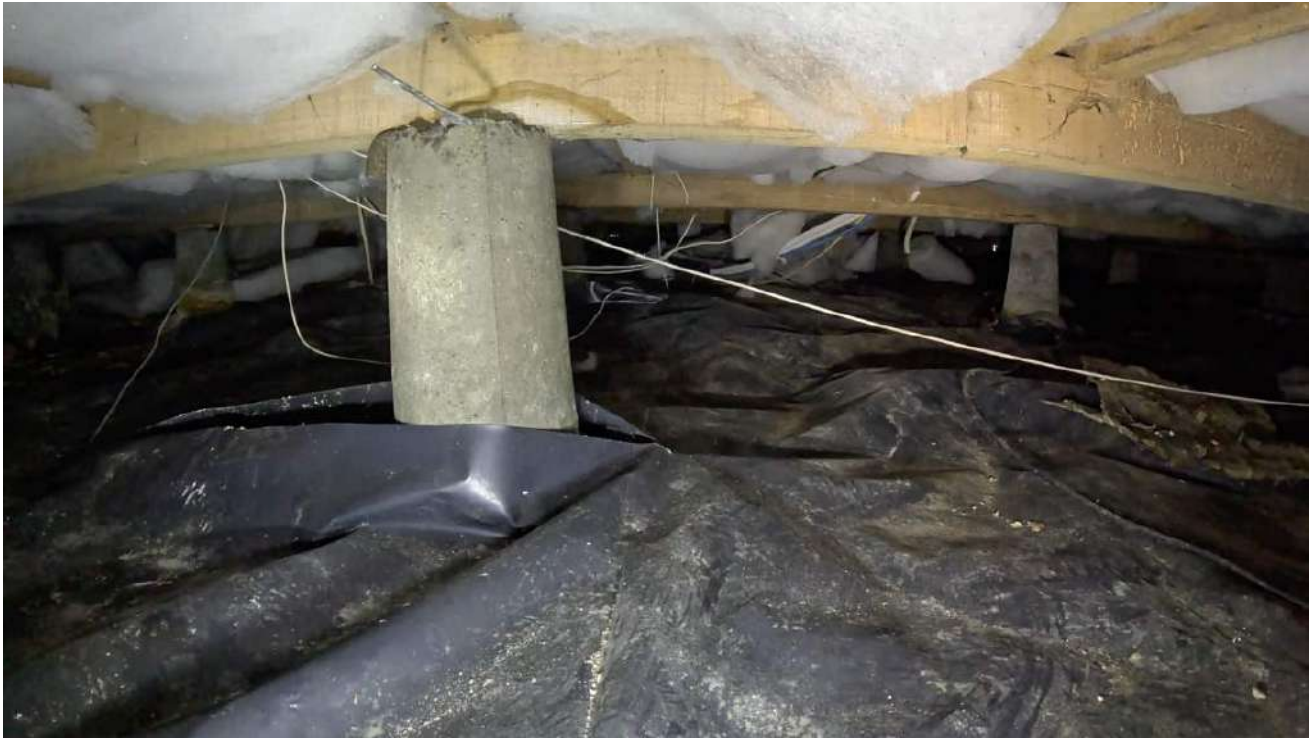
28: Precast concrete pile with no connection.

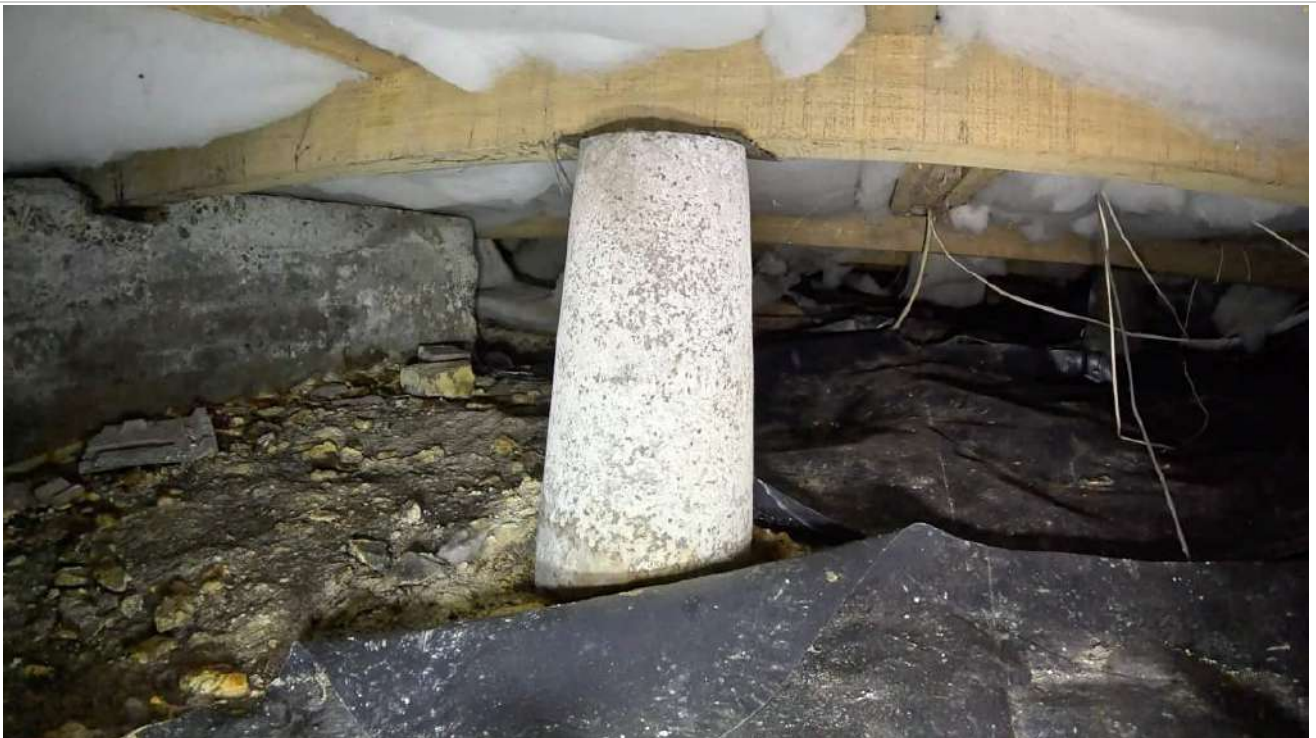
29: View of bearer meeting concrete base.

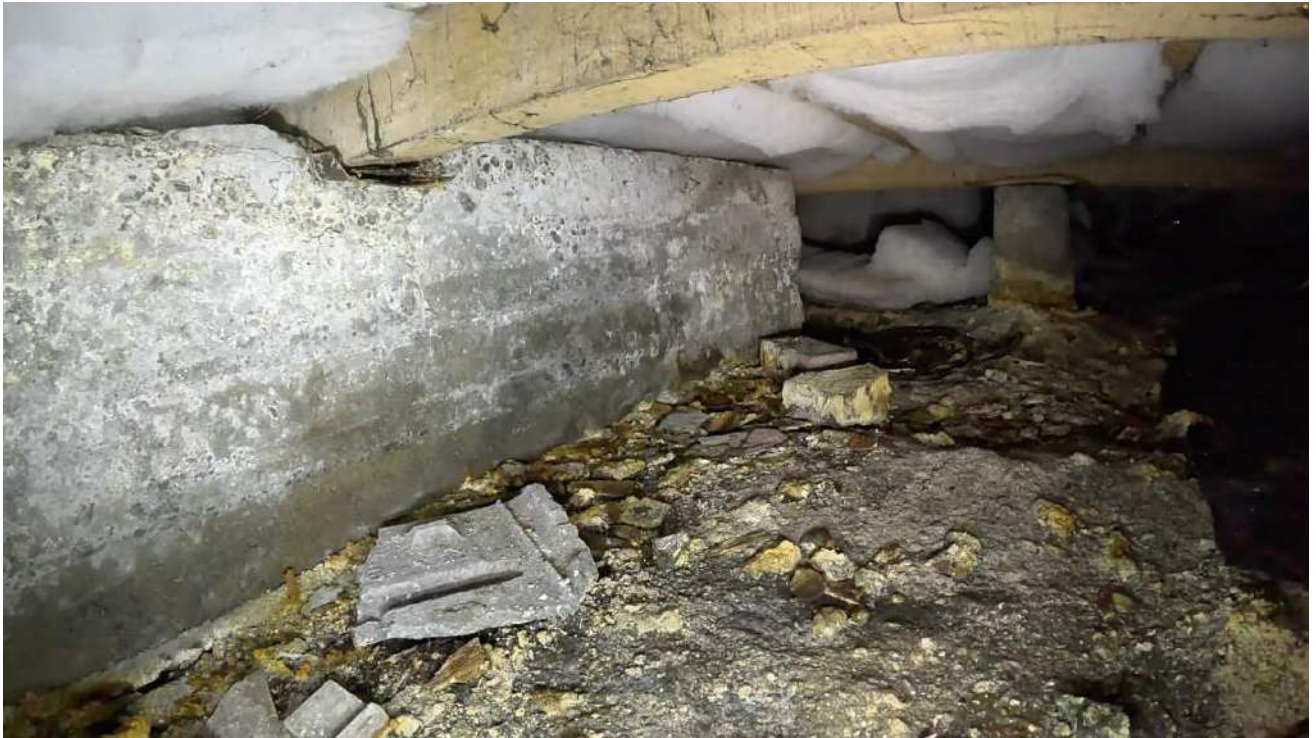
30: View of concrete base.

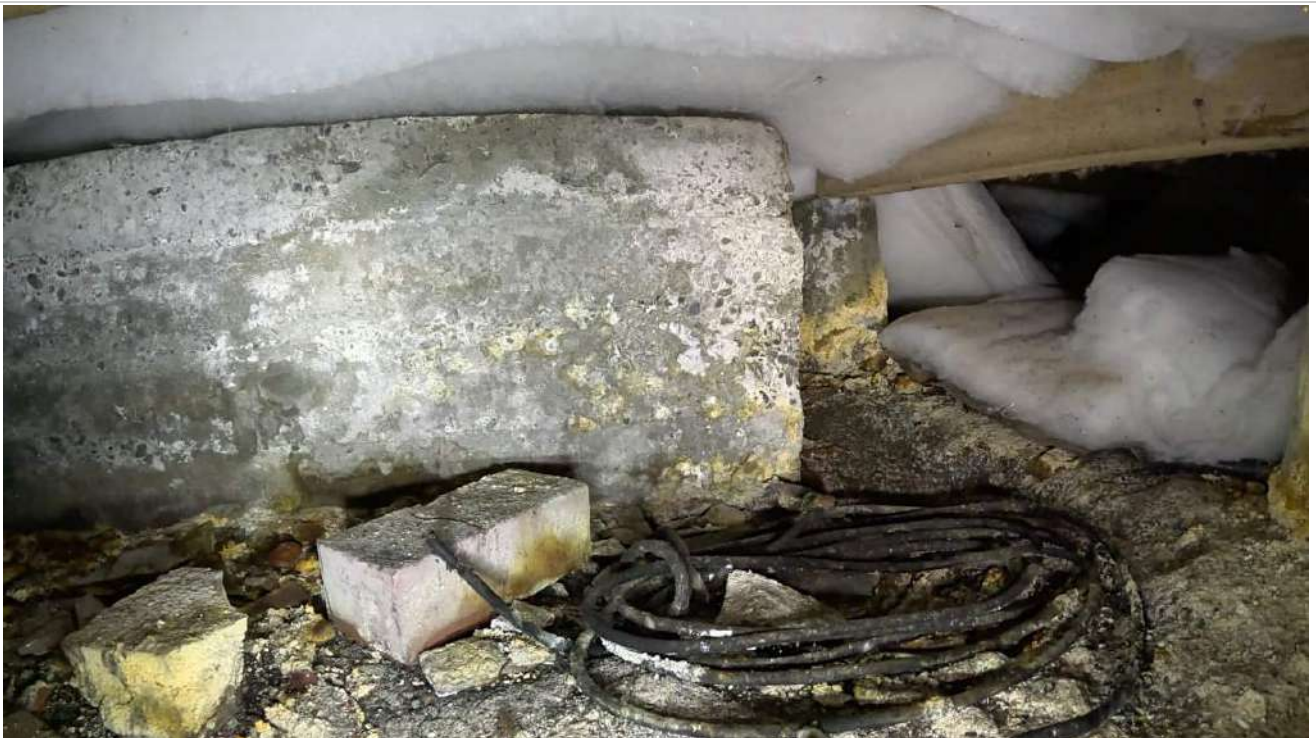
31: Precast concrete pile with no connection.

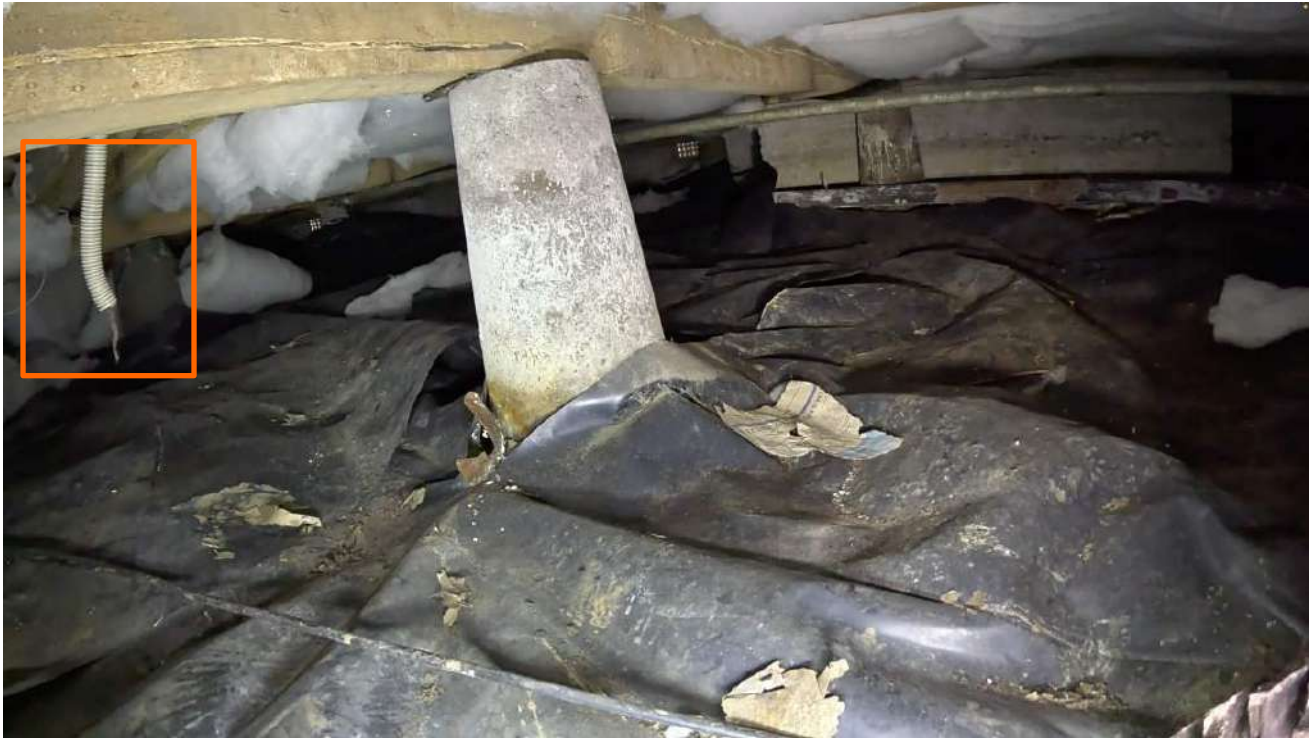
34: View of concrete base.

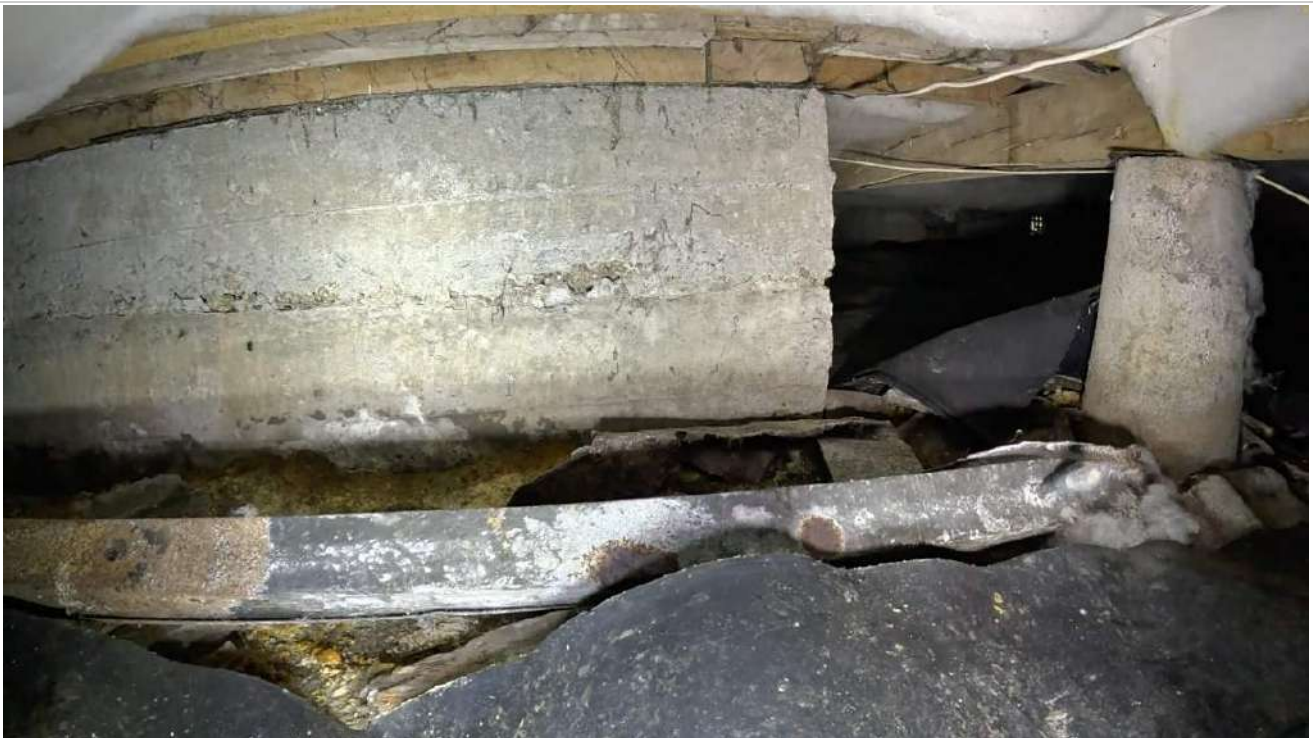
35: Precast concrete pile with no connection.

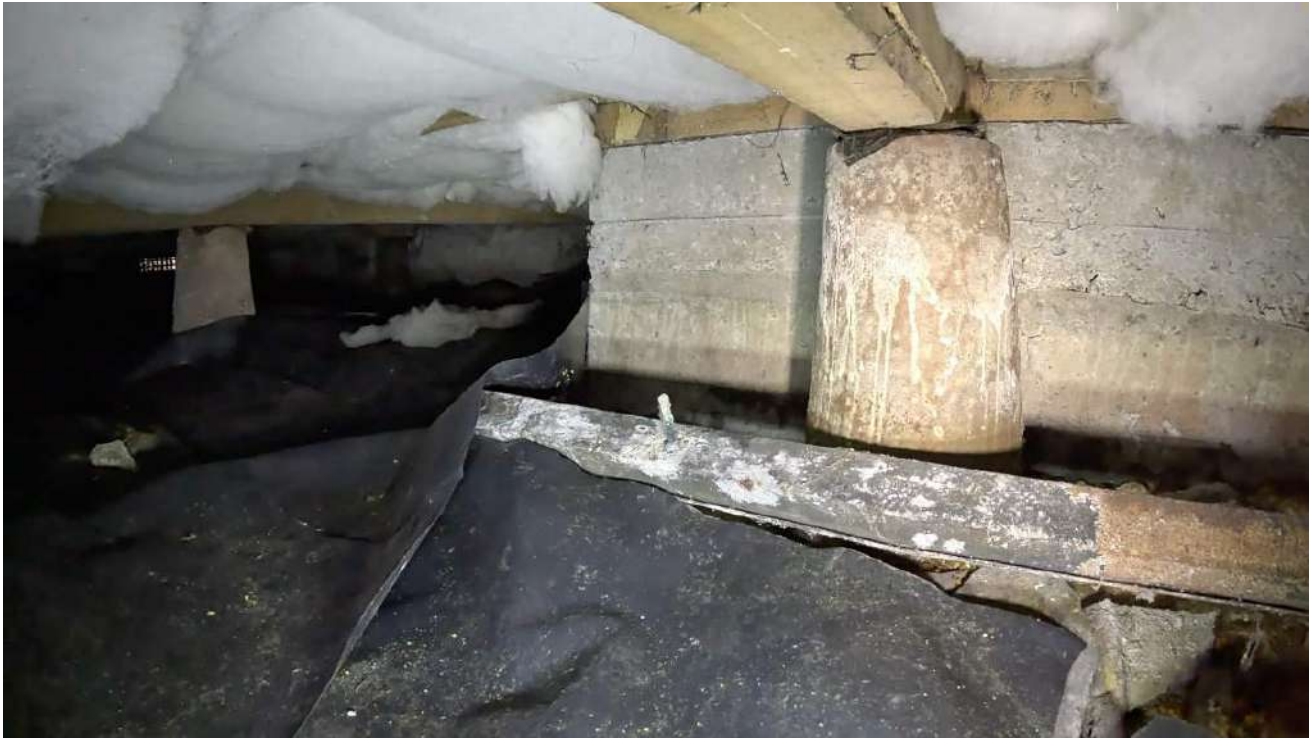
36: View of ring foundation with concrete base to the right.

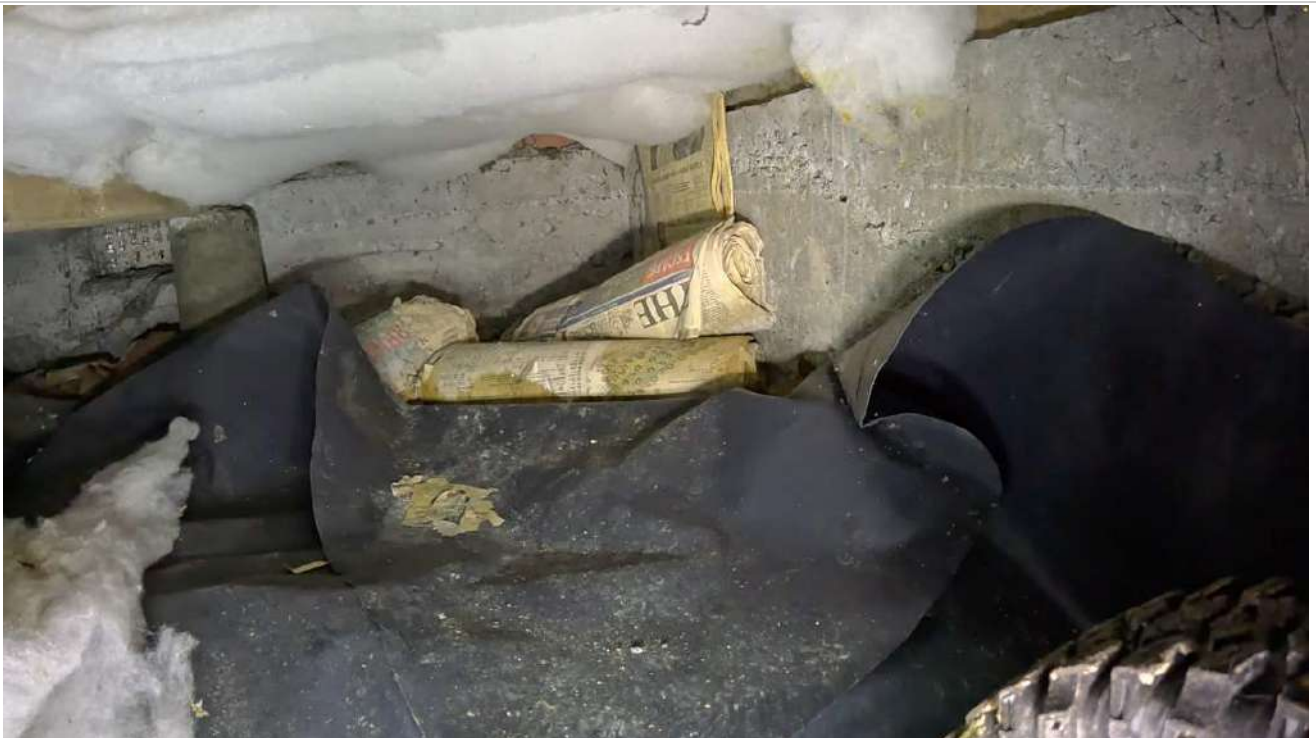
37: Precast concrete pile with no connection.

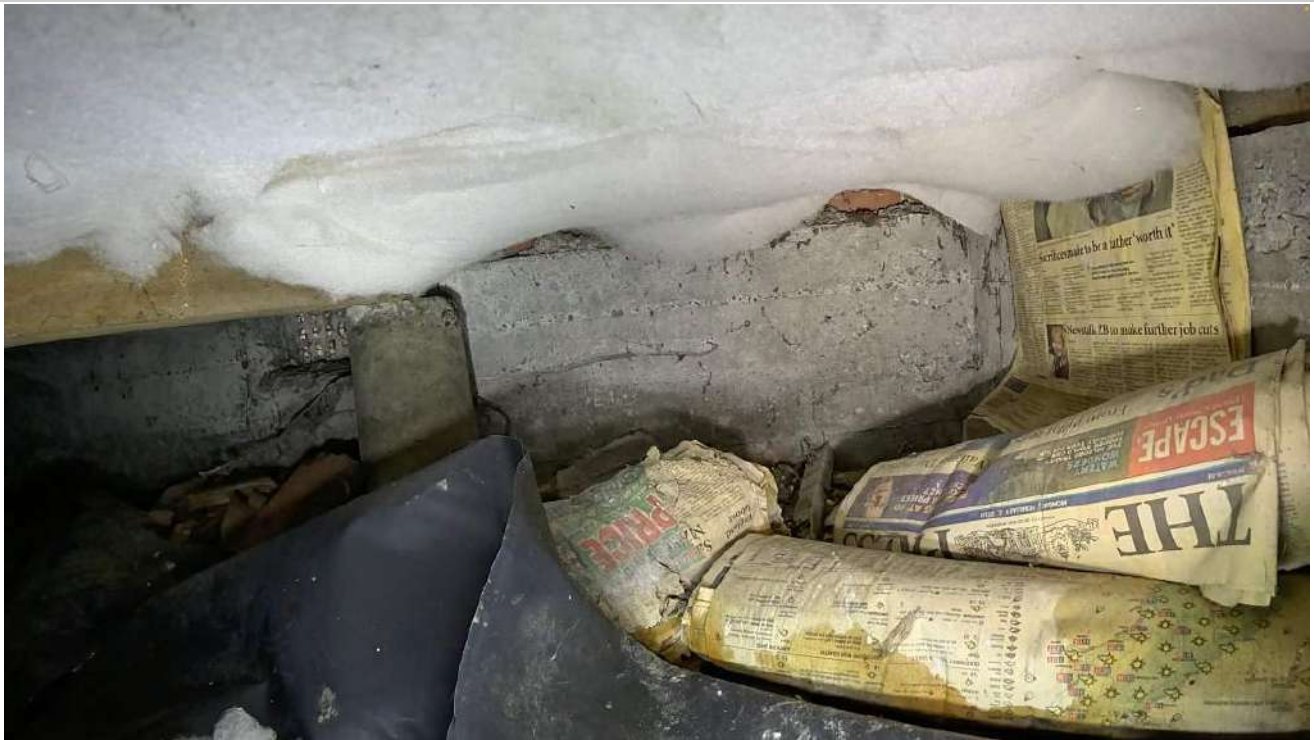
38: Precast concrete pile with no connection.

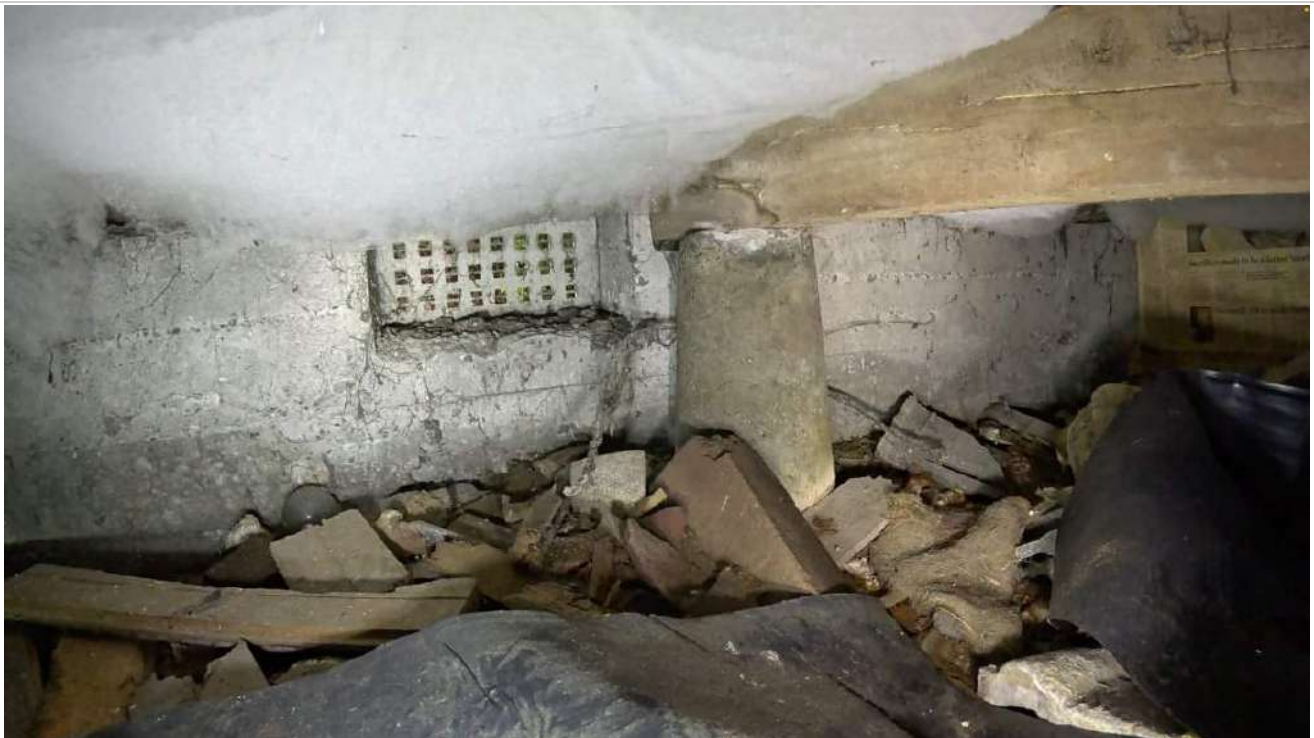
39: Precast concrete pile with no connection.

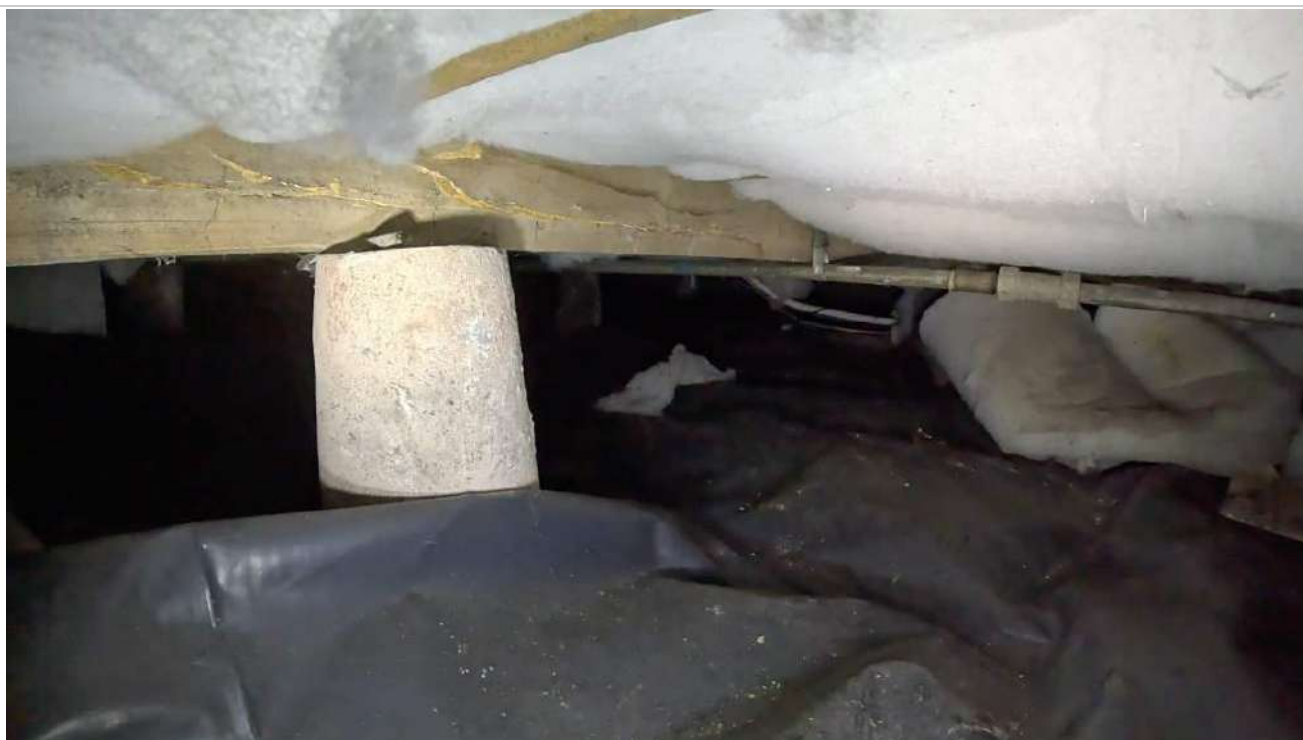
40: Precast concrete pile with no connection.

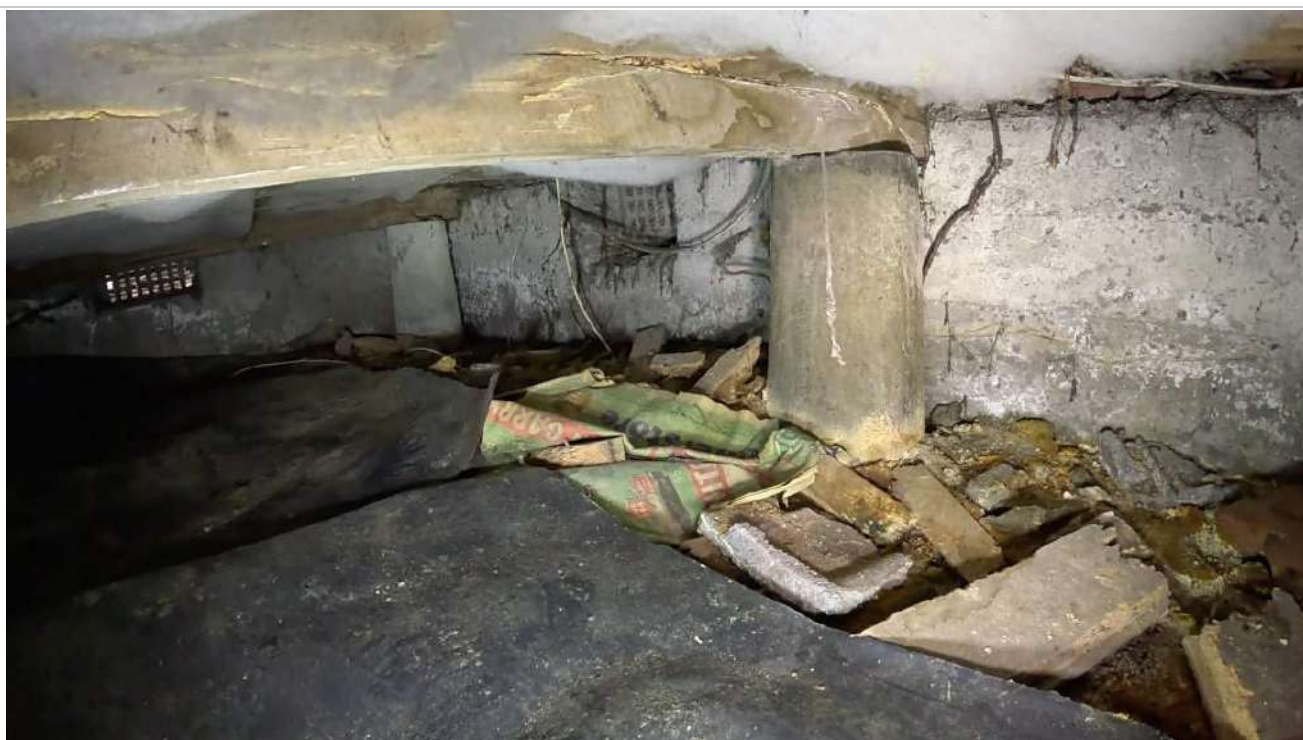
41: Precast concrete pile with no connection.

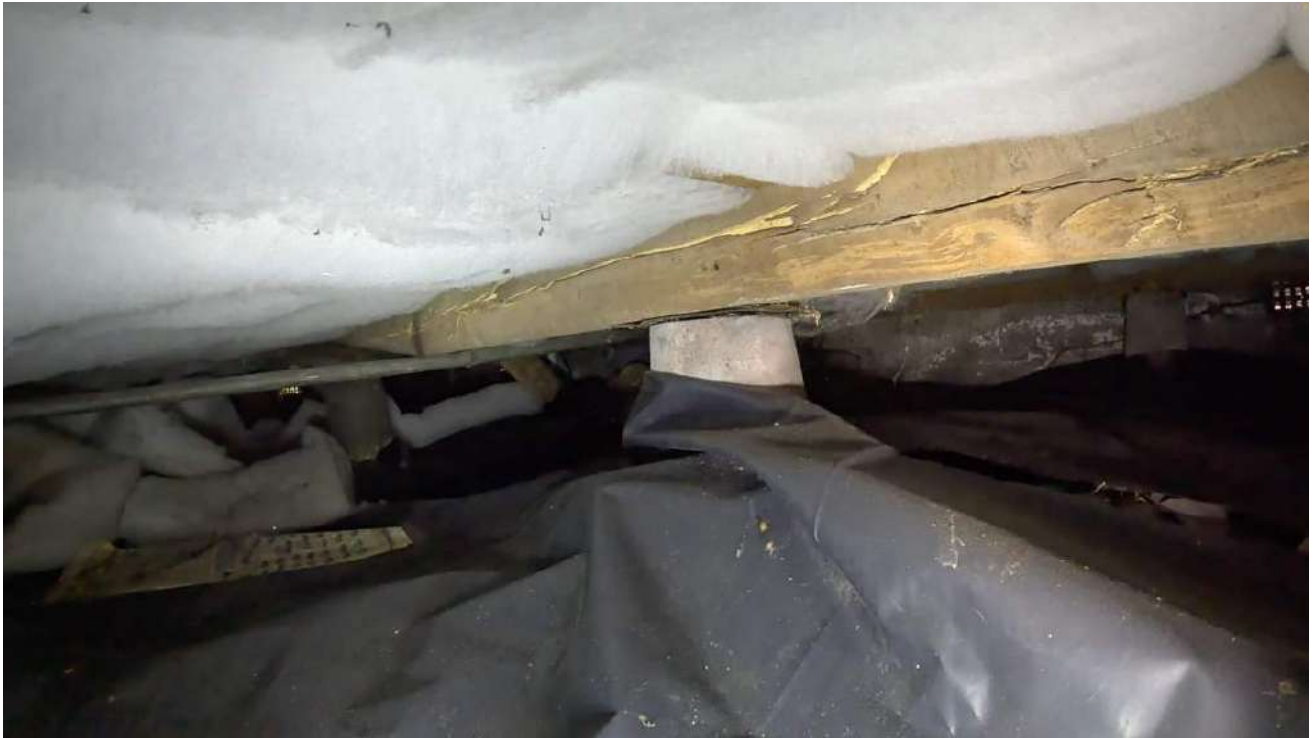
42: Precast concrete pile with no connection.

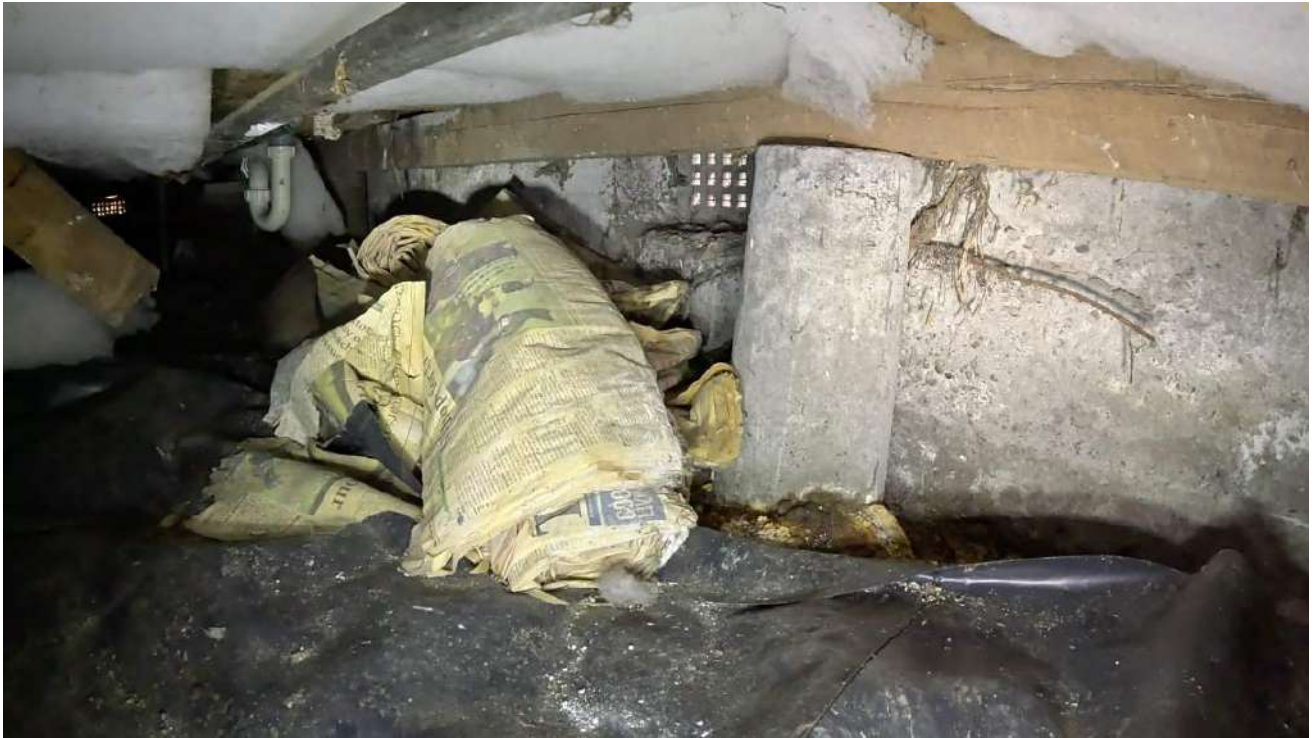
46: View along ring foundation with services.

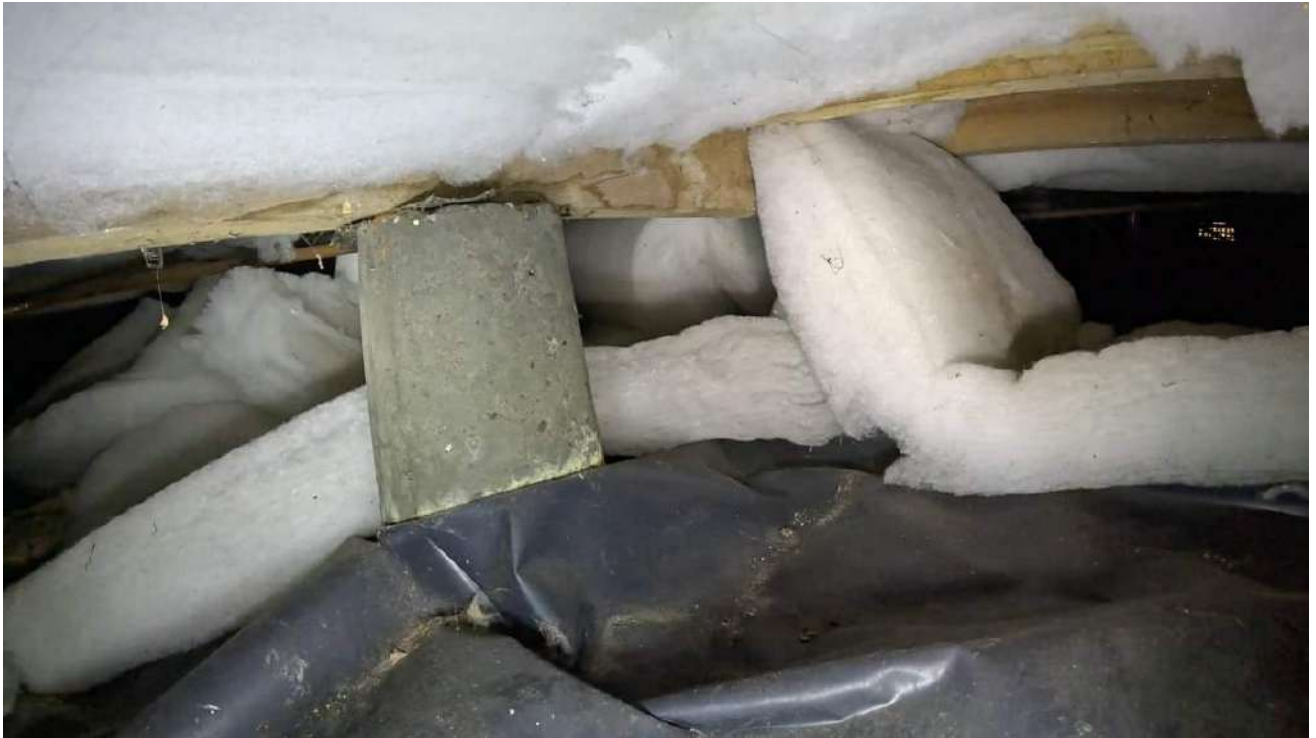
48: Precast concrete pile with no connection.

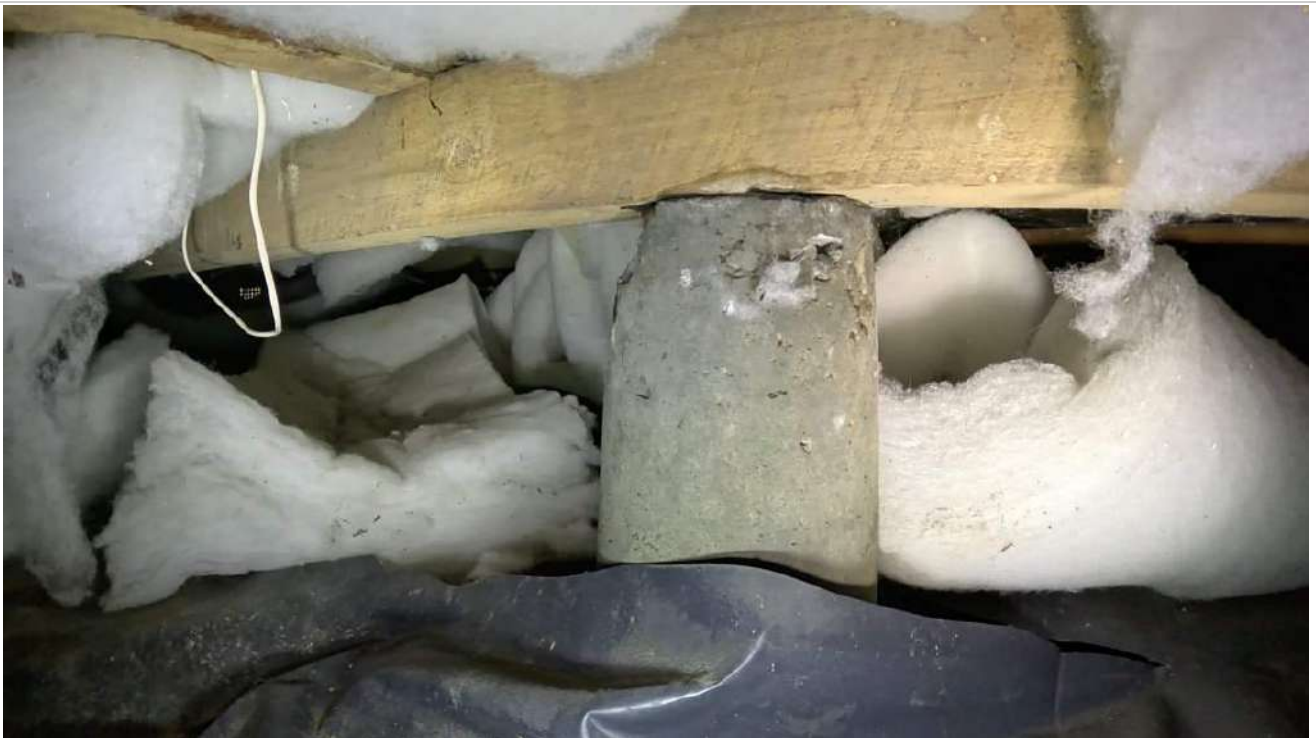
49: Precast concrete pile with no connection.

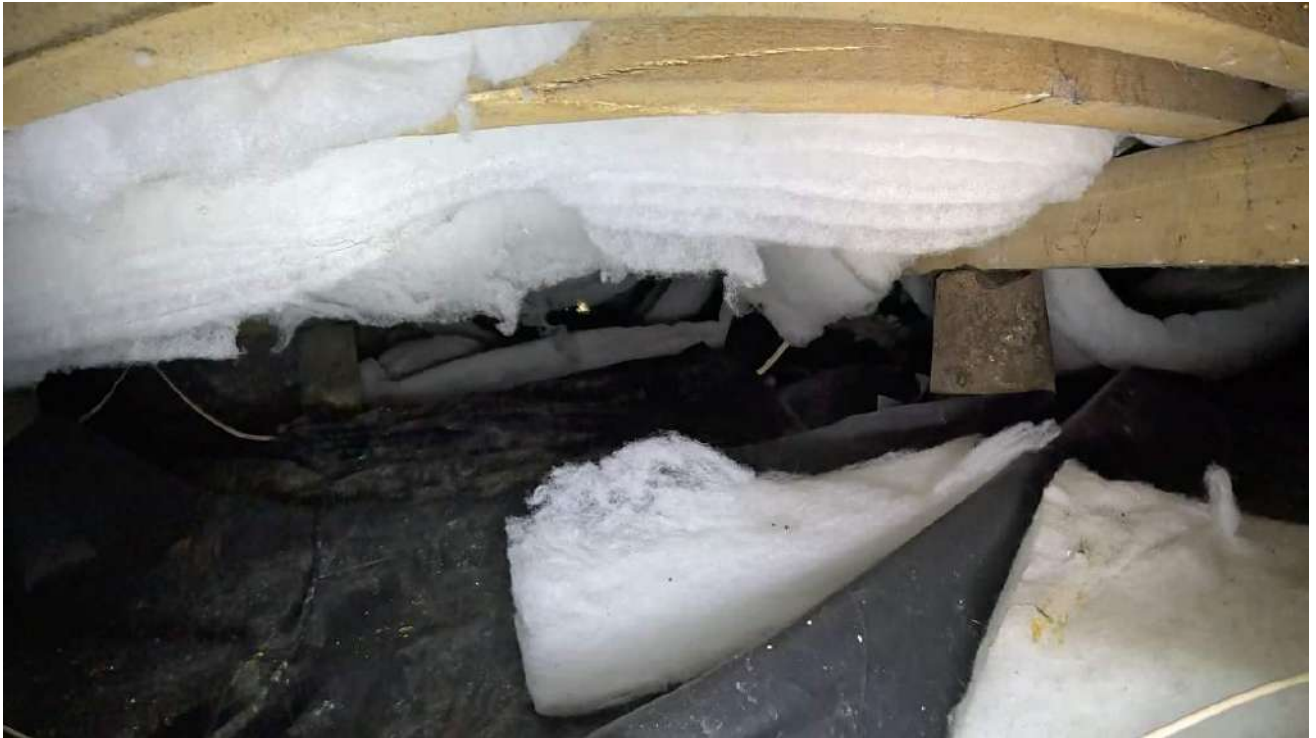
50: We were unable to proceed any further.
