# PRE-SALE BUILDING INSPECTION REPORT

for: Hamish Nimmo C/ Estate of L.Tod

15 Pratt Street  
Waikouaiti, Otago  
9510 New Zealand

Inspected by: Nathan Farrell | Inspection Date: 15 Jun 2026 | Ph: 027 4556106

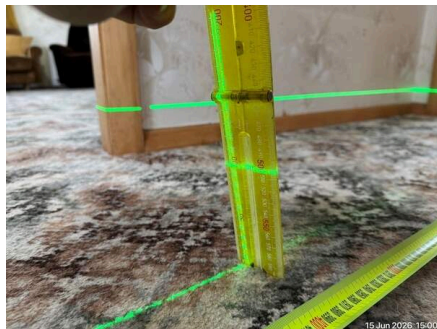
#24: Datum 95mm at 4m

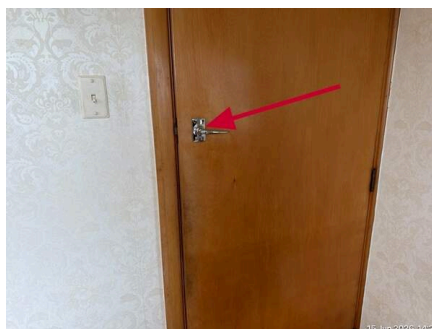
#30: Bedroom door striker not engaging.

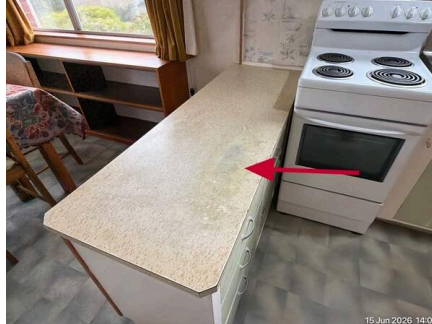
#32: Wear to the benchtop.

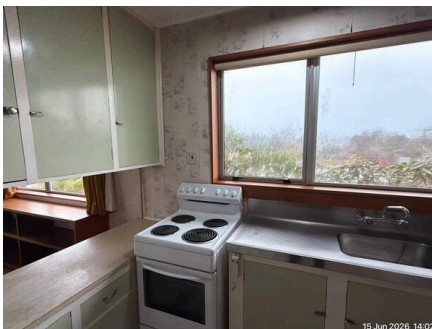
#36: No range hood.

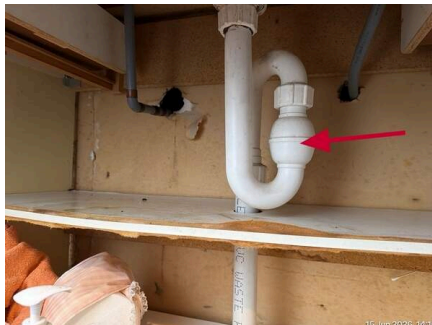
- **Plumbing** - Grey Dux Qest plumbing pipe was sighted, and the shower waste pipe is actively leaking into the subfloor. A leak was also detected at the bathroom basin waste. A licensed plumber should be engaged to assess and determine the best repair or replacement solution.

#47: Leaking waste.

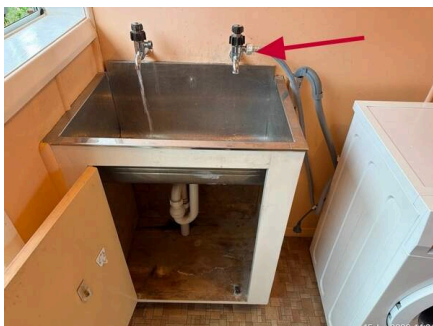
- The right-hand laundry tap is inoperable. Engage a licensed plumber to assess and repair the fixture.

#60: Unable to turn on the RH tap.

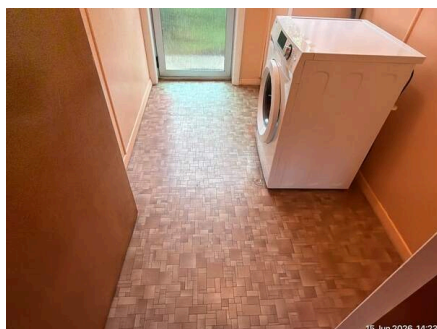
#64

**Flooring Covering Details:** - Due to the age of the dwelling, the vinyl or the backing of the vinyl used for the floor coverings could contain asbestos, this is unknown without lab testing. CheckHome recommends keeping the product sealed and not disturbing, we recommend testing prior to any remedial works taking place.

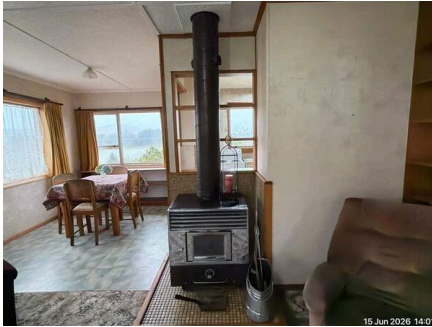
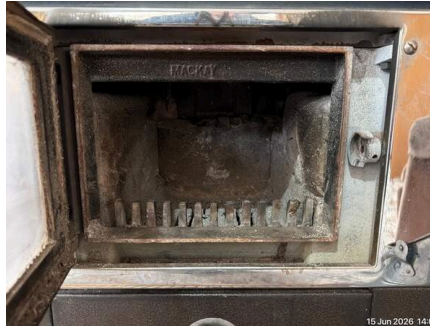
A fireplace was in place. I recommend that a fire tech inspect it to ensure it is working correctly and safe to use.

Further investigation

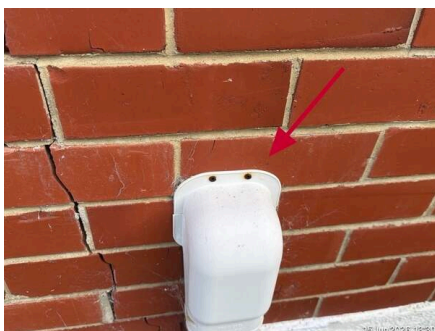
- An unsealed cladding penetration was detected. This is a higher-risk design feature that could potentially cause water ingress into the wall cavity. The penetration requires sealing or having a flange around the perimeter to ensure it is watertight. A licensed builder should be engaged to complete the work.

Action Required

#89: Unsealed penetration.

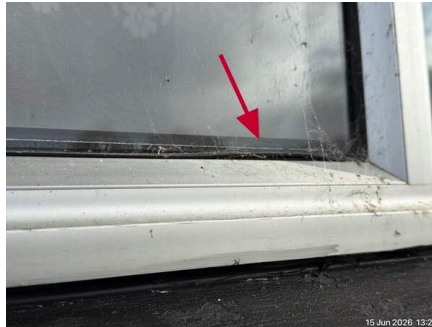
- Shrunken glazing rubbers were detected in some units, replacement of the glazing rubbers would be recommended to help improve the weather-tightness of the units.
  - Gaps were visible around the aluminium windows when closed, this is commonly due to the friction stays loosening, replacement of the stays is recommended in areas to enable the windows to pull up tight when closed.
- An aluminium joiner can complete this.
- Gaps were sighted at the window to cladding junctions, as photographed below. This could be allowing water ingress to the wall cavity. Upgrades to the junction are required to help prevent this. A licensed builder is required to assess and determine the best repair solution.
- Rating: Action Required

#91: Loose rubbers

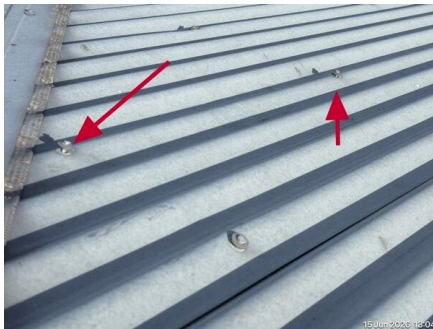
- Popped nail fixings were sighted; this can be common with properties of this age, although it can potentially lead to water ingress around the penetration. Replacement of the popped roofing nails with sufficient roofing screws is required now; this would help prevent potential moisture ingress and roof uplift. A licensed roofer could complete this and should determine if the replacement of the remainder of the roofing nails would be a beneficial upgrade.

#109: Popped fixings.

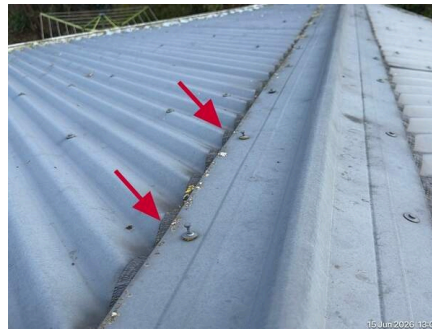
#110: Popped fixings.

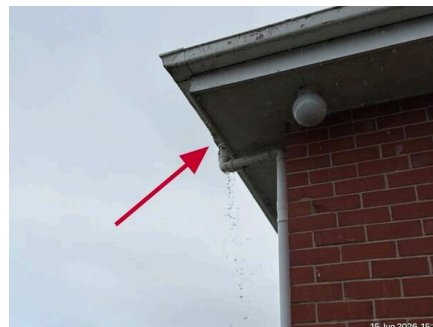
#126: Detached downpipe.

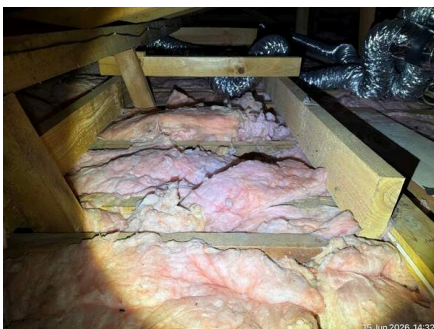
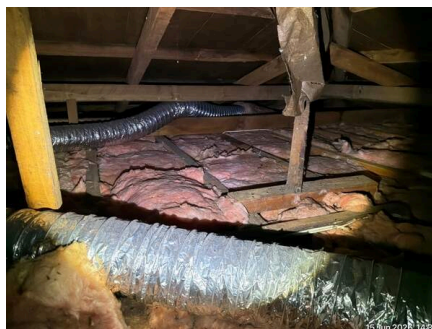
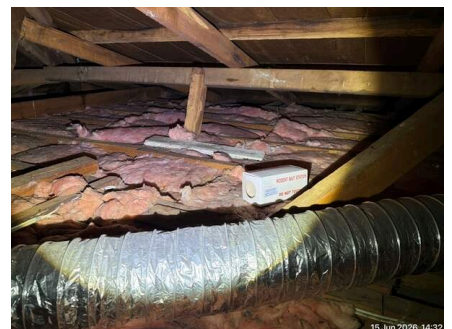
**Insulation Details:** - The insulation in place has dropped, this can be common with older insulation, upgrades to the insulation would improve the thermal barrier to prevent the transfer of heat energy coming in and out of the home.  
**Insulation Type:** Fibreglass wool  
**Rating :** Minor Maintenance

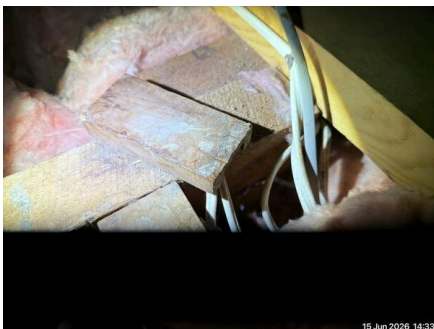
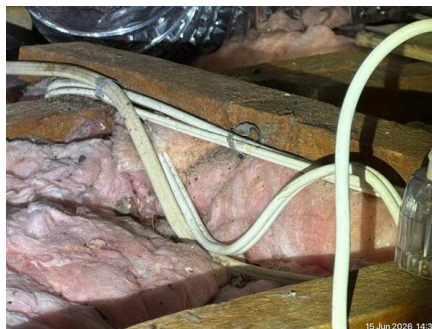
(TPS wiring is currently compliant. Two/single-core wiring/no earth; This version of TPS wiring is no longer used.)  
As this is not an electrical inspection, for further information regarding the electrical cable type & condition, a licensed electrician is required to assess.

**Wiring Details:** - Further Investigation is recommended by a licensed electrician.  
**Rating :** Further Investigation

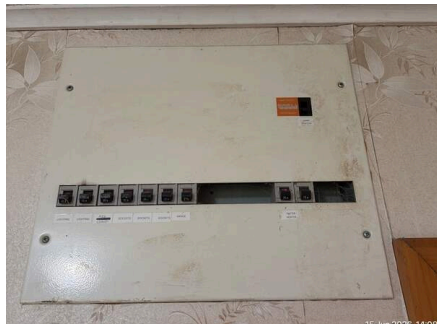
#185

**Fuse Switchboard Details:** - A licensed electrician is required to inspect the fuse board to determine what fuses are in use and if upgrades are recommended.

**Rating:** Further Investigation

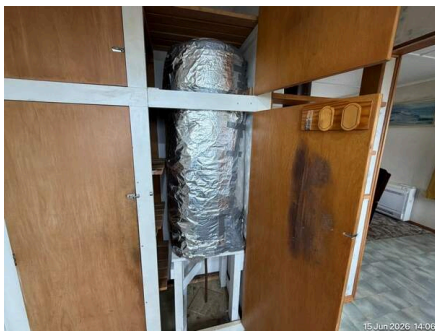
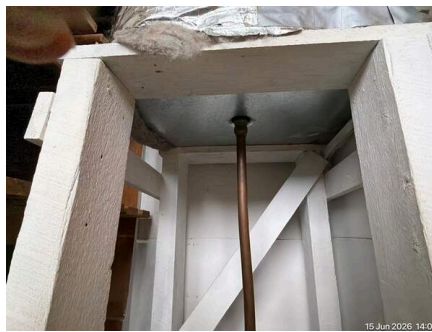
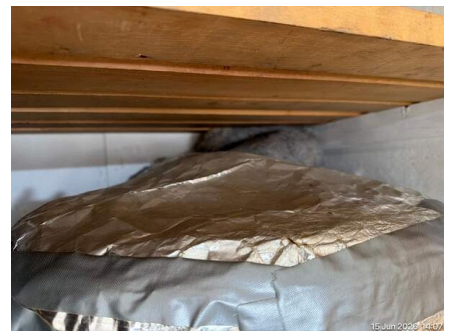
**Age:** Unable to sight  
**Rating:** Further investigation

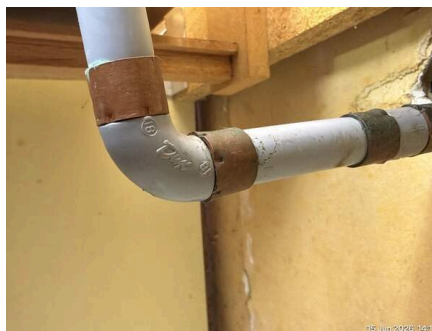
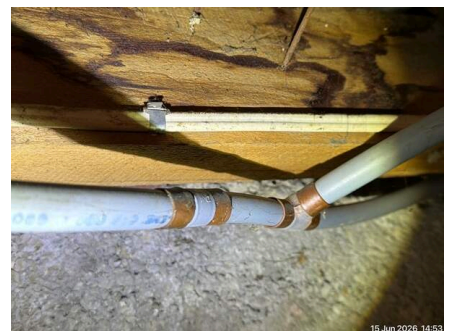
**Plumbing Pipe Details:** - Grey Dux Qest pipe was sighted, I recommend further investigation takes place by a licensed plumber to determine if this piping has the same problems as the black Dux Qest, we recommend further investigation and if required replacement by a trade qualified plumber.  
**Rating:** Further Investigation

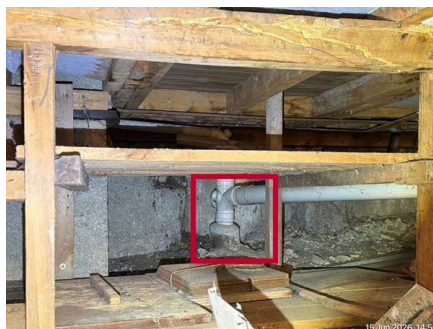
#205: PVC and earthenware.

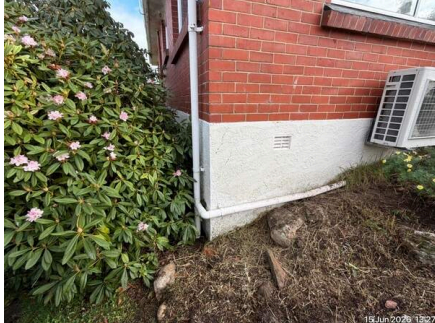
- The downpipe joint is unglued and loose. Engage a licensed plumber to secure the connection with the appropriate adhesive and install downpipe clips to secure the pipe to the dwelling exterior.

Minor Maintenance

#206: Downpipe connection.

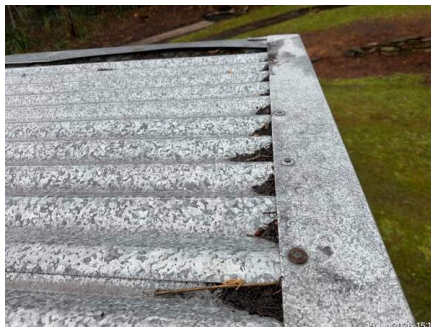
#228: Debris needs to be cleaned from the flashing junctions.

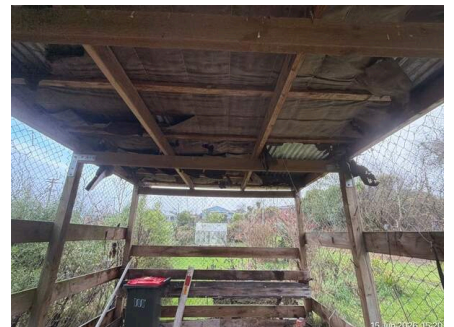
**Out Building Details:** - Tears and gaps were sighted to the roofing paper, water staining was also evident to the timber framing. This is common for this style of garage, replacing the roofing nails with modern screws and ensure the gutters are kept clean and clear are recommended.

**Rating:** Minor Maintenance

#229: Tears and sagging roofing paper.

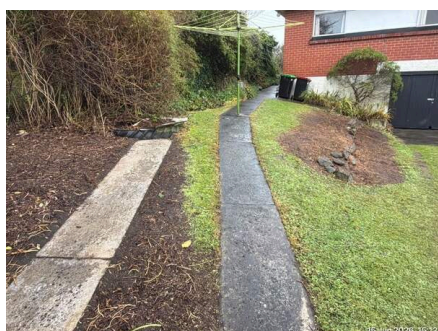
#232

The pathways and driveways appeared well-formed, free from any obvious signs of excessive subsidence and safe to walk upon.

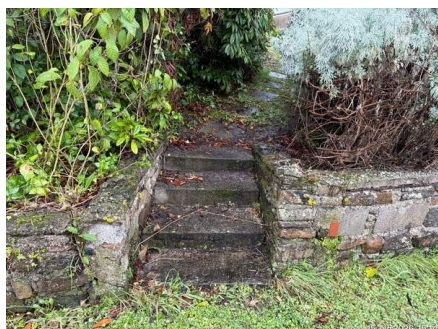
#238

The steps appeared well-formed and safe to walk upon.

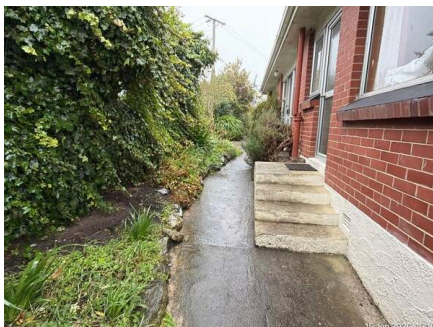
#242

- Due to the contour of the land, surface water will naturally run towards and/or under the dwelling. I recommend this area be monitored. During wet periods, if water buildup occurs on the property. Surface water upgrades would help reduce this.

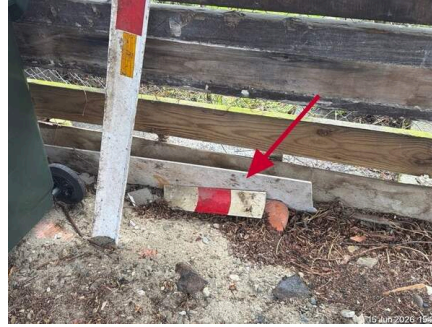
#245: Potential asbestos.
