## Visual Non-Invasive Property Inspection

21/05/2026

Phil Staunton

2 Chrystalwood Lane, Governors Bay

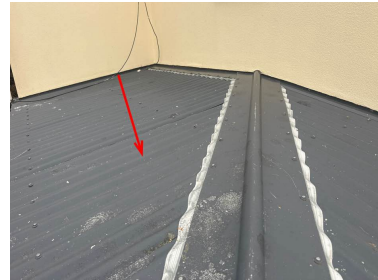
**Corrugated colour steel roofing**

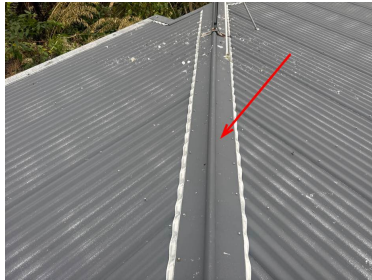
**Ridge and hip flashings**

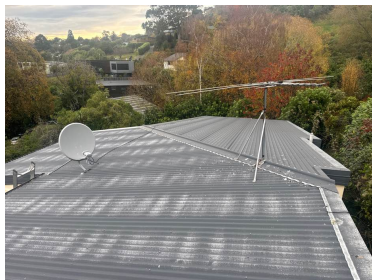
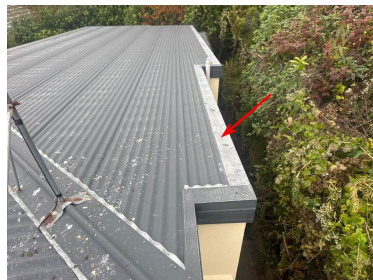
**Barge flashings**

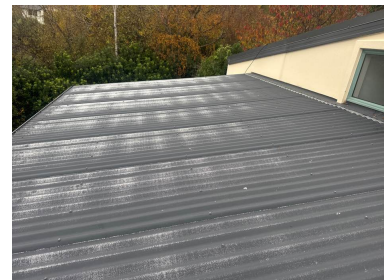
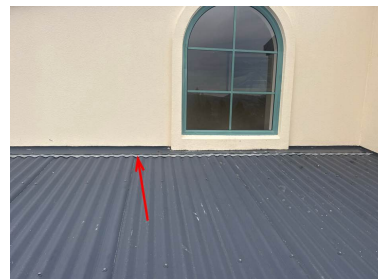
**Apron flashing**

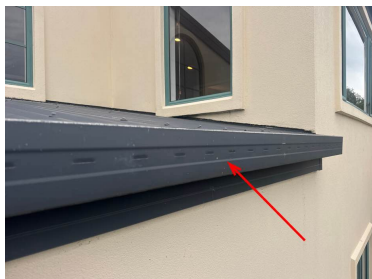
**Colour steel gutter system**

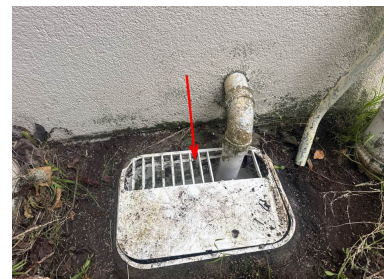
**Gully trap**

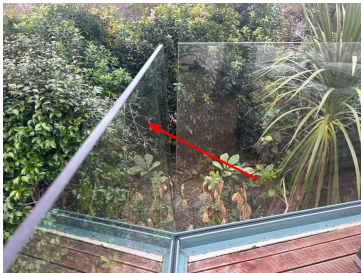
Glass Bella strain leaning out

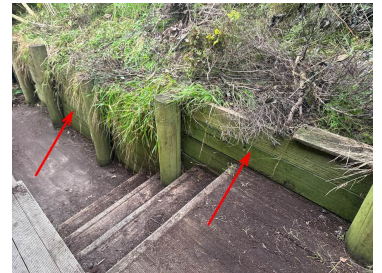
Retaining wall leaning out

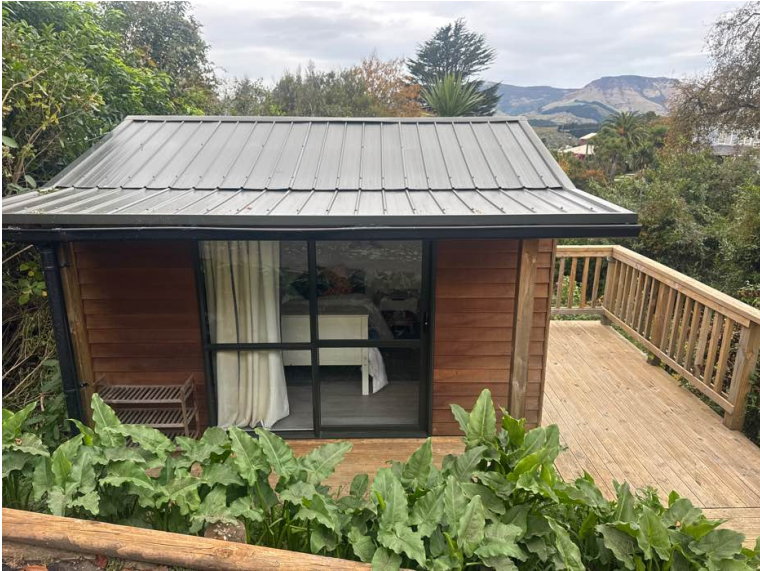
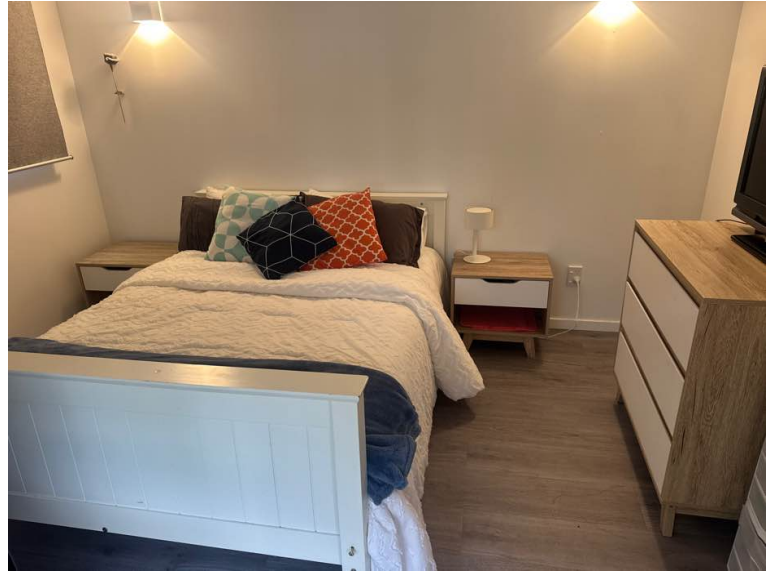
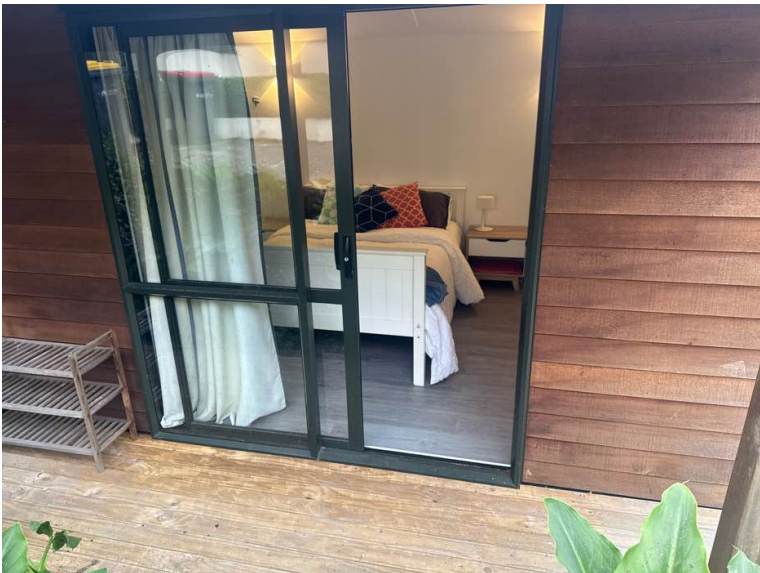
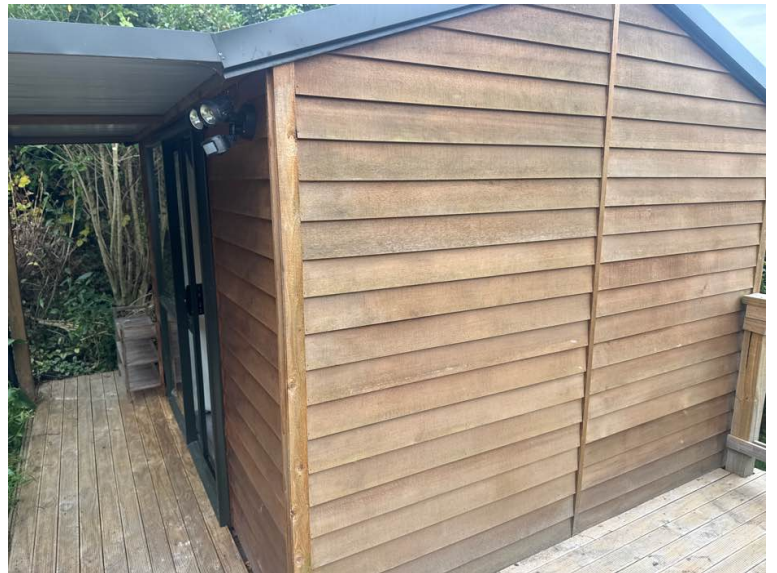
### Sheds/Sleepout

The detached sleepout is clad with cedar weatherboards and fitted with Coloursteel tray roofing. The exterior cladding and roofing appeared in generally good condition at the time of inspection, with no significant deterioration observed.

The single-glazed aluminium ranch slider entry door and small aluminium window were visually inspected and appeared to be operating as intended. Interior areas of the sleepout appear tidy, well maintained, and in generally good condition. Power was operational at the time of inspection. Floors felt stable under foot during the inspection, with no obvious movement noted internally.

No sufficient access was available to inspect the foundation or subfloor structure beneath the sleepout at the time of inspection, therefore the condition of supporting components could not be confirmed.

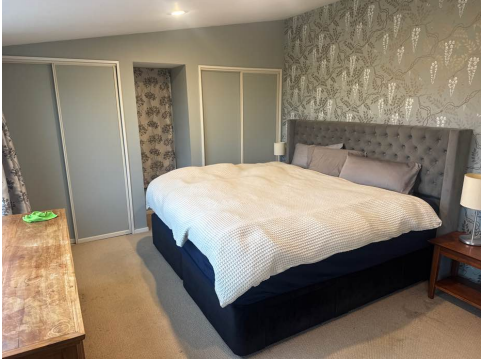
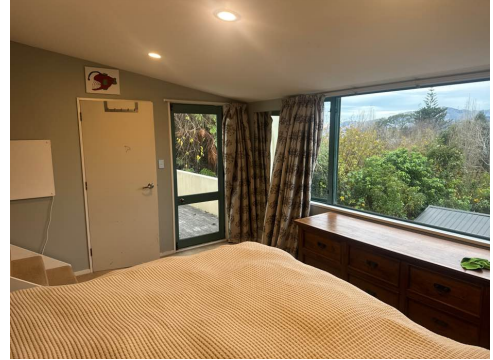
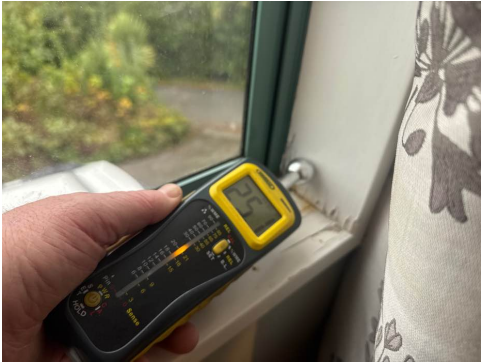
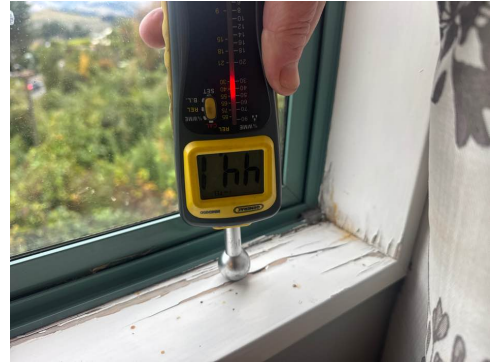
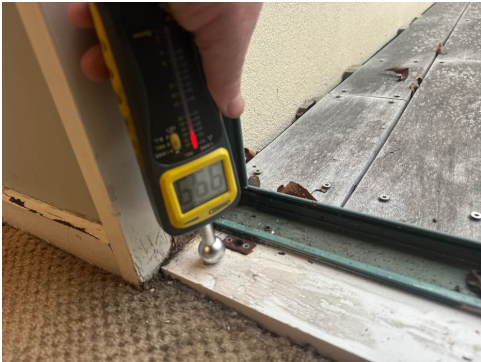
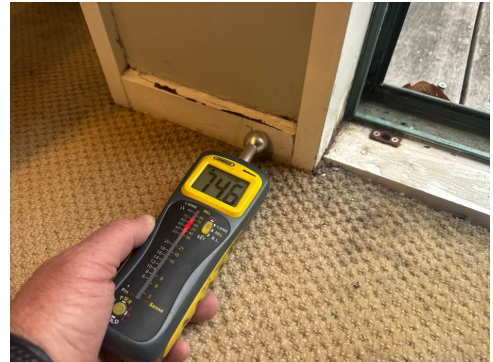
### Master Bedroom

The master bedroom is in generally fair to good condition for its age; however, the carpet is heavily worn and replacement is recommended due to staining, carpet moth damage, and general deterioration throughout the room.

Elevated moisture readings were detected around the front window frame, particularly to the lower sill areas and corners, along with elevated moisture readings to the sill and skirting areas beside the aluminium exterior door leading onto the deck. These areas require further investigation to determine the source of moisture ingress and assess whether remedial repairs are necessary. Refer to photos.

The entrance door has a damaged hole present requiring repair or replacement. Sliding wardrobe doors were tested and appeared to be functioning as intended at the time of inspection.

- Investigate elevated moisture readings around front window and exterior door areas.
- Repair any identified moisture ingress defects and reseal as required.
- Replace damaged and heavily worn carpet.
- Repair or replace damaged entrance door surface.

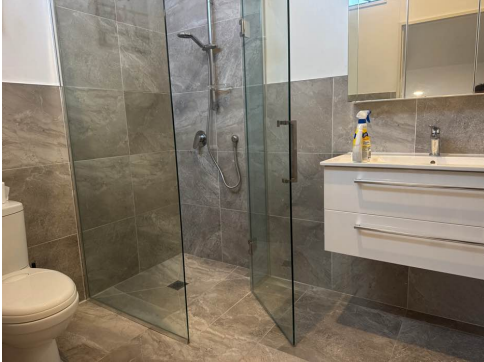
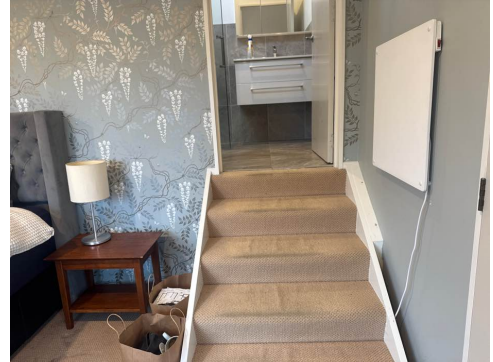
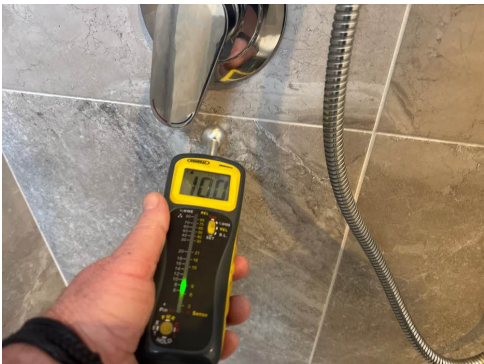
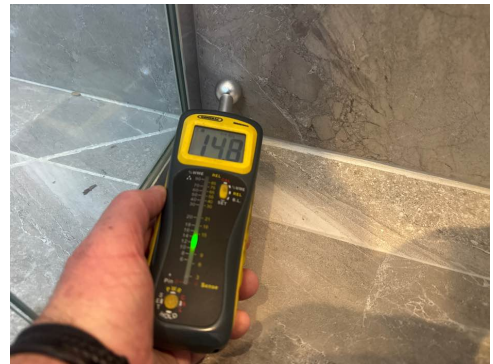
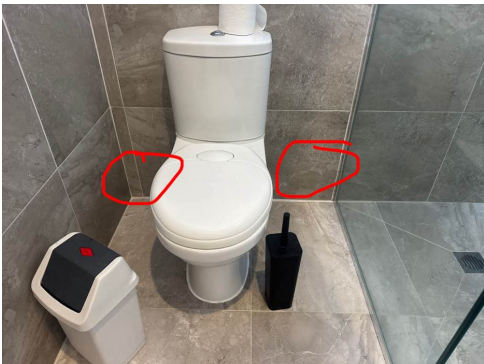
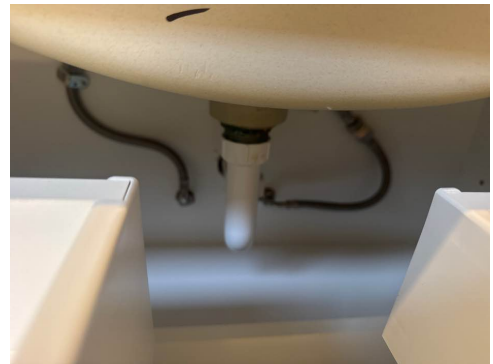
### Ensuite

A visible crack is present on the wall area above the door frame. Repair is recommended to prevent further deterioration. Refer to photo.

Very high moisture content in these areas

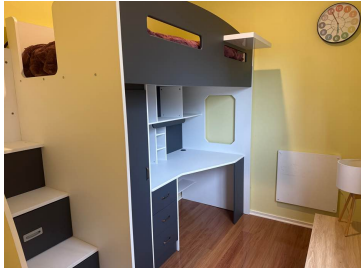
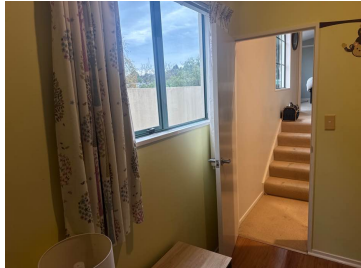
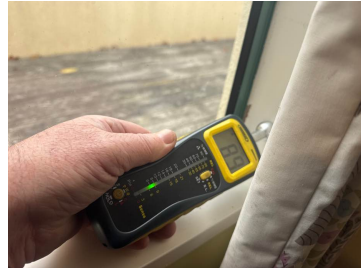
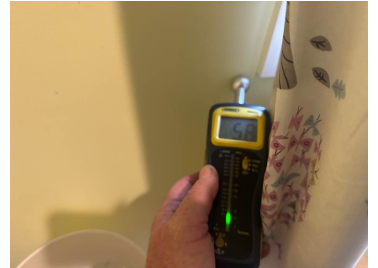
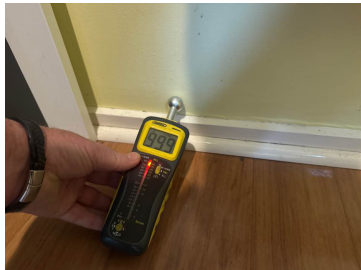
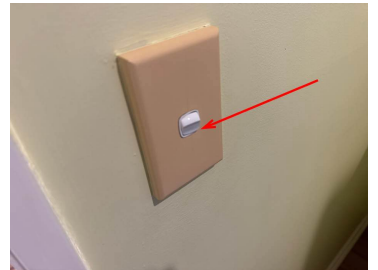
### Bedrooms

Very high moisture reading  
in this area bunk room

Switch needs replacing

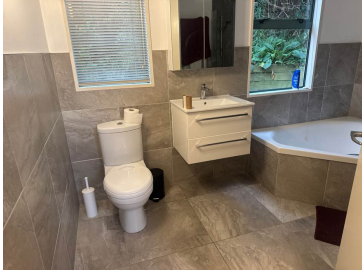
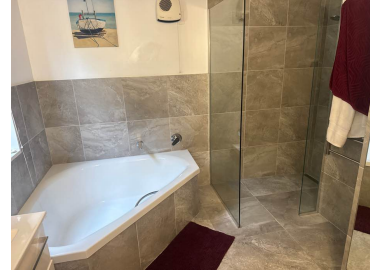
### Master Bathroom

Significant water damage backing onto the shower

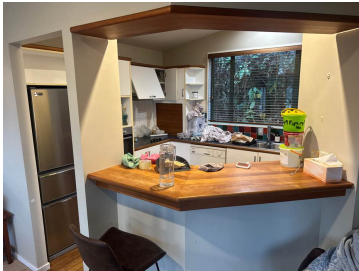
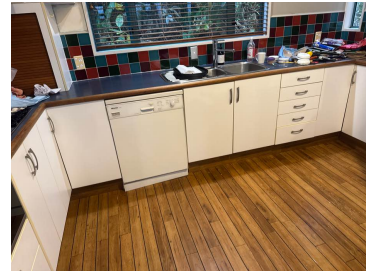
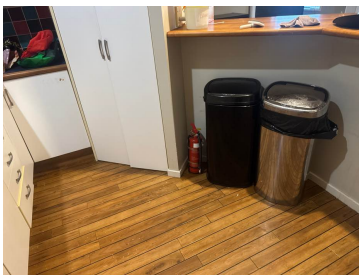
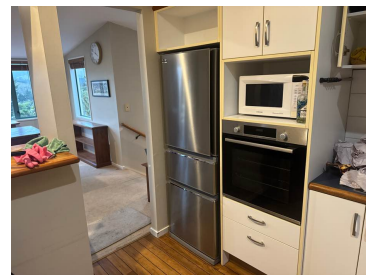
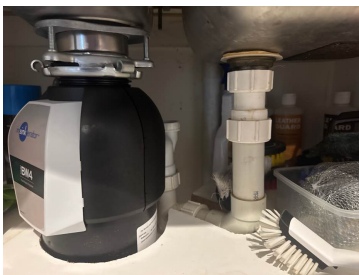
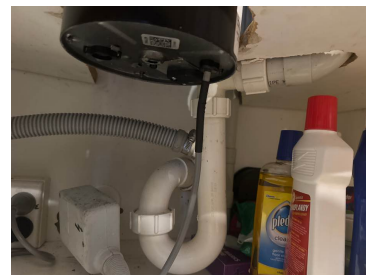
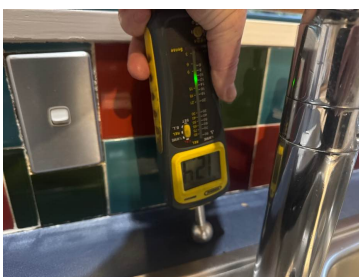
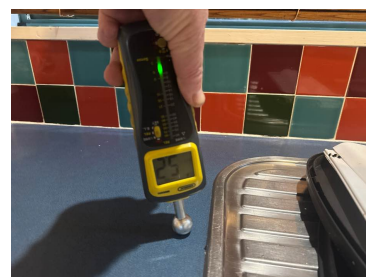
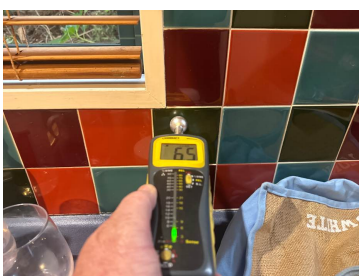
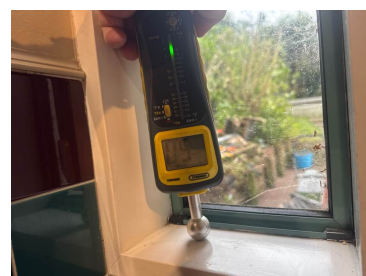
### Kitchen

The kitchen is in generally good condition for its age. Cabinetry, benchtops, sink, tapware, and plumbing fixtures appeared serviceable and functioning as intended at the time of inspection. No leaks were observed beneath the sink area during the visual inspection.

Wall and ceiling surfaces appeared generally tidy, with no significant defects noted within the kitchen area. Moisture testing was carried out to relevant accessible risk areas, with no elevated moisture readings detected at the time of inspection.

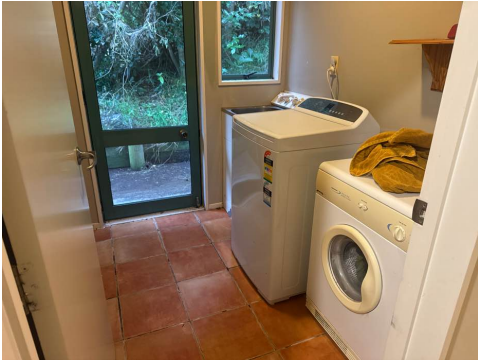
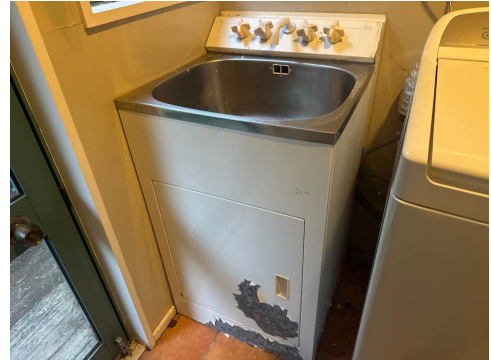
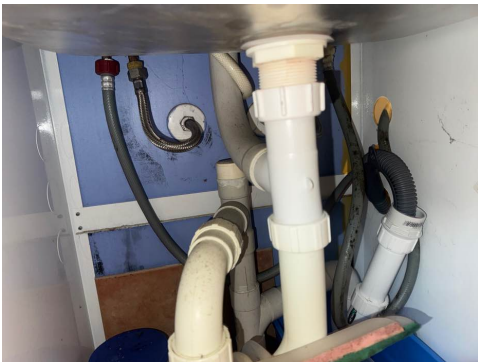
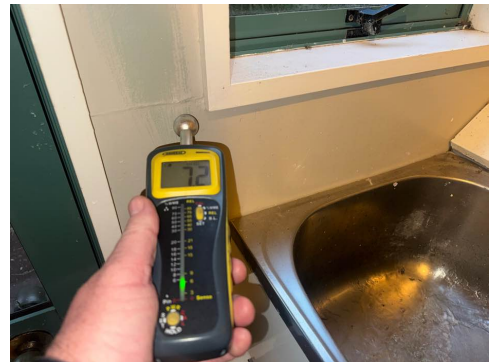
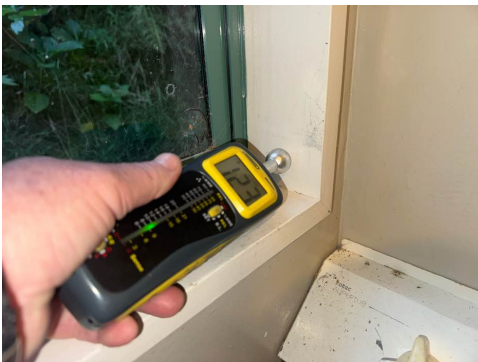
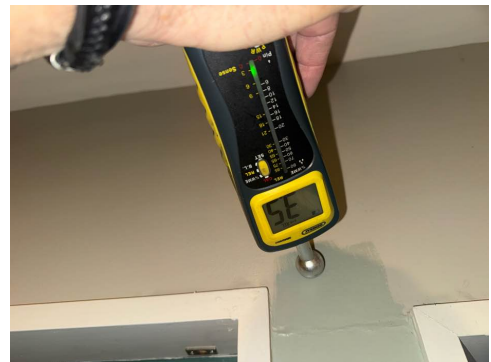
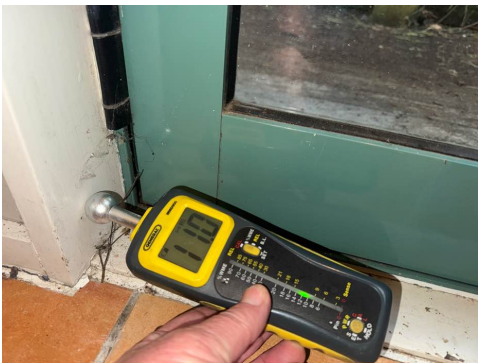
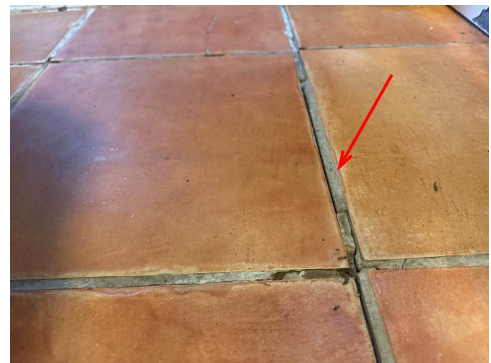
### Laundry

The laundry is serviceable and generally functional; however, the tiled surfaces show significant deterioration to mortar joints and grout lines in areas. Maintenance and regrouting are recommended to help prevent future moisture penetration and further deterioration.

The laundry tub shows significant surface wear and deterioration consistent with age and use; however, it remains functional at the time of inspection. No leaks were observed beneath the tub during the visual inspection.

The rear exterior door was tested and appeared to be opening and closing adequately at the time of inspection. Moisture testing was carried out to relevant accessible risk areas, with no elevated moisture readings detected.

- Repair and regrout deteriorated tile mortar joints.
- Consider replacement or resurfacing of deteriorated laundry tub over time.

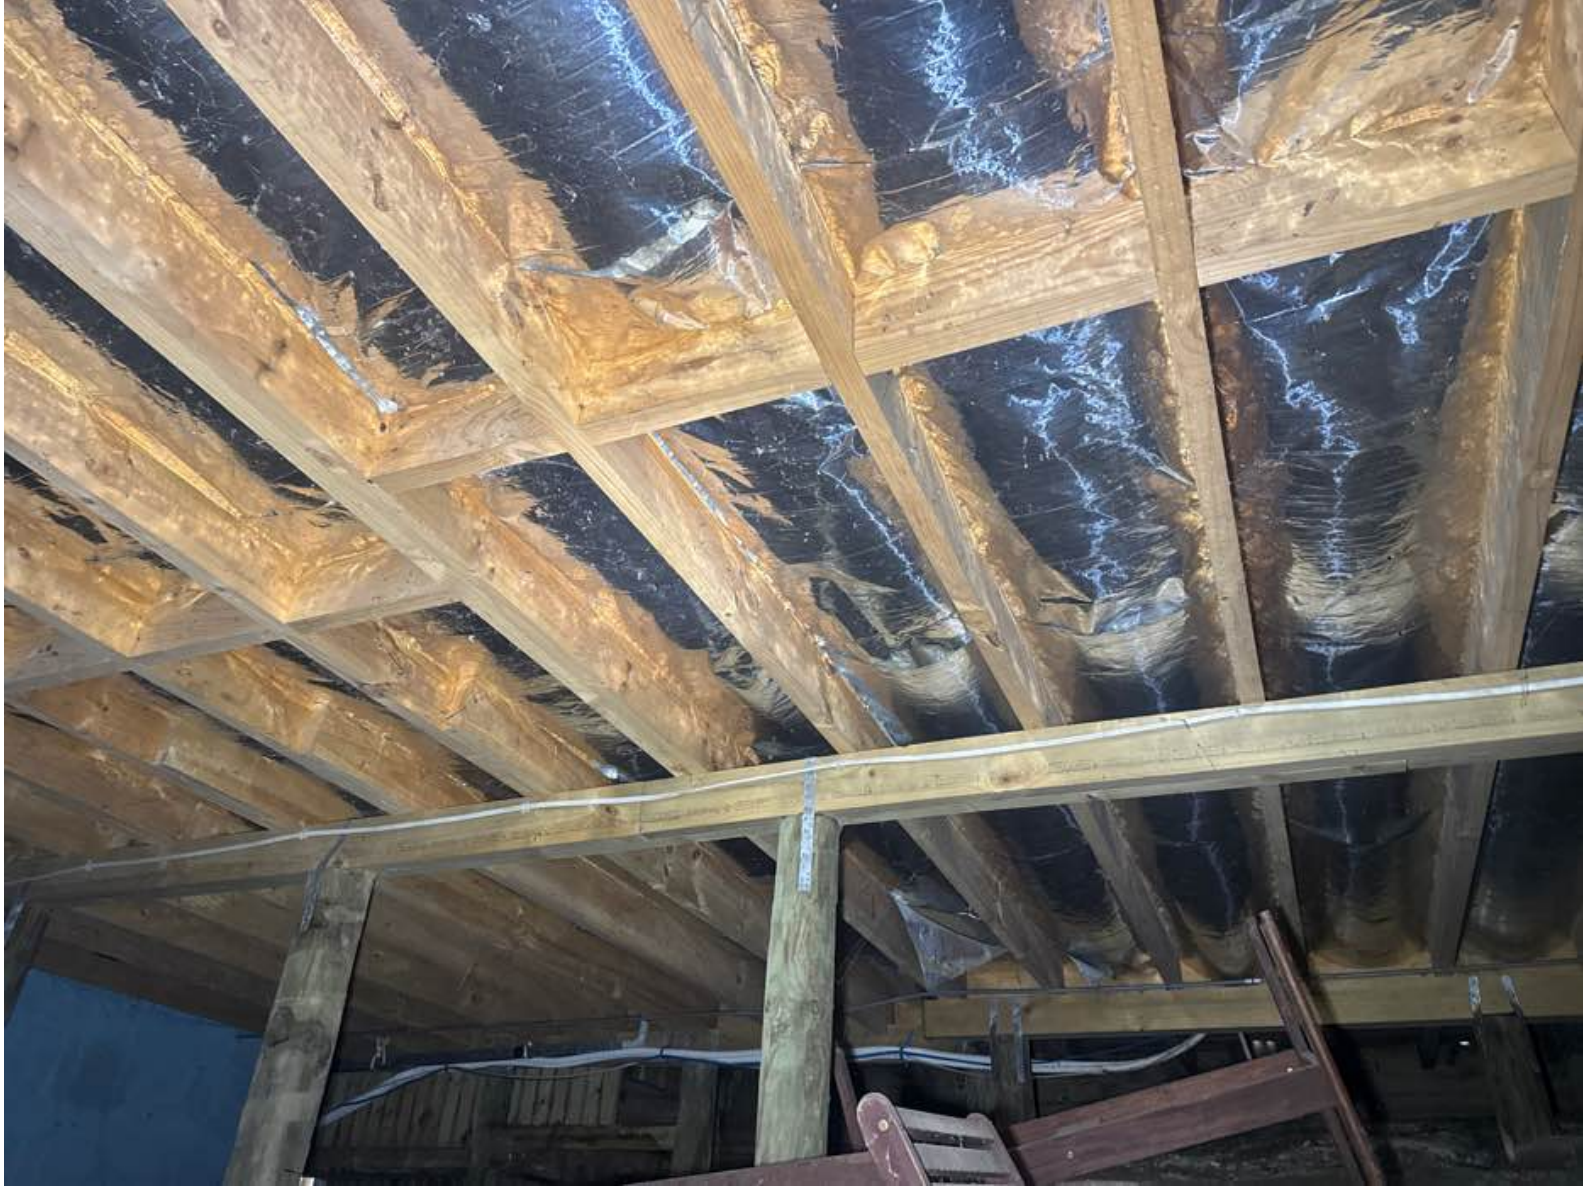
### Insulation

Foil insulation was observed installed beneath the timber floor structure, stapled to the underside of the floor joists. This older style of insulation provides limited thermal performance compared to modern insulation systems. Although still present, improved thermal efficiency would be achieved by installing modern insulation blanket or batt systems beneath the floor structure.

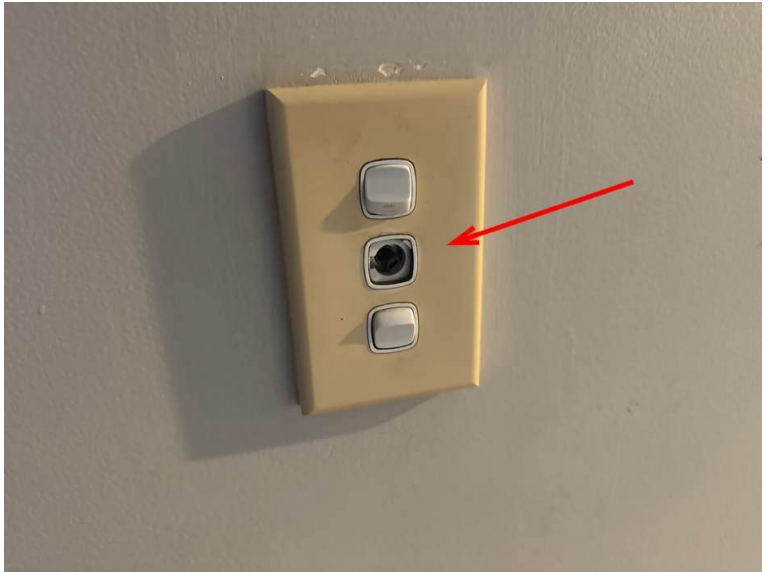
## Electrical

The switchboard was visually inspected and appears in generally good condition at the time of inspection. Visible switches, power sockets, and light fittings throughout the house generally appeared sound and functioning as intended.

A small number of switches and power points were noted to be slightly loose and may require minor repair or tightening by a qualified electrician.

- Repair or secure loose switches

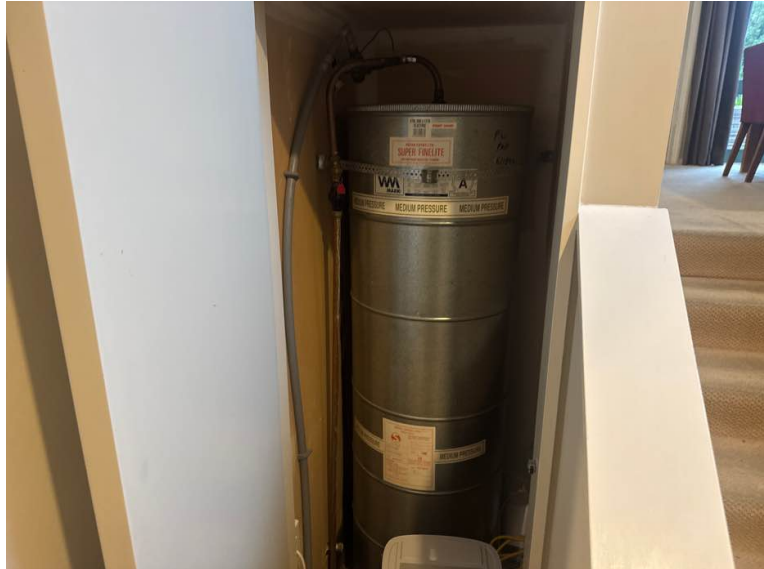
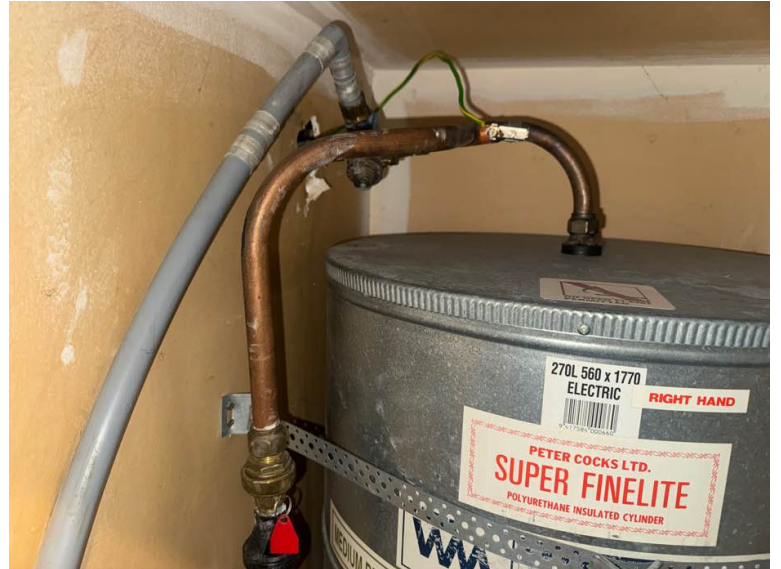
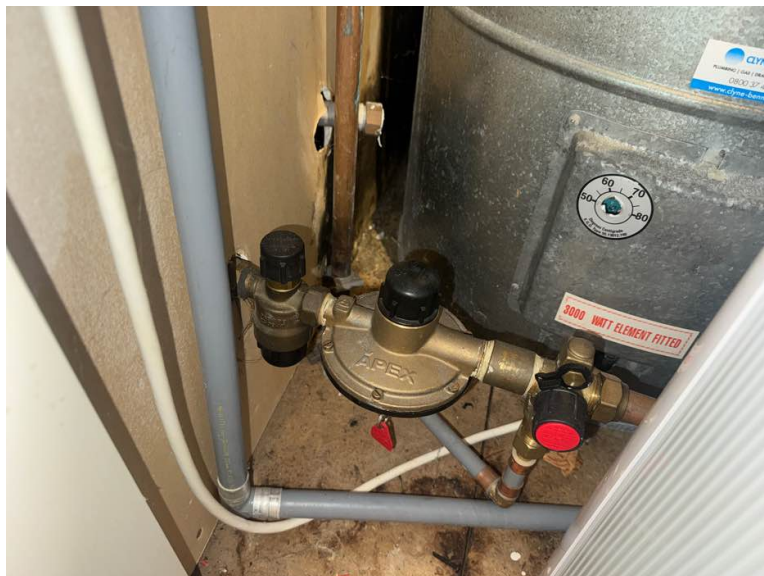
### Hot Water

**Comments** The hot water cylinder was visually inspected and appears in generally good condition at the time of inspection. The cylinder and associated visible pipework appeared secure, with no significant deterioration or leakage observed during the inspection.
